**GROUNDWATER AND STREAM ASSESSMENT REPORT
MERCHANTS METALS**

Statesville, Iredell County, North Carolina

**ESI Project ER10-125.02
August 26, 2011**

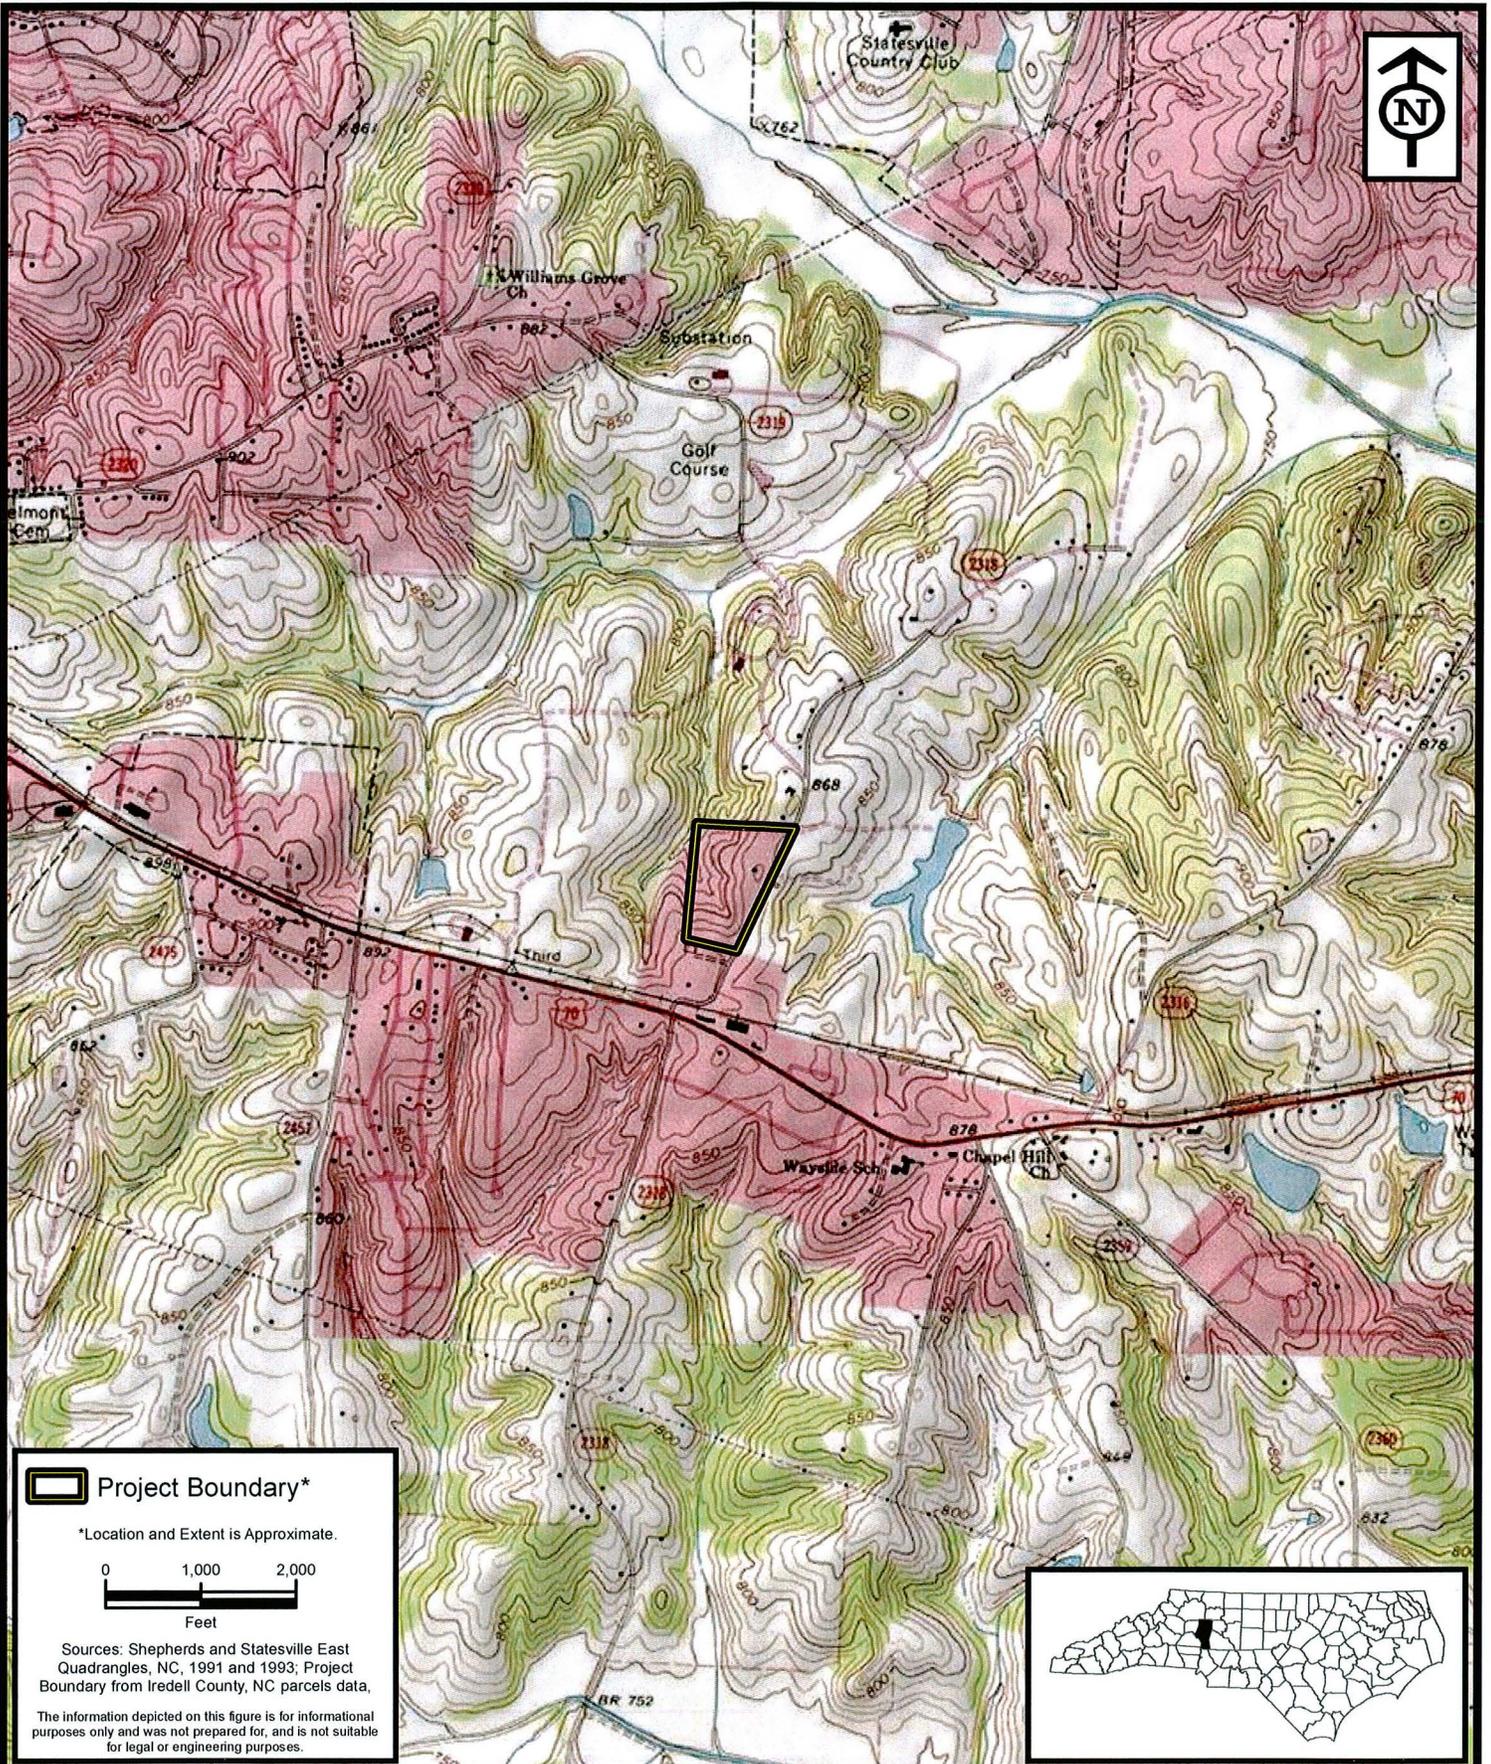
Project:	ER10125.02
Date:	Aug 2011
Drwn/Chkd:	KT/MB
Figure:	1

Project Location
Merchants Metals
Iredell County, North Carolina

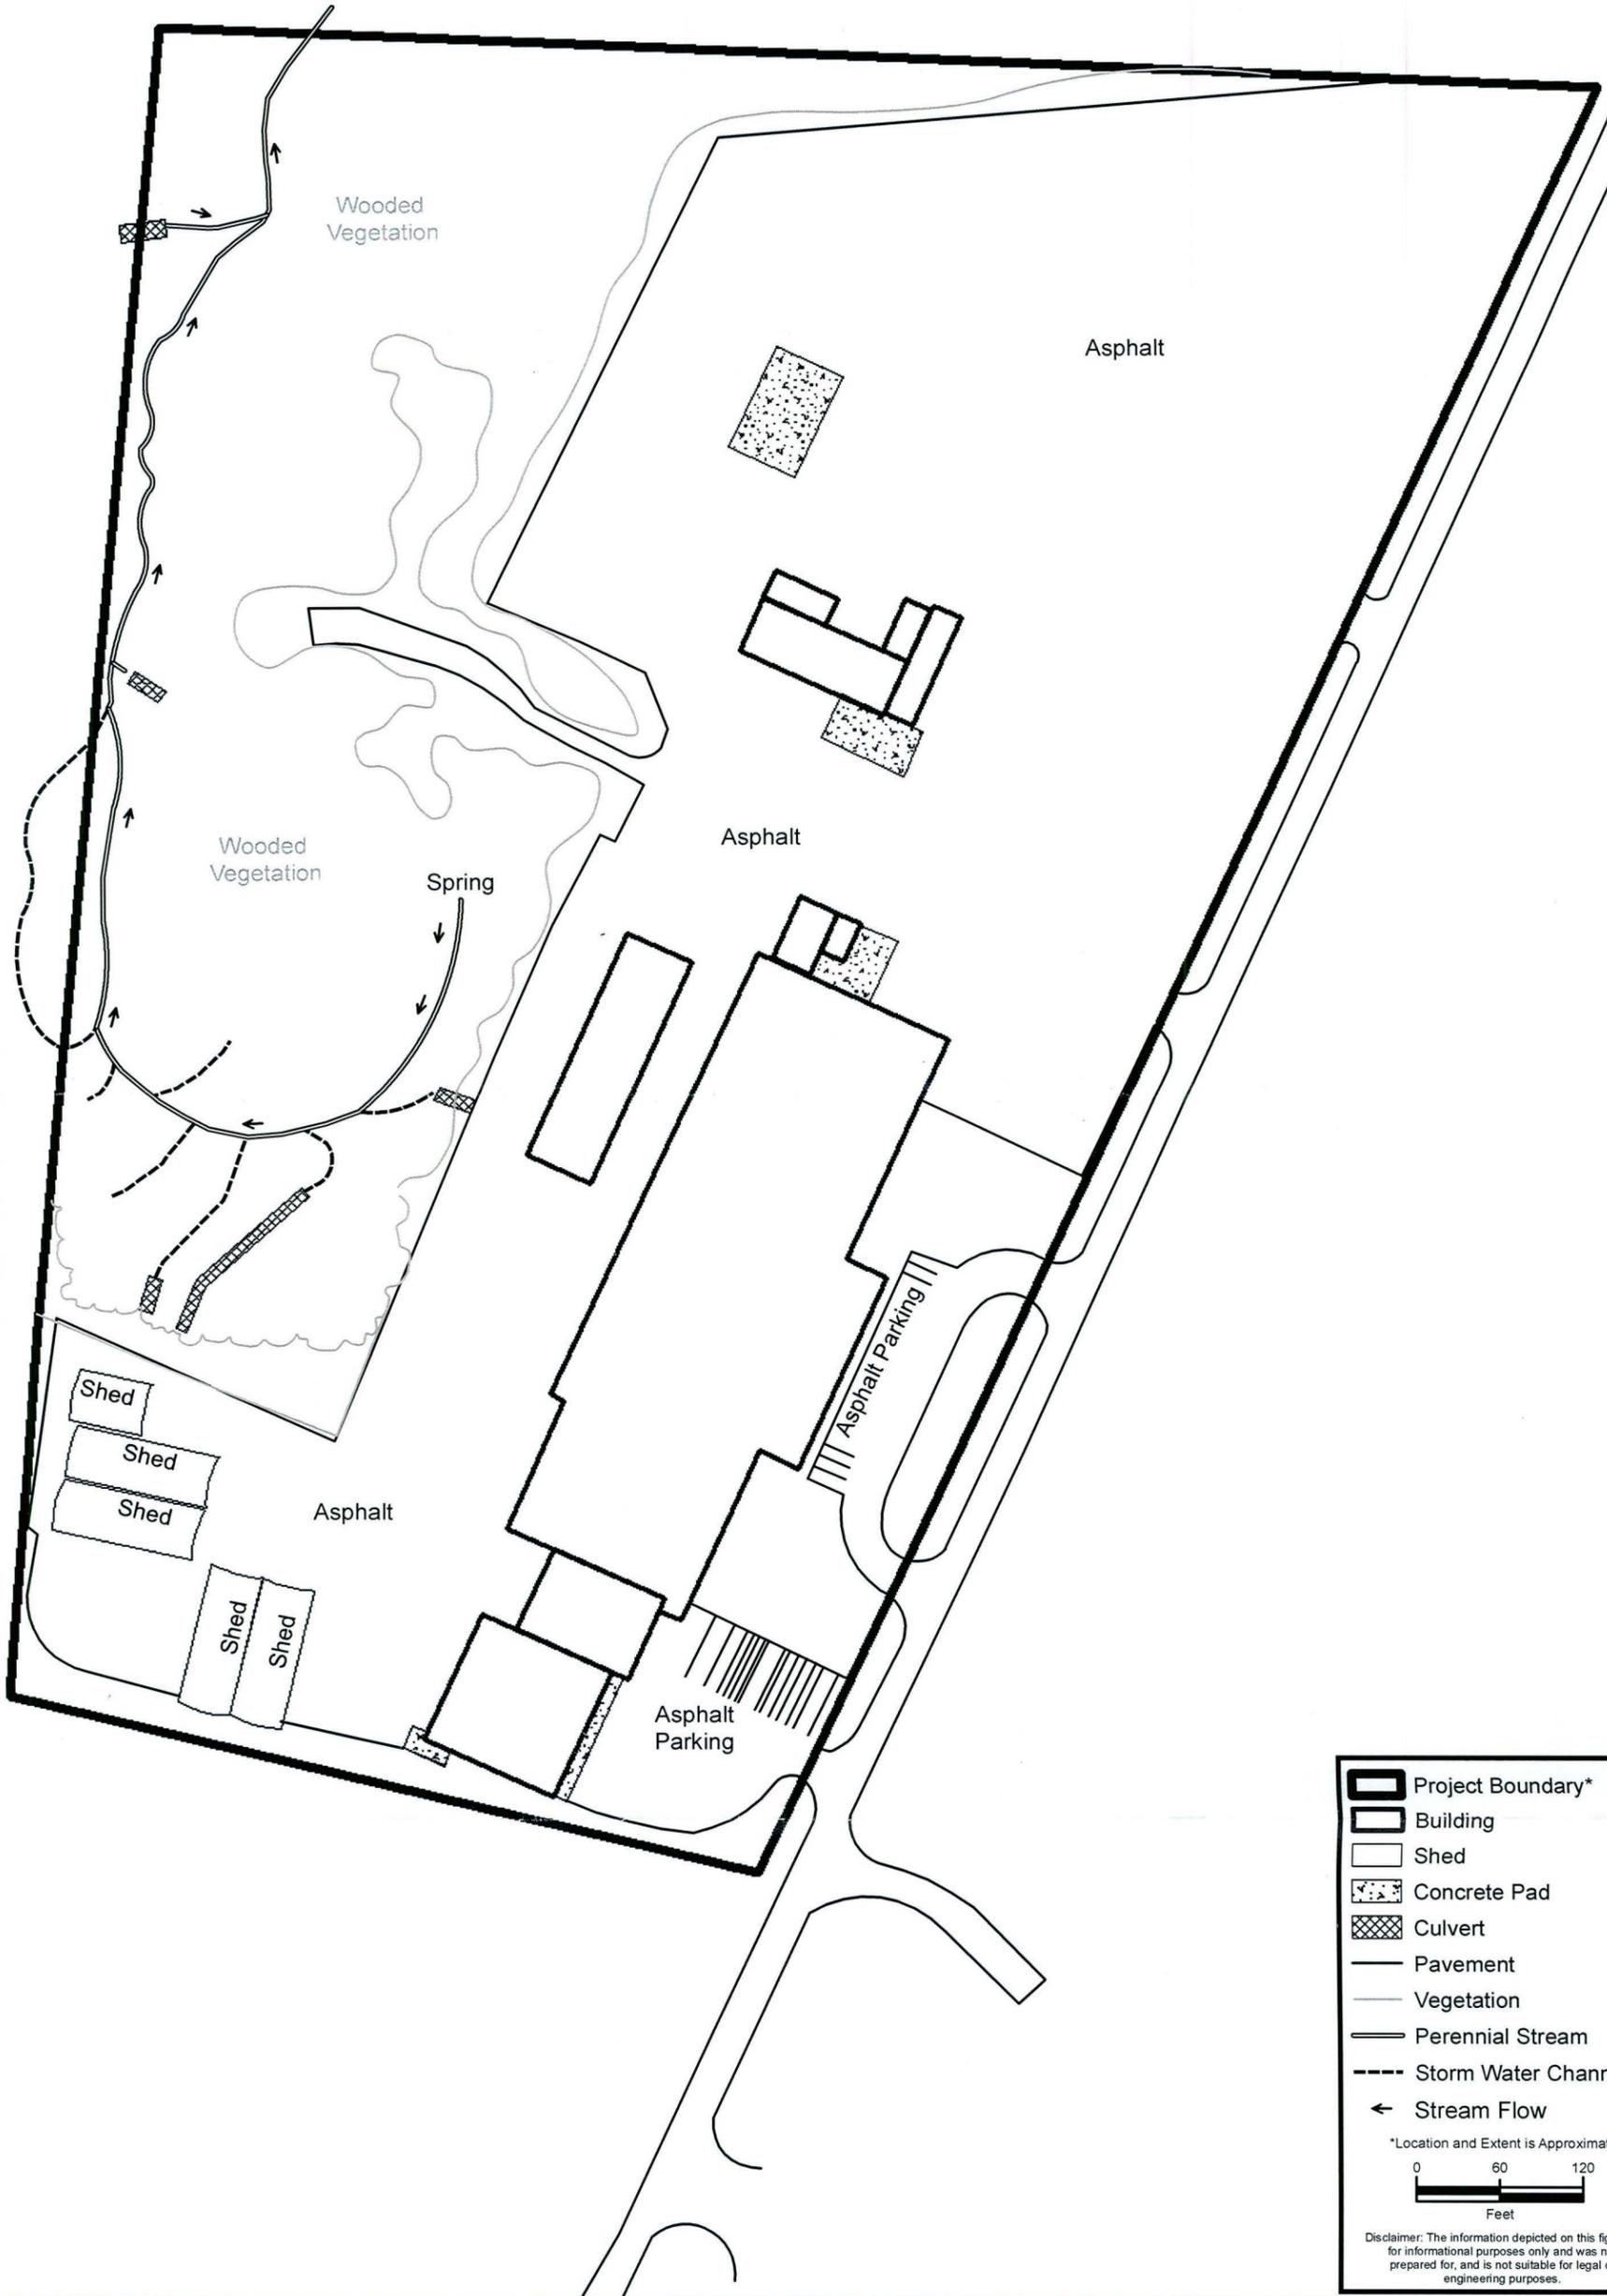
Project:	ER10125.02
Date:	Aug. 2011
Drwn/Chkd:	KT/MB
Figure:	2

Site Plan
Merchants Metal
Iredell County, North Carolina

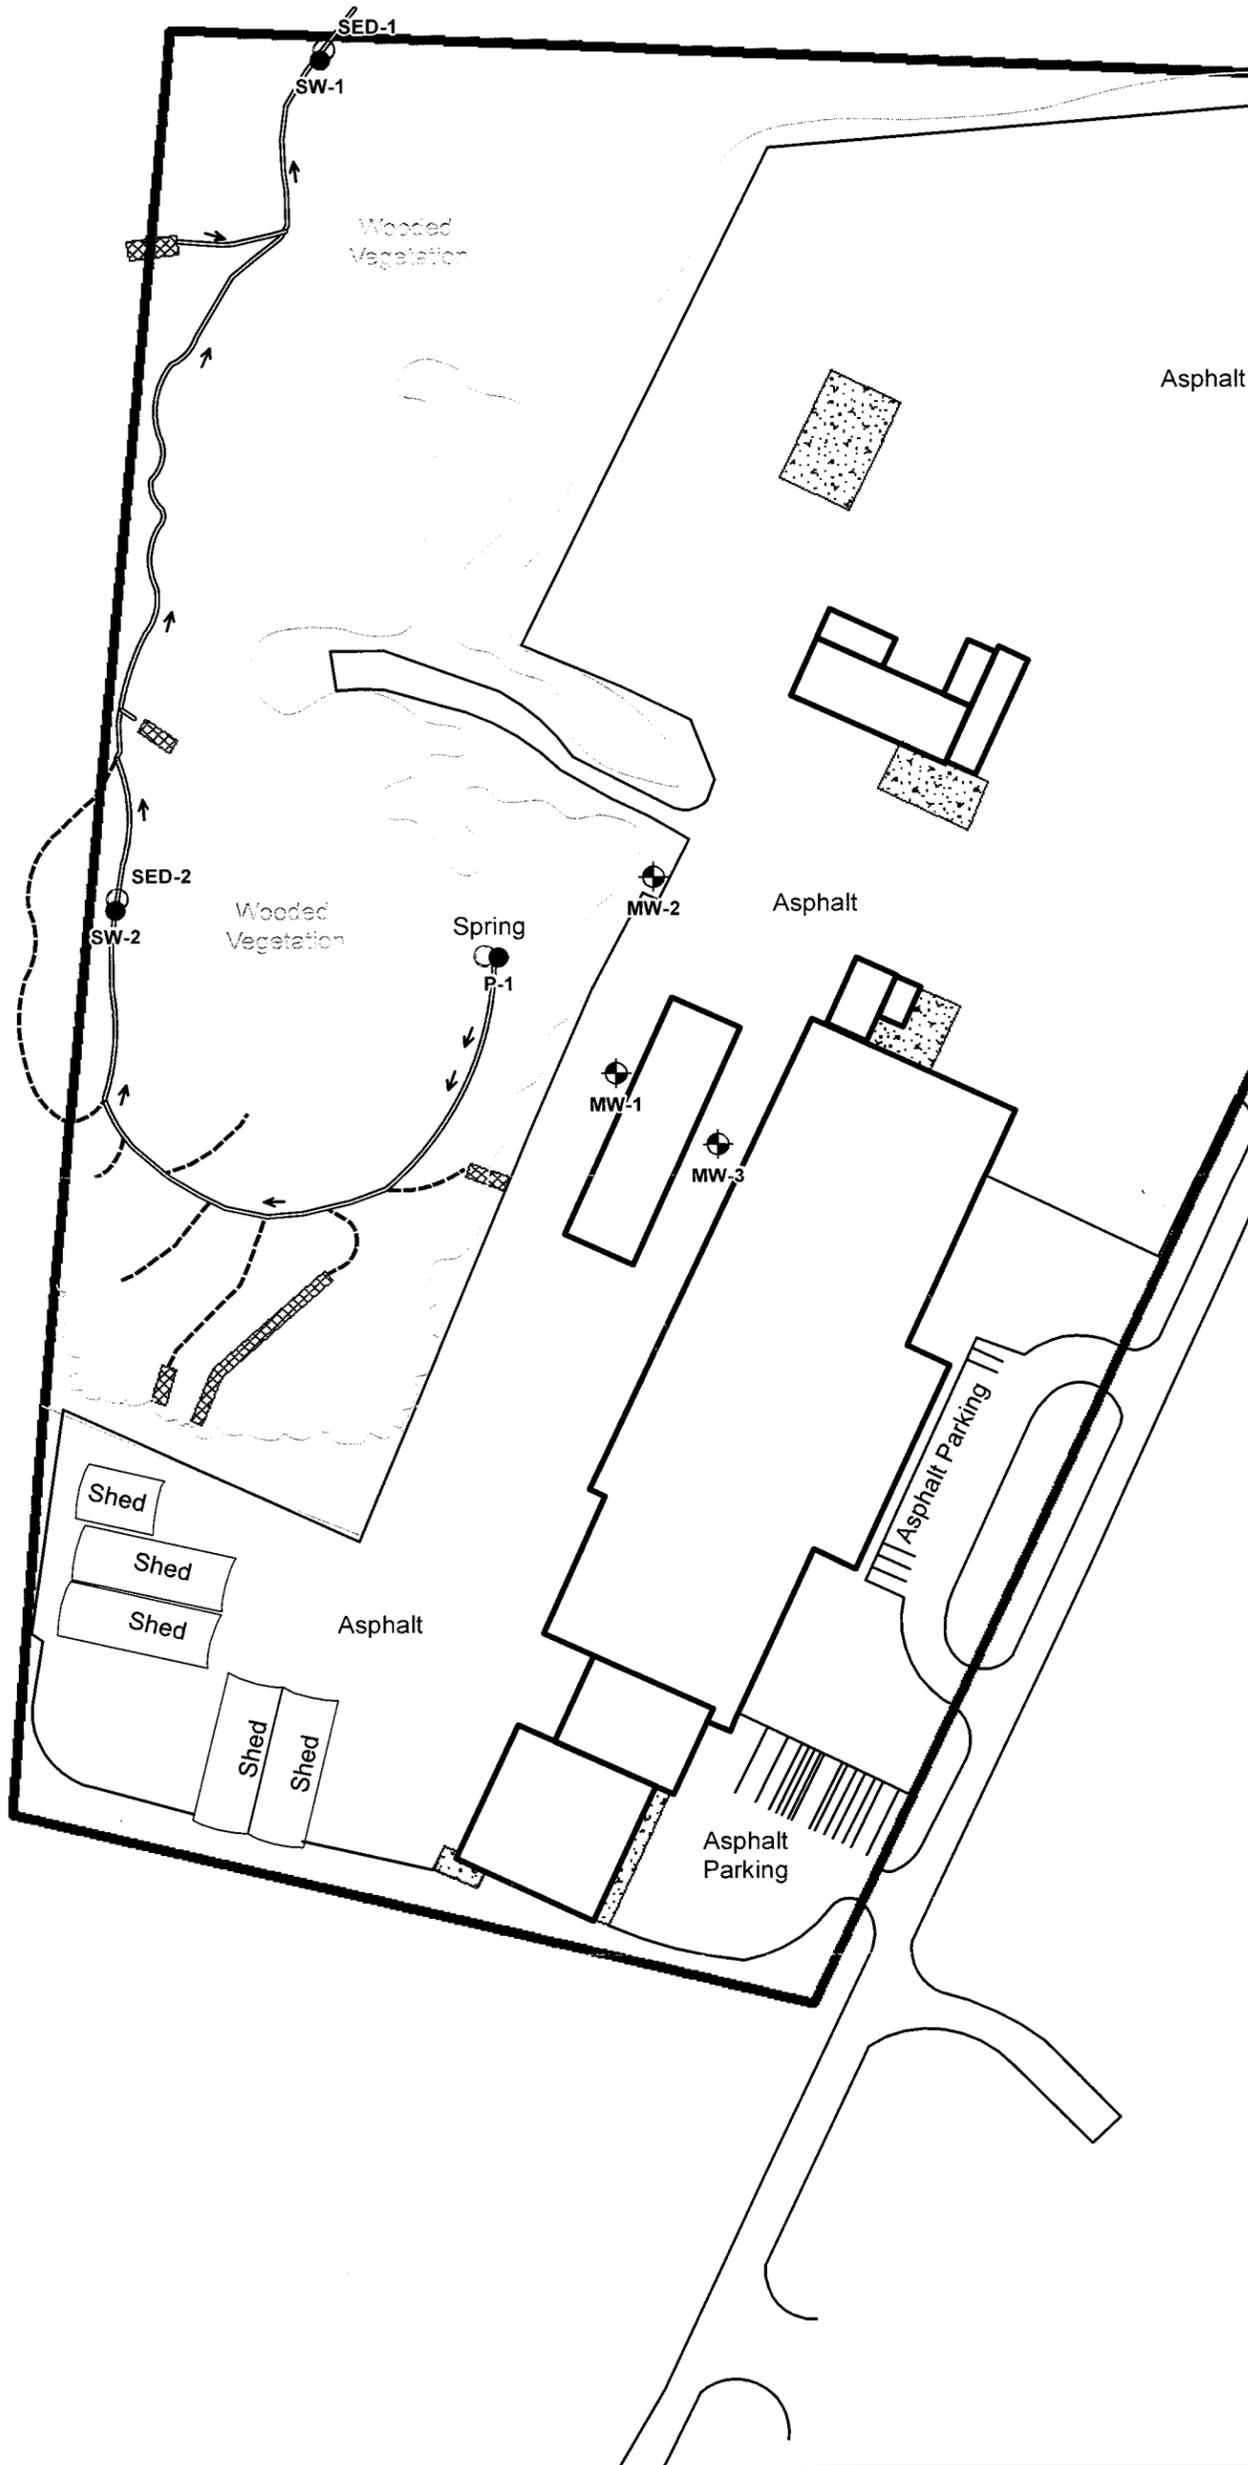
Project: ER10125.02
Date: Aug. 2011
Drwn/Chkd: KT/MB
Figure: 3

Sample Locations
Merchants Metal
Iredell County, North Carolina

Since the spring appeared to be where some of the stream flow originated on the site, ESI personnel collected a water sample (P-1/GW) and a sediment sample (P-1/SED). There was buried fence materials, empty drums and other debris noted in the area where the spring originated. The spring samples were collected and submitted for laboratory analysis for zinc, lead and cadmium per SW846-6010C. The water samples included SM-3030C preparation. **Figure 3** in **Appendix 1** shows the approximate location of the spring and sample locations.

After collecting the spring samples, ESI personnel collected surface water and sediment samples at an area south of a large four feet diameter drainage culvert and along the stream at the northern *property* line (downstream). The sample locations are presented on **Figure 3** in **Appendix 1**. The surface water samples

no PVC glue or solvents will be used in the monitoring well construction. A sand pack of #2 torpedo sand was placed from the bottom of the soil boring to one foot above the well screen interval. A two foot thick layer of bentonite was placed above the sand pack. Cement grout was tremied into the soil boring to the ground surface. The well was constructed with a 2 foot by 2 foot concrete pad, with a flush-mount manhole cover and locking cap. The monitoring well construction logs and soil boring logs are included in the **Appendix 2**. The top of casing elevations were measured referencing monitoring well MW-1 as a datum of 100 feet. The monitoring well construction details are provided on **Table 1** in the **Appendix 3**. The monitoring well locations are provided as **Figure 3** in **Appendix 1**.

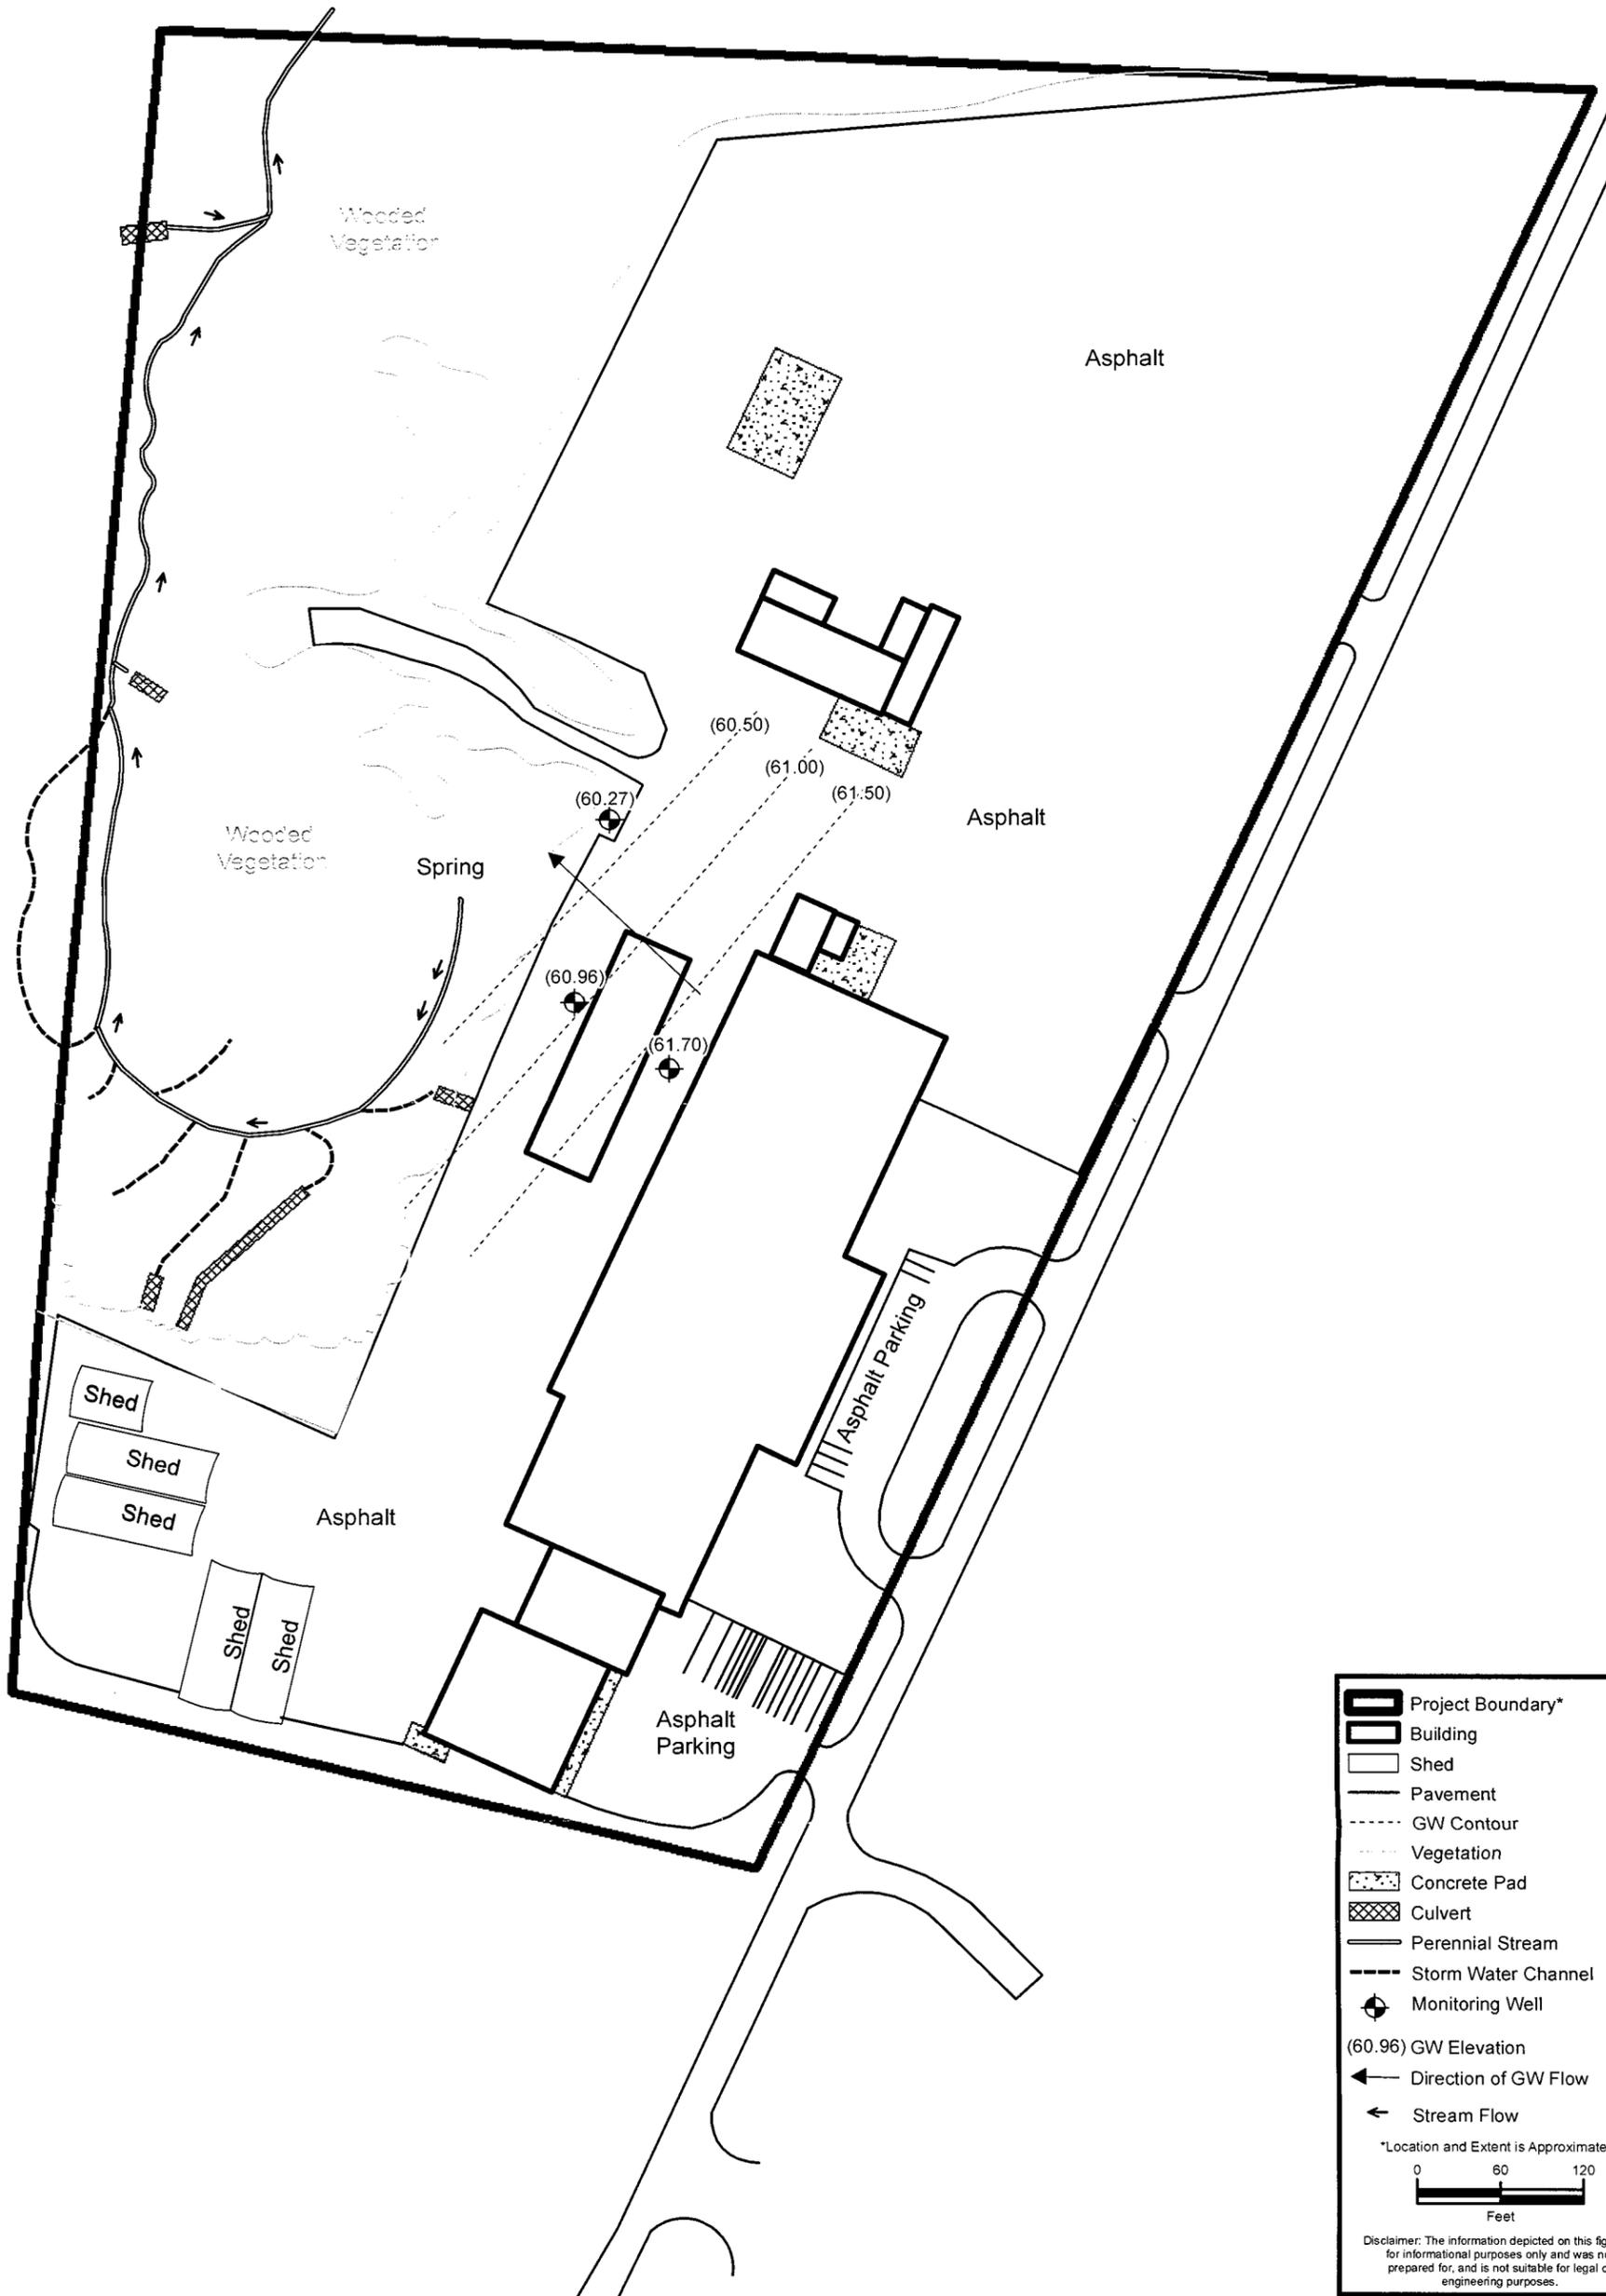
Project: ER10125.02
Date: Aug. 2011
Drwn/Chkd: KT/MB
Figure: 4

Groundwater Contours
Merchants Metal
Iredell County, North Carolina

Groundwater levels in the monitoring wells were measured using a Solinst water level meter capable of readings to 0.01 feet. The water level meter was decontaminated between measurements to prevent cross-contamination. The water level meter was lowered into the well until a tone sounded and the depth was recorded. Groundwater levels measured on June 23, 2011 in the monitoring well MW-1 was 39.04 feet bgs, MW-2 was 37.86 feet bgs, and MW-3 was 38.20 feet bgs. The groundwater level measurement data from the monitoring wells are provided on **Table 1** in **Appendix 3**. A groundwater contour map is provided as **Figure 4** in **Appendix 1**. Based on the groundwater elevation data collected on June 23, 2011, groundwater in the vicinity of the former galvanizing building appears to be flowing to the northwest.

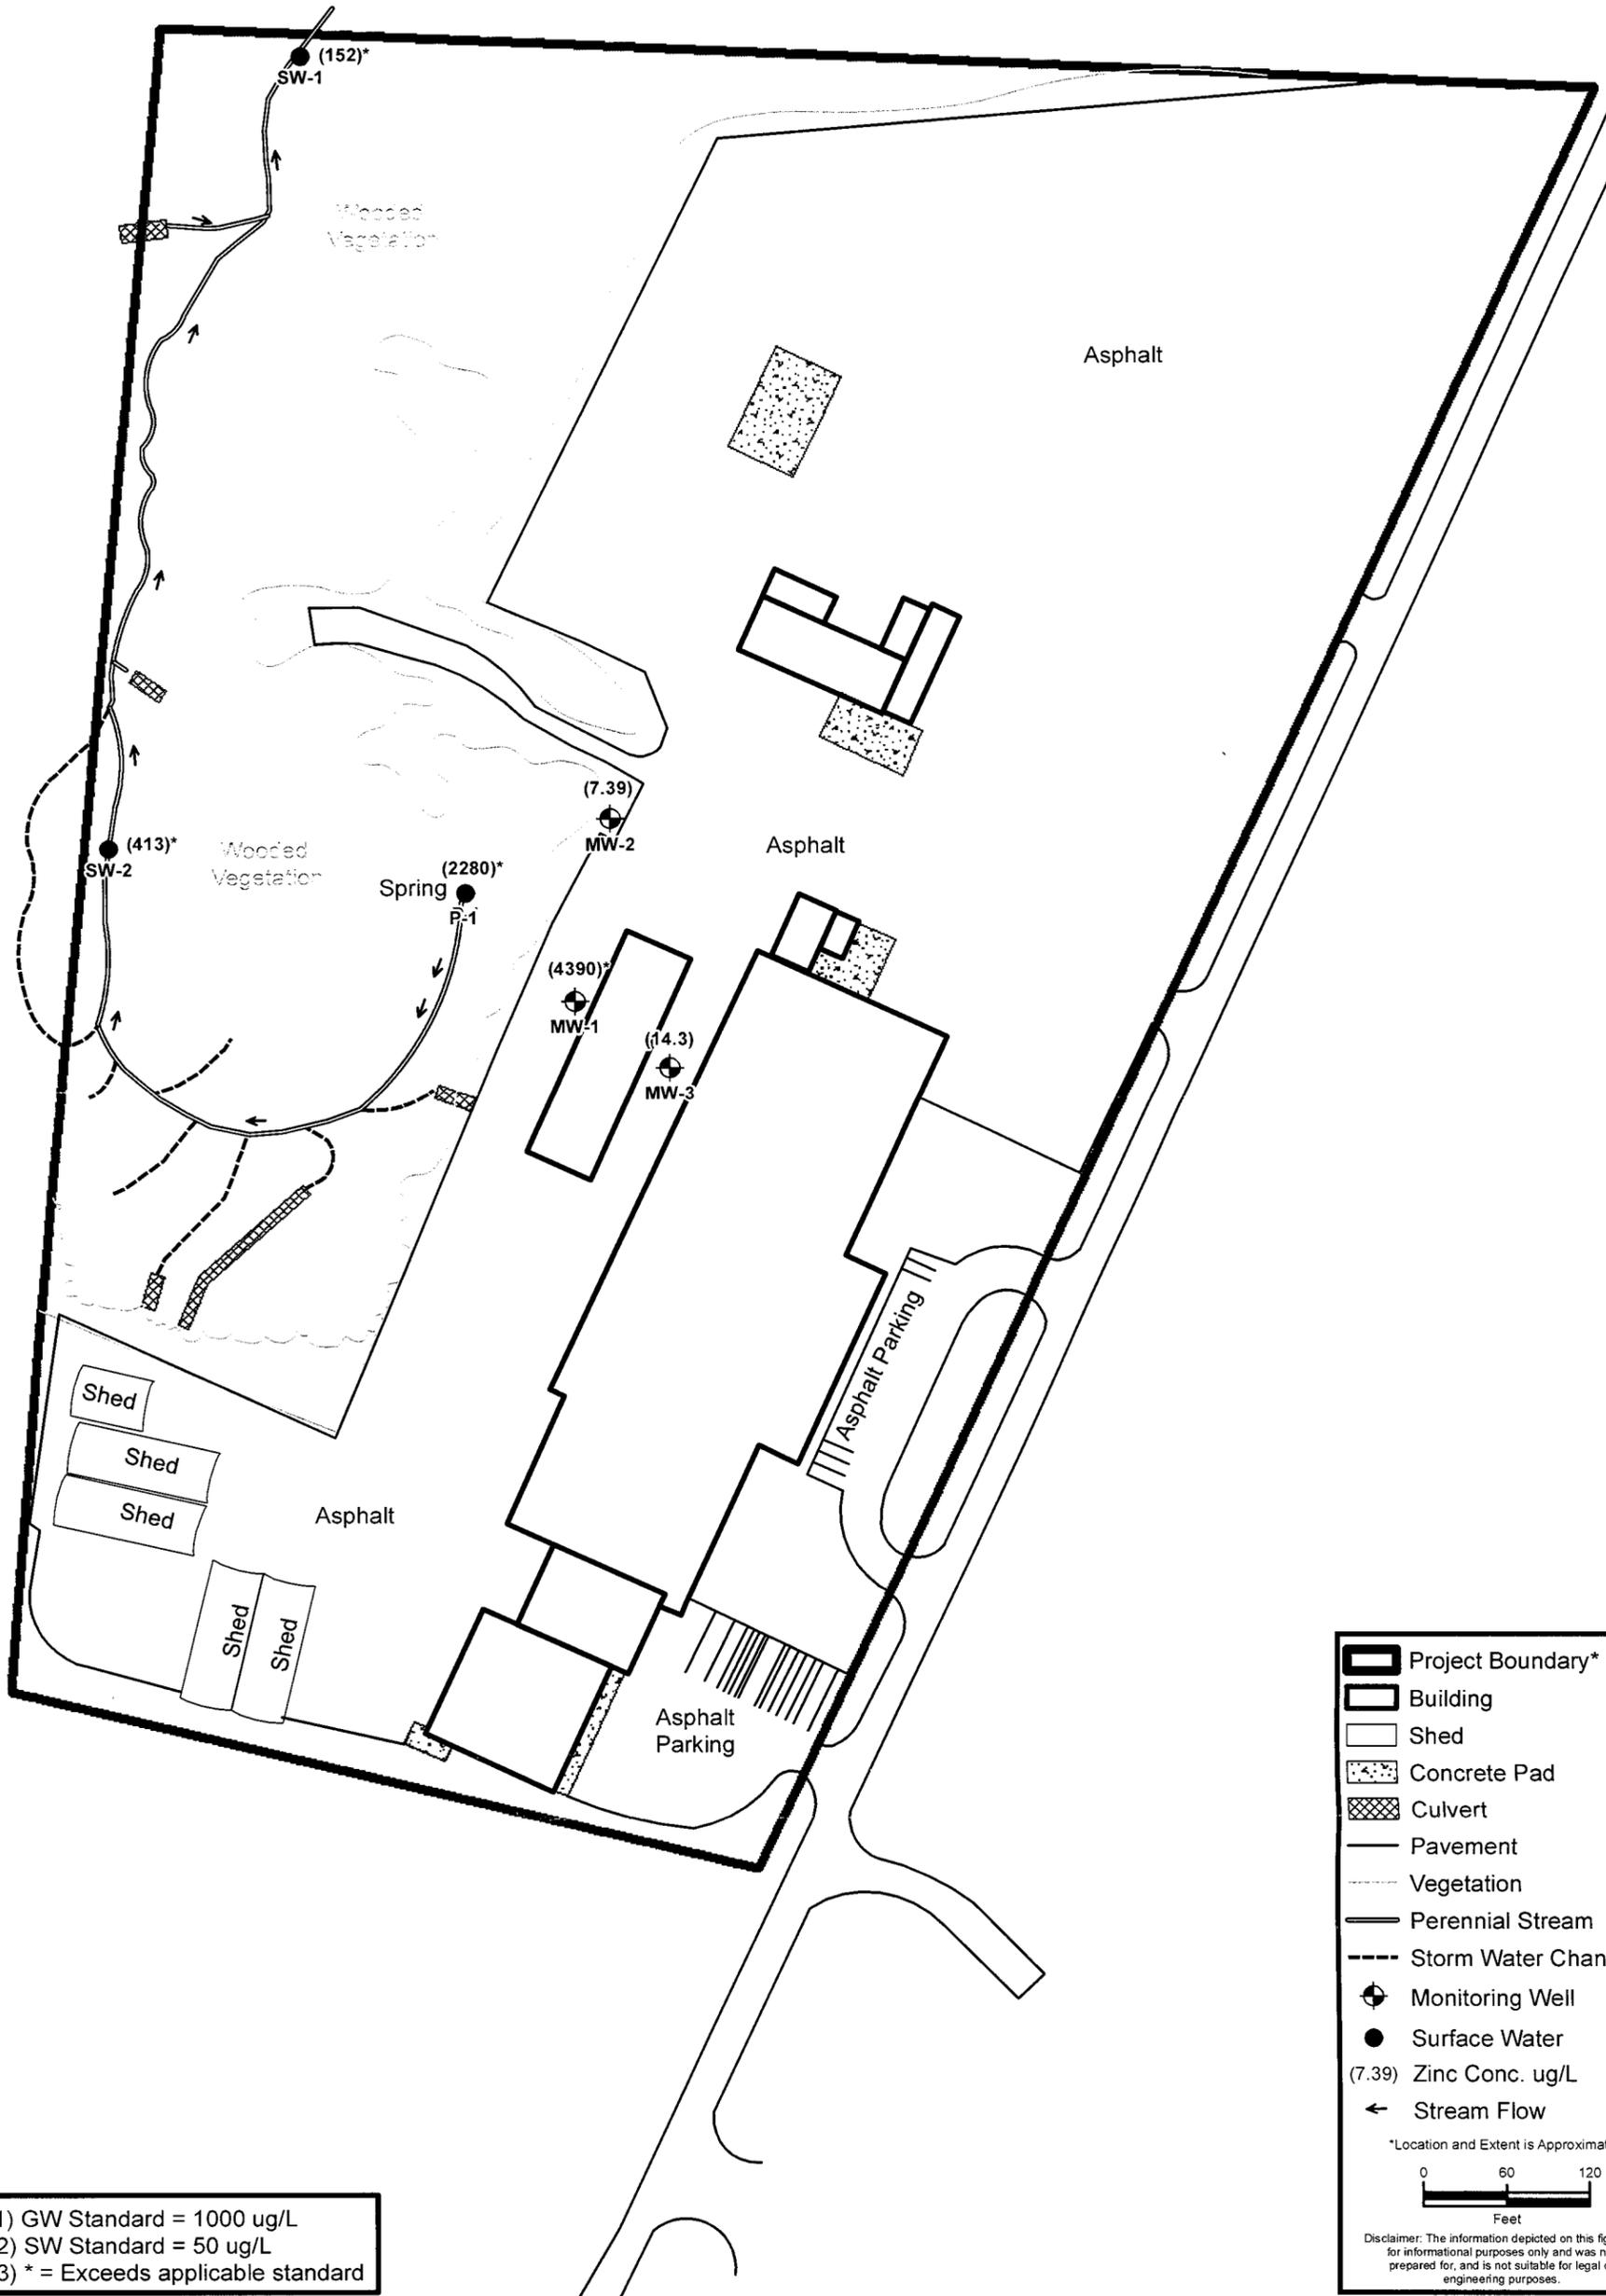
Project: ER10125.02
 Date: Aug. 2011
 Drwn/Chkd: KT/MB
 Figure: 5

Note: 1) GW Standard = 1000 ug/L
 2) SW Standard = 50 ug/L
 3) * = Exceeds applicable standard

Groundwater/ Surface Water Concentrations - Zinc
Merchants Metal
 Iredell County, North Carolina

- ✓ Zinc concentrations exceeded the NC 2B Standard of 50 micrograms per liter (ug/L) in sample locations P-1 (2280 ug/L), SW-2 (413 ug/L) and SW-1 (152 ug/L).

- ✓ Zinc concentrations exceeded the NC 2L of 1000 micrograms per liter (ug/L) in sample location MW-1 (4390 ug/L).
- ✓ Cadmium concentrations exceeded the NC 2L of 2 ug/L and in sample location MW-1 (2.6 ug/L).

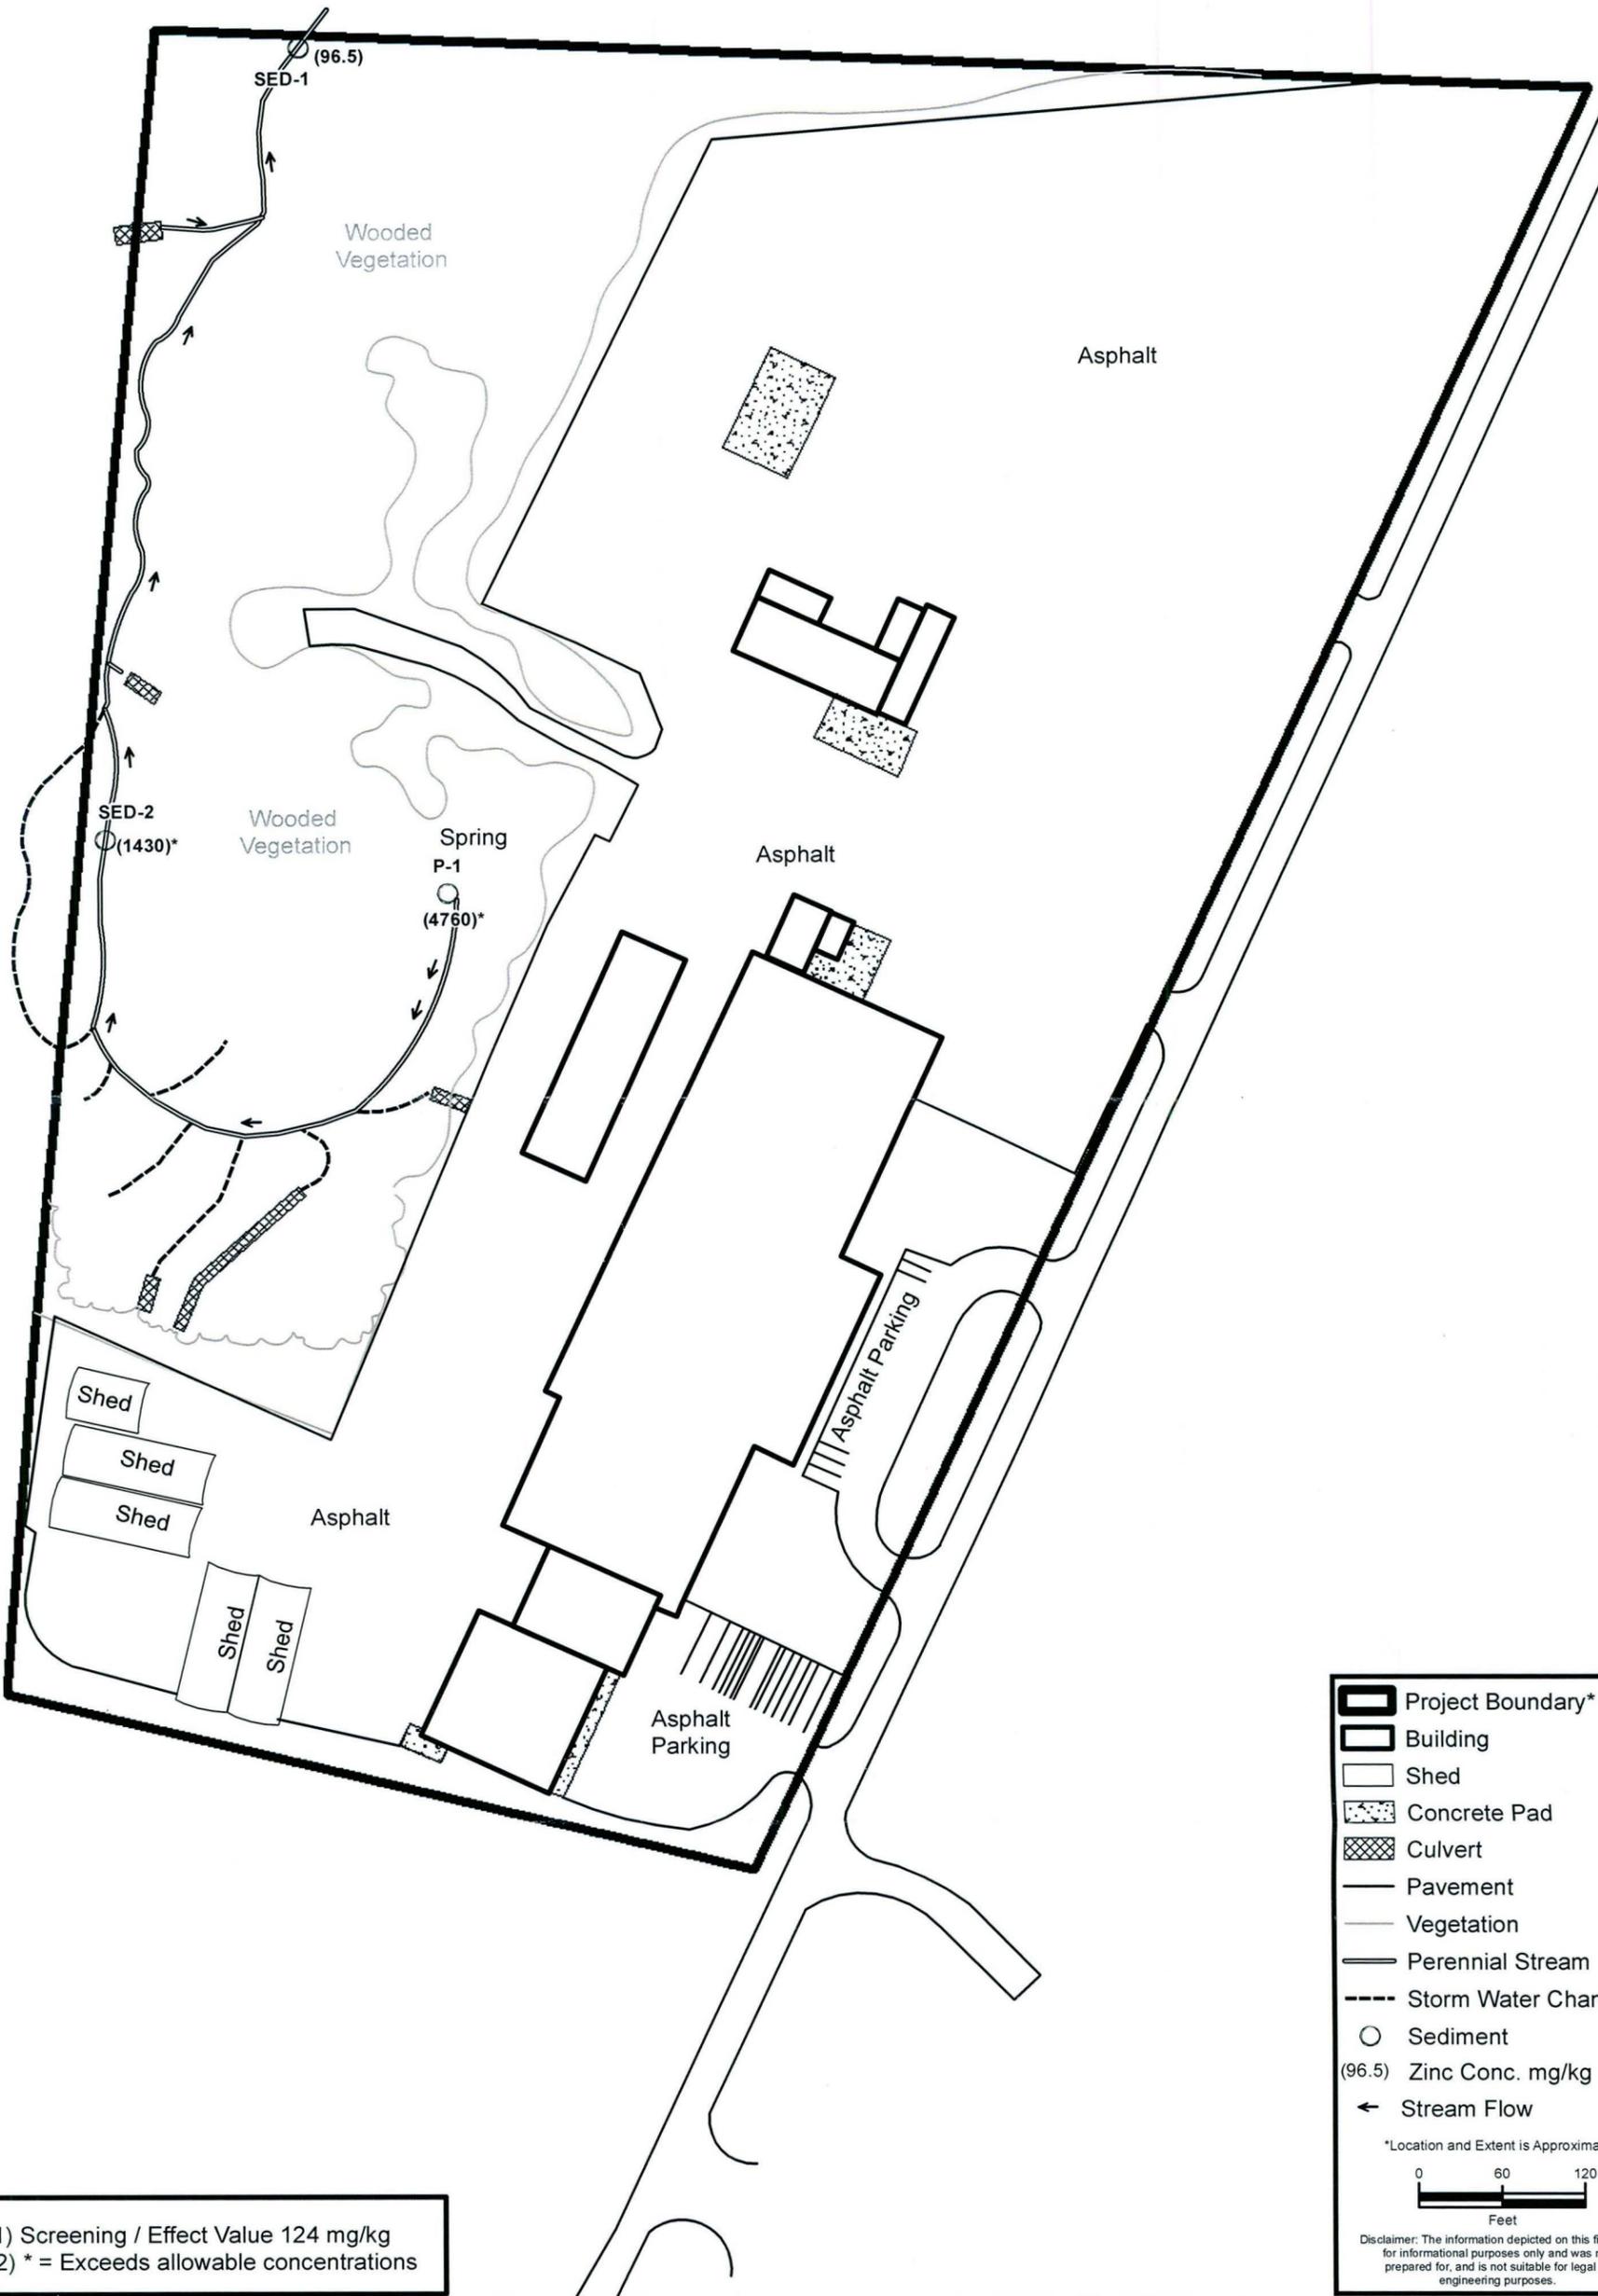
Note: 1) Screening / Effect Value 124 mg/kg
 2) * = Exceeds allowable concentrations

- ✓ Zinc concentrations exceeded the Screening Value/Effects Value of 124 milligrams per kilogram (mg/Kg) in sample locations P-1 (4790 mg/Kg) and SED-2 (1430 mg/Kg).
- ✓ Cadmium concentrations exceeded the Screening Value of 1 mg/Kg and the Effects Value of 0.676 mg/Kg in sample location P-1 (4.53 mg/Kg).
