**GROUNDWATER AND STREAM ASSESSMENT REPORT
MERCHANTS METALS**

Statesville, Iredell County, North Carolina

**ESI Project ER10-125.02
August 26, 2011**

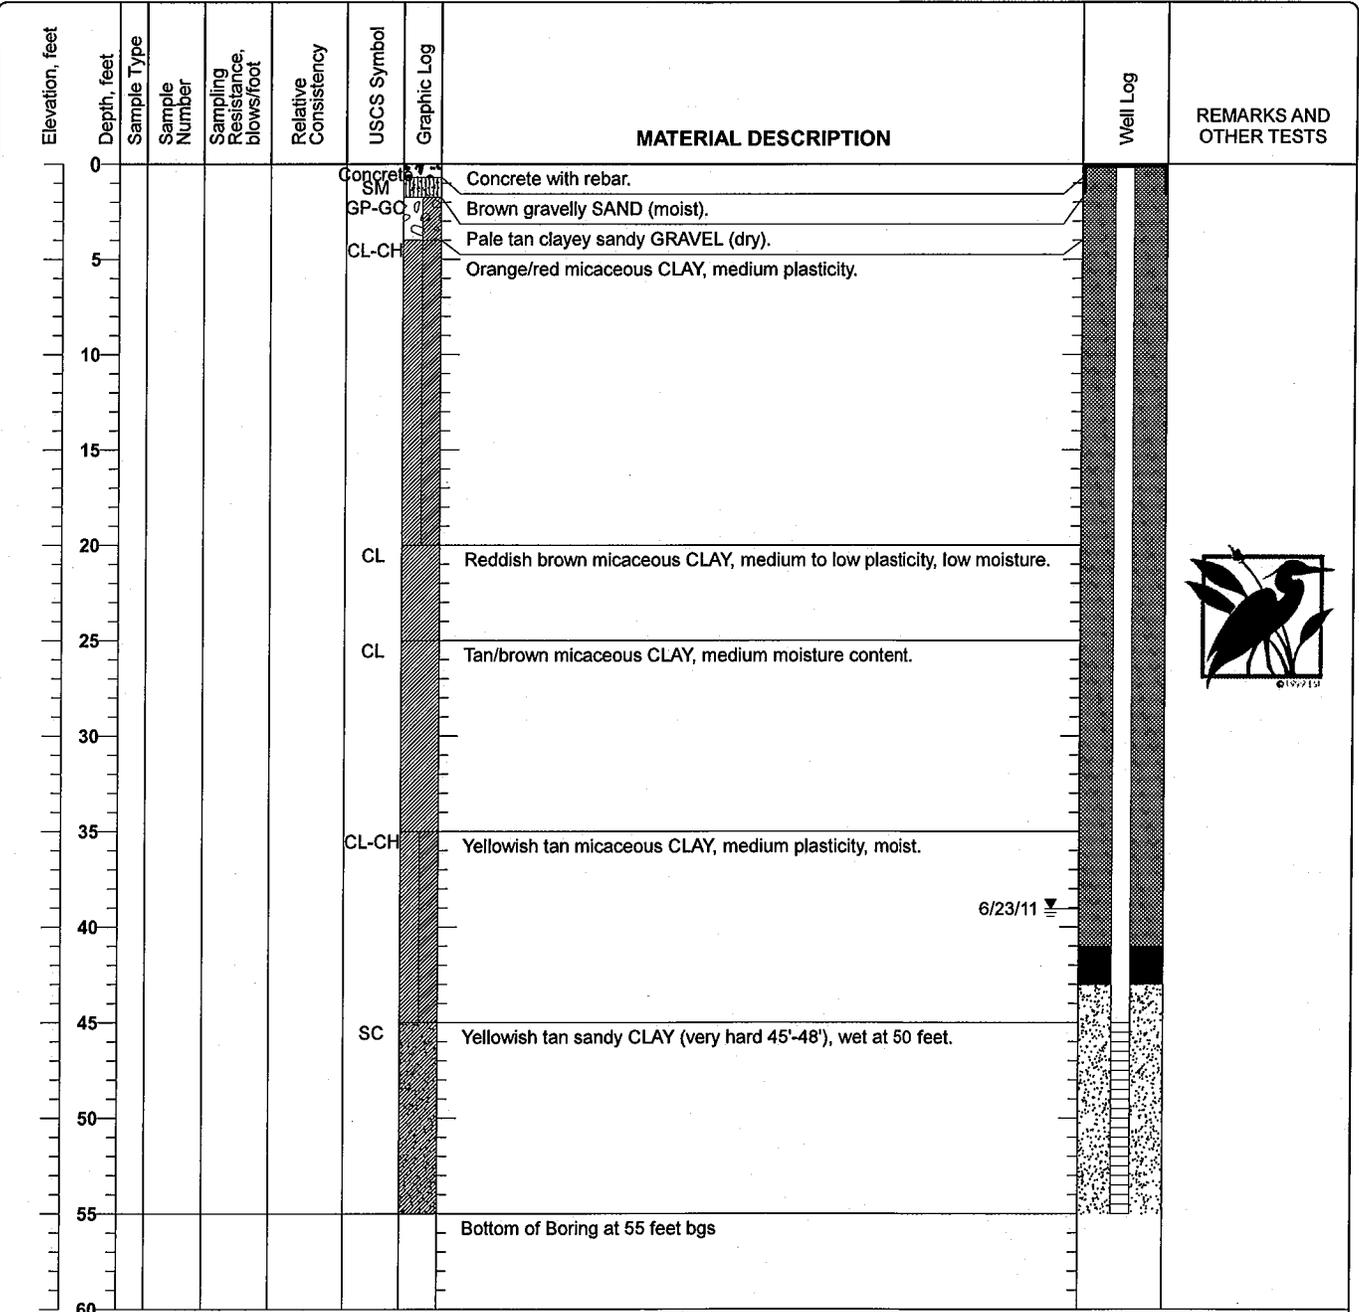
Project: Merchants Metals Project Location: Statesville, Iredell County, North Carolina Project Number: ER10-125.02	<h2 style="margin: 0;">Log of Boring MW-1</h2> <p style="margin: 0;">Sheet 1 of 1</p>
--	---

Date(s) Drilled June 21, 2011	Logged By Brett Miller	Checked By MJB
Drilling Method Hollow Stem Auger	Drill Bit Size/Type 8.2 inch	Total Depth of Borehole 55 feet bgs
Drill Rig Type Drillmax 2400	Drilling Contractor Geologic Exploration, Inc.	Approximate Surface Elevation
Groundwater Level 39.04 feet measured on and Date Measured 6/23/11	Sampling Method(s) None	Hammer Data
Borehole Backfill	Location West side of former Galvanizing Building

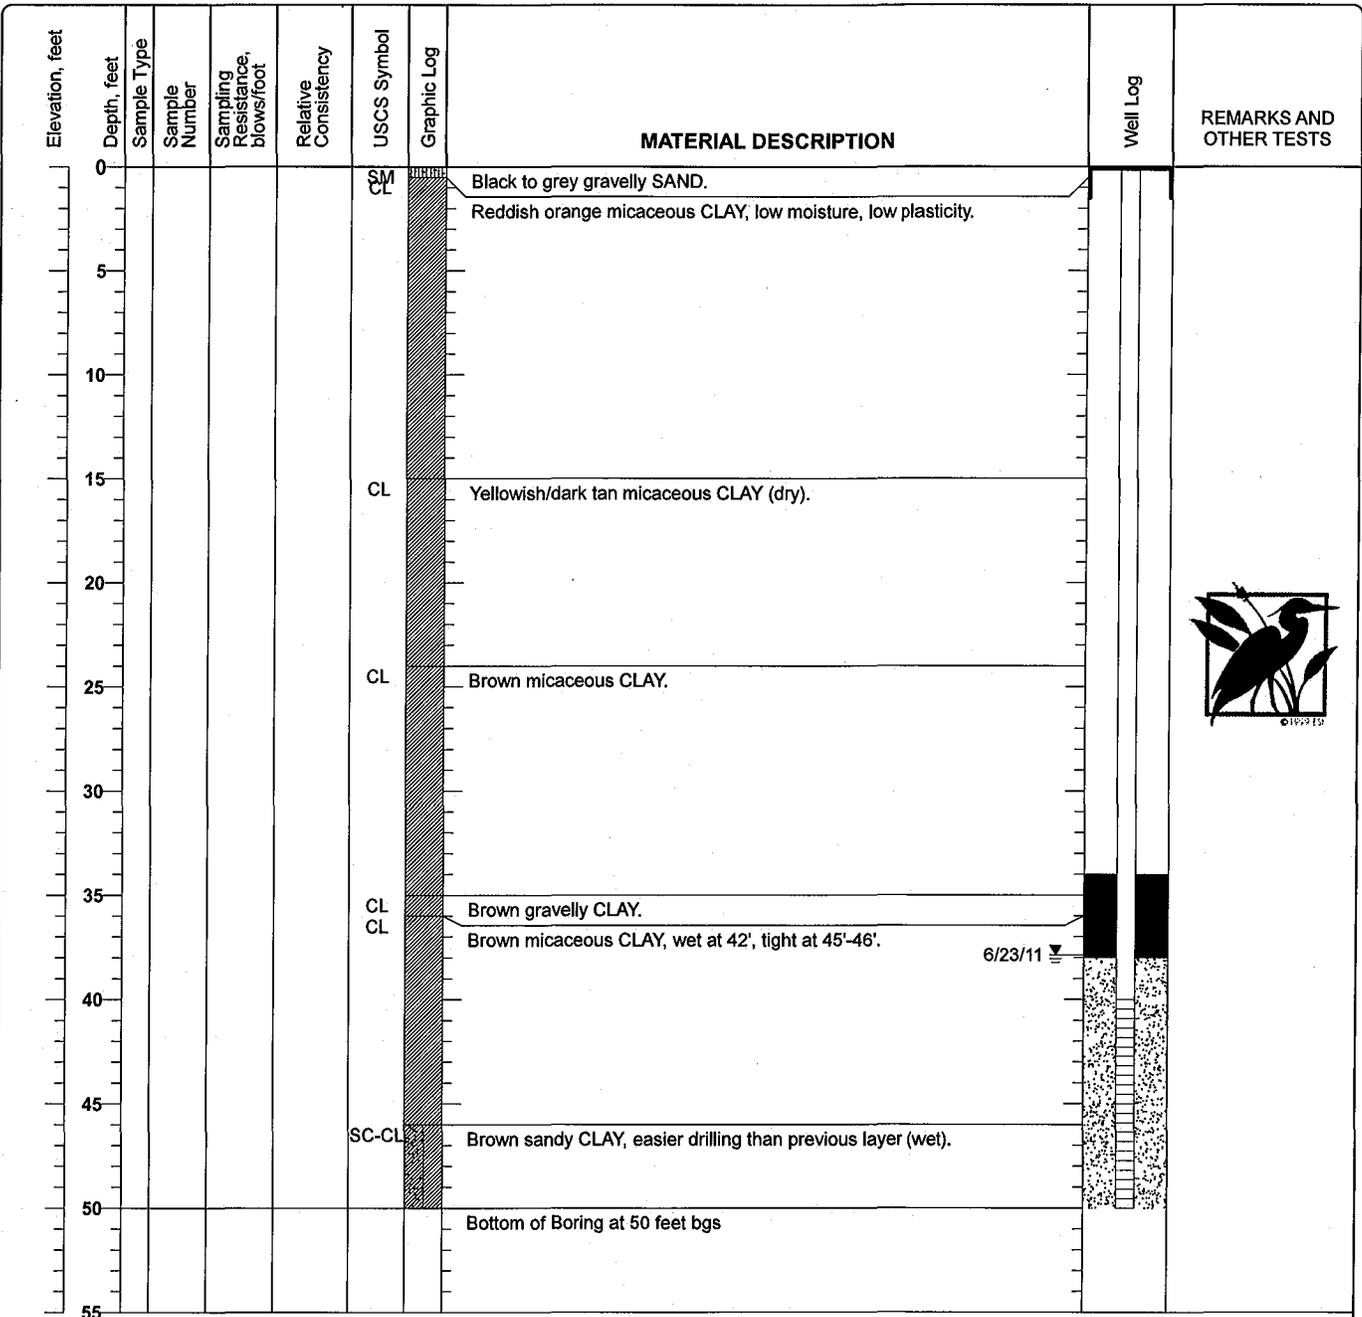
Log of Boring MW-2
 Sheet 1 of 1

Date(s) Drilled	June 22, 2011	Logged By	Brett Miller	Checked By	MJB
Drilling Method	Hollow Stem Auger	Drill Bit Size/Type	5.2 inch	Total Depth of Borehole	50 feet bgs
Drill Rig Type	Drillmax 2400	Drilling Contractor	Geologic Exploration, Inc.	Approximate Surface Elevation	
Groundwater Level and Date Measured	37.86 feet measured on 6/23/11	Sampling Method(s)	None	Hammer Data	
Borehole Backfill	Location Northwest of former Galvanizing Building

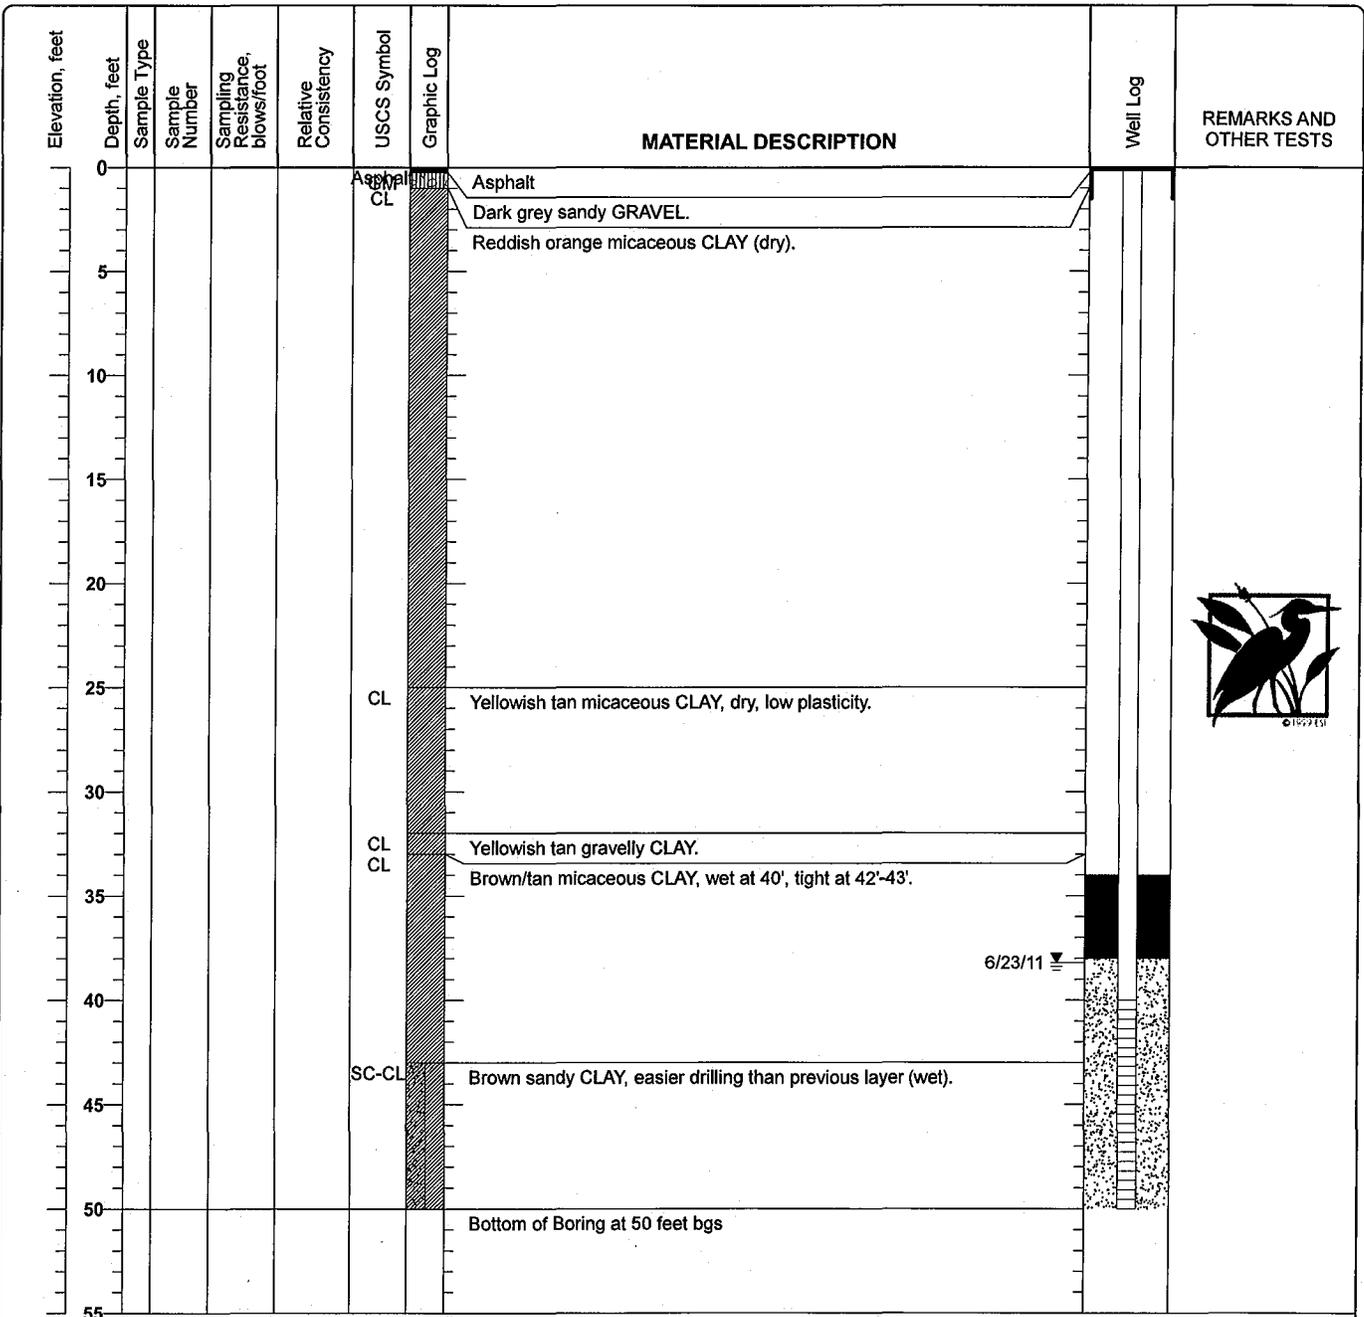
Sheet 1 of 1

Date(s) Drilled	June 22, 2011	Logged By	Brett Miller	Checked By	MJB
Drilling Method	Hollow Stem Auger	Drill Bit Size/Type	5.2 inch	Total Depth of Borehole	50 feet bgs
Drill Rig Type	Drillmax 2400	Drilling Contractor	Geologic Exploration, Inc.	Approximate Surface Elevation	
Groundwater Level and Date Measured	38.2 feet measured on 6/23/11	Sampling Method(s)	None	Hammer Data	
Borehole Backfill	Location East of former Galvanizing Building
