RE Groundwater and Stream Assessment Report Addendum
Merchants Metals
Statesville, Iredell County, North Carolina
ESI Project ER10-125.02

Environmental Services, Inc., (ESI) on behalf of Merchants Metals, Inc. is pleased to submit this Addendum to the August 29, 2011 Groundwater and Stream Assessment Report for the referenced property. This Addendum presents the stormwater runoff results for sampling completed on September 6, 2011.

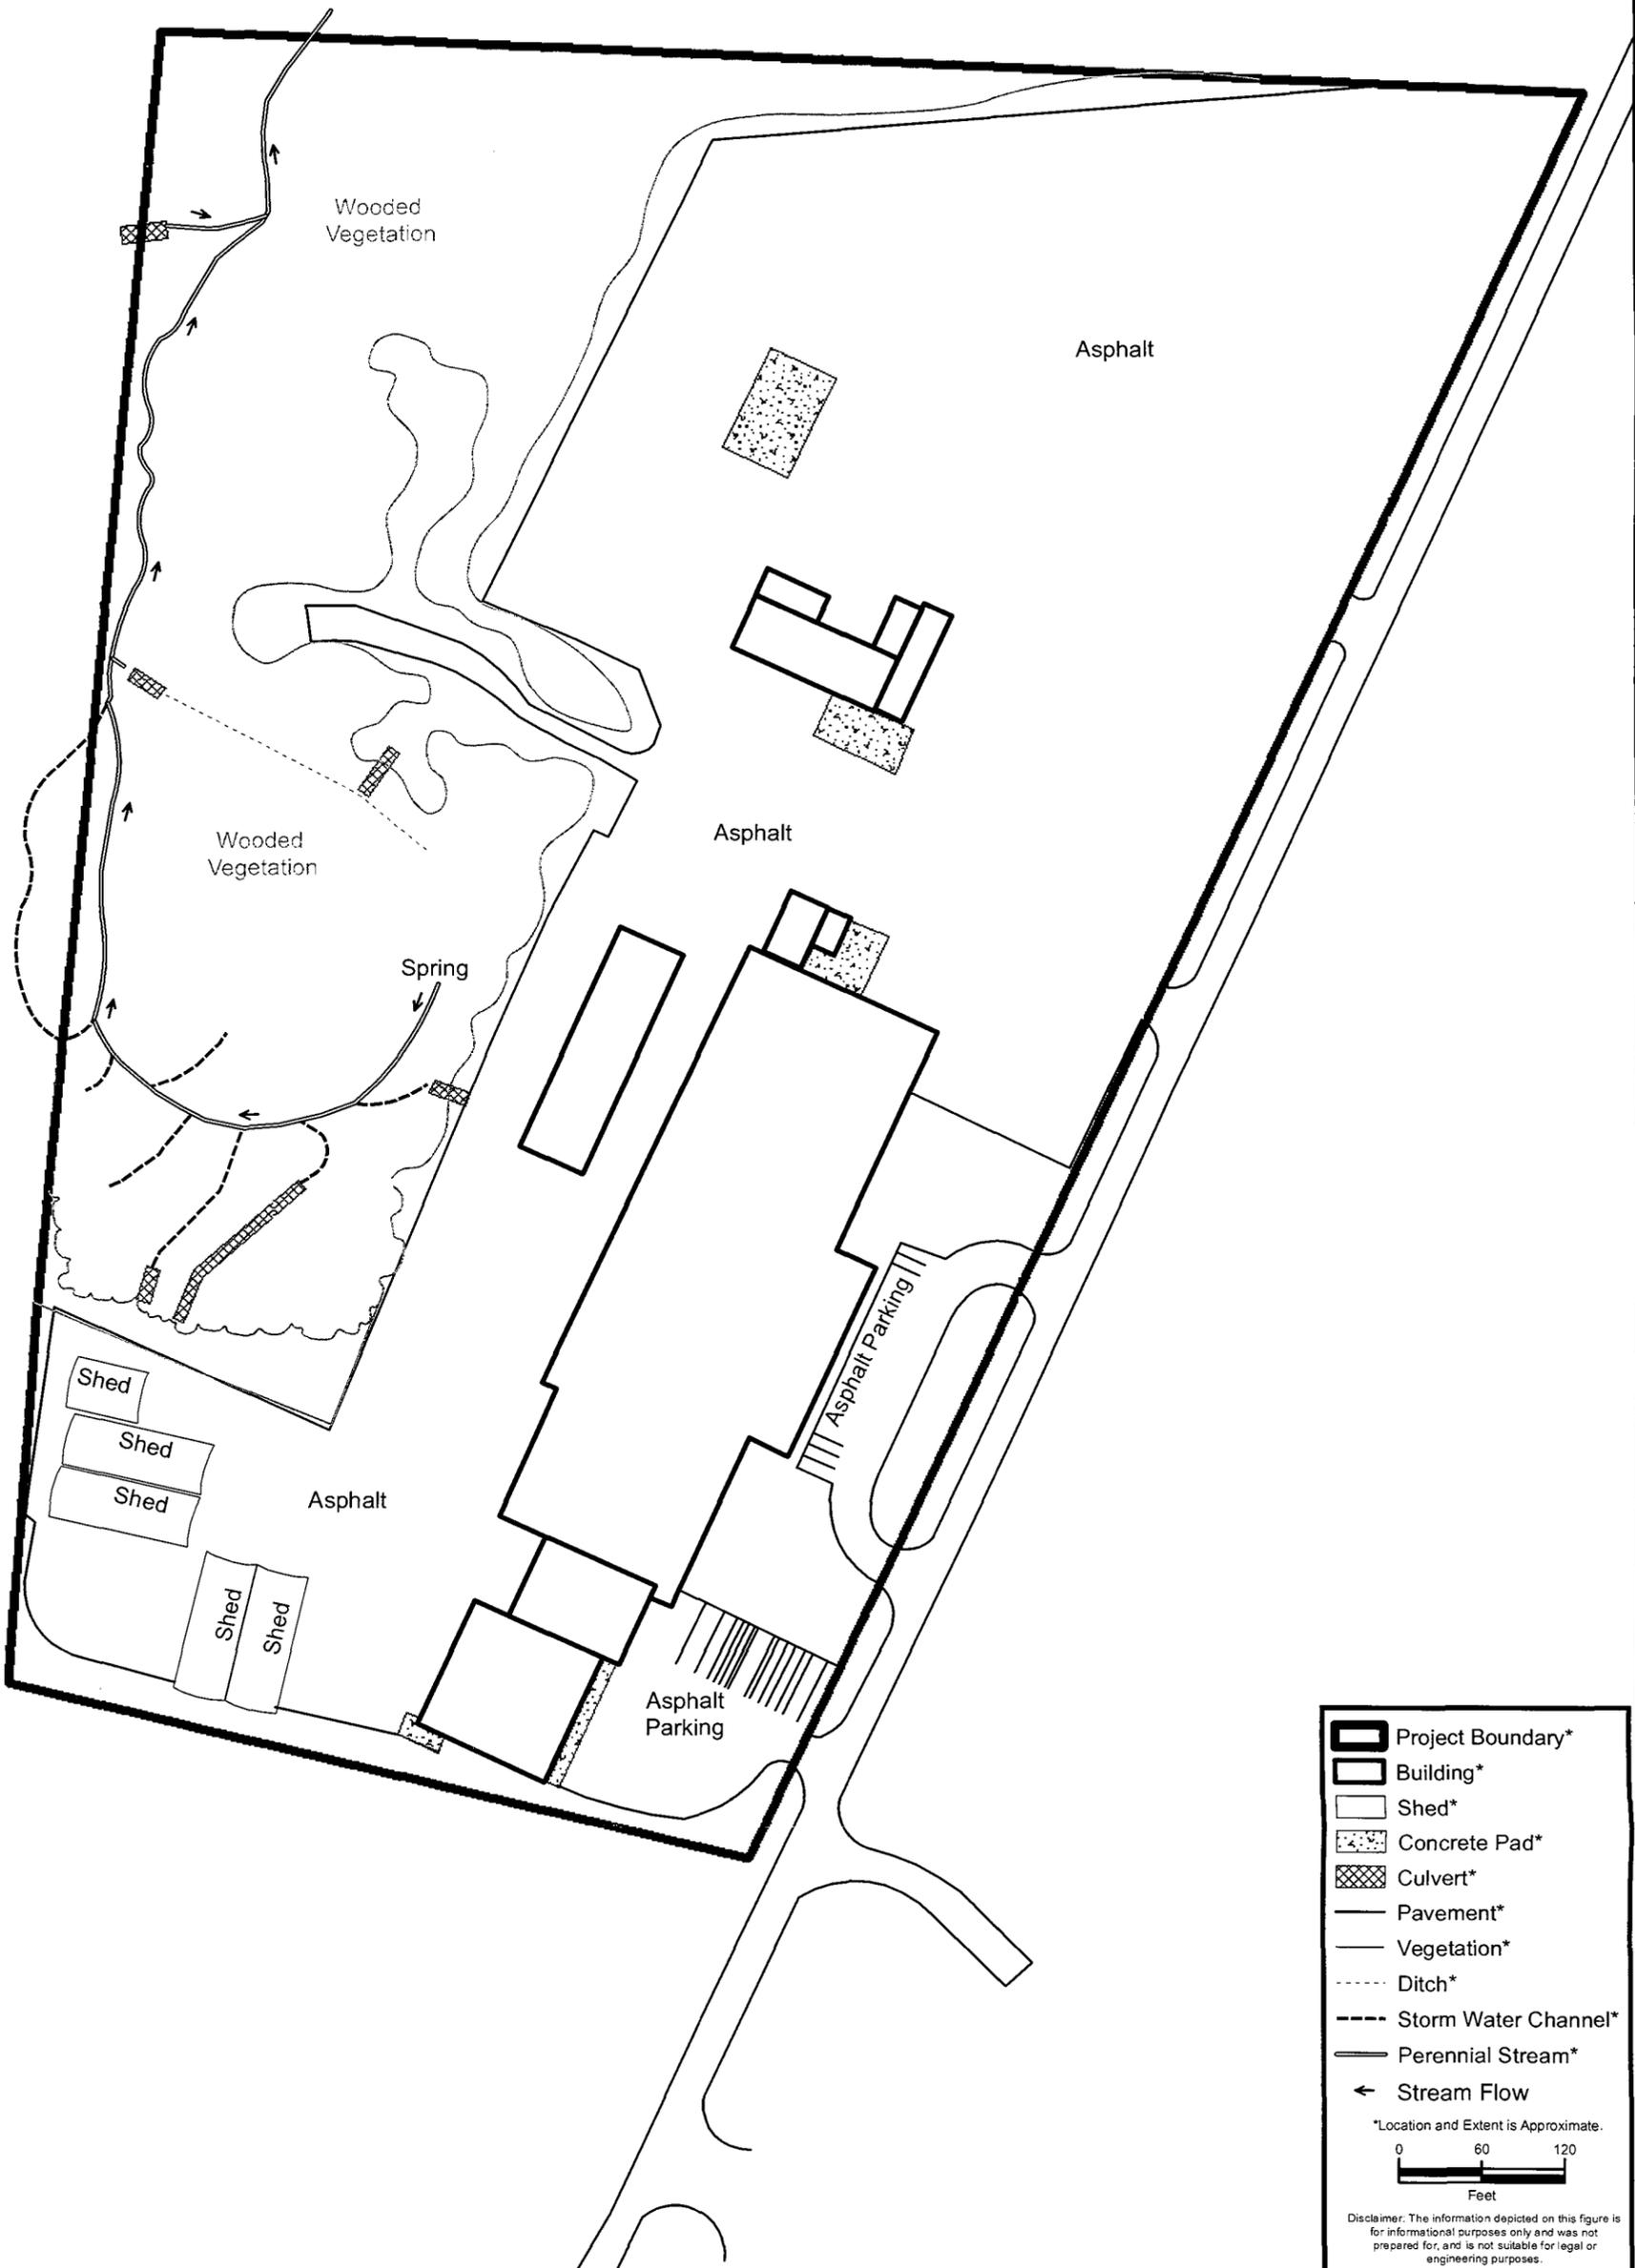
Project:	ER10125.02
Date:	Sep 2011
Drwn/Chkd:	KT/MB
Figure:	2

Site Plan
Merchants Metals
Iredell County, North Carolina

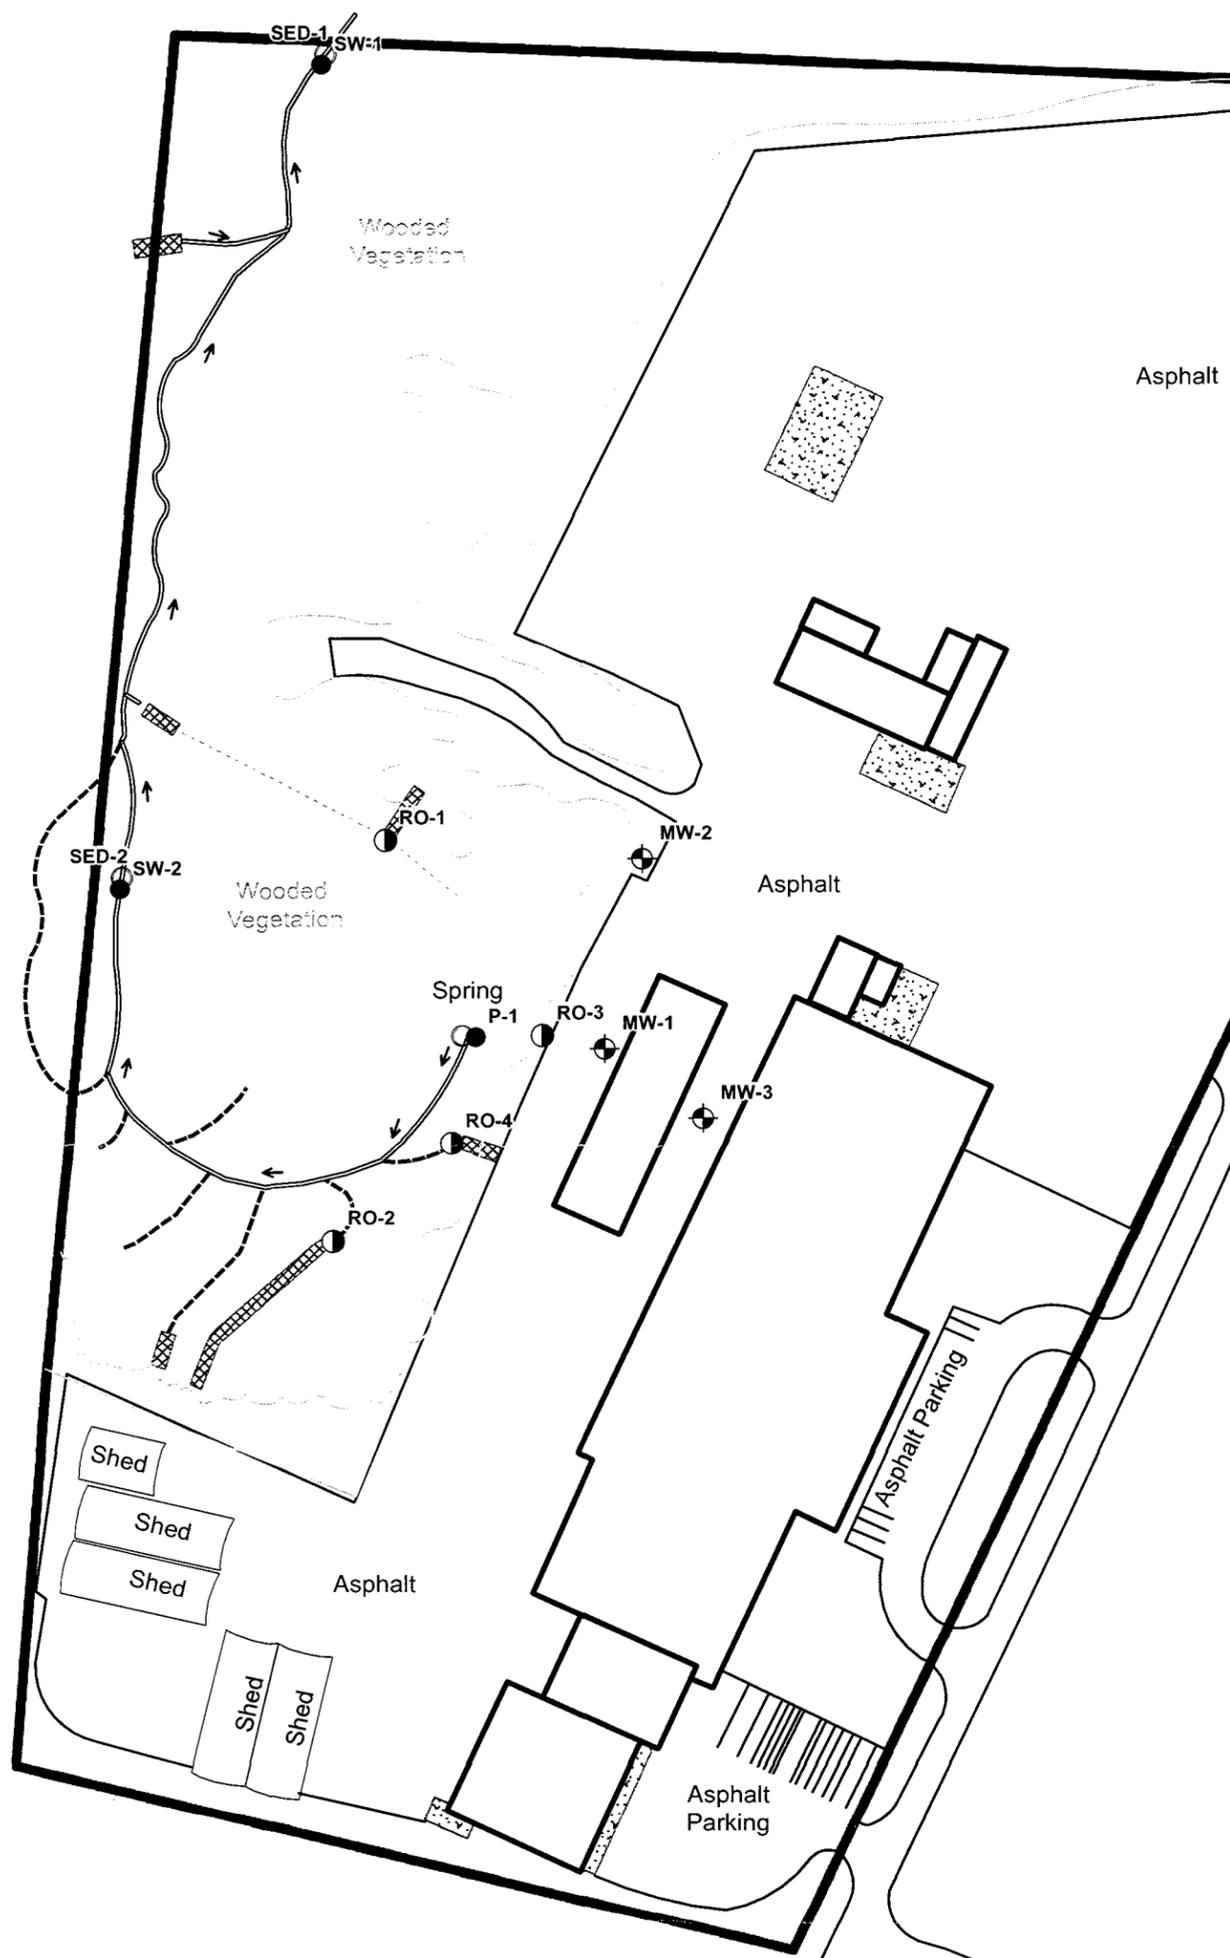
Project:	ER10125.02
Date:	Sep 2011
Drwn/Chkd:	KT/MB
Figure:	3

Sample Locations
Merchants Metals
Iredell County, North Carolina

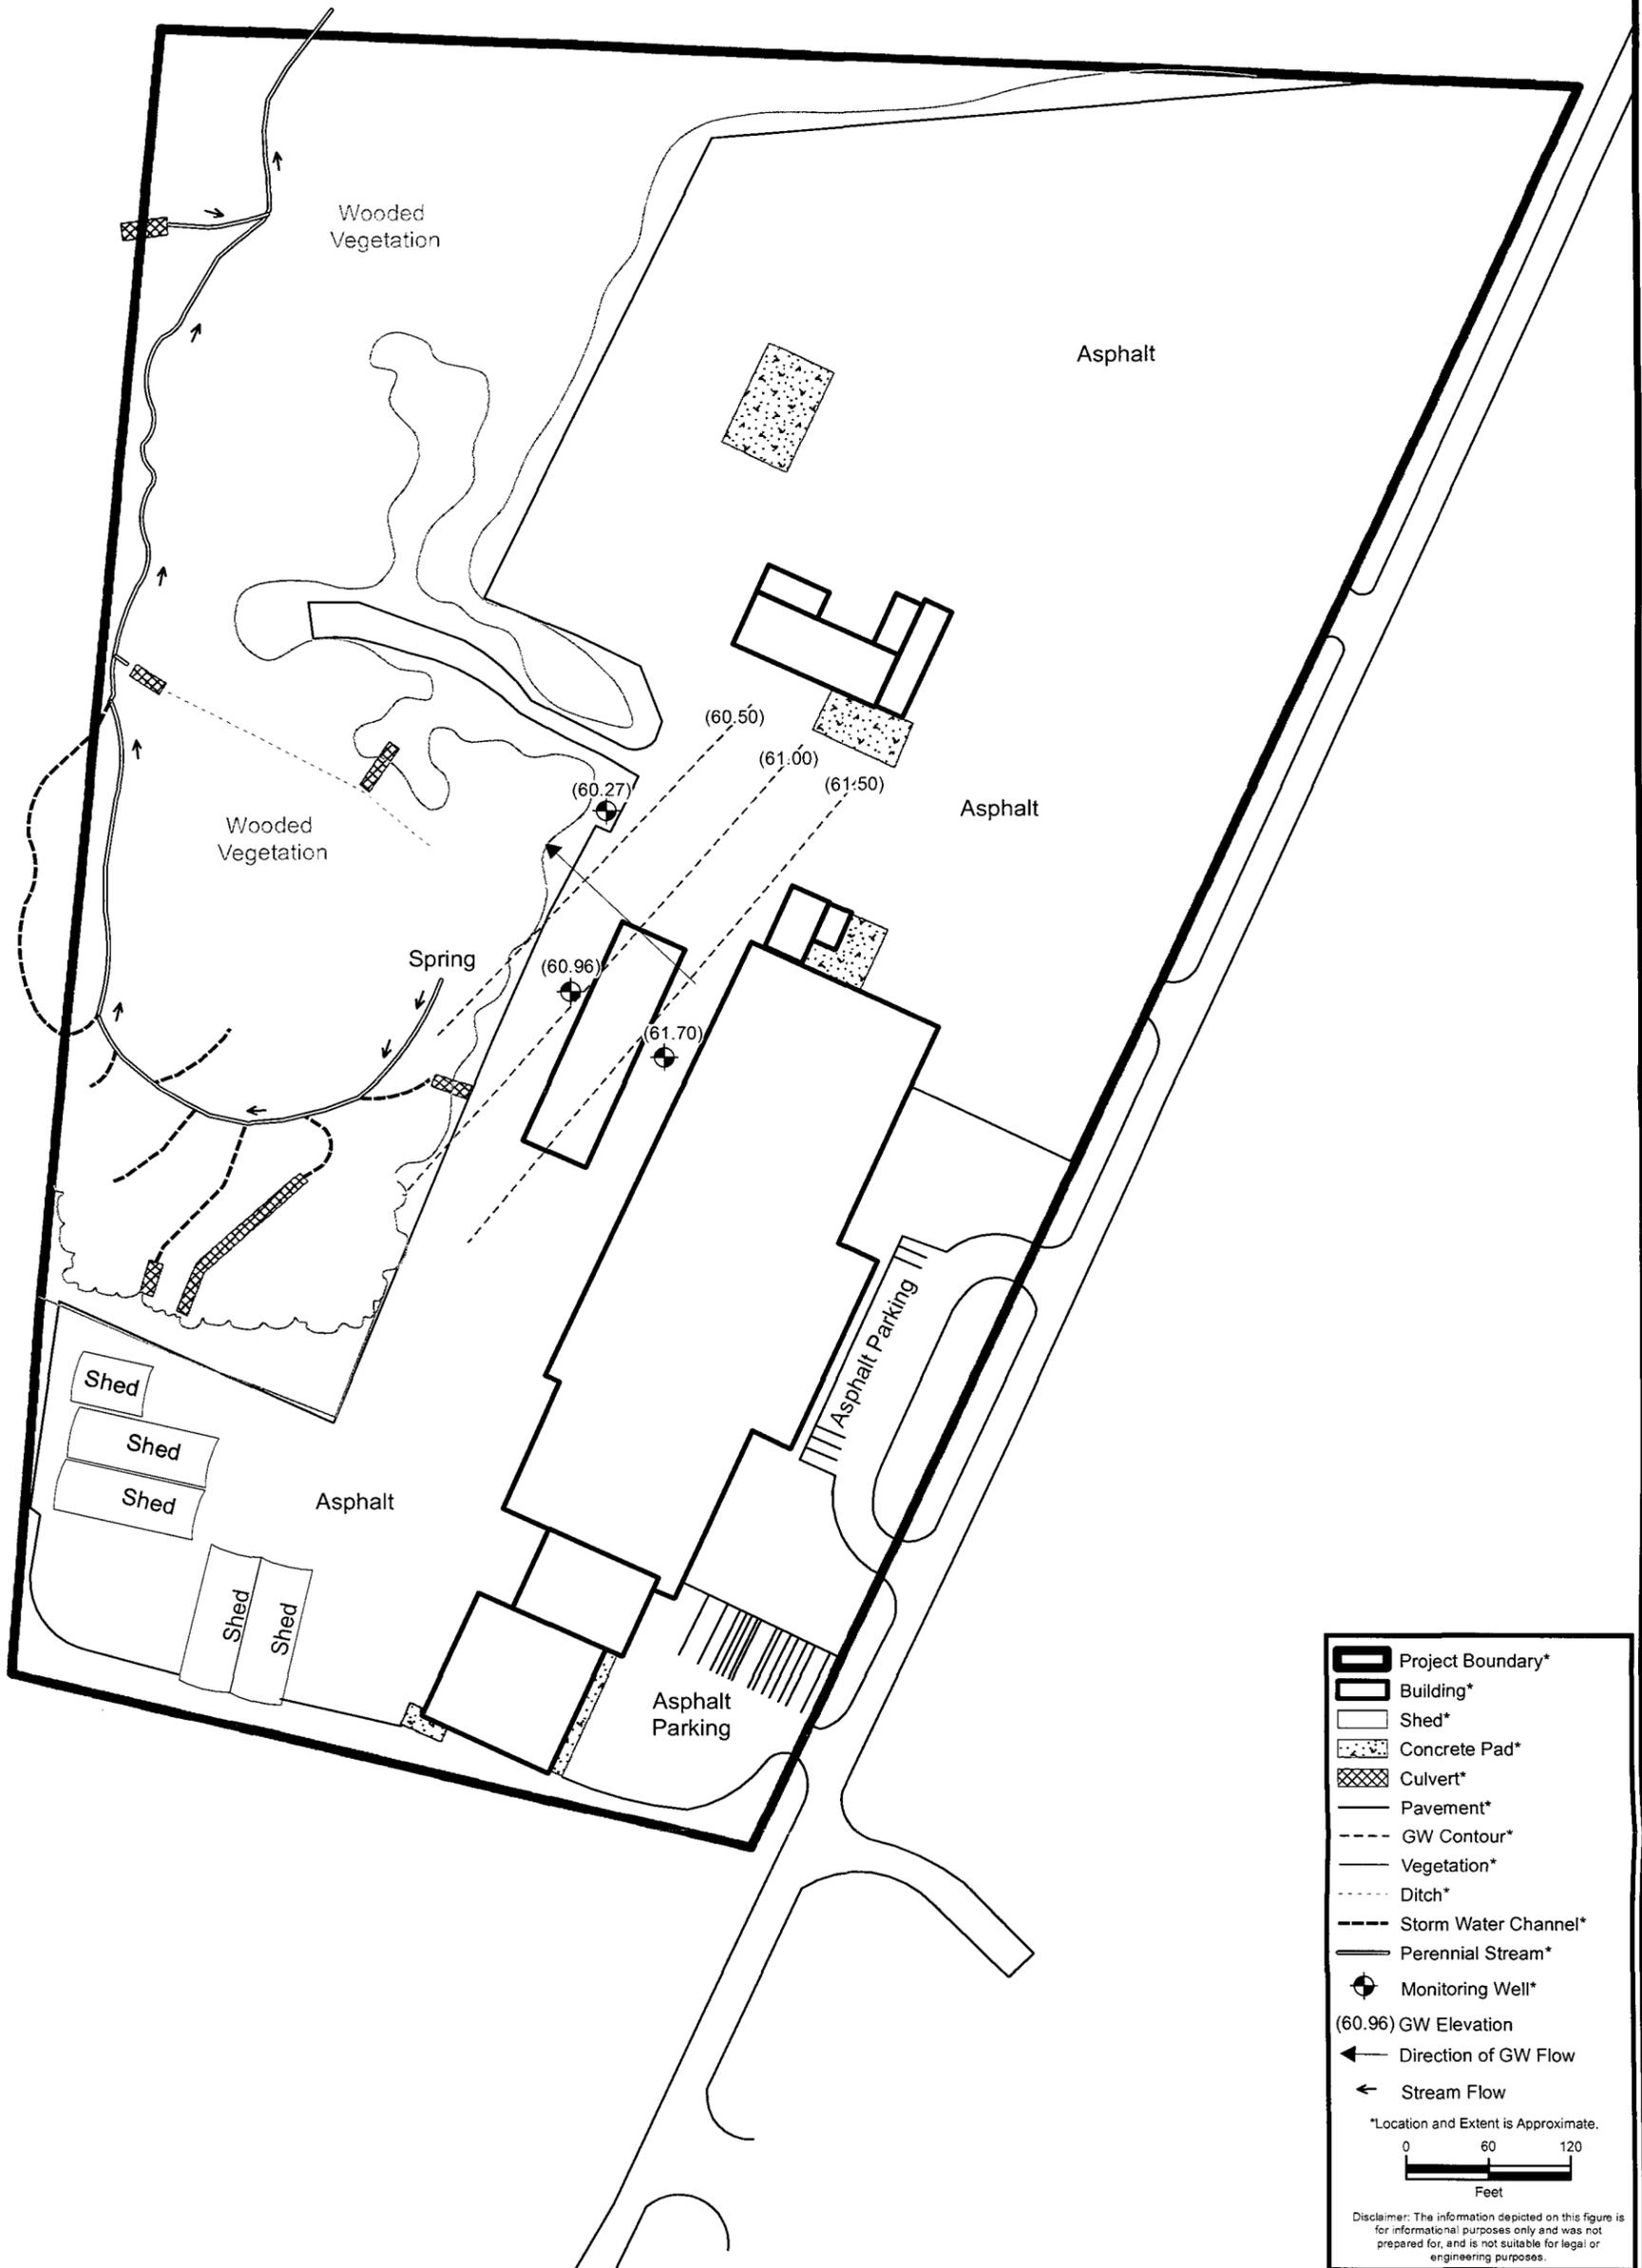
Project: ER10125.02
Date: Sep 2011
Drwn/Chkd: KT/MB
Figure: 4

Groundwater Contours
Merchants Metals
Iredell County, North Carolina

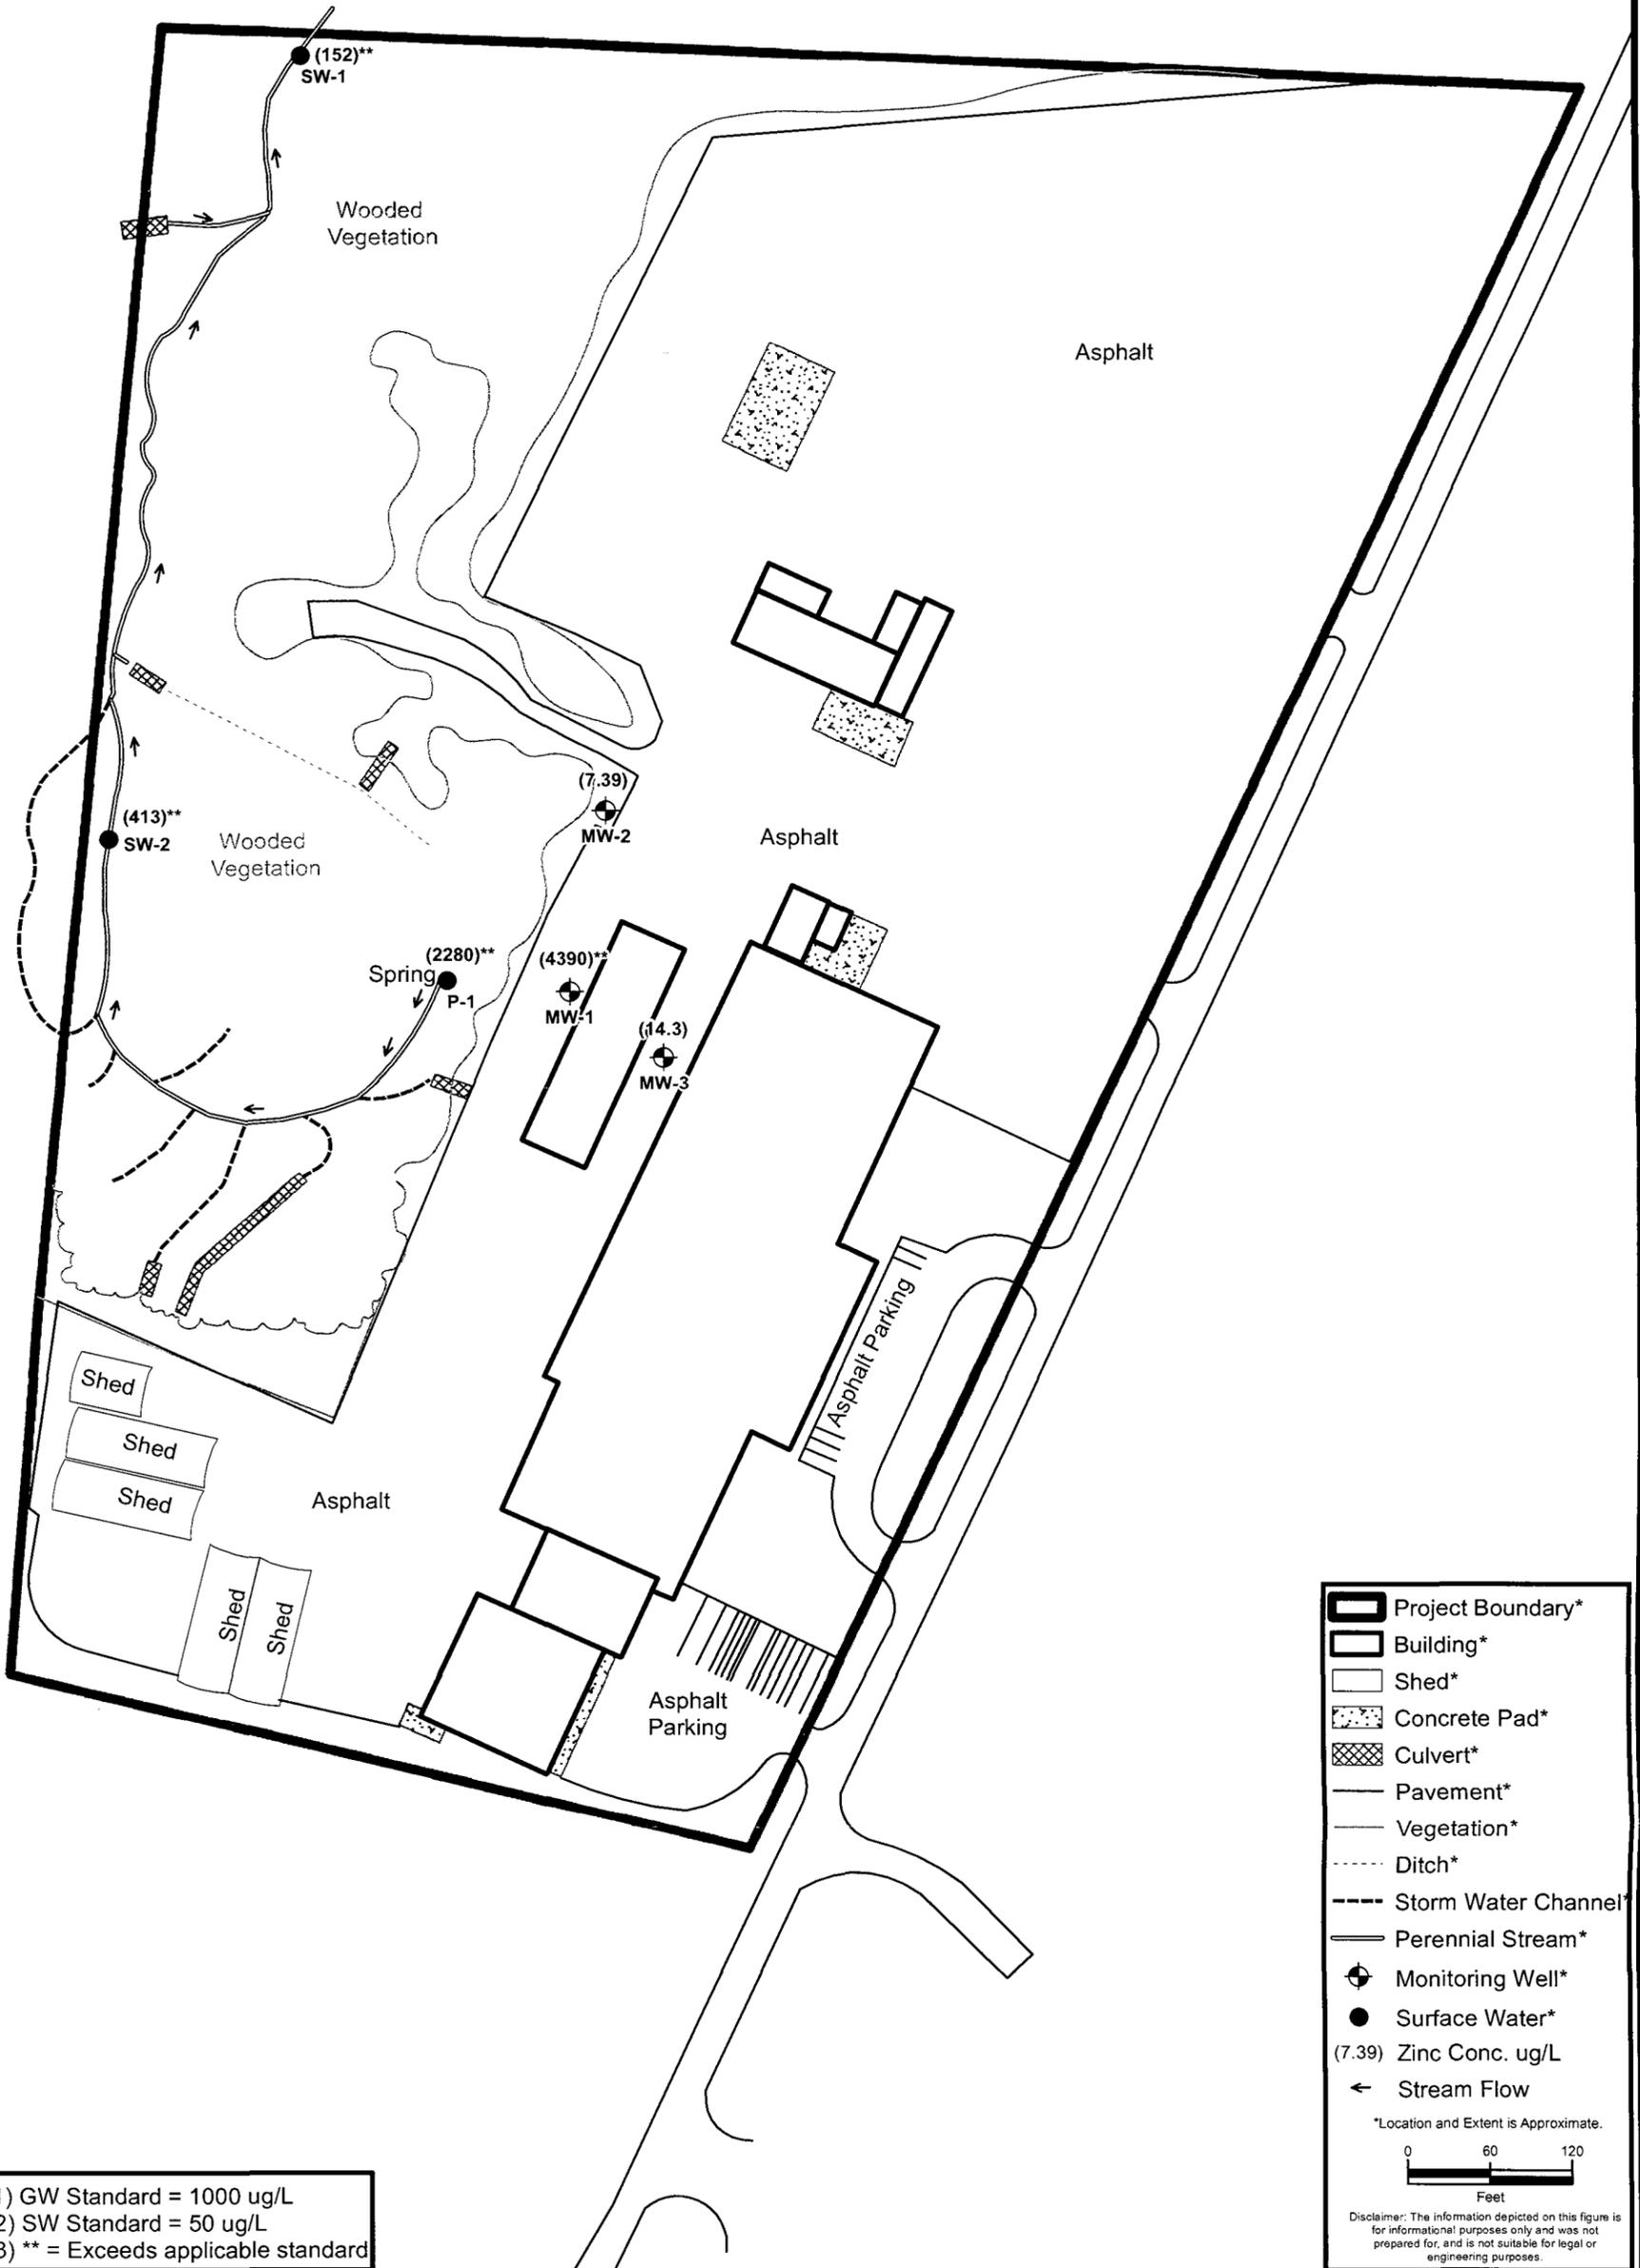
Project: ER10125.02
 Date: Sep 2011
 Drwn/Chkd: KT/MB
 Figure: 5

Note: 1) GW Standard = 1000 ug/L
 2) SW Standard = 50 ug/L
 3) ** = Exceeds applicable standard

Groundwater/ Surface Water Concentrations - Zinc
Merchants Metals
 Iredell County, North Carolina

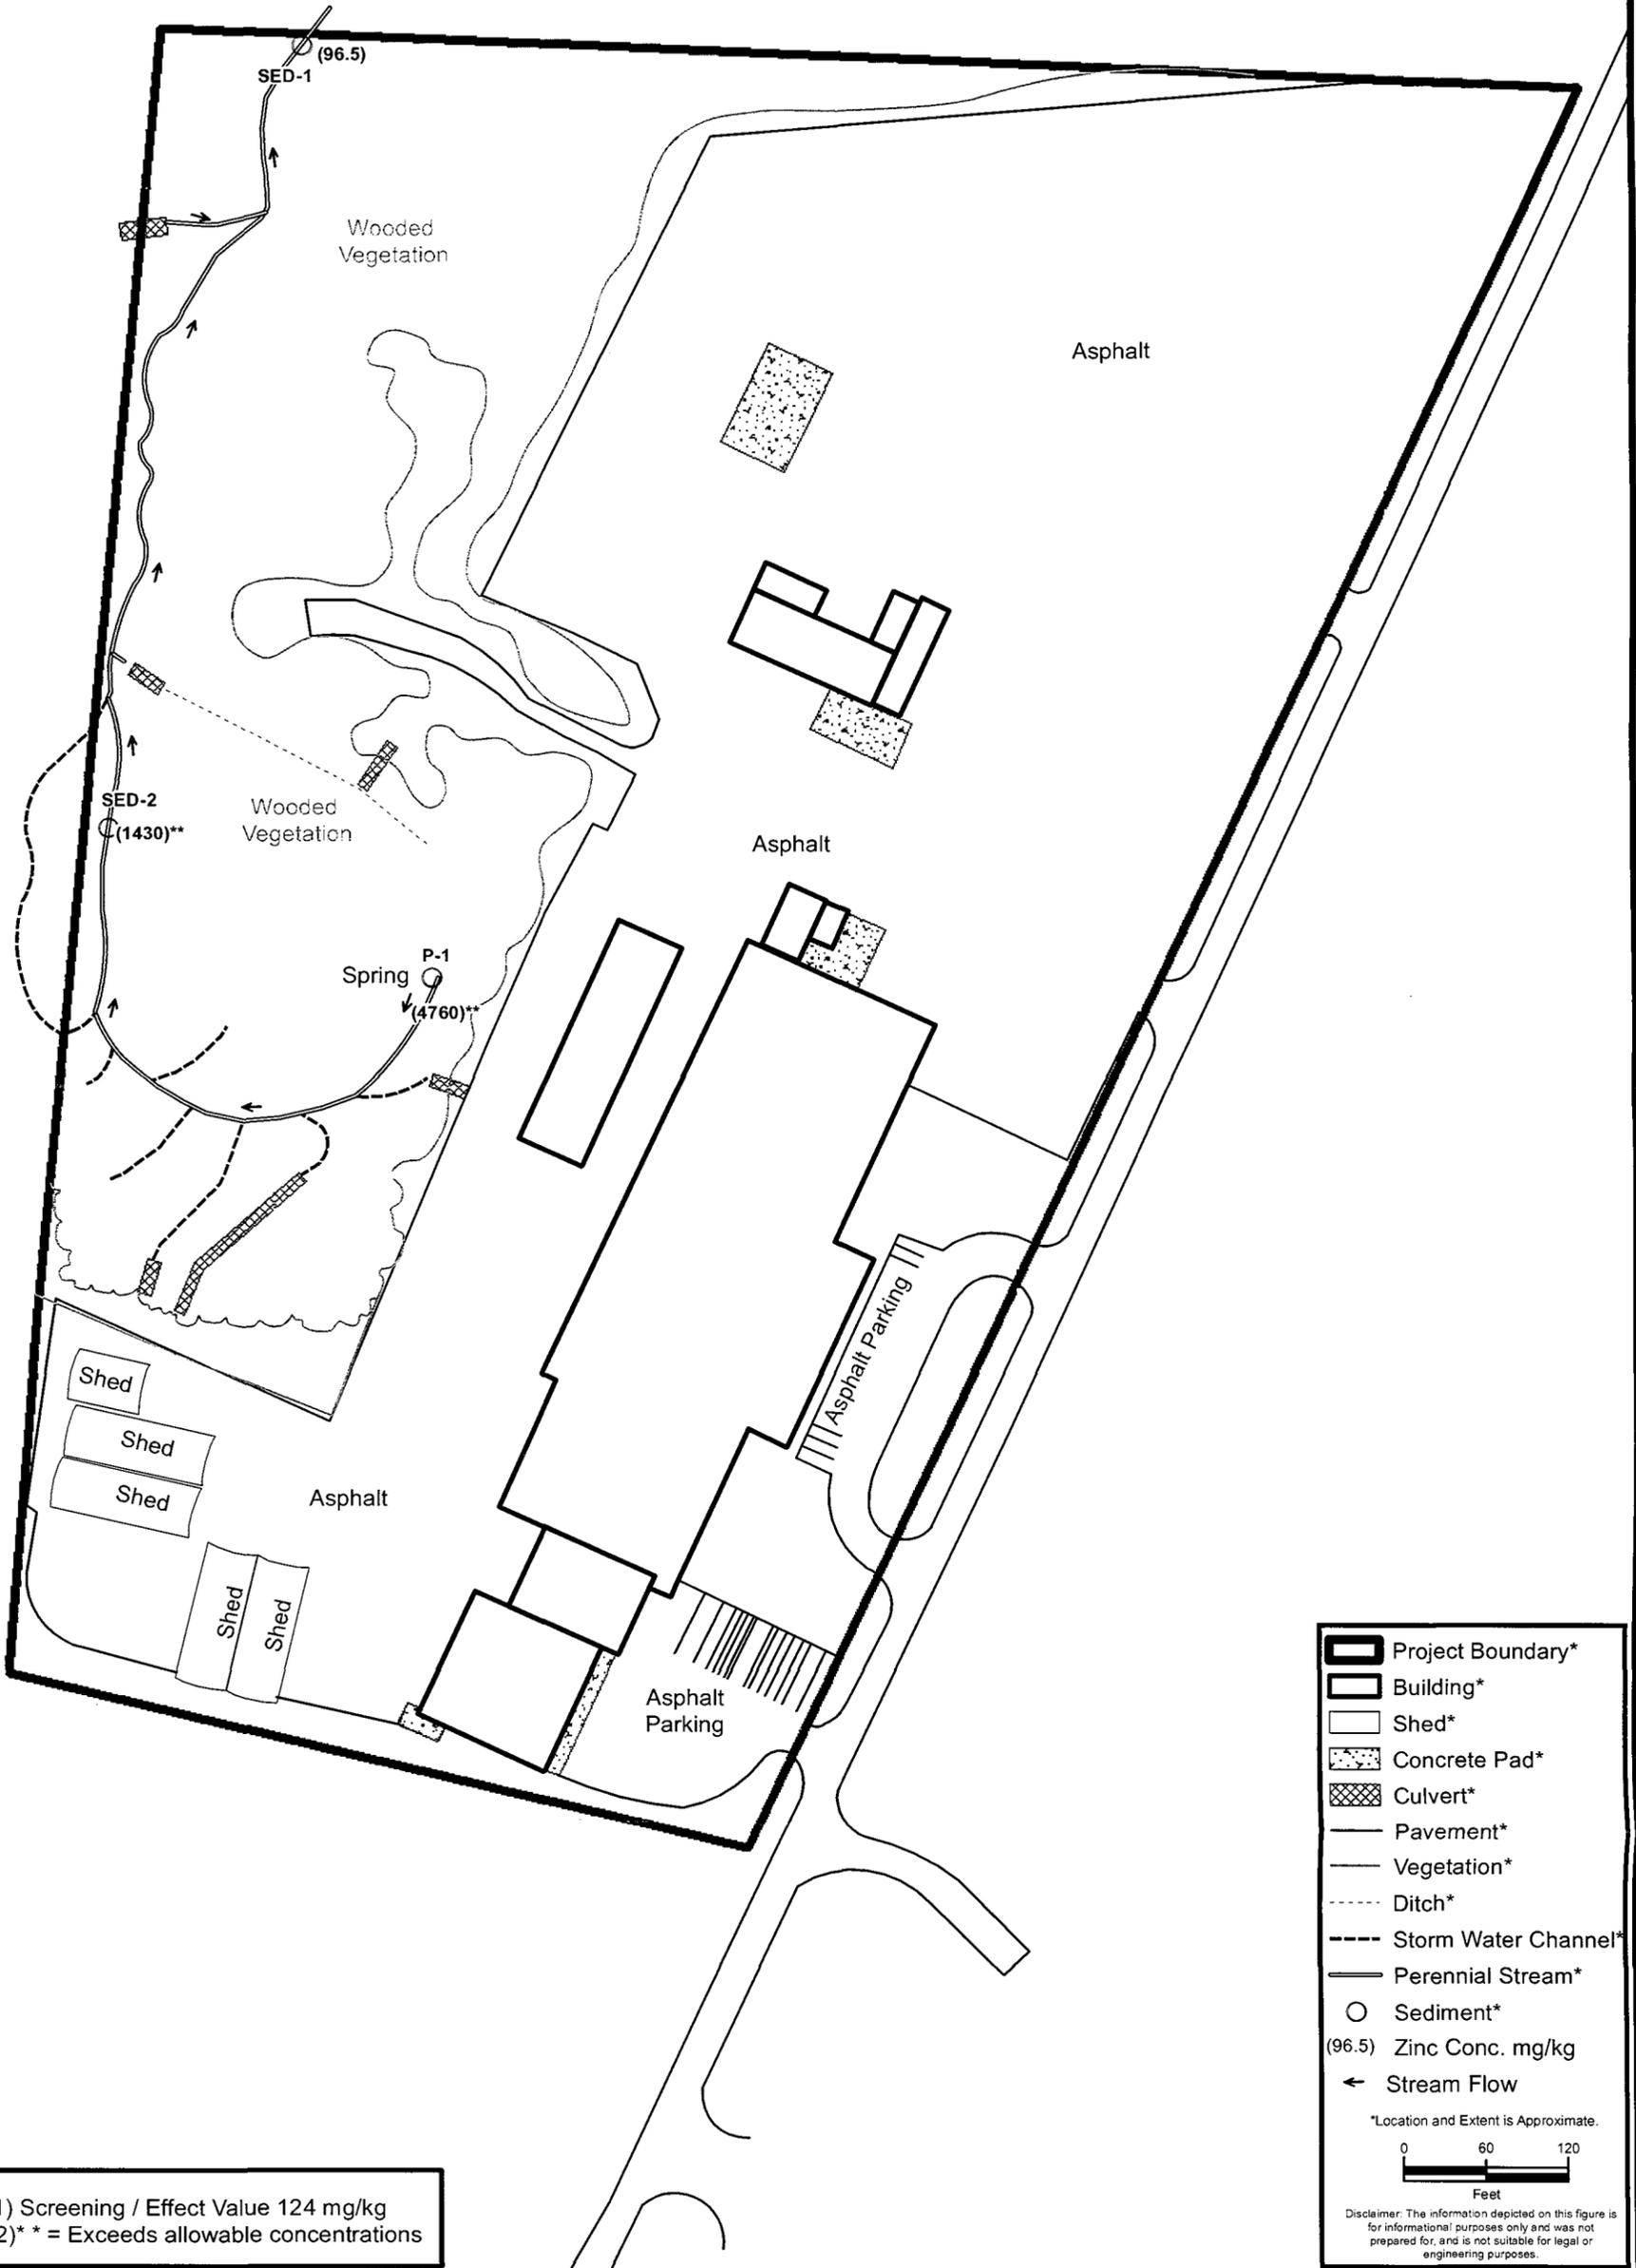
Project: ER10125.02
 Date: Sep 2011
 Drwn/Chkd: KT/MB
 Figure: 6

Note: 1) Screening / Effect Value 124 mg/kg
 2) * * = Exceeds allowable concentrations

Sediment Concentrations - Zinc
Merchants Metals
 Iredell County, North Carolina

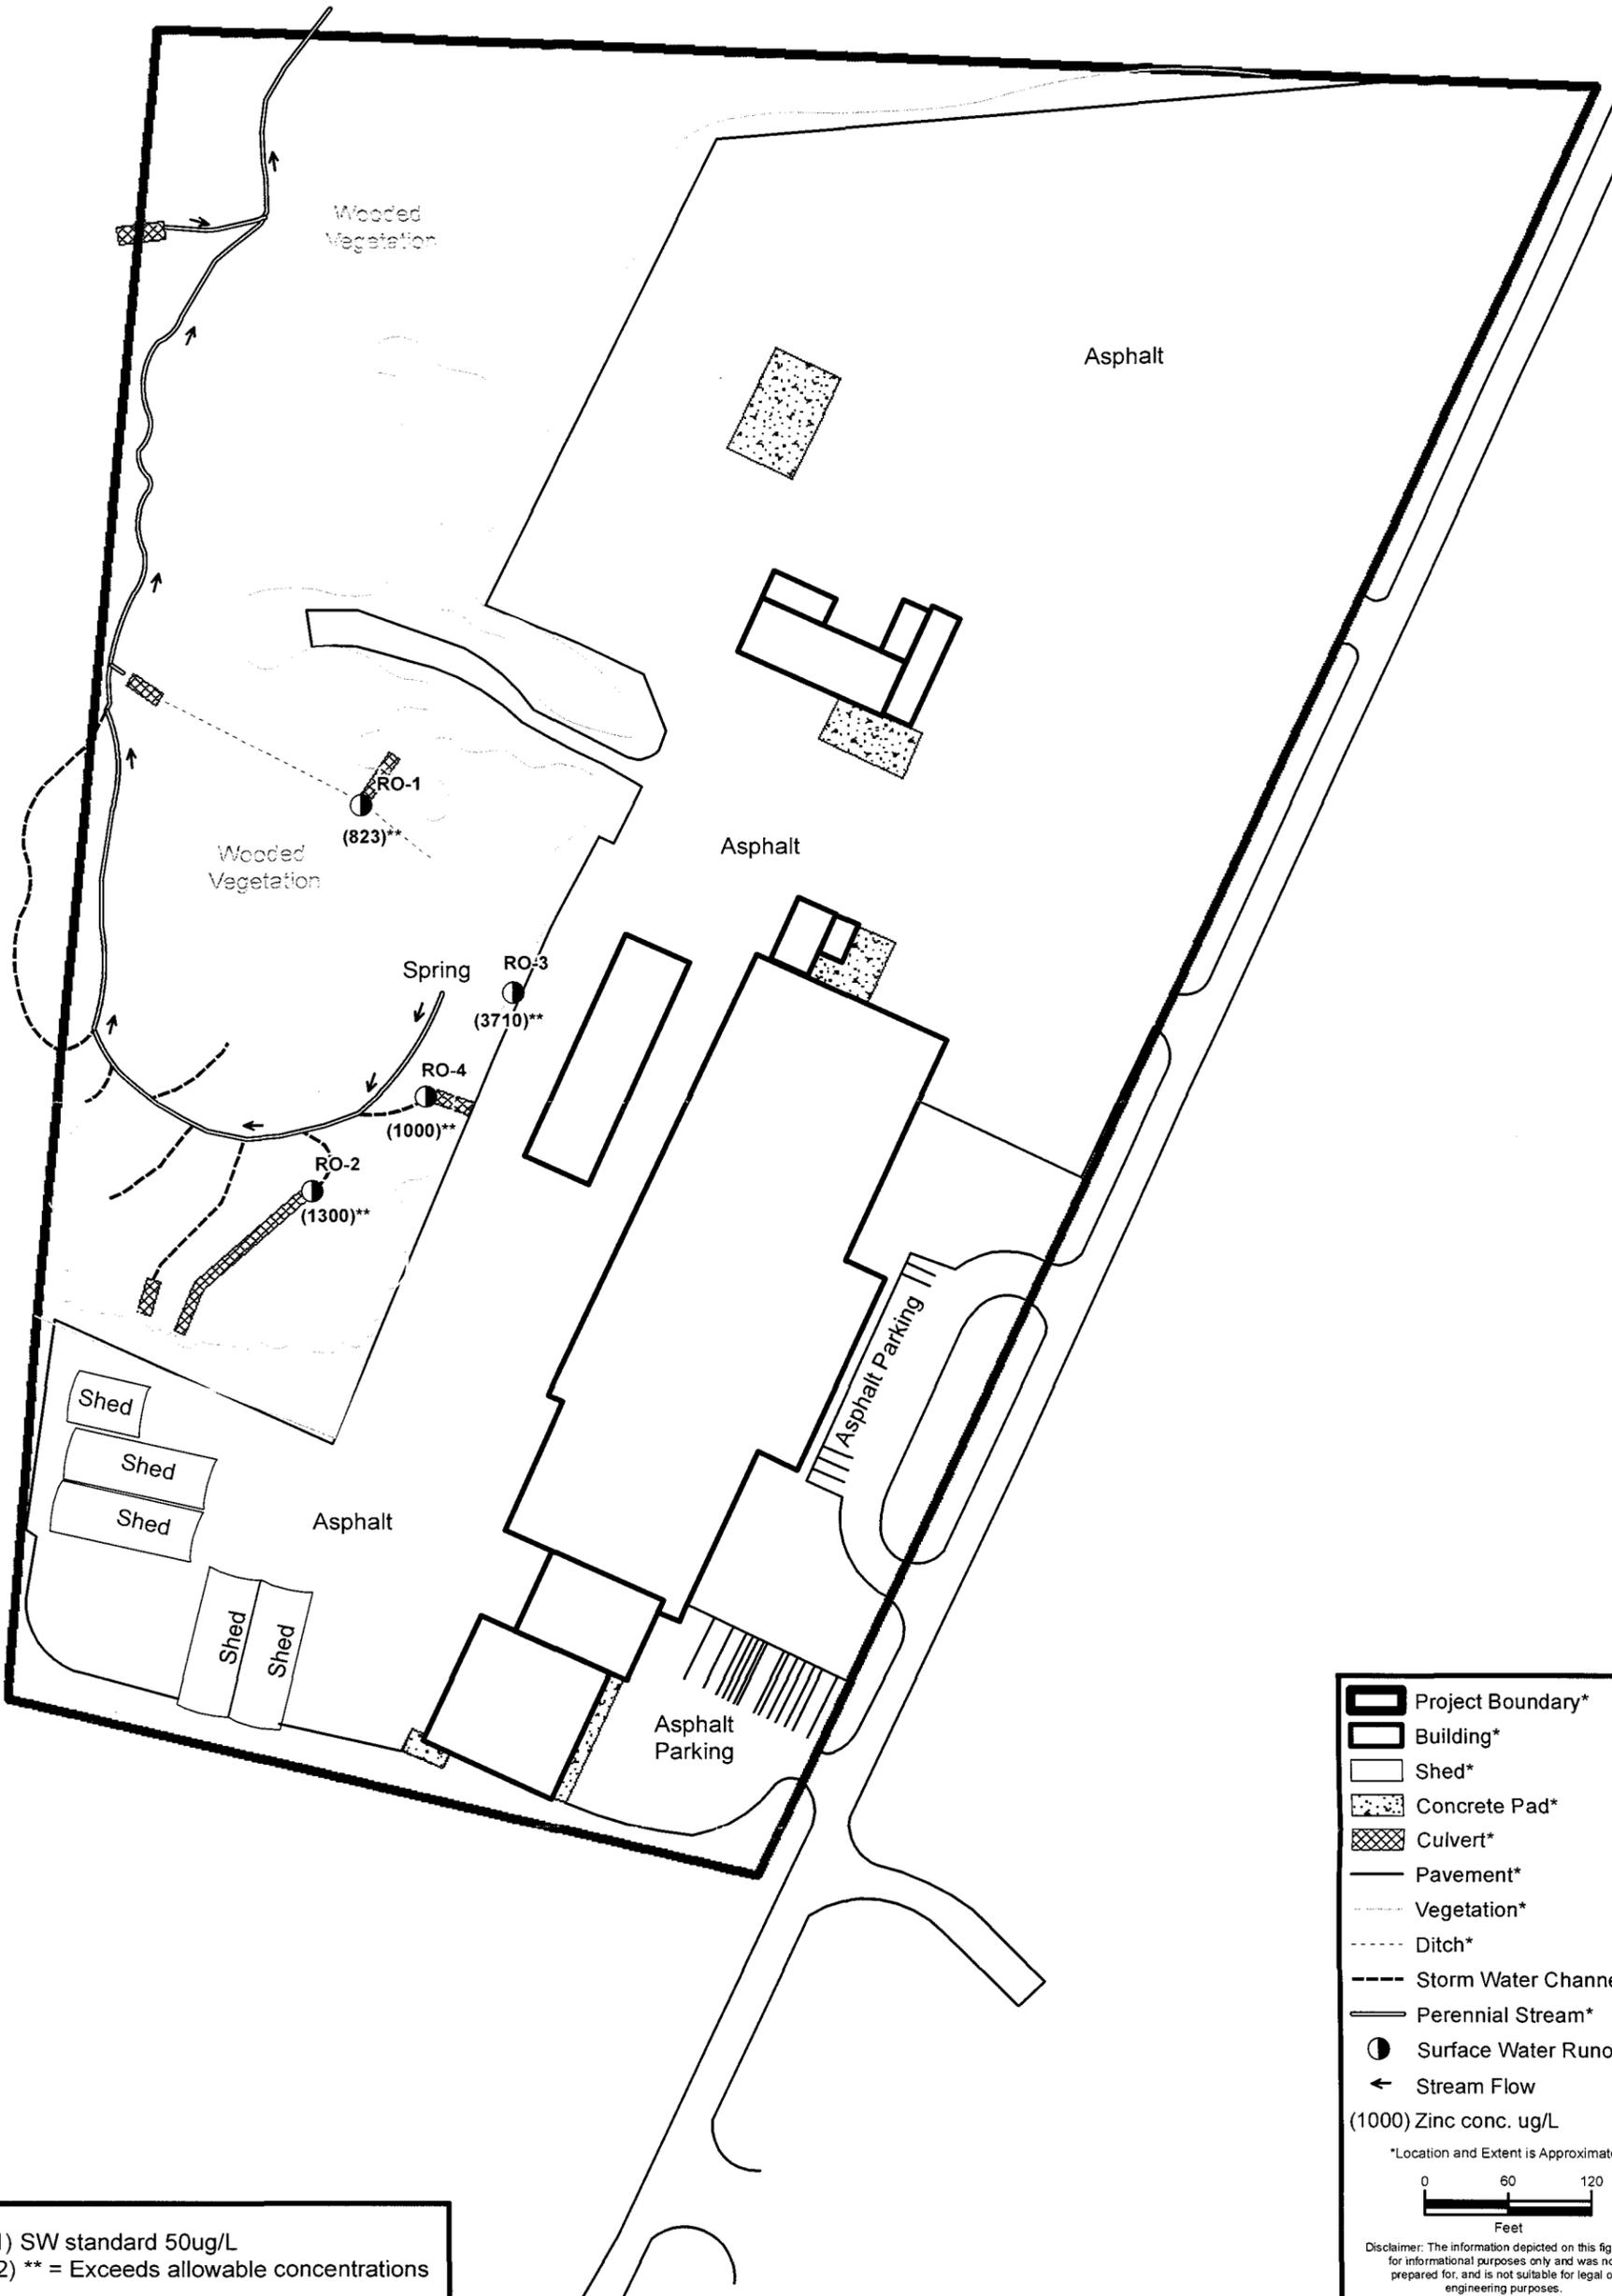
Project: ER10125.02
 Date: Sep 2011
 Drwn/Chkd: KT/MB
 Figure: 7

Stormwater runoff samples collected on September 6, 2011 indicated concentrations of zinc and lead (at one location) above regulatory standards.

Note: 1) SW standard 50ug/L
 2) ** = Exceeds allowable concentrations

Stormwater Runoff Concentrations - Zinc
Merchants Metals
 Iredell County, North Carolina
