**Part B Permit Application Final
Former Porcelanite Facility
20 Victor Street
Lexington, North Carolina 27292
EPA ID #NCD 986 181 451
February 1, 2019**

Reference: **Part B Permit Application Final**
(Former) Porcelanite Facility
20 Victor Street
Lexington, North Carolina 27292
EPA ID Number: NCD 986 181 451

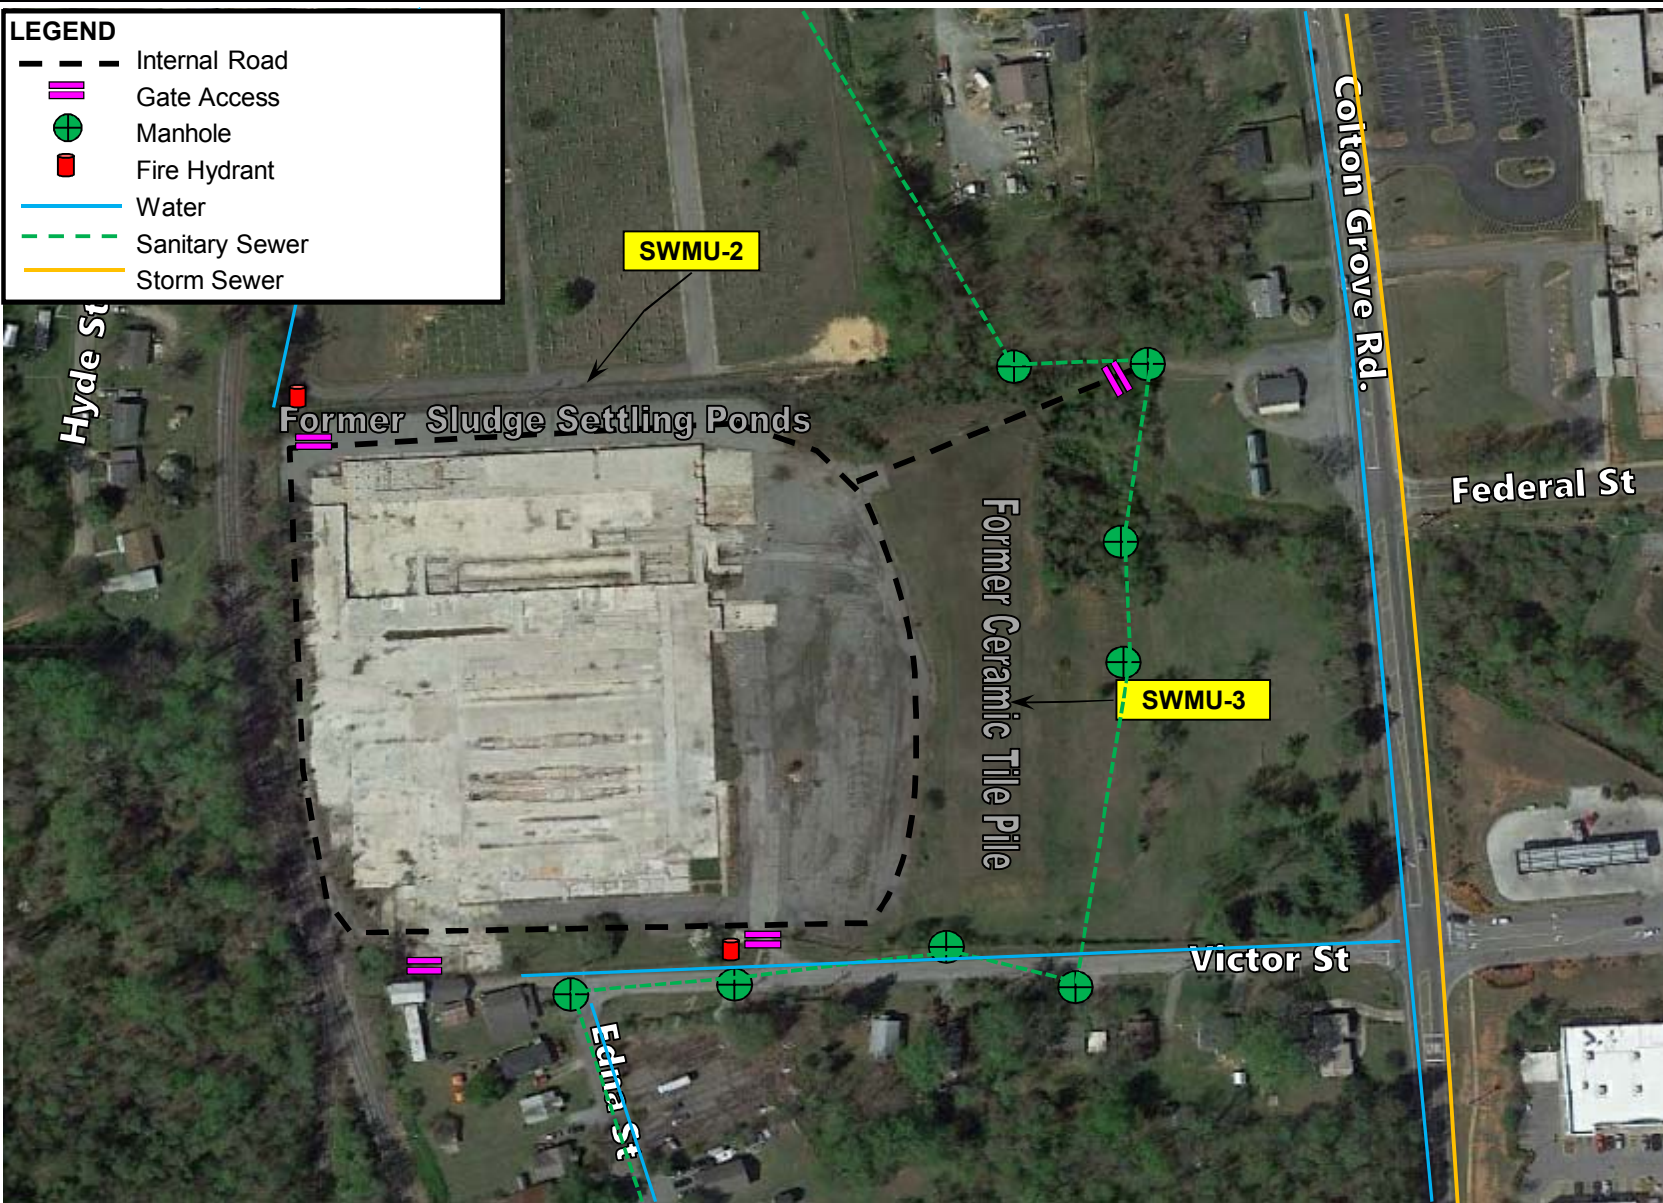
<i>Drawing</i> 15-006 Fig B-3	<i>Image Source</i> Google Earth	<i>Revision Date</i> 12/6/2017	<i>Date</i> 2/24/2017	<i>Title</i> SWMU-2 and SWMU-3 Location Map
<i>Job No.</i> R1-21	<i>Image Date</i> 4/8/2017	<i>Figure</i> B-3	<i>Scale</i> 1" ~ 200'	<i>Project</i> Former Porcelanite Facility Lexington, North Carolina

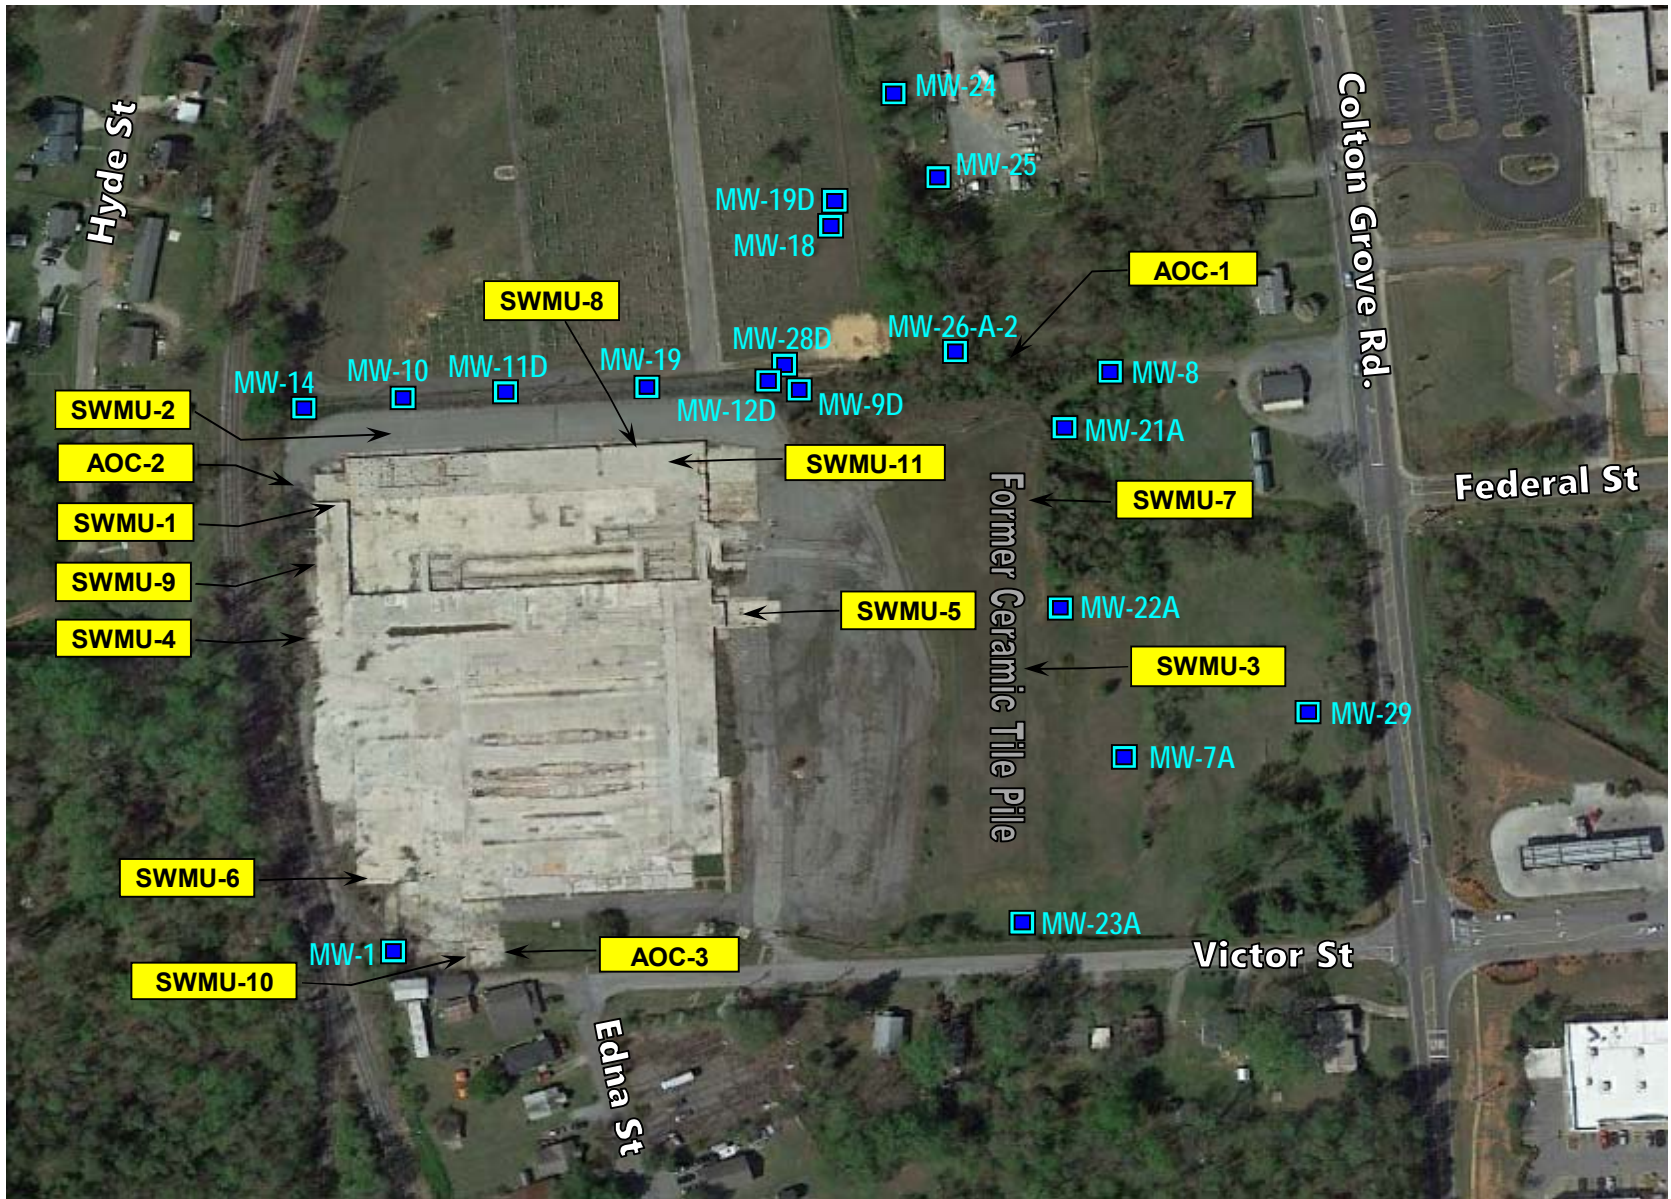
<i>Drawing</i> 15-006 Fig B-4	<i>Image Source</i> Google Earth	<i>Layers</i>	<i>Revision Date</i> 11.30.2017	<i>Title</i> SWMU and AOC Location Map
<i>Job No.</i> R1-21	<i>Image Date</i> 4.8.2017	<i>Figure</i> B-4	<i>Scale</i> 1" ~ 200'	<i>Project</i> Former Porcelanite Facility Lexington, North Carolina

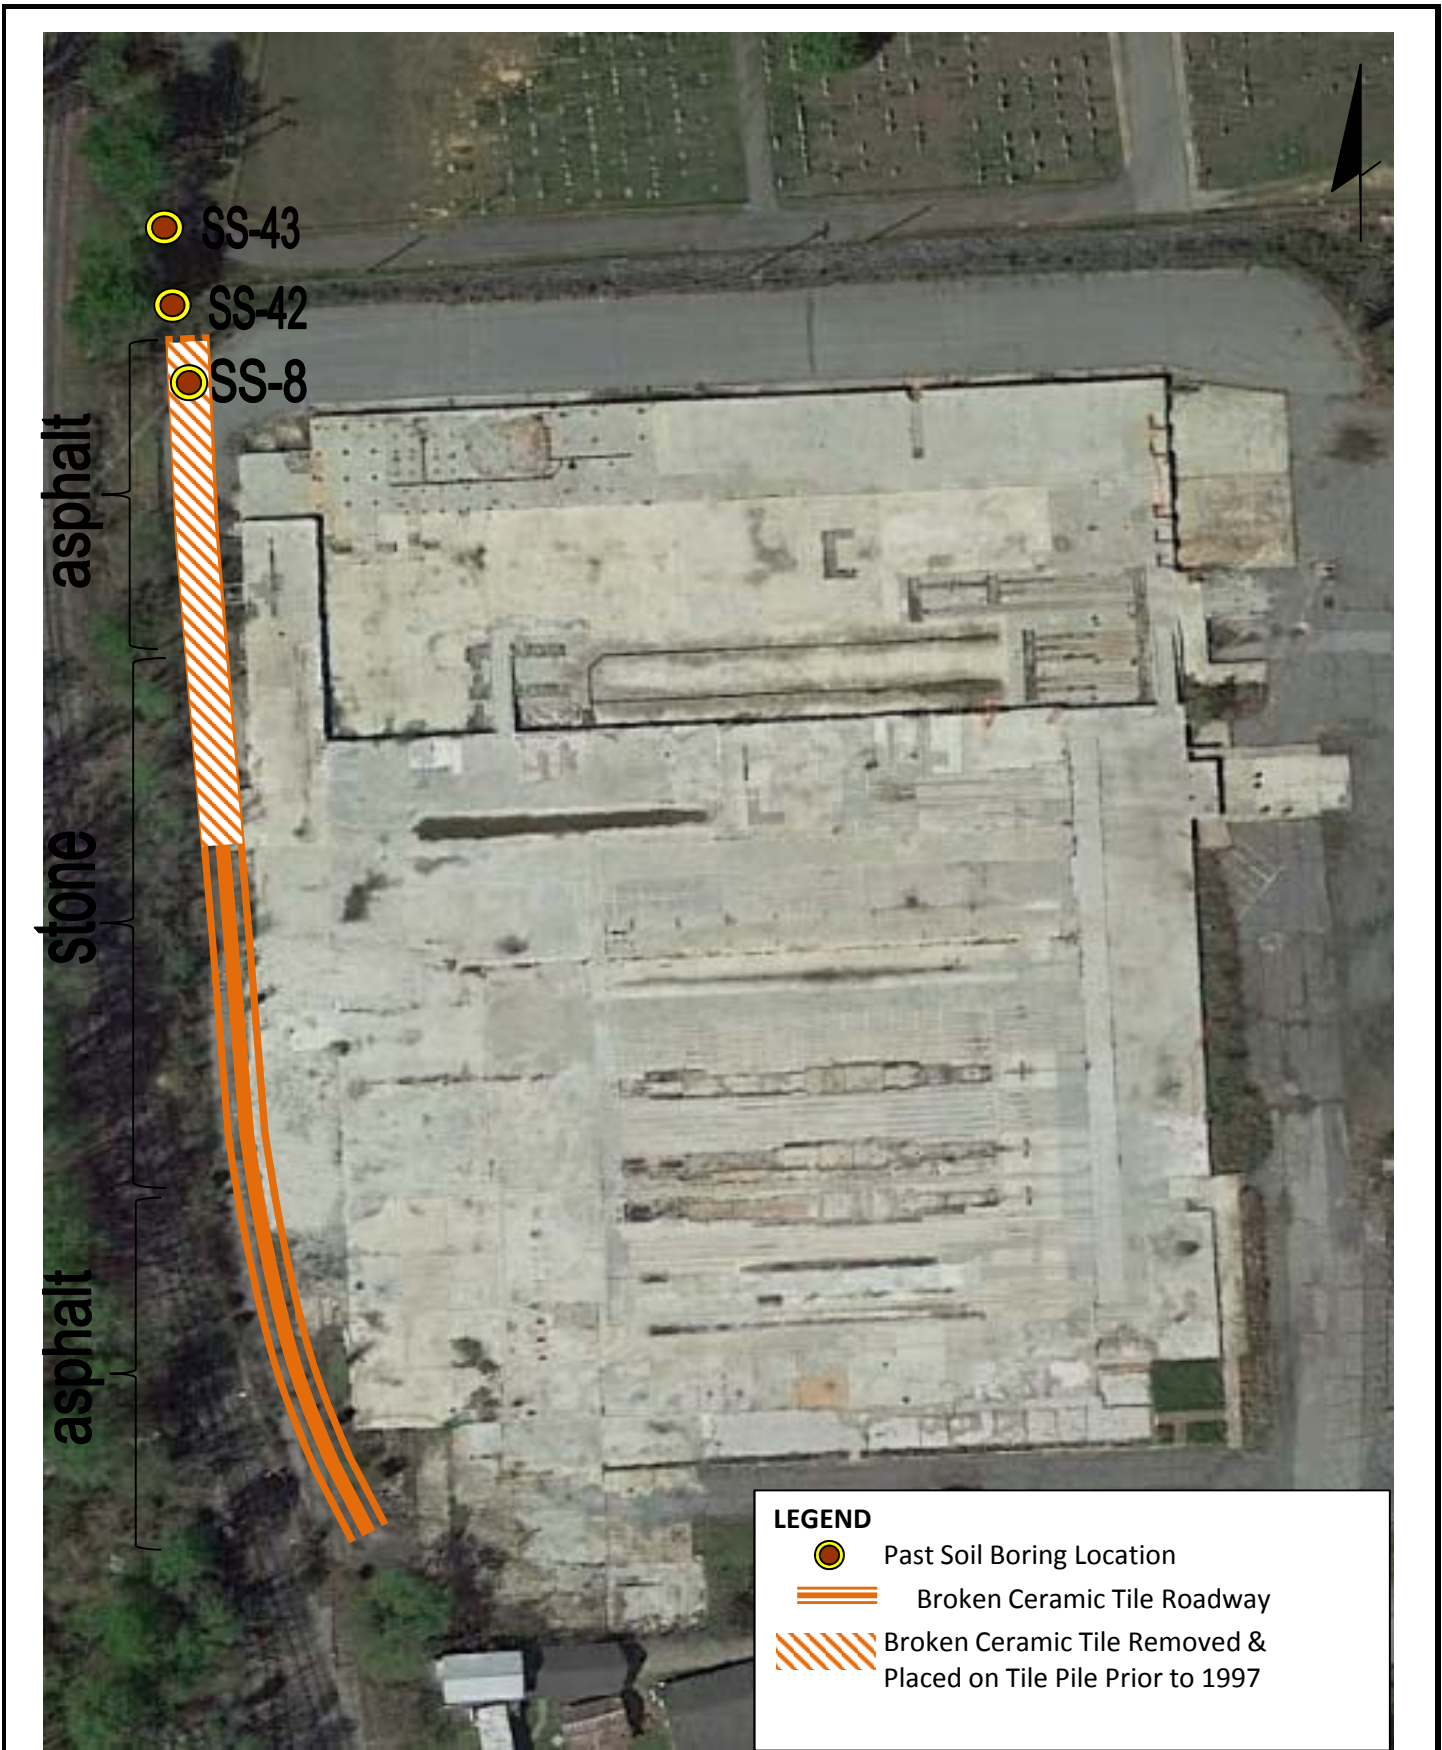
<i>Author</i>	<i>Drawing</i> Part L Fig L-3	<i>Date</i> 10.18.2016	<i>Title</i> AOC-2 Soil Boring Location Map Location Map
<i>Job No.</i> R1-21	<i>Figure</i> L-3	<i>Scale</i> 1" = 100'	<i>Project</i> Former Porcelanite Facility Lexington, North Carolina
