Waste Management
ENVIRONMENTAL QUALITY

FACILITY COMPLIANCE INSPECTION REPORT
Division of Waste Management
Solid Waste Section

Date of Site Inspection: March 24, 2016

Northfield Farms LCID Landfill
306 W. Old Glencoe Road
Burlington, NC 27217

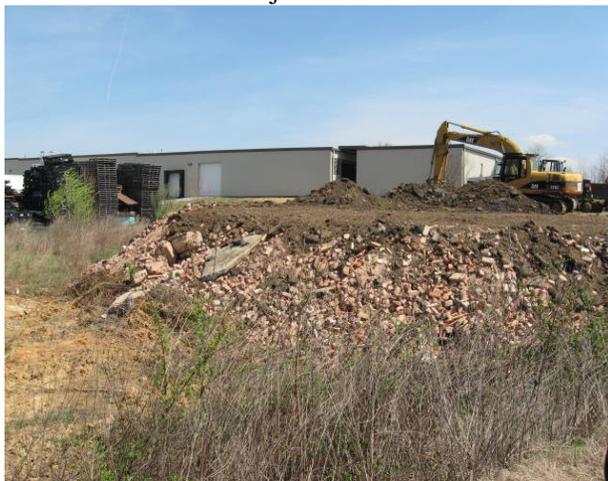
Inert debris fill area adjacent to landfill access road

12. Mr. Buckland stated that the LCID landfill meets all required buffers specifically that it is 100 feet from the disposal area to property lines.
13. Inert debris areas (not associated with the LCID landfill) used as beneficial fill are adjacent to the landfill access road and on the left side of the lot adjacent to the end of the gravel road.

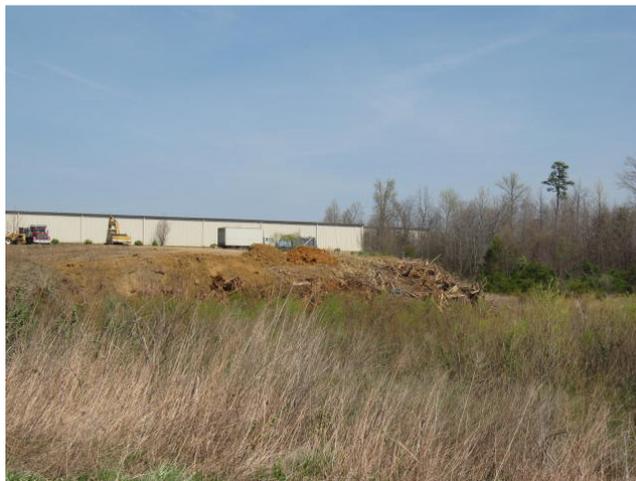
Notified LCID landfill

3. The LCID landfill is ~ 1.6 acres.
4. The LCID landfill is covered on top with soil. The sides slopes contain land clearing debris (LCD).
5. Mr. Buckland stated that uncovered material was received < 30 days ago.

9. Side slopes should be graded and covered with soil such that a 3:1 slope ratio is obtained or a ratio of which no indication of erosion or runoff is observed.

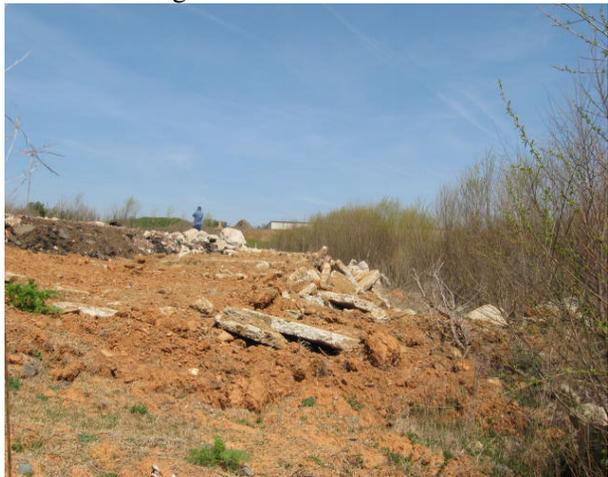
Inert debris fill area - left side of the lot adjacent to the end of the gravel road

14. The SWS received a complaint regarding the inert debris fill areas specific to runoff/a dark liquid and a conduit pipe placed in a waterway.
15. During the inspection there was no evidence of uncontrolled runoff observed from the inert material fill area. The area in question is being filled with broken red brick that stormwater likely filtered though from a recent rain event. The area at the toe of slope serves as a catch basin and is piped for stormwater. Mr. Buckland stated that as the area is filled with inert material the catch basin will be reconfigured. The conduit pipe was inspected by NCDEQ – Division of Water Resources. No problems observed affecting water quality was stated.

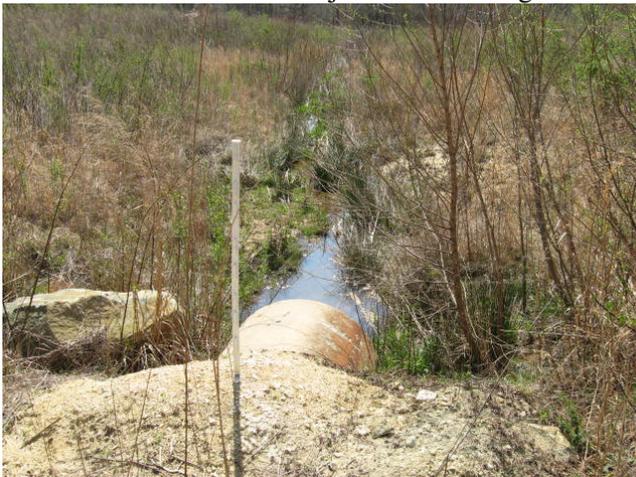
Conduit pipe placed in waterway at inert debris fill area on left side of lot adjacent to end of gravel road

16. Mr. Buckland stated that he may add additional conduit pipe to the waterway as additional inert material is placed in the area.
17. Ensure rebar is cut flush with concrete.
