**UST Closure Report  
R-Way II, Property  
6414 US Highway 158  
Guilford County, North Carolina  
Facility ID: 0-009763**

**Solutions - IES Project No. 2561.05A3.DENR**

**July 18, 2005**

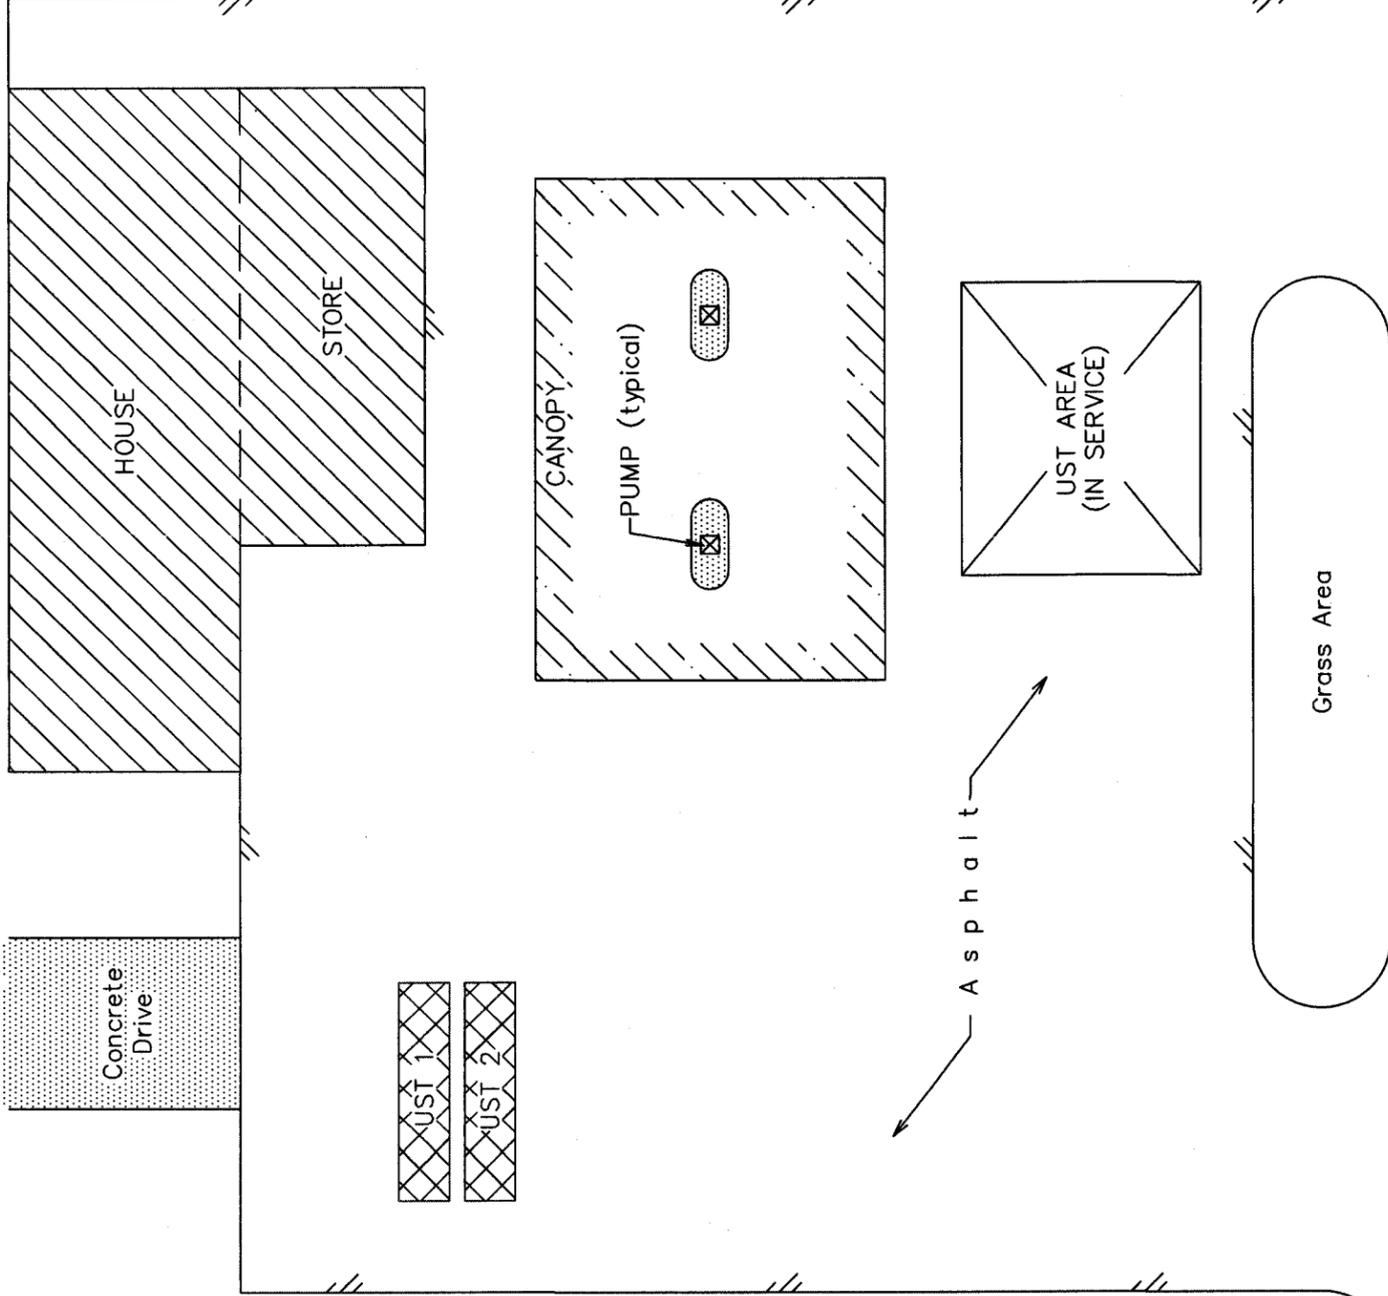
FIGURE:  
 2  
 SITE MAP  
 R-WAY II  
 6412 U.S. HIGHWAY 158  
 SUMMERFIELD, GUILFORD COUNTY, NORTH CAROLINA

Figure 2 shows the site features and locations of the USTs. Both USTs (UST-1 and UST-2) were located approximately 40 feet west of the store. When these tanks were taken out of service, the product lines extending from this tank pit were cut and capped near the dispenser pumps. Vent pipes extending from these tanks were previously removed.

The tanks were removed using the track-hoe bucket with a chain attached to eyelets on the USTs. Upon removal from the ground, the USTs were visually inspected for exterior damage and signs of leakage and the soil was checked for signs of petroleum impact. Soil samples were collected as described in Section 4.0. Figure 2 shows the tank locations and site layout.

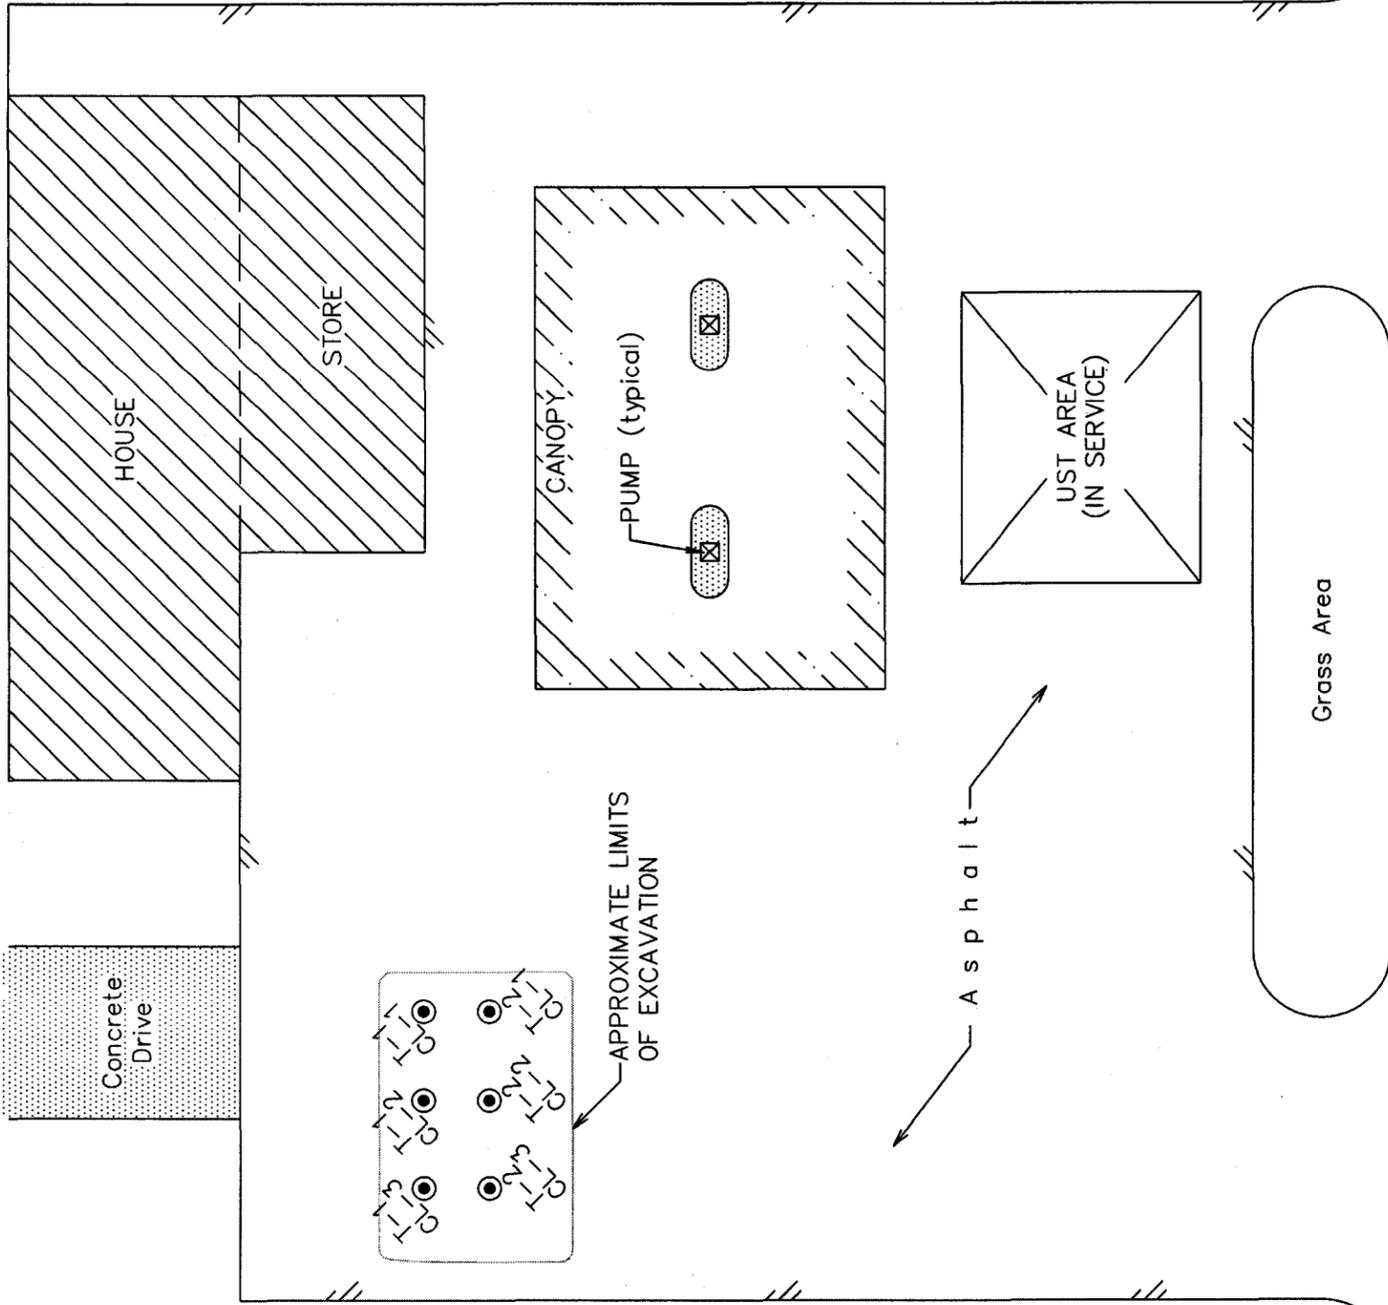
CLOSURE SAMPLE LOCATION MAP  
 R-WAY II  
 6412 U.S. HIGHWAY 158  
 SUMMERFIELD, GUILFORD COUNTY, NORTH CAROLINA

A total of six closure samples were collected upon removal of the two tanks. Based on the size of the tanks, three closure samples were collected beneath each tank, UST-1 and UST-2. All of the closure samples were collected within 1 to 2 feet of the tank bottoms.

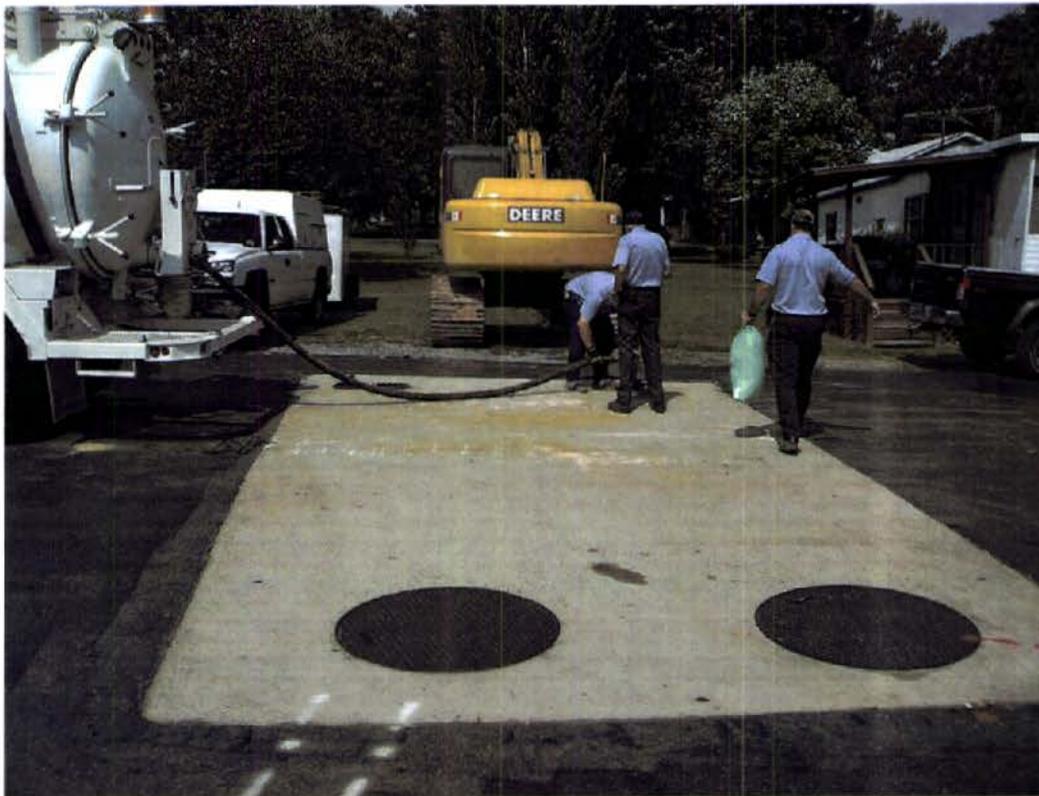
Photograph 1. View showing former tank pit.

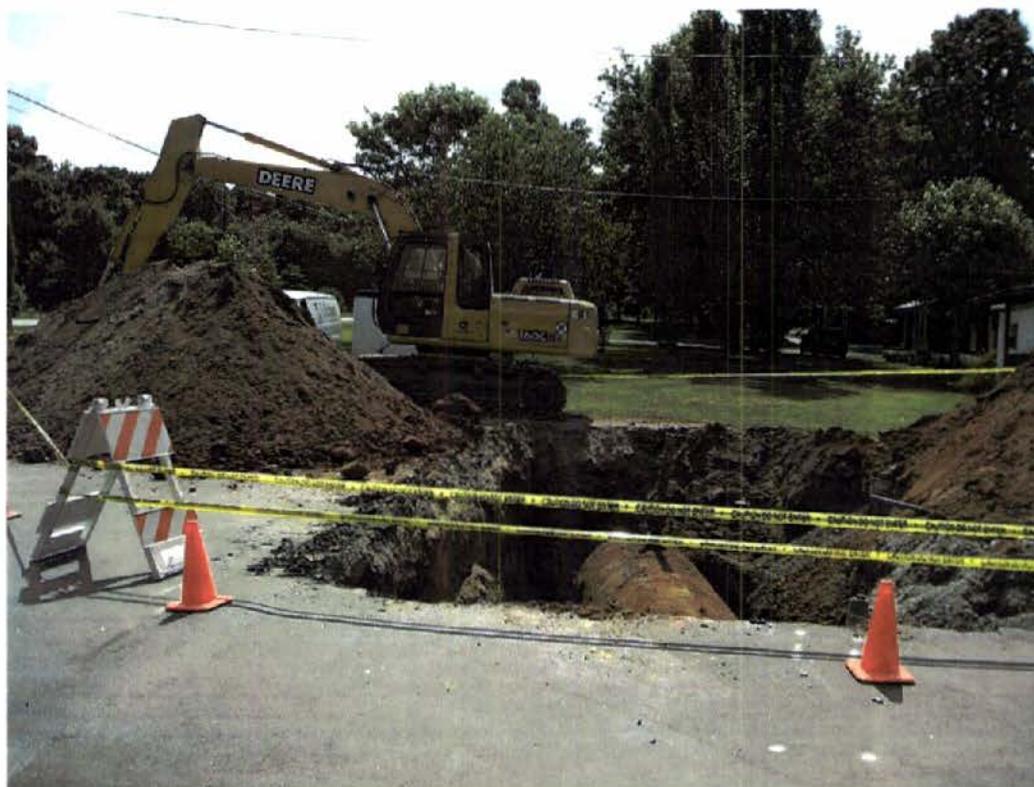
Photograph 2. View showing partially excavated tank pit.

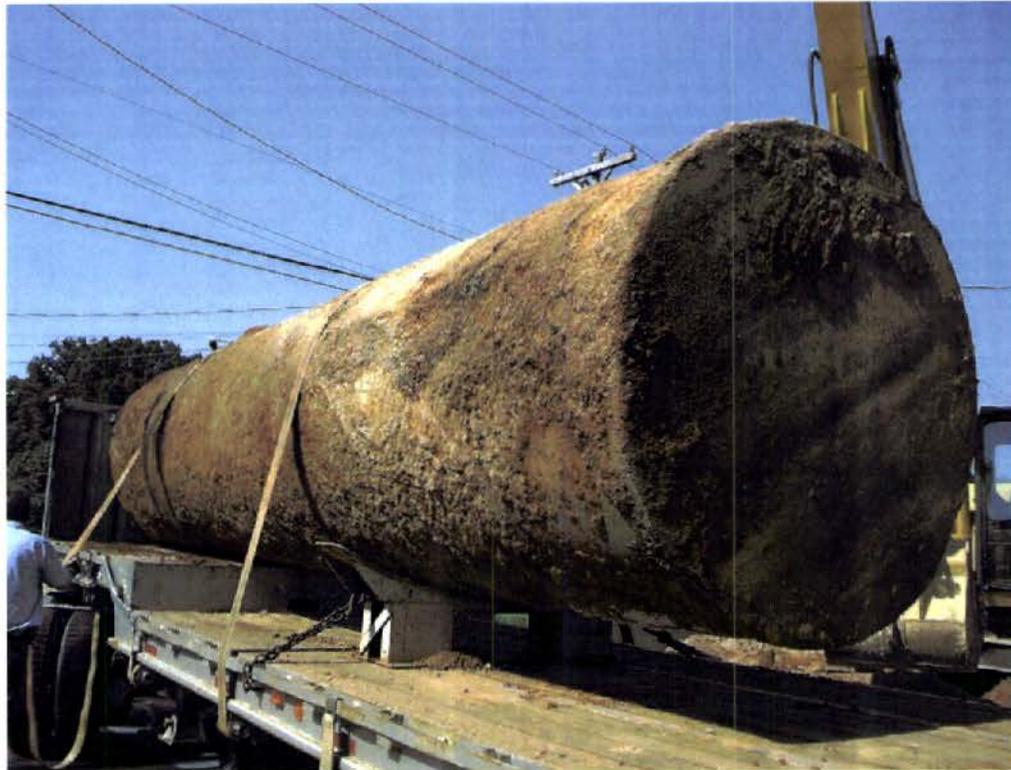
UST-1 and UST-2 were oriented side by side in an east/west direction in the tank pit located approximately 40 feet from the west side of the convenience store. These tanks were excavated on June 21, 2005. The tanks were covered with approximately 4 feet of soil and were both approximately 5.5 feet in diameter and 24 feet long. After removing the tanks, the resulting excavation was approximately 9.5 feet deep. Visual inspection of the tanks upon their removal revealed that they were both in generally good condition, free of holes, and both showed only minor corrosion.

Photograph 3. View of UST-2.

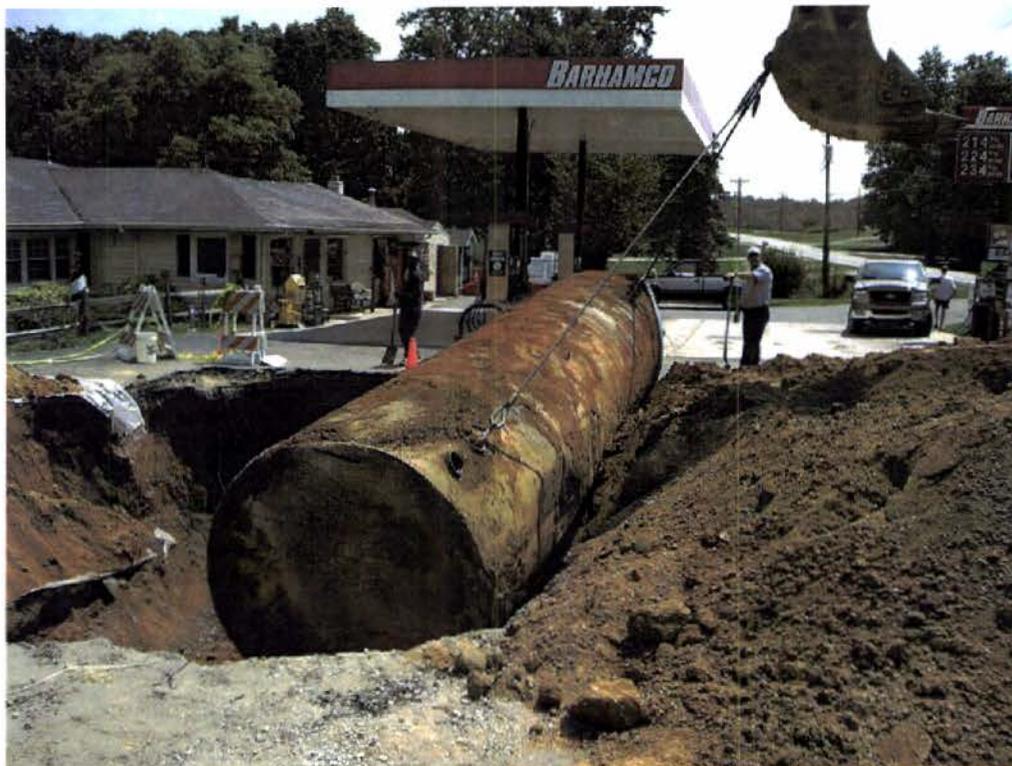
Photograph 4. Removal of UST-1.

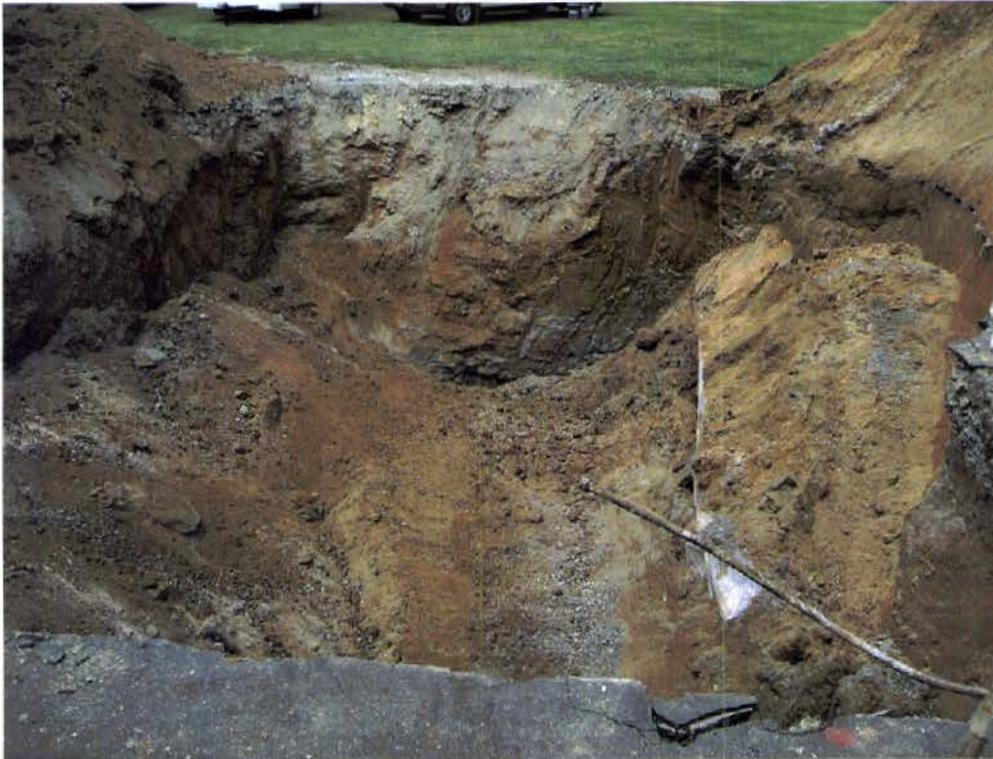
Petroleum-impacted soil was not identified upon removal of the tanks from the excavation (i.e., no odors and/or low FID readings). The excavations were backfilled on June 21, 2005 with the overburden soil that originally covered the tanks and additional clean soil provided by Soil Solutions. The backfill was compacted in 12-inch lifts with the track-hoe bucket and leveled to a depth of 8-inches bls. Crushed stone was placed within the top 8-inches of the excavation and leveled to match the existing asphalt grade. The property owner plans to have this area repaved with asphalt.

Photograph 5. View of excavation after removal of USTs.

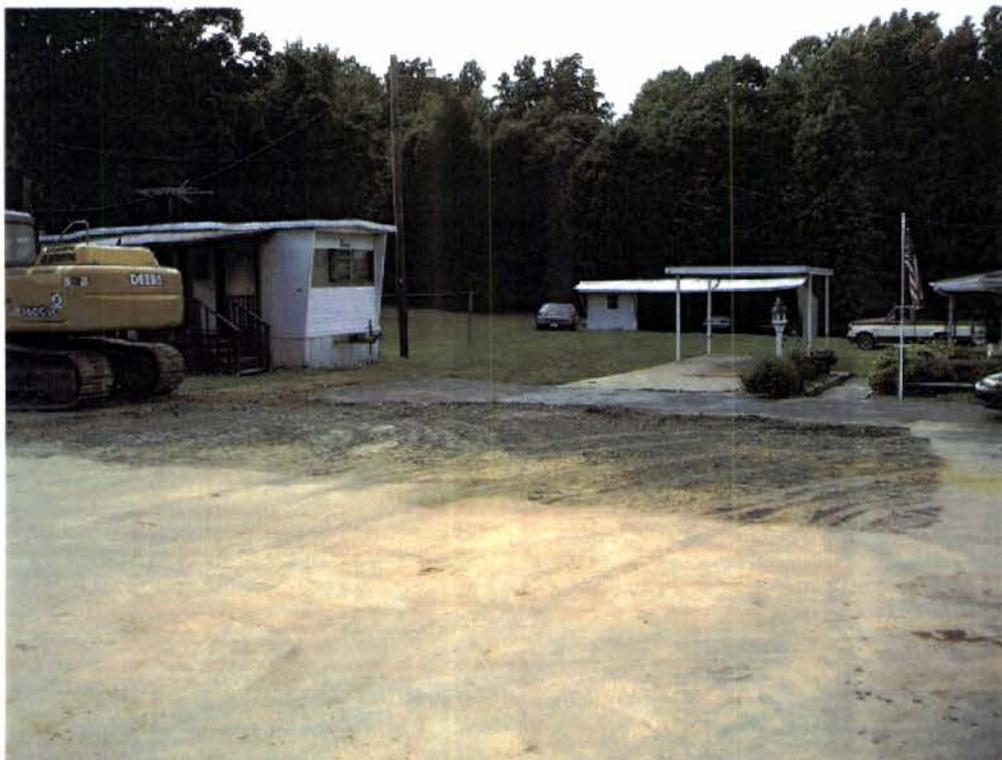
Photograph 6. View of backfilled excavation.
