April 16, 2008

Subject: **UST Closure Report
PNG Operations Center
2623 Uwharrie Road
High Point, North Carolina
Facility ID: 0-009658
MACTEC Project 6228-07-4191-04**

**UNDERGROUND STORAGE TANK CLOSURE REPORT
PNG OPERATIONS CENTER
2623 UWHARRIE ROAD
HIGH POINT, NORTH CAROLINA 27263**

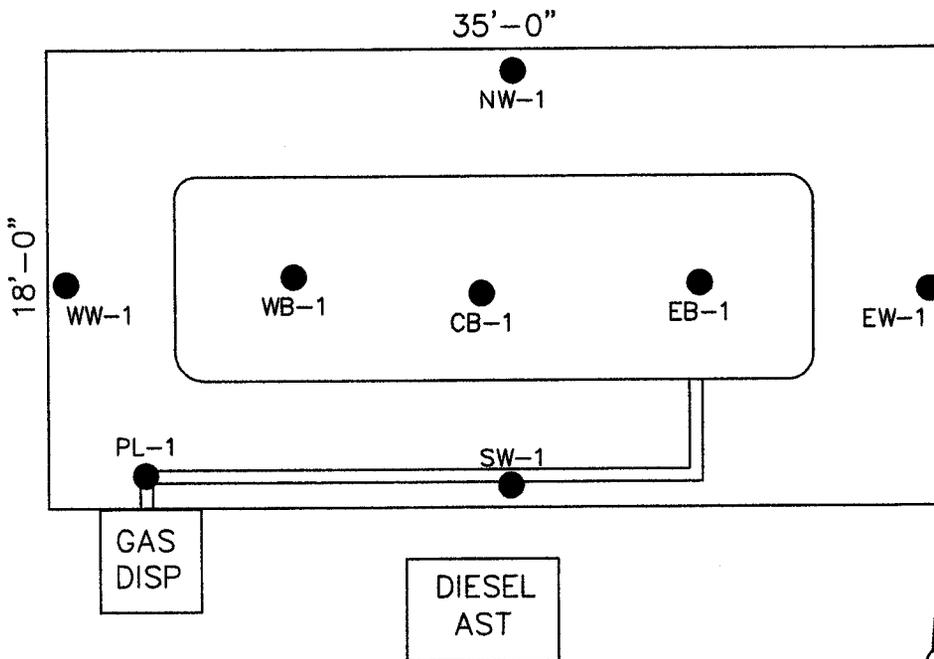
PREPARED BY: <i>Mtm</i>	DATE: <i>4/16/08</i>	CHECKED: <i>CC</i>	DATE: <i>4/16/08</i>	JOB NO. 6228-07-4191	FIGURE 3
-------------------------	----------------------	--------------------	----------------------	----------------------	----------

- APPROXIMATE LOCATION OF SAMPLE BORINGS

SITE PLAN
 PNG OPERATIONS CENTER - UST REMOVAL
 2623 UWHARRIE ROAD
 HIGH POINT, NORTH CAROLINA

The product supply lines were buried approximately four feet below the ground surface and extended from the UST to the fuel dispenser within the tank pit (Figure 3). The fuel dispenser was located adjacent to the southwest corner of the excavation. The product lines were removed on March 12, 2008. Soil samples were obtained along the product line, near the dispenser and at the sidewalls and floor of the tank excavation.

The former UST, product lines, and dispenser locations are shown on Figure 3. Photographs of UST closure activities are provided in Appendix C.

Sample locations are presented on Figure 3.

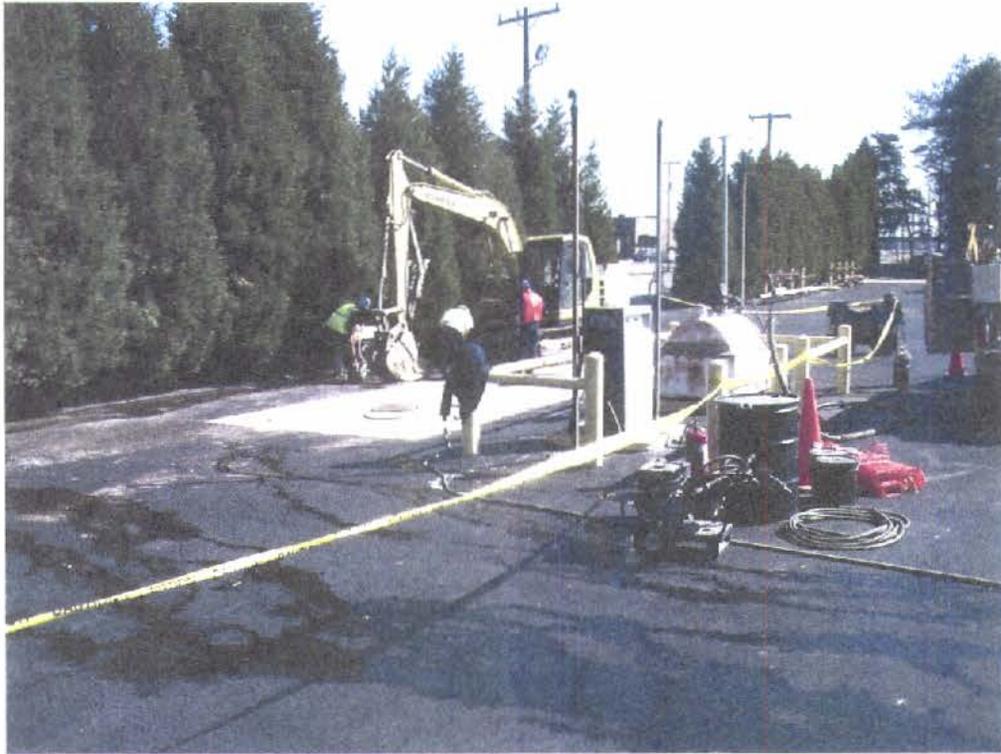
Photograph 1: View of excavation area.

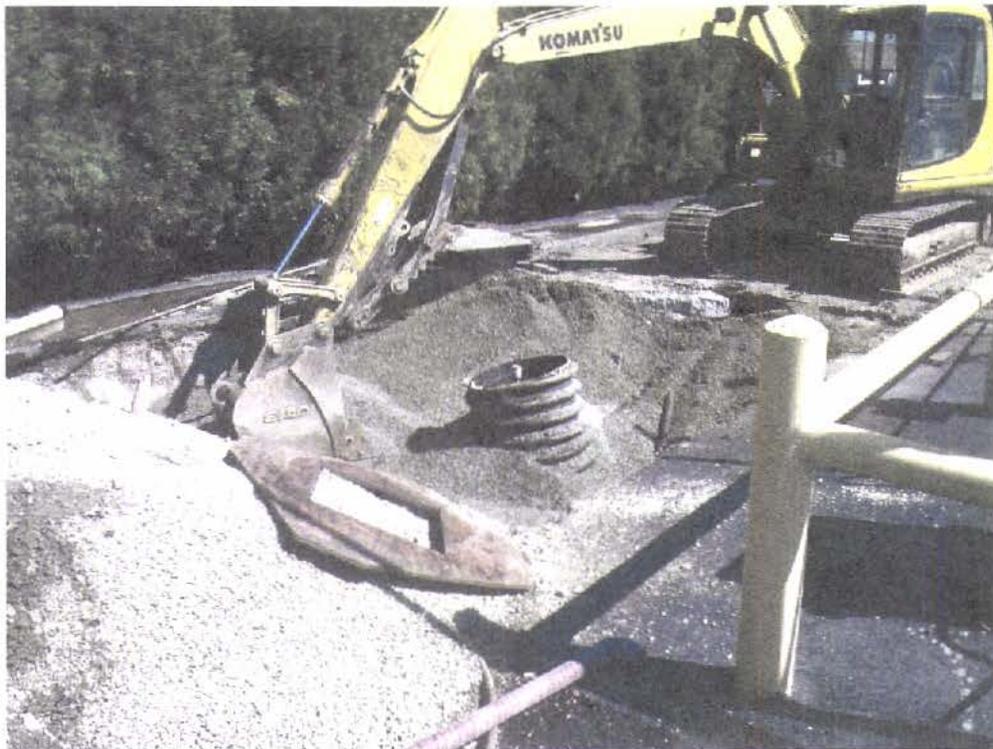
Photograph 2: View of Day 1 removal activities (3-12-08).

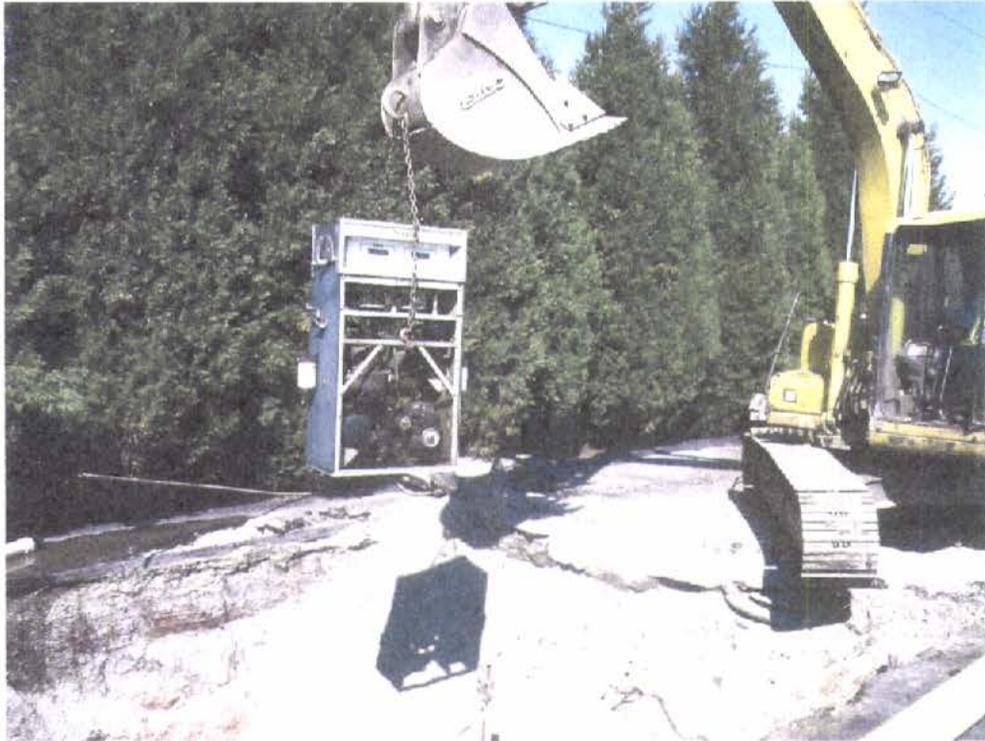
Photograph 3: View of dispenser removal (3-12-08).

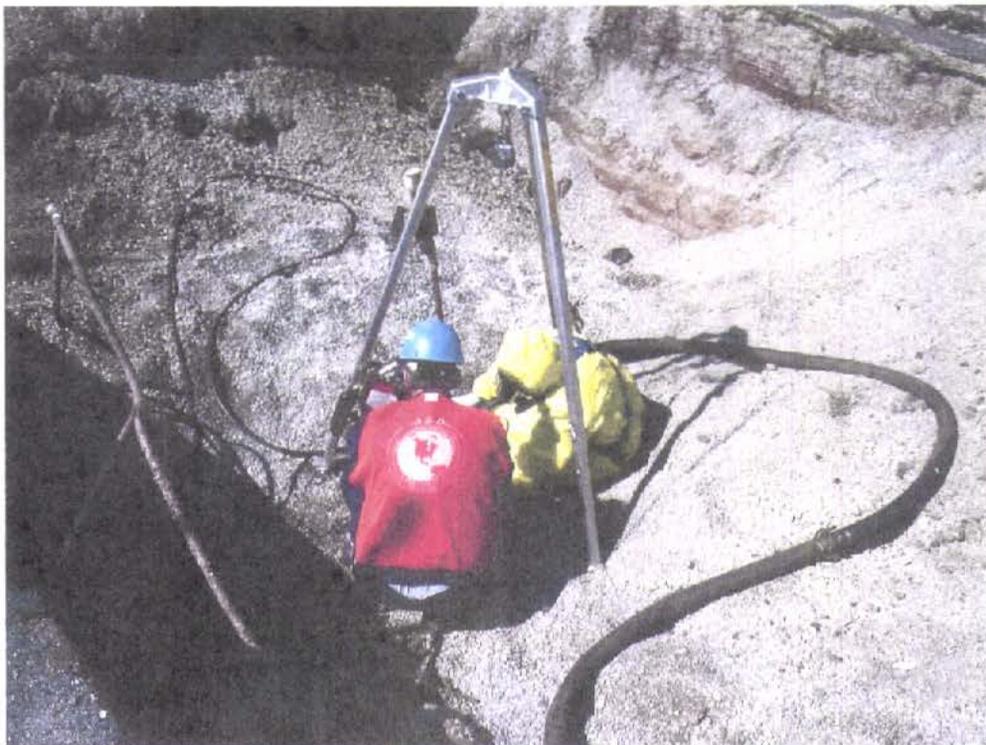
Photograph 4: View of confined space entry (3-12-08).

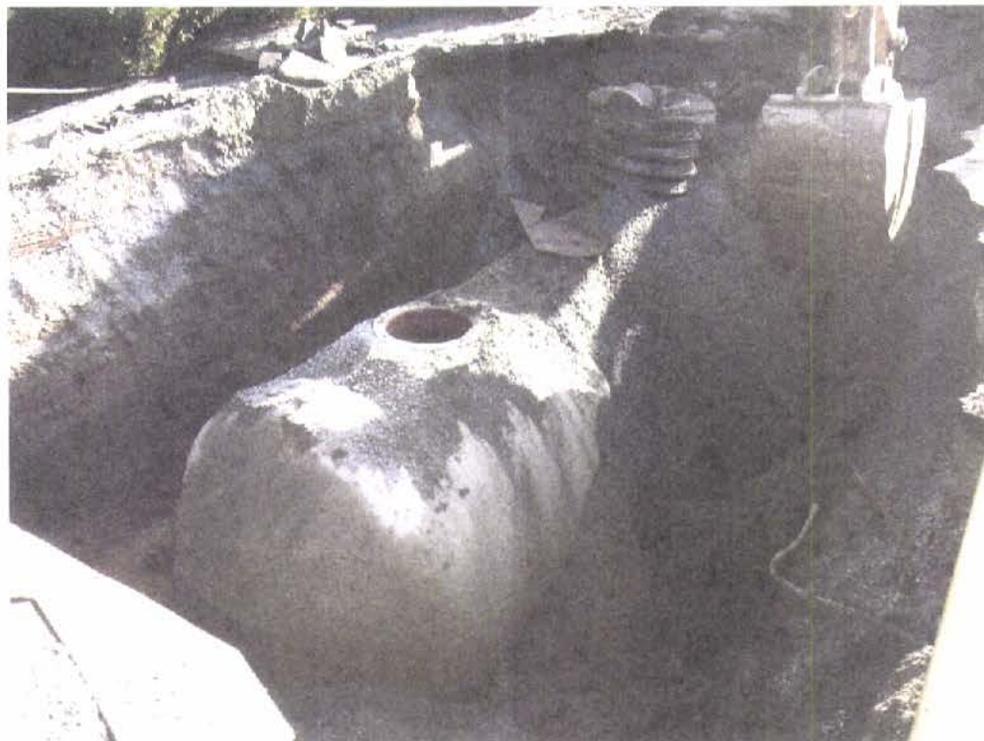
Photograph 5: View of Day 2 removal activities (3-13-08).

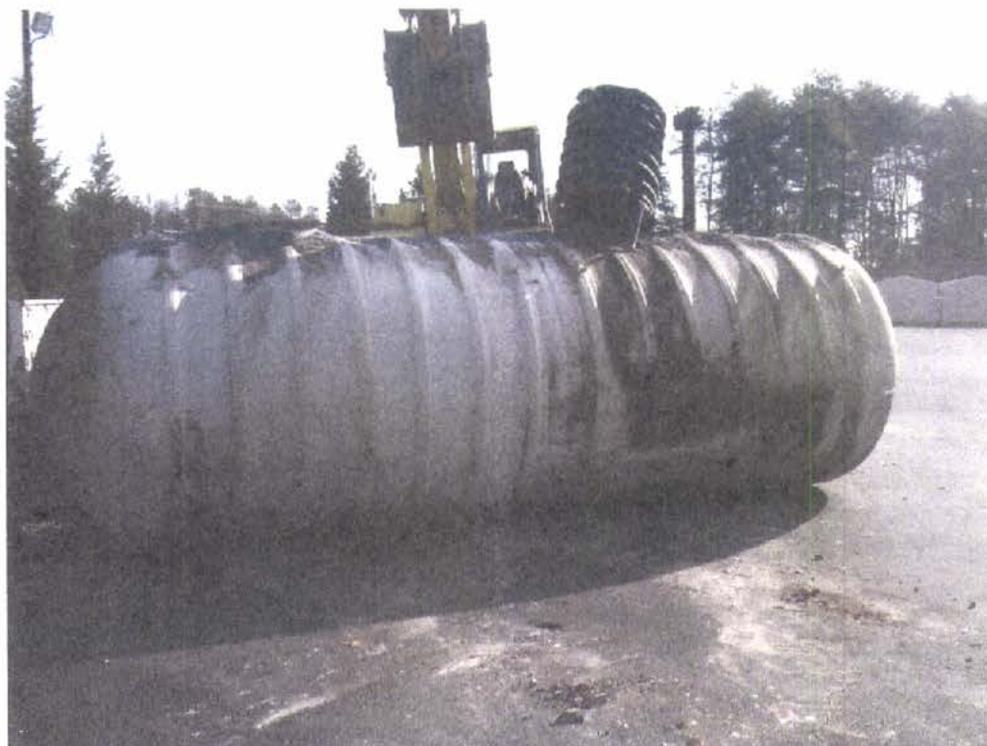
Photograph 6: View of 8,000-gallon fiberglass UST removed from excavation.

An 8,000-gallon gasoline UST was removed from the site on March 13, 2008. Initially, concrete and asphalt overlying the tank was removed. A mixture of pea gravel and reddish brown clayey silt was excavated from atop and along the sides of the tank using a trackhoe.

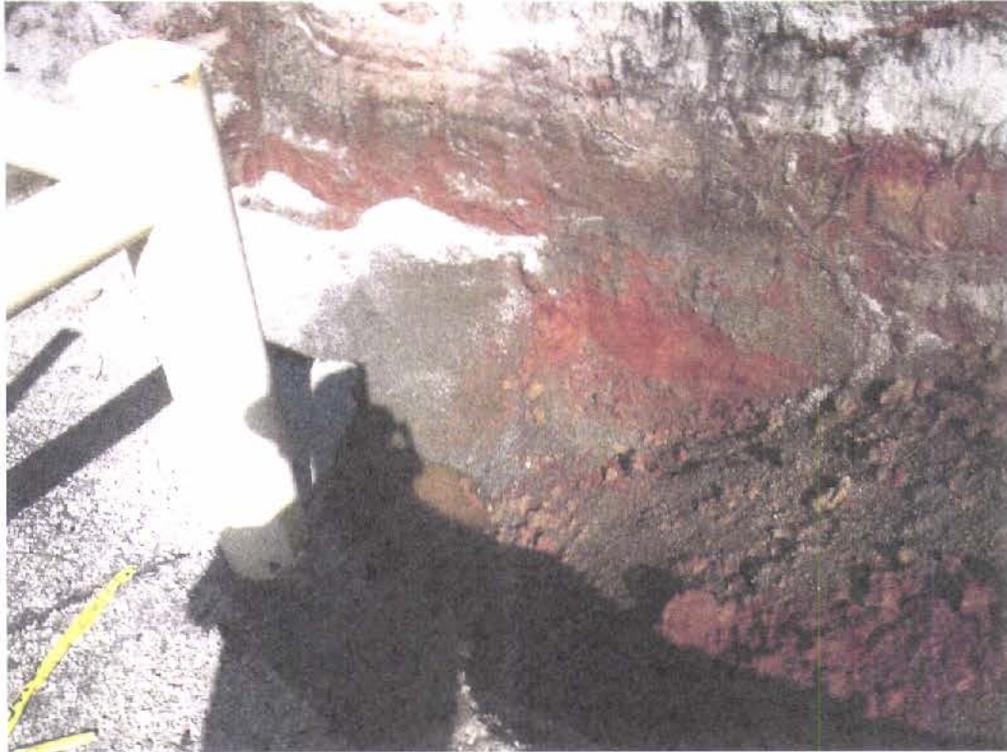
Photograph 7: View of excavation pit (3-28-08).

The dimensions of the excavation were approximately 35 feet (length) by 18 feet (width) with a depth of approximately 15 feet. The tank was buried approximately four feet below grade.

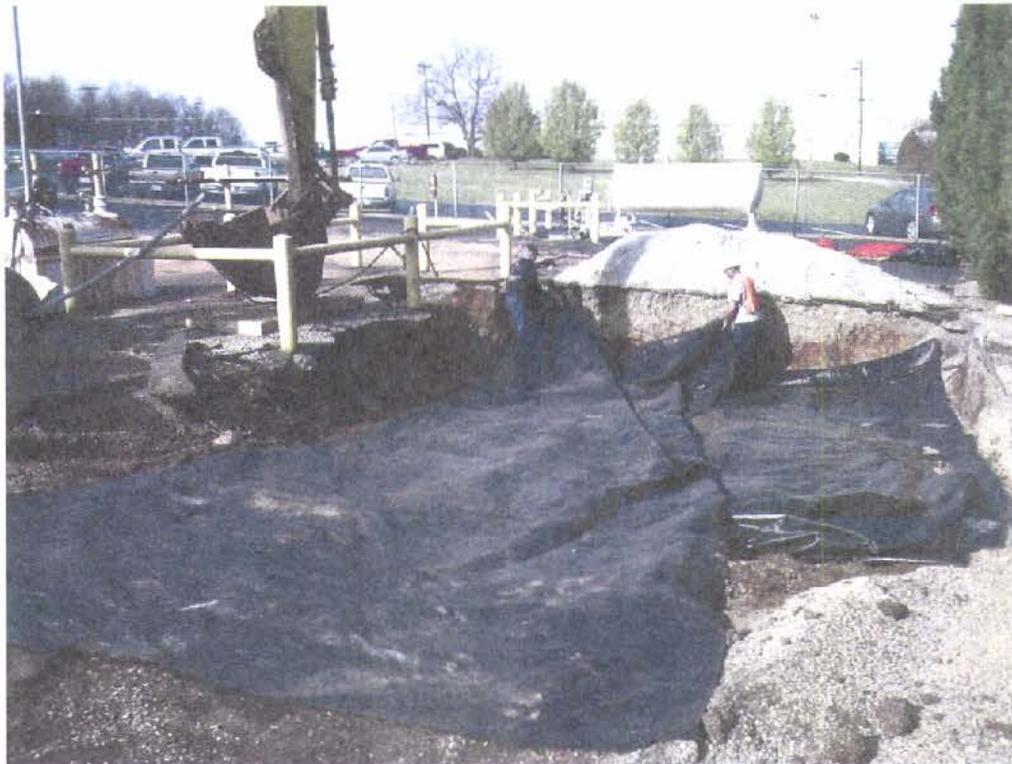
Photograph 8: View of filter fabric placed on pea gravel (backfill).

A&D imported additional "clean" fill soils and ABC stone to the subject property for use in backfilling the excavation.

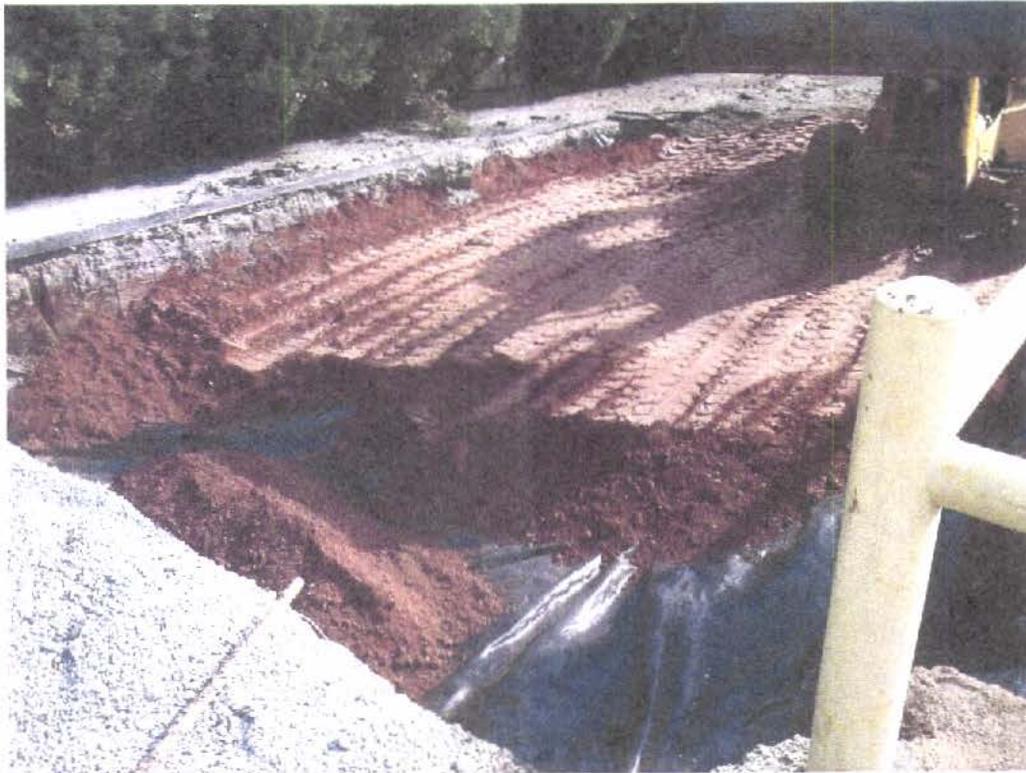
Photograph 9: View of backfilling red clay on top of filter fabric.
