**Subject:** Tank Closure Report

# TANK CLOSURE REPORT

North Bridge Street BP

666 North Bridge Street  
Elkin, NC 28621

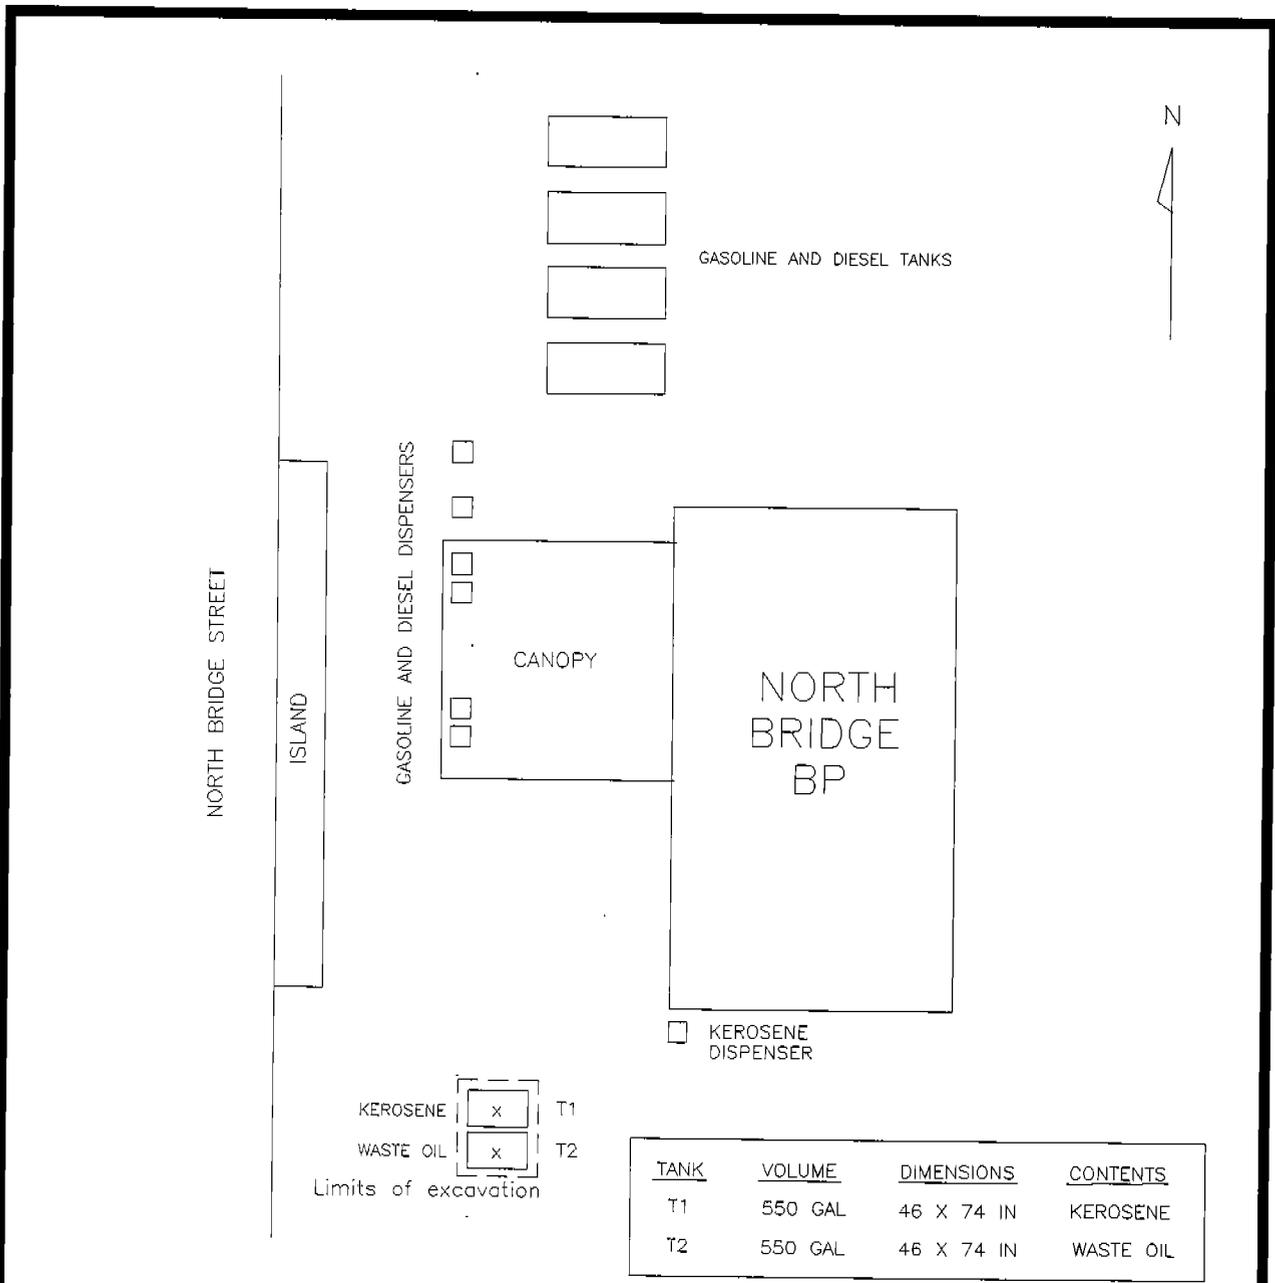
FIGURE 2. NORTH BRIDGE BP  
666 NORTH BRIDGE ST  
ELKIN, NC

TANK	VOLUME	DIMENSIONS	CONTENTS
T1	550 GAL	46 X 74 IN	KEROSENE
T2	550 GAL	46 X 74 IN	WASTE OIL

AREA IS SERVICED BY CITY WATER LINES. NO WELLS ARE LOCATED WITHIN 1500 FT RADIUS OF SITE.

SITE IS >1500 FT UPGRADIENT OF THE NEAREST PERENNIAL STREAM TO WHICH SITE AREA DRAINS.

CITY WATER AND SEWER LINES, EXACT LOCATIONS UNKNOWN. POSSIBLE OTHER SUBSURFACE UTILITIES IN AREA.

SITE LAYOUT, SAMPLE LOCATIONS,  
WATER SUPPLIES, AND OTHER  
INFORMATION

Tank removal consisted of removing the least amount of soil necessary to remove the tanks. No petroleum staining or odor was detected in the soil around or beneath the tanks. Approximate excavation dimensions were 8.5 ft by 10 ft, as indicated in Figure 2 of Appendix A.

- Location of samples  
One soil sample was collected from beneath the midline of each tank as indicated in Figure 2, Appendix A of the closure report.

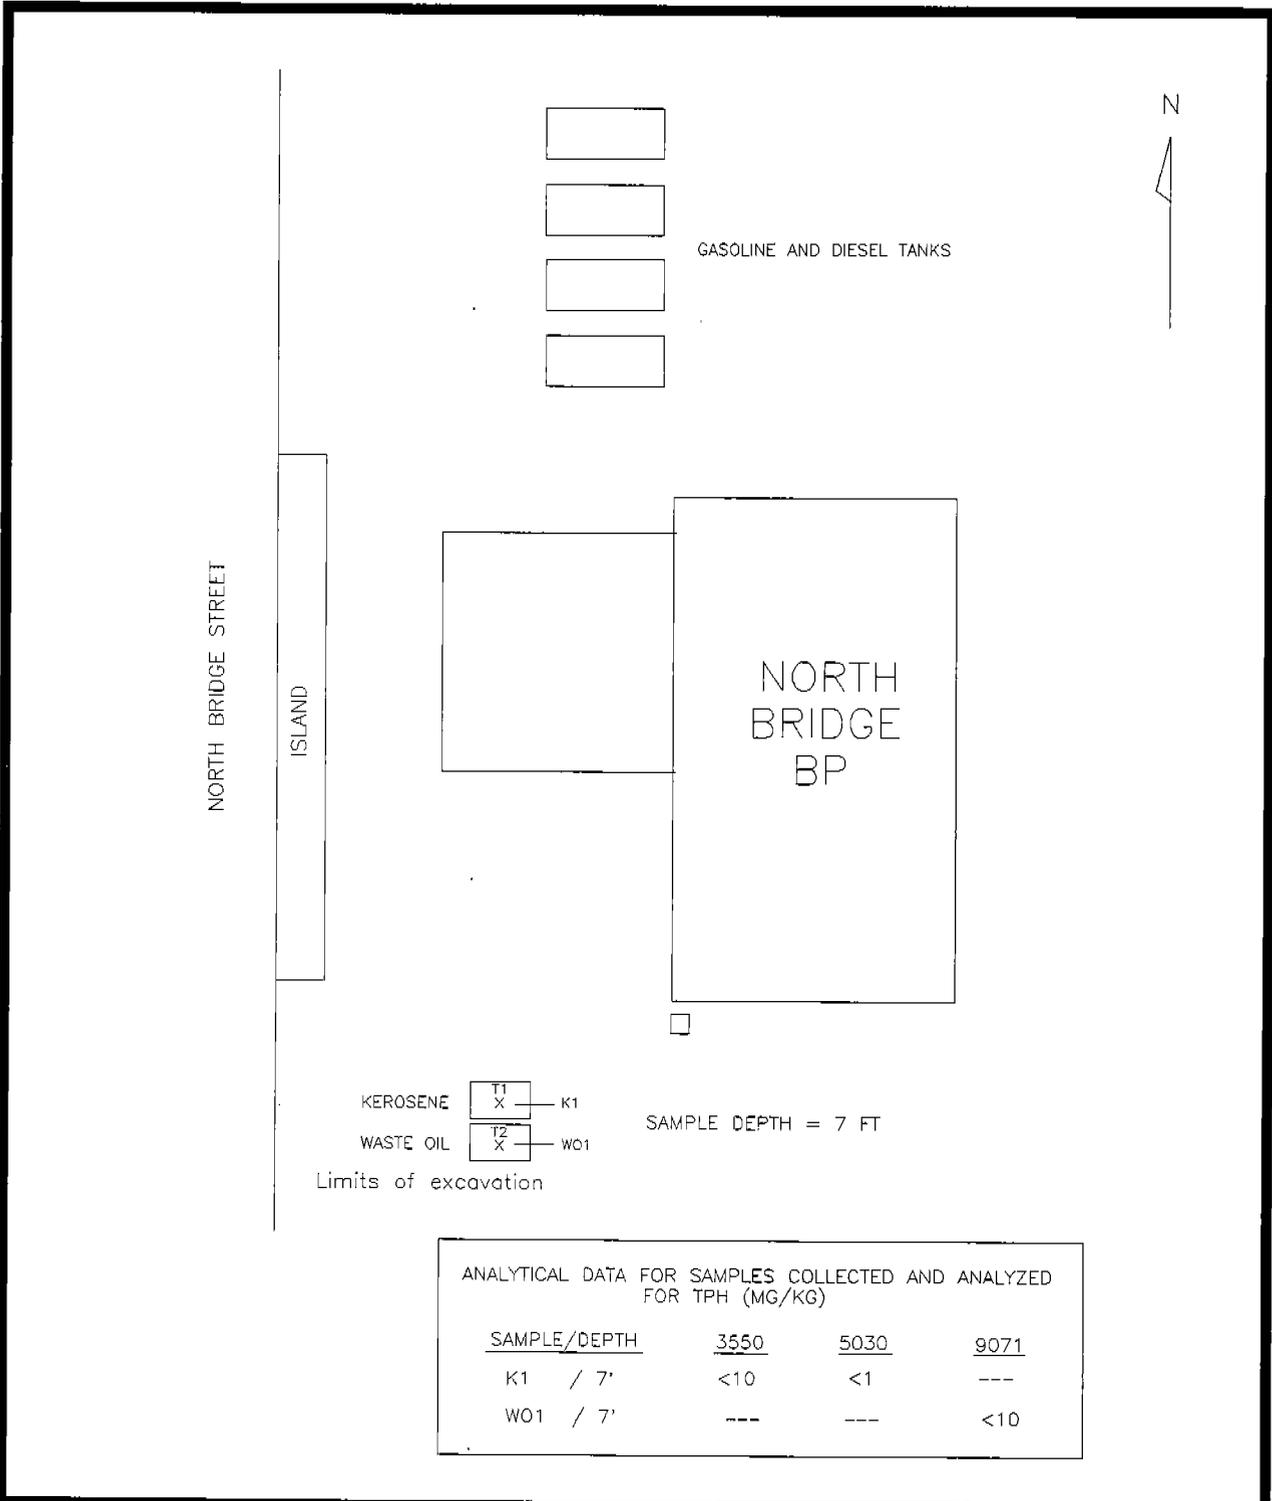
FIGURE 3. NORTH BRIDGE BP  
 666 NORTH BRIDGE ST  
 ELKIN, NC

ANALYTICAL DATA FOR SAMPLES COLLECTED AND ANALYZED FOR TPH (MG/KG)

SAMPLE/DEPTH	3550	5030	9071
K1 / 7'	<10	<1	---
W01 / 7'	---	---	<10

ANALYTICAL RESULTS AND  
 OTHER DATA

A kerosene and a waste oil tank were closed at North Bridge BP. Analysis of soil samples from beneath these tanks by EPA Methods 3550 and 5030 (kerosene tank) and EPA Method 9071 (waste oil tank) indicated TPH levels of <10 and <1 for 3550 and 5030 hydrocarbons, respectively, and <10 for 9071 hydrocarbons. Since minimum NC DEM clean up standards were not exceeded, no further action is recommended.
