FACILITY COMPLIANCE INSPECTION REPORT
Department of Environmental Quality
Division of Waste Management - Solid Waste Section

Date of Site Inspection: November 10, 2015

Watauga County Transfer Station
 336 Landfill Road
 Boone, North Carolina 28607

Comprehensive Inspection

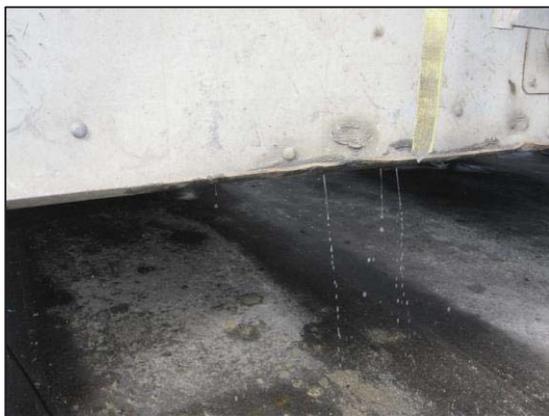
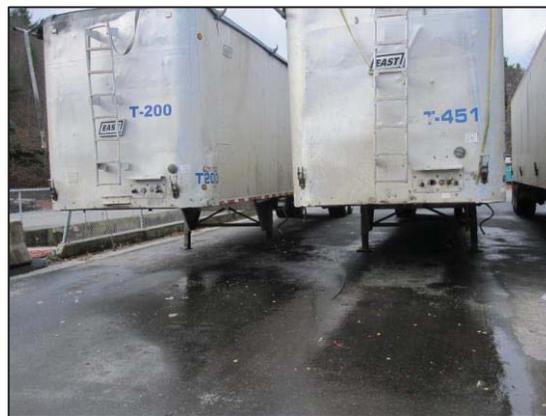
Watauga County in in violation of Section 59.2(c) in that leachate was observed actively leaking from loaded trailers being used at Watauga County Transfer Facility to collect and transport solid waste. Leachate was observed flowing across the pavement to the edge of a vegetated area to the north and then flowing east to an excavated area within the vegetated area.

View of leachate leaking from loaded trailers.

Mr. Scott Barrett, Regional Manager with KRD Trucking, Inc. confirmed by telephone on November 13, 2015 that both trailers observed leaking during the November 10, 2015 inspection had been repaired and placed back into service.

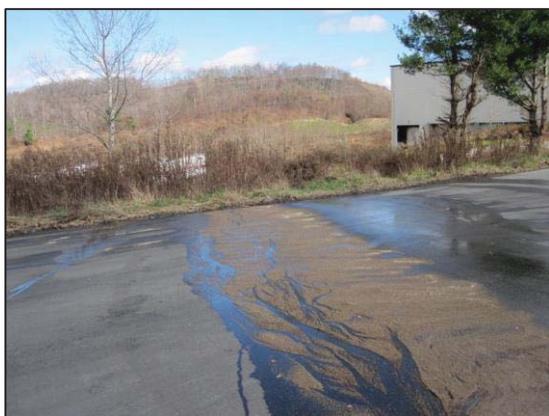
View of leachate flowing across pavement toward vegetated area. Note drying material displaced by leachate flow.

1. Contact Ervin Lane, Compliance Hydrogeologist, to determine the requirements for a soil sampling plan in order to determine the impact of the leachate release.

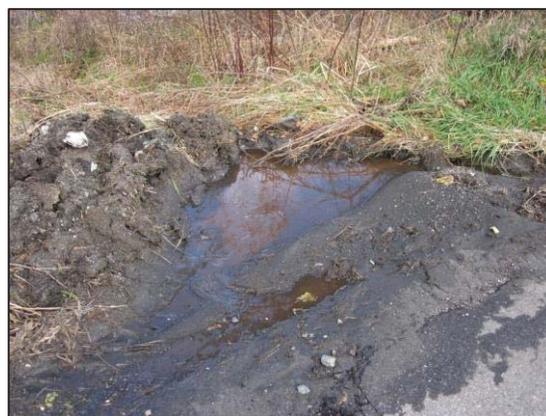
View of ponded leachate in vegetated area adjacent to trailer parking/staging area.
