SUBJ: Resource Conservation and Recovery Act (RCRA) Compliance Evaluation Inspection (CEI)
U.S. Army Fort Bragg XVIII Airborne Corps, NCD 210 020 121

RCRA COMPLIANCE EVALUATION INSPECTION REPORT

U.S. Army Fort Bragg XVIII Airborne Corps AFZA-PW-EE Building 3-2238
Fort Bragg, North Carolina 28310-5000

June 11, 2013

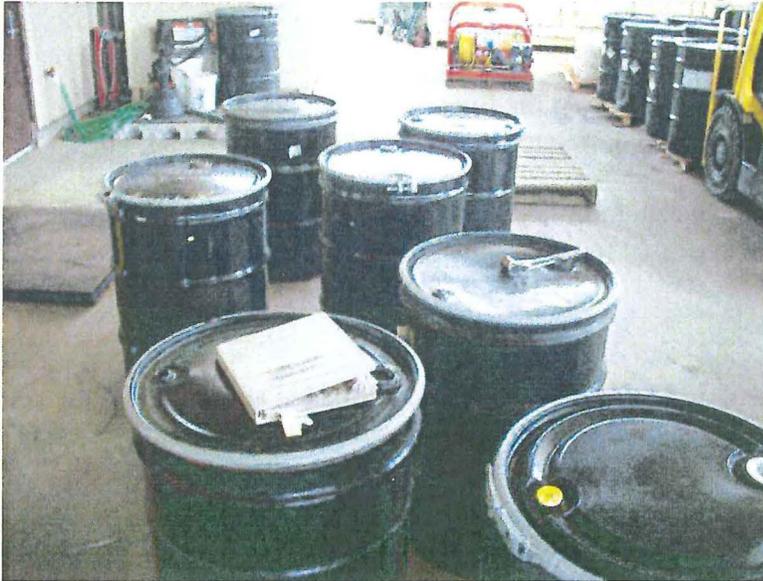
This area uses 15 individual portable storage buildings which each have secondary containment and ventilation. All buildings are designated for specific waste streams which provide separation of incompatibles. The inspectors observed all of the containers inside of the portable storage buildings and found no violations; however, there were five 55-gallon drums which had been off

loaded in the storage area which were observed to have no date and another five 55-gallon drums that were not labeled with the words "Hazardous Waste" (See Picture #1).

Picture 1: PWBC Storage Area - Off loaded containers. Five of these 55-gallon containers were not marked with an accumulation start date and five were not labeled with the words “Hazardous Waste.”

Pursuant to 15A NCAC 13A .0107(c) [40 CFR § 262.34(a)(2)], the date upon which each period of accumulation begins must be clearly marked and visible for inspection on each container.

Pursuant to 15A NCAC 13A .0107(c) [40 CFR § 262.34 (a)(3)], a container holding hazardous waste that is located in a less than 90-day hazardous waste storage area must be labeled with the words "Hazardous Waste" or other words that describe the contents of the container.

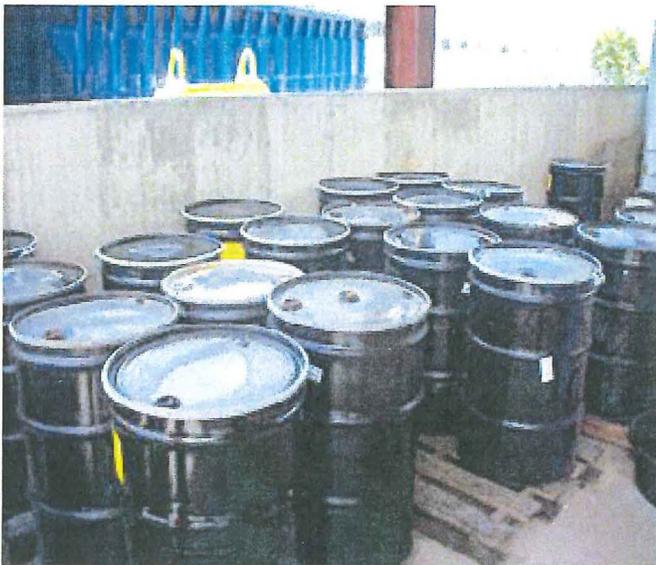
The "soil yard" area is located within the PWBC Storage Area. During the inspection the inspectors remarked to facility personal that the soil yard should be identified on the PWBC Storage Area emergency contingency plan. The area was observed to contain 20 55-gallon drums of solvent bottoms which were waiting to be distilled. One of these containers was observed without an accumulation start date and many of the containers were stored in a manner which prevented access due to the lack of two feet of aisle space.

Picture 2: Picture of hazardous waste containers in the “soil yard.” One 55-gallon container in the “soil yard” was not marked with an accumulation start date. Additionally, there was not two feet of aisle space available in the “soil yard” as required.

Pursuant to 15A NCAC 13A .0107(c) [40 CFR § 262.34(a)(2)], the date upon which each period of accumulation begins must be clearly marked and visible for inspection on each container.

Pursuant to 15A NCAC 13A .0110(c) [40 CFR § 265.35], the owner or operator must maintain aisle space of at least two feet to allow the unobstructed movement of personnel, fire prevention equipment, spill control equipment, and decontamination equipment to any area of facility operation in an emergency.
