**Facility Name:** Haz-Mat Transportation & Disposal, Inc.

SUBJECT: Compliance Evaluation Inspection  
Haz-Mat Transportation & Disposal, Inc.  
EPA I.D. # NCD 048 461 370  
Mecklenburg County

**USED OIL TRANSPORTER, PROCESSOR, MARKETER; HAZARDOUS WASTE  
TRANSPORTER INSPECTION  
COMPLIANCE EVALUATION INSPECTION (CEI) REPORT**

**5. DATE OF INSPECTION:** 1/21/2015; An announced CDI was conducted on 2/9/2015.

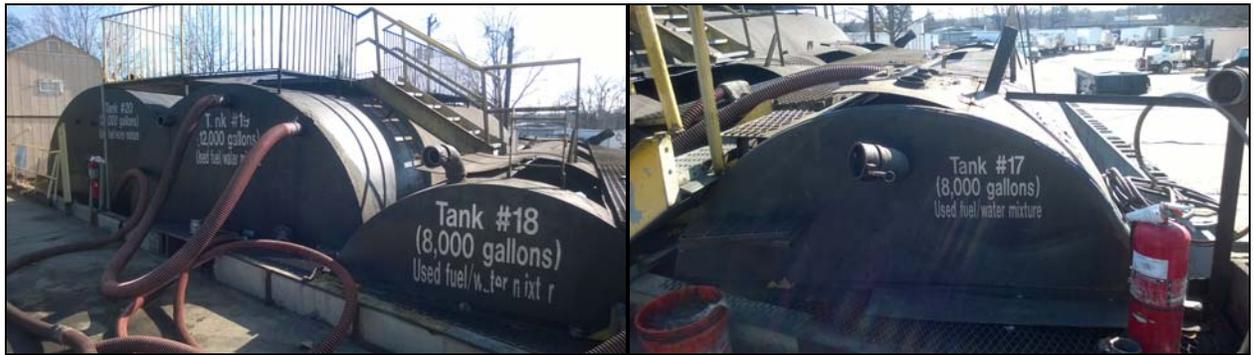
The facility failed to label four high water used oil tanks as “Used Oil” in that the tanks were labeled as “Used Fuel/Water Mixture”.

Figures 1 & 2: Used oil tanks that are not labeled as “Used Oil”.

- 40 CFR 279.54(f)(1) – Failure to label four used oil tanks as “Used Oil”. At the time of inspection there were four above ground storage tanks that were not labeled as “Used Oil”, including one 20,000-gallon, one 12,000-gallon, and two 8,000-gallon tanks where used oil and water are physically separated.

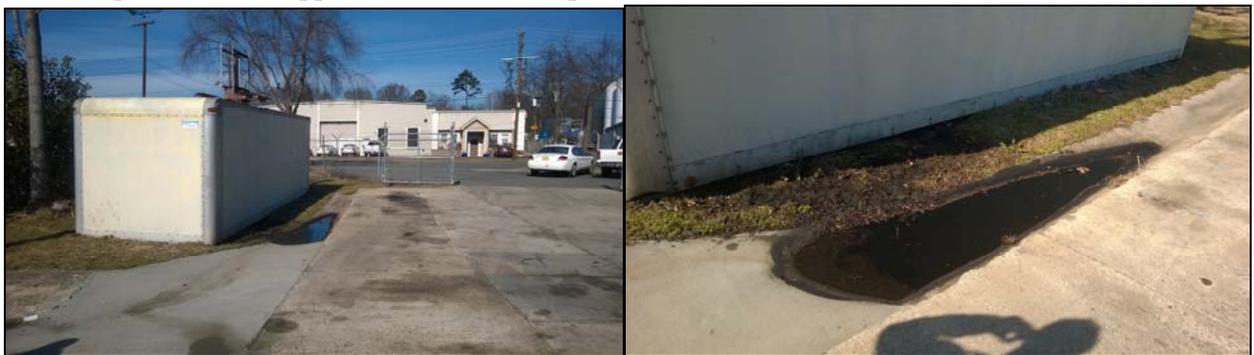
These tanks were located inside a concrete block containment structure. The facility failed to clean up and manage properly released used oil and other materials in that at the time of inspection, used oil was observed spilled to a concrete area (approximately 16 ft<sup>2</sup> area) and released to an adjacent grassy area (approximately 10 ft<sup>2</sup> area). The impacted grassy area abuts a storage trailer. Mr. Neil Danziger explained that the discharge may have occurred during the unloading of used oil into the ASTs earlier in the day. During the February 9, 2015 visit, the spill and release appeared to be cleaned up.

Figures 3 & 4: Used oil release to the ground observed on January 21, 2015.

- 40 CFR 279.54(g)(3) – Failure to clean up and manage properly released used oil and other materials.
  - At the time of inspection there was an area of discharged used oil that was spilled to a concrete area (approximately 16 ft<sup>2</sup> area) and released to an adjacent grassy area (approximately 10 ft<sup>2</sup> area). During the February 9, 2015 visit, the spill and release appeared to be cleaned up.

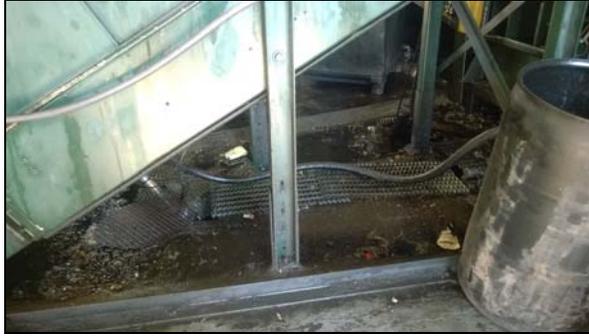
Figure 5: Used oil and solids located beneath the used oil filter crusher observed on January 21, 2015.

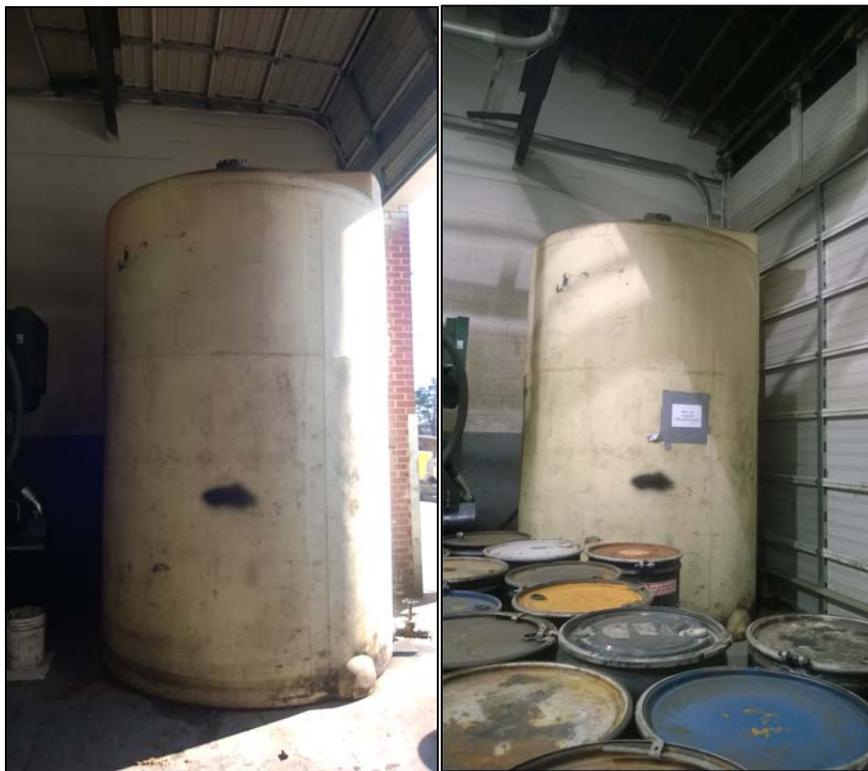
One 3,000-gallon, single walled used oil tank is located in the building where used oil filters are crushed and used oil is accumulated prior to processing. The facility failed to provide secondary containment in that, at the time of inspection, secondary containment was not provided for the 3,000-gallon used oil tank. During the February 9, 2015 visit the tank was labeled as “Used Oil” and Mr. Neil Danziger explained that they were planning on replacing the tank with a double walled tank in the near future.

Figures 6 & 7: 3,000-gallon Used Oil above ground tank observed on January 21, 2015 (left) and February 9, 2015 (right) without secondary containment.

- 40 CFR 279.54(d) – Failure to provide secondary containment for a used oil tank. At the time of inspection, there was one 3,000-gallon, single walled used oil tank where used oil from crushed used oil filters is accumulated prior to processing. There was no secondary containment provided for this tank.

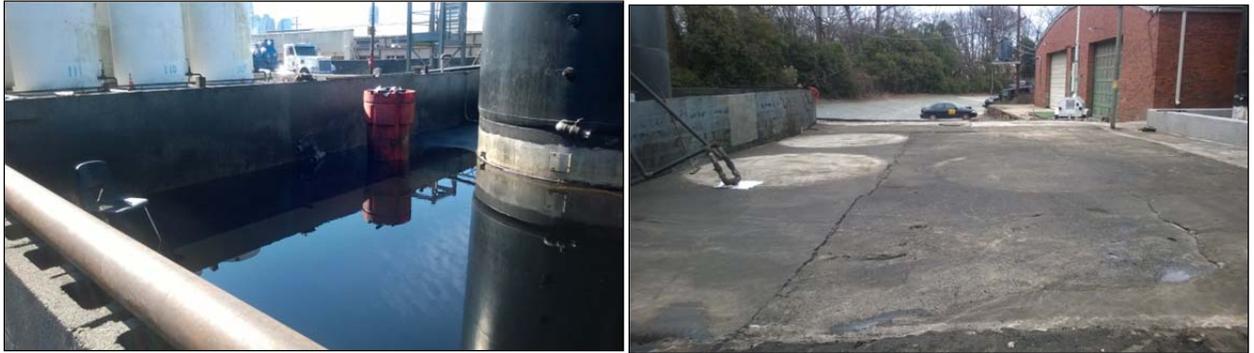
Used oil ASTs located on the 210 Dalton Avenue parcel are all located within areas with secondary containment. At the time of inspection, the tank renovation project was not complete. Used oil tanks located along the northern side of the property had been emptied in preparation to be moved. The facility failed to store used oil in tanks or containers. Approximately 400 ft<sup>2</sup> of standing used oil was observed spilled inside the secondary containment area. Potential cracks were observed in the floor of the containment area.

Figures 8 & 9: 1/21/2015: (Left) Standing used oil was observed spilled inside the secondary containment area. 2/9/2015: (Right) Spilled used oil cleaned up, tanks and concrete wall removed.

- 40 CFR 279.54(a) – Failure to store used oil in tanks or containers. During the 1/21/2015 inspection, approximately 400 ft<sup>2</sup> of standing used oil was observed spilled inside the secondary containment area.

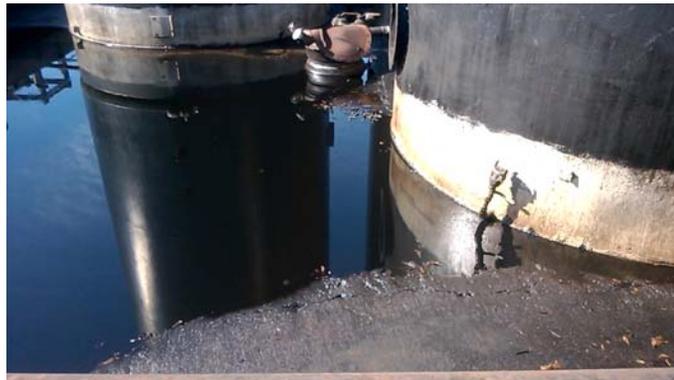
Figure 10: 1/21/2015: Floor of concrete secondary containment area appears to have potential cracks.

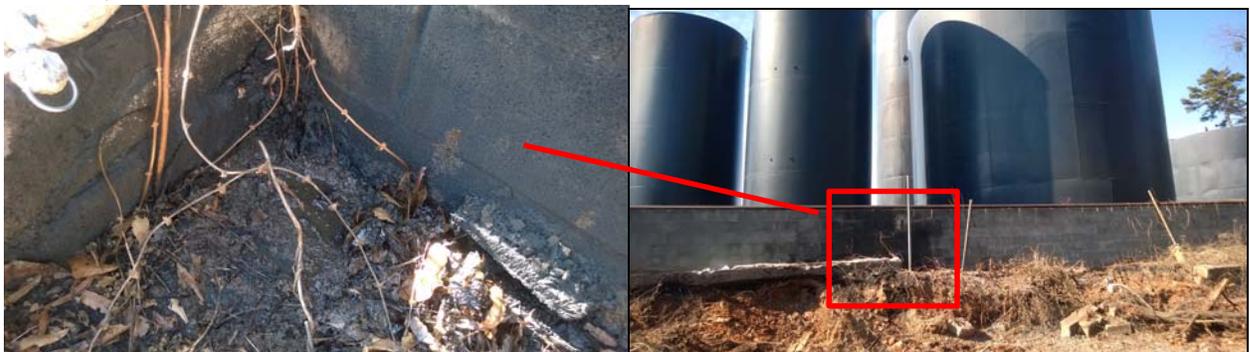
The facility failed to clean up and manage properly the released used oil and other materials in that at the time of inspection used oil was observed released to the ground on the eastern side of the used oil secondary containment area, adjacent to the spilled used oil inside the containment area. Used oil and darkened soil was observed in the area which appeared to originate from the used oil spilled inside the secondary containment structure. During the site visit on February 9, 2015 the used oil spills and releases had been cleaned up. Mr. Neil Danziger explained that he thought there may also be ground water coming up to the surface in the area. During the February 9, 2015 visit, there was no evidence of groundwater or other wet soils in the area. The facility should take steps to ensure there are no other releases of used oil to the ground from the used oil tank secondary containment structure.

Figures 11 & 12: 1/21/2015 - Used oil appears to be released to the outside of the secondary containment area to the ground.

- At the time of inspection there was a release of used oil to the ground outside of the used oil processing tank secondary containment area on the 210 Dalton Avenue parcel. During the February 9, 2015 visit, the spill and release appeared to be cleaned up.

- The facility should take steps to ensure there are no other releases of used oil to the ground from the used oil tank secondary containment structure.

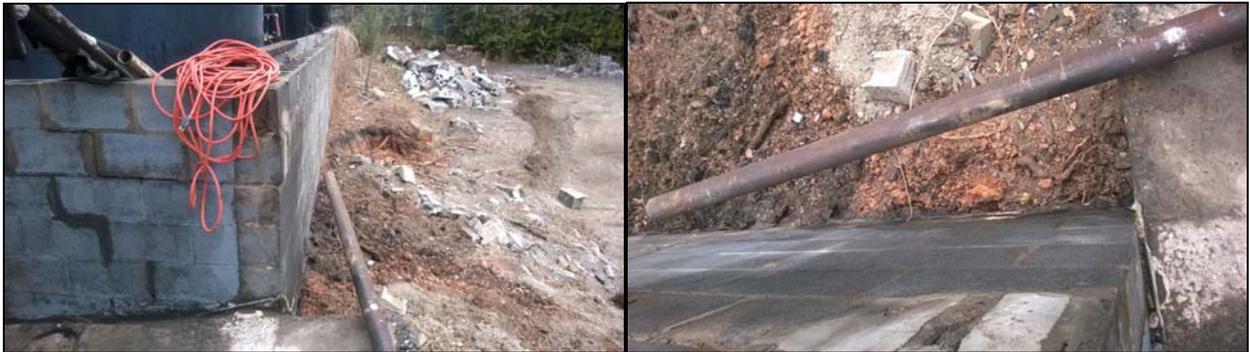
Figures 13 & 14: 2/9/2015 - Used oil release to ground cleaned up.

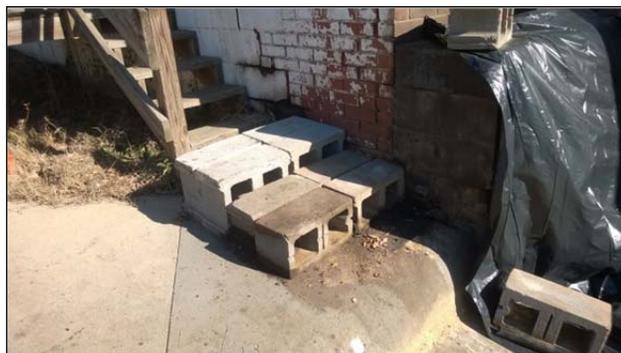
- **Drum Crusher:** The facility maintains one drum crusher in the same room as the used filter crusher. Mr. Neil Danziger explained that the facility utilizes 55-gallon containers until they cannot be used any further. These drums are rinsed and then crushed in the drum crusher. It is a reminder that the facility must conduct waste determinations, per 40 CFR 262.11, on all waste streams. Containers are not sent off site to be refurbished. Crushed containers are sent for metal recycling. At the time of inspection, used oil was observed staining the outside of the building wall just opposite of where the drum crusher sits. During the February 9, 2015 visit, the drum crusher was placed inside a metal catch pan. The wall adjacent to the drum crusher was cleaned and sealed. The area outside the building was cleaned up.

Figure 15: Used oil from the drum crusher leaking through the building wall to the outside as observed on January 21, 2015.

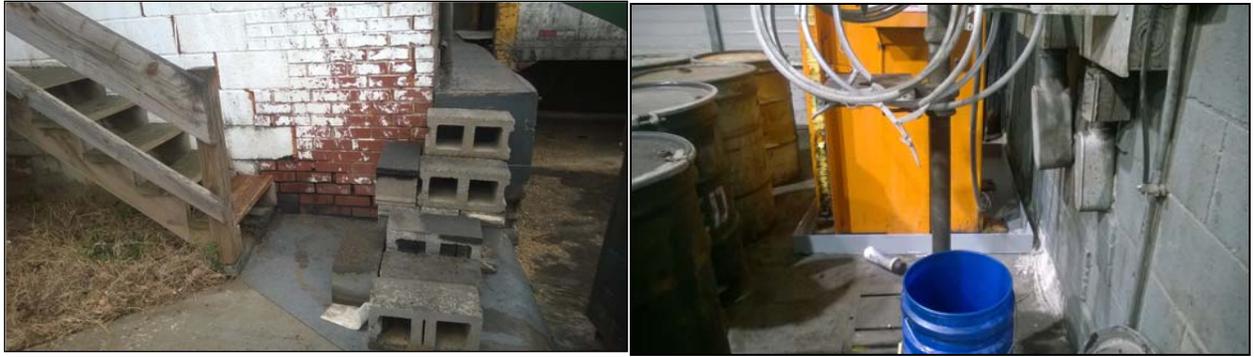
Figures 16 & 17: (left) Used oil cleaned up from outside of building and (right) the orange drum crusher placed inside a new catch pan with building walls sealed.

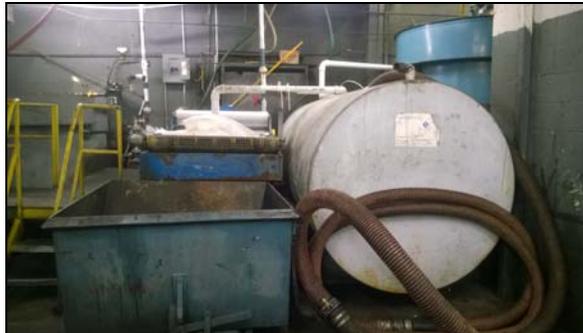
- **Other Waste Streams** – Industrial waste water pre-treatment system. The facility operates an industrial waste water pre-treatment system on the 210 Dalton Avenue parcel, which accepts small amounts of underground storage tank petroleum contaminated groundwater for treatment. Water separated from used oil processed on both 221 & 210 Dalton Avenue is sent to the industrial waste water pre-treatment system which is permitted under Charlotte Mecklenburg Utilities (Permit #5012). Treated waste water is discharged into the POTW for further treatment. At the head of the pre-treatment system, debris is filtered out. This debris is sent over to the 221 Dalton Avenue parcel and mixed with sawdust for solidification prior to disposal. Sludge and final polishing waste that is removed from the treated waste water is sent over to the 221 Dalton Avenue parcel and mixed with sawdust for solidification prior to disposal. It is a reminder that the facility must conduct waste determinations, per 40 CFR 262.11, on all waste streams.

Figure 18: Industrial waste water pre-treatment system sludge tank and final polishing.
