**HAZARDOUS WASTE SECTION - COMPLIANCE BRANCH
FILE TRANSMITTAL & DATA ENTRY FORM**

Your Name: Heather Sorensen
Facility ID Number: NCR000007591
Facility Name: Reagents Holdings, LLC
Document Group: Inspection/Investigation (I)
Document Type: I - Compliance Evaluation Inspection (CEI)
Description for File: SQG CEI. CO issued. Reference Docket #2014-047
Date of Document: 2/28/2014
Author(s) of Document: Heather Sorensen

**STATE OF NORTH CAROLINA
DEPARTMENT OF ENVIRONMENT AND NATURAL RESOURCES
DIVISION OF WASTE MANAGEMENT
HAZARDOUS WASTE SECTION**

An evaluation to determine compliance with regulations described at 40 CFR 261, 262, 265, 268, 273 and 279; and the North Carolina Hazardous Waste Management Rules (Rules).

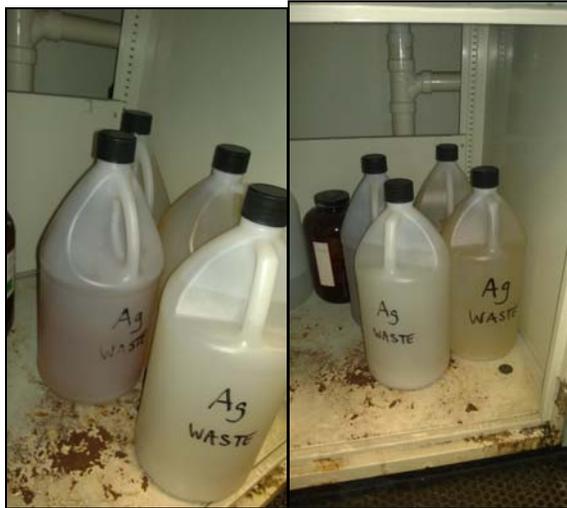
- Satellite Accumulation Areas (SAAs) –
 - Laboratory – During the inspection there were four (4) 4-liter satellite containers that were closed and labeled as "Ag Waste" in a storage cabinet located in the laboratory. It was explained by Ms. Bierschbach that silver nitrate waste is generated from routine laboratory processes and stored in this area.

2/28/2014: Satellite accumulation containers which are closed and labeled.

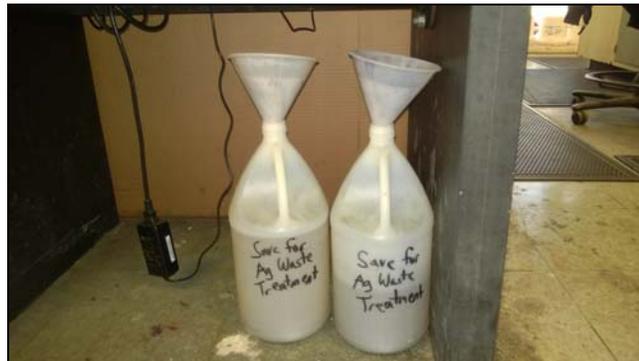
The accumulated silver nitrate liquid waste is then poured through a filter to catch the solids and the remaining liquid drains into a second satellite container located in the same area of the laboratory. The solid waste material collected in the filter is then put into a separate container as silver waste for the purpose of silver recovery. The facility failed to keep satellite containers closed when not adding or removing waste. Two (2) 4-liter satellite containers with open tops, labeled as “Save for Ag Waste Treatment”, were open during the inspection. The containers were open with funnels sticking out of the top. The waste liquid was not actively being filtered during the inspection.

2/28/2014: Two (2) open satellite accumulation containers with funnels.

7. **40 CFR 262.34(c)(1)(i) reference 265.173** – The facility failed to keep satellite containers closed when not adding or removing waste. During the inspection, there were two (2) 4-liter satellite containers accumulating silver waste in the laboratory that were open.

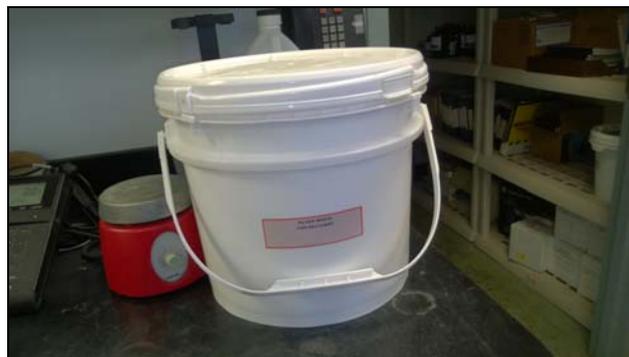
Ms. Bierschbach explained that the waste liquid in the two (2) “Save for Ag Waste Treatment” containers would be poured into a metals hazardous waste container in the HWSA. There was one (1) 3.5 gallon container that was closed and labeled as “Silver Waste for Recovery” stored in the laboratory closet. It was explained by Mr. Brian Vinciguera - Chemist that approximately 700 grams of silver waste was in the container.

2/28/2014: Silver waste container.

The facility speculatively accumulated waste silver. The facility was unable to provide information to demonstrate that the material is potentially recyclable and did not recycle 75% by weight or volume of the amount of material accumulated from the beginning of each year since January 1, 2009. Although the facility has continued to accumulate the silver waste, the facility has not attempted silver recovery since 2008. The facility also failed to document claims that a material is not a solid waste or conditionally exempt from regulation. Ms. Bierschbach explained that the last shipment of silver waste was sent to a facility for silver recover in 2008 and the receiving facility denied silver recovery of the material. The material was then sent for disposal as a hazardous waste in lieu of recycling. During the inspection, Ms. Bierschbach was unable to identify a silver recovery facility that would accept the silver waste. No other documentation or information was provided for the silver waste.

2. **40 CFR 261.2(f)** – The facility failed to document claims that a material is not a solid waste or conditionally exempt from regulation. Ms. Bierschbach explained that the last shipment of silver waste was sent to a facility for silver recover in 2008 and the receiving facility denied silver recovery of the material. The material was then sent for disposal as a hazardous waste in lieu of recycling. During the inspection, Ms. Bierschbach was unable to identify a silver recovery facility that would accept the silver waste. No other documentation or information was provided for the silver waste.

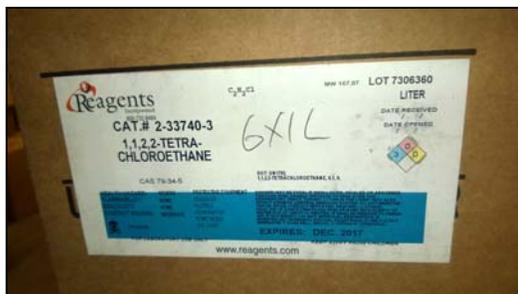
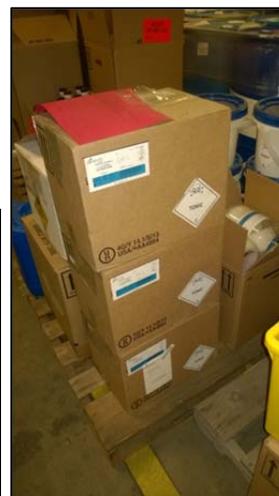
2. Hazardous Waste Storage Areas (<180-days) – The facility had two (2) <180-day hazardous waste storage areas.
 - Packaging (Building 4746) – During the inspection Ms. Bierschbach explained that flammable products from the flammable materials building were temporarily being stored in the area where hazardous waste is stored. Ms. Bierschbach explained that off specification or out of date products are brought to a quarantine area to await disposition to determine if the material can be reworked as a product or if it is a waste. The <180-day hazardous waste storage area was mixed in with the quarantine area. It is recommended that the facility provide a dedicated area for the <180-day hazardous waste storage area that is separated from product and quarantine containers. (See Comments below.) After a chemical is determined to be a waste it is left in its original container. During the inspection the following hazardous wastes were stored together on a pallet: three (3) containers of 1,1,2,2-tetrachloroethane (U209), 15 1-gallon containers of phenol crystals (U188), one (1) 10-liter container of potassium hydroxide 0.250 N in Methanol (U154), one (1) 5-gallon container of “Characteristic Metal Waste”, and one (1) 5-gallon container of “As Waste”. Ms. Bierschbach explained that the metal waste container may contain each of the eight (8) RCRA metals. The facility failed to clearly mark the accumulation start date on <180-day hazardous waste storage containers. None of the 21 hazardous waste containers were marked with an accumulation start date. There was one (1) red piece of paper lying on the containers that had a date of 10/17/2013 with the comments to dispose of the phenol material. Ms. Bierschbach used this paper to establish how long all of the hazardous waste containers had been stored in the area. The facility failed to clearly label or mark the hazardous waste storage containers with the words “Hazardous Waste”. None of the 21 hazardous waste containers were marked or labeled with the words “Hazardous Waste”. The facility failed to maintain 24” aisle space. 16 of the hazardous waste storage containers were not accessible for inspection due to the lack of maintained aisle space.

2/28/2014: Three (3) 1,1,2,2-Tetrachloroethane hazardous waste containers that are not labeled as “Hazardous Waste” or dated with a start accumulation date.

9. **40 CFR 262.34(d)(4) reference 262.34(a)(2)** – The facility failed to clearly mark the accumulation start date on <180-day hazardous waste storage containers.

10. **40 CFR 262.34(d)(4) reference 26.34(a)(3)** – The facility failed to clearly label or mark the hazardous waste storage containers with the words “Hazardous Waste”.

- During the inspection, 21 hazardous waste containers, stored in the Packaging building <180-day hazardous waste storage area, were not marked or labeled with the words “Hazardous Waste”.

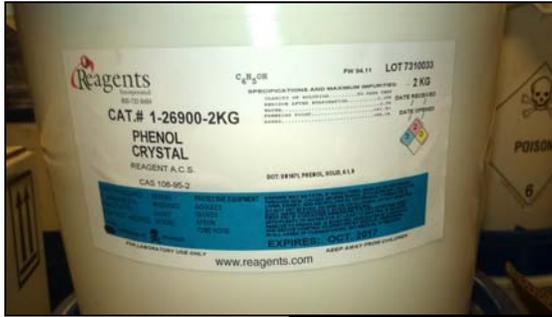
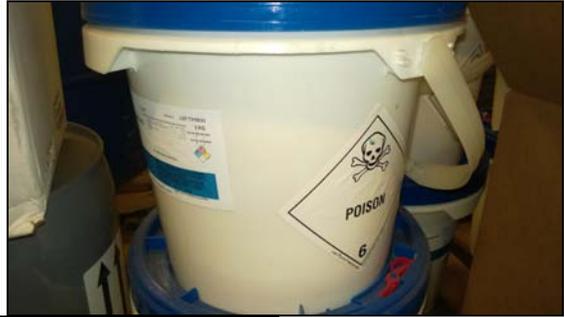
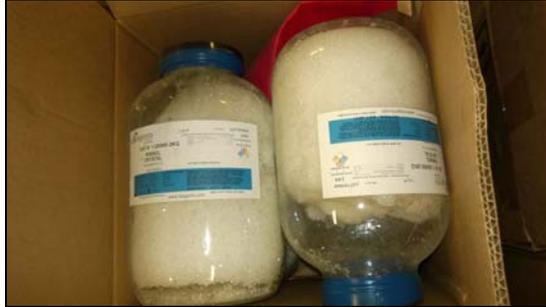
2/28/2014: Phenol Crystal hazardous waste containers that are not labeled as "Hazardous Waste" or dated with a start accumulation date.

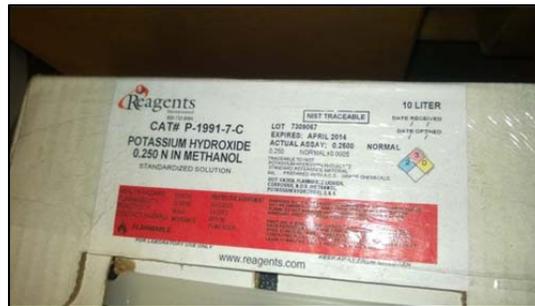
2/28/2014: Potassium hydroxide 0.250 N in Methanol hazardous waste container that is not labeled as "Hazardous Waste" or dated with a start accumulation date.

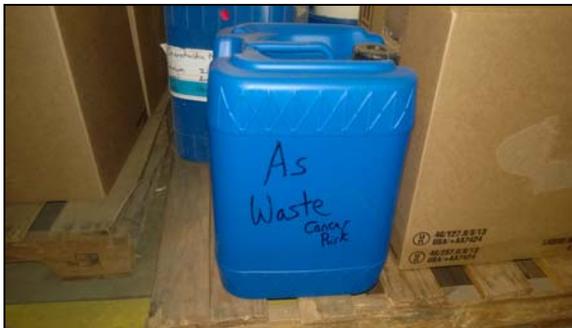
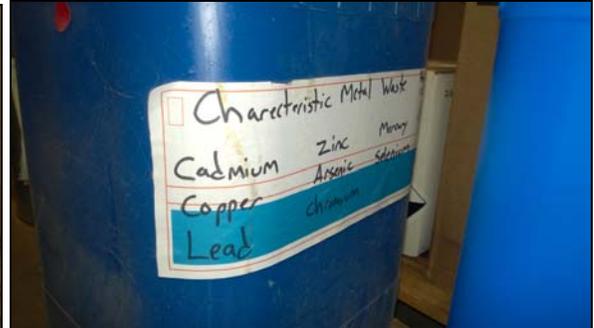
2/28/2014: "As Waste" and "Characteristic Metal Waste" hazardous waste containers that are not labeled as "Hazardous Waste" or dated with a start accumulation date.

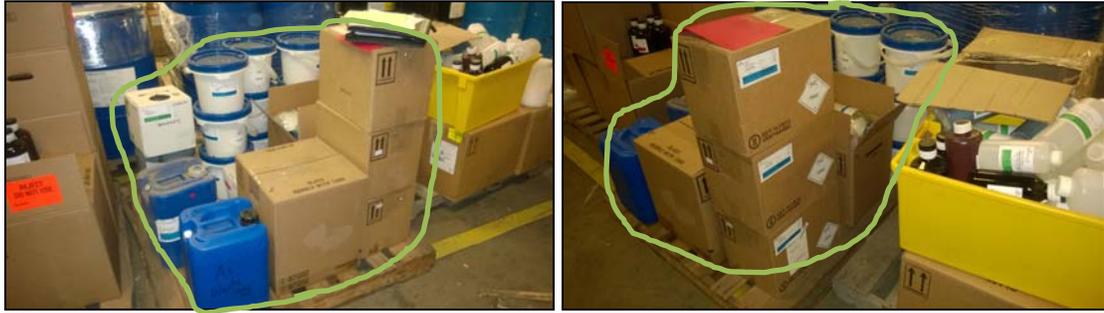
2/28/2014: Overview pictures of <180-day hazardous waste storage area containers and quarantine containers. Less than 24 inches of aisle space is provided for 16 hazardous waste storage containers.

There is no telephone in this area. There is a pull station in this area. Ms. Bierschbach explained that workers can yell for assistance in this area. There are fire extinguishers located throughout the building and spill kits in the area.

12. **40 CFR 262.34(d)(4) reference 265.35, NCAC 13A .0110(c)** – The facility failed to maintain 24” aisle space. 16 of the hazardous waste storage containers were not accessible for inspection due to the lack of maintained aisle space.

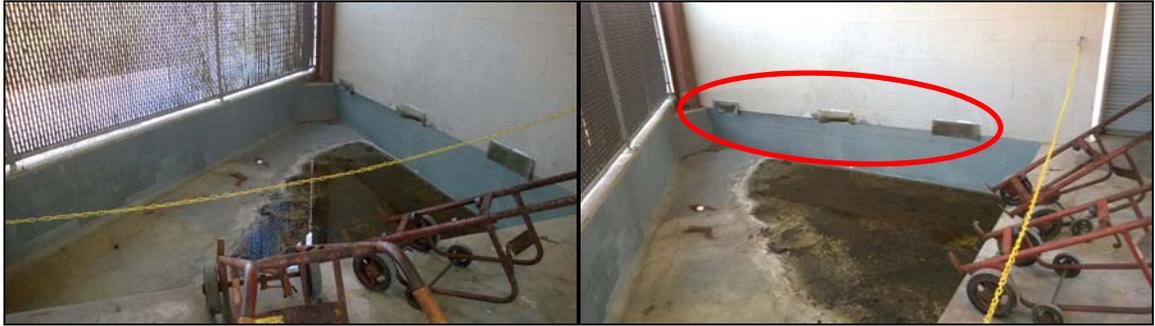
- Flammable Materials Blending Area - Upon inspection of the outside secondary containment it was explained that flammable materials are blended outside in the area adjacent to the secondary containment structure. This area is a raised concrete pad with a roof covering that connects the Packaging building to the Flammable building. Chemicals spilled in the flammable material blending area could reach the secondary containment area. There was also one (1) approximate 3-gallon container of a corrosive and toxic creosol sitting on its side in a container around the edge of the secondary containment area. It was unclear if this container was a product or a waste.

2/28/2014: Outside secondary containment area. Three (3) wall ports are visible that allow for the discharge of waste water from the chemical blending area.

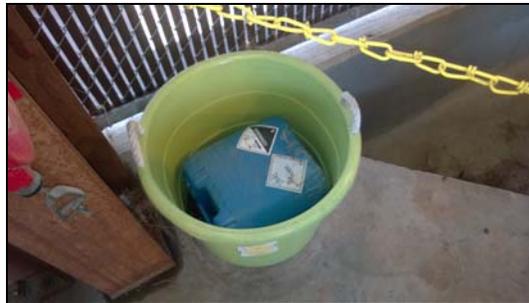
2/28/2014: One (1) container of creosol staged in a plastic container near the edge of the concrete secondary containment area.

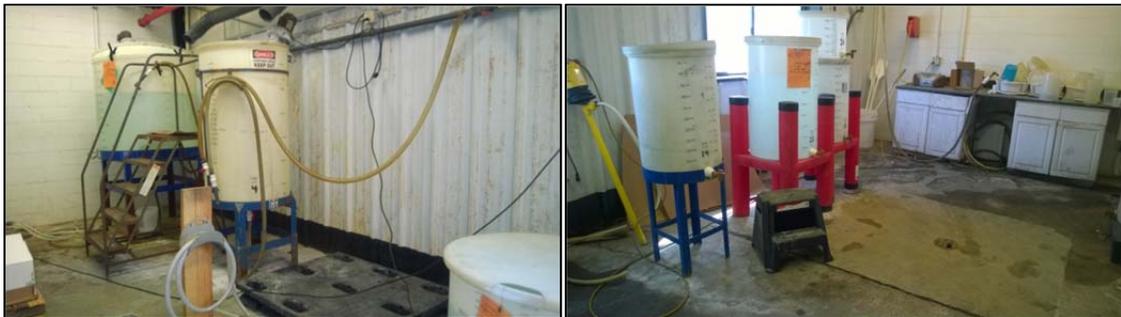
- Hazardous Materials Blending Area – Non-flammable hazardous chemicals are blended in the flammable building - hazardous materials blending area. After a batch is finished blending, the blending containers are rinsed and the waste water drains across the concrete floor and into the municipal sanitary sewer. During the inspection there were eight (8) mixing containers that may be rinsed once or twice a day, as explained by a facility technician. Mr. Watson and Ms. Bierschbach were unsure if Charlotte-Mecklenburg Utilities (CMU) had been contacted regarding the chemicals that are discharged into the sanitary sewer system. Ms. Sorensen contacted CMU on 3/6/2014 regarding the facility.

2/28/2014: Hazardous Materials Blending Area with blending containers and floor drain to municipal sanitary sewer.

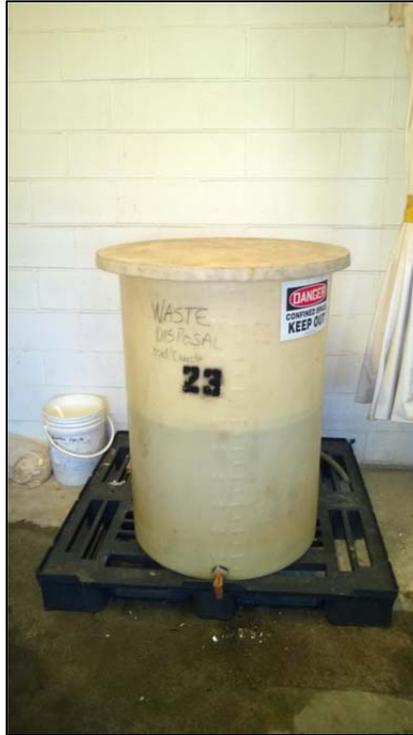
There was one (1) 100-gallon container in this area labeled as “Waste Disposal Acid/Caustic”. The container had a loose lid covering the top of the container. Ms. Bierschbach explained that off specification chemicals are poured into this container. The waste is then neutralized before discharging to the sanitary sewer. During the inspection, Ms. Bierschbach indicated that the waste was non-hazardous. When asked about the basis for this statement, Ms. Bierschbach (1) failed to provide an analytical waste profile, and (2) failed to articulate a claim of generator knowledge of the characteristics of the waste in light of the processes used to produce the waste. Upon inquiry of the pH of the waste it was explained that the pH would be between 2 and 12.5. No waste profile or other information regarding a waste determination was provided.

2/28/2014: 100-gallon container labeled "Waste Disposal Acid/Caustic" that accumulates waste in the hazardous materials blending area. The lid is not attached to the container.

- During the inspection, Ms. Bierschbach indicated that the off specification chemicals that are poured into a 100-gallon container in the Hazardous Materials Blending area was non-hazardous. When asked about the basis for this statement, Ms. Bierschbach (1) failed to provide an analytical waste profile, and (2) failed to articulate a claim of generator knowledge of the characteristics of the waste in light of the processes used to produce the waste. Upon inquiry of the pH of the waste it was explained that the pH would be between 2 and 12.5. No waste profile or other information regarding a waste determination was provided.

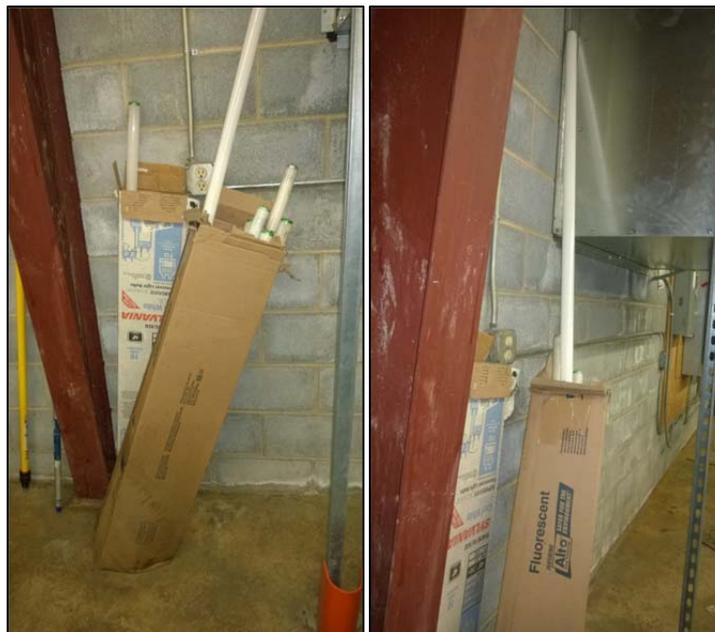
4. Used Oil – The facility does not generator or manage used oil.
5. Universal Waste – During the inspection used lamps were stored in the Finished Product Warehouse. There were two (2) 4-foot boxes with one (1) 8' used lamp sticking out of one (1) of the boxes. Broken lamps were observed in one (1) of the containers. The facility failed to maintain used lamps in a closed and labeled containers. There were a total of approximately 30 used lamps stored in the open and unlabeled boxes. The facility failed to demonstrate storage time of universal waste. Mr. Watson explained that Hill Electric picks up the used lamps for recycling, but was unsure of the last time Hill Electric picked up the used lamps. Mr. Watson was also unsure of how long the lamps had been stored onsite. The facility failed to provide universal waste training. Mr. Watson explained that the facility had not provided universal waste training.

2/28/2014: Universal waste used lamps containers, which consist of two (2) open and unlabeled boxes and approximately 30 used lamps.

16. **40 CFR 273.13(d)** – The facility failed to maintain used lamps in a closed container. During the inspection there were approximately 30 used lamps stored in open boxes in the Finished Product Warehouse. Broken lamps were observed in one (1) of the containers.

17. **40 CFR 273.14(e)** – The facility failed to maintain used lamps in a labeled container. During the inspection there were approximately 30 used lamps stored in unlabeled boxes in the Finished Product Warehouse.

19. **40 CFR 273.16** – The facility failed to provide universal waste training. During the inspection used lamps were stored in the Finished Product Warehouse. Mr. Watson explained that the facility had no provided universal waste training.
