Waste Management
ENVIRONMENTAL QUALITY

FACILITY COMPLIANCE INSPECTION REPORT

UNIT TYPE:												
Lined MSWLF		LCID		YW		Transfer		Compost		SLAS	<input checked="" type="checkbox"/>	COUNTY: Stokes PERMIT NO.: SLAS-85-11 FILE TYPE: COMPLIANCE
Closed MSWLF		HHW		White goods		Incineration		T&P		FIRM		
CDLF		Tire T&P / Collection		Tire Monofill		Industrial Landfill		DEMO		SDTF

B & M Septic Tank, Inc.
3639 Beasley School Road
Snow Creek, NC 27042

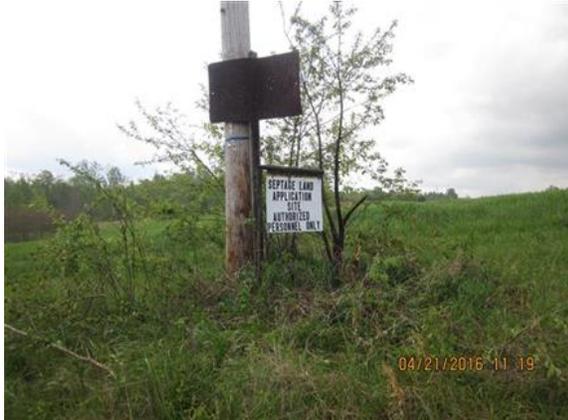
<p data-bbox="164 1188 467 1213">NOTES Obstructed field marker</p>

5. Field disposal area boundaries were well delineated with permanent markers corresponding to the site map. with the exception of several posts that were replaced during the inspection. Several markers were obscured by woody vegetation. The vegetation will need to be removed.
