Vapor Intrusion Investigation:  
Results of Subslab Soil Vapor and  
Indoor Air Sampling

Alpha Mill Apartments  
220 Alpha Mill Lane  
Charlotte, North Carolina

Prepared by:  
**ENVIRON International Corporation**  
Groton, Massachusetts

Date:  
**August 27, 2012**

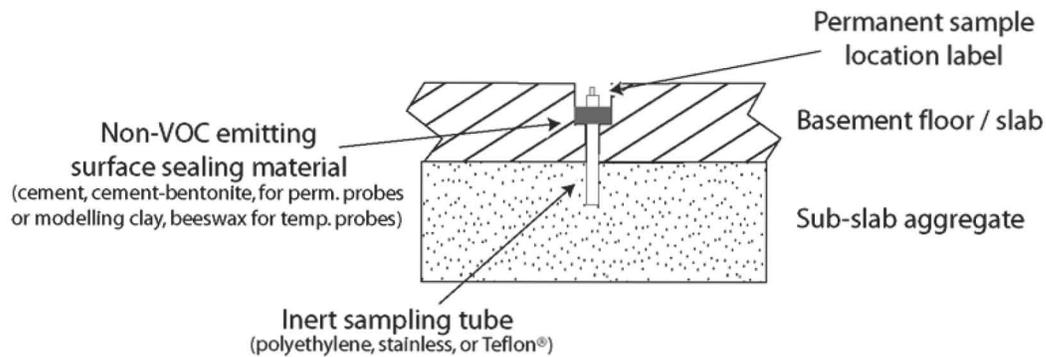
Permanent subslab sampling ports were installed away from the exterior walls on July 16-17, 2012 in general accordance with the New York Department of Health’s *Guidance for Evaluating Soil Vapor Intrusion in New York State*, October 2006, as referenced in the NCDENR *Supplemental Guidelines for the Evaluation of Structural Vapor Intrusion Potential for Site Assessments and Remedial Actions Under the Inactive Hazardous Sites Branch*, June 2011. A one-inch diameter, one-inch deep countersink hole to house the probe tubing couplings was drilled into ground floor slab using a hammer drill. Through the countersink hole, a small diameter drill bit (1/2-inch diameter) was advanced through the slab to access subslab soils. The probe was constructed of ¼-inch stainless steel (SS) tubing and SS swaging fittings. The probe tubes extended no deeper than one inch beyond the bottom of the slab into the subslab aggregate. Expanding quick-set hydraulic cement was placed to seal the probe to the surrounding concrete slab.

After leaving the concrete to cure overnight, helium tracer gas leak testing was conducted, with no leaks detected, except in Building 4 Unit 112. No sample was collected from this location

due to the failed leak test, which was likely caused by tight soils resulting in limited air flow beneath the slab. Finally, Teflon-lined sample tubing was attached to the probe using swage-type fittings and Teflon tape thread sealant, and VOC and radon sampling commenced.

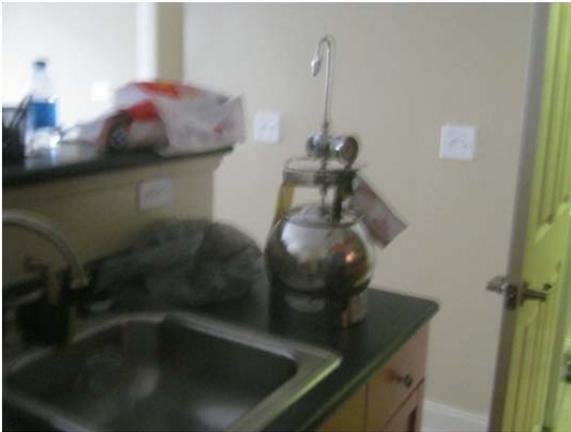
**Photo 1.** Example of indoor air SUMMA canister and radon test kit setup

The indoor air VOC samples were collected in six-liter SUMMA canisters with the sample collection point placed at breathing height on the first floor in two apartment units per building (Figure 2 [site-wide] and Figures 2A-2F [building details]). A flow controller was used on each canister to collect air continuously over a 72-hour period.

The indoor air radon samples were over a 72-hour period (same as the VOCs) using a ProChek activated charcoal radon test kit, provided by Air Chek, Inc. of Mills River, North Carolina. Air Chek maintains a fully accredited laboratory that is used to analyze their activated charcoal radon sample using gamma ray spectroscopy, as described in Section 2.4 of USEPA's *Indoor Radon and Radon Decay Product Measurement Device Protocols* (EPA 402-R-92-004). The radon test kits were collocated with the VOC SUMMA canisters at breathing height on the apartment units.

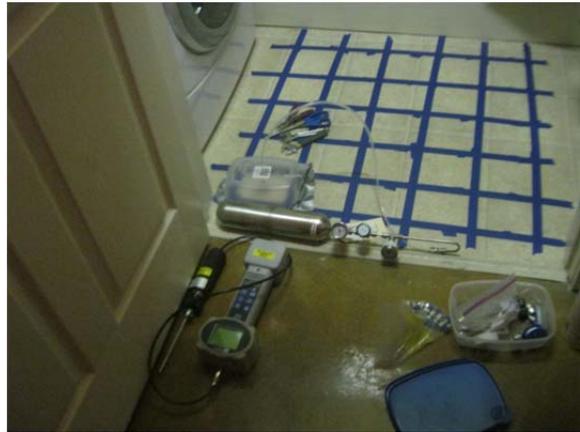
**Photo 2.** Example of subslab VOC sample collection setup

Following the sampling port installation, subslab VOC samples were collected in one liter SUMMA canisters, using a flow controller to collect air continuously over a five minute period.

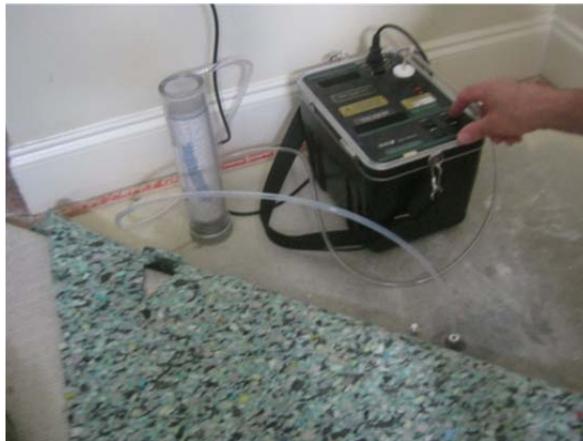
**Photo 3.** Example of subslab radon measurement setup

After the completion of subslab VOC sample collection, a Niton or DurrIDGE RAD7 Radon Detector, a continuous radon monitoring instrument, was connected to the same Teflon-lined tubing for a purge period of up approximately 12 minutes and a sampling period of 30-60 minutes. The subslab radon sampling was conducted by Indoor Environmental of Charlotte, North Carolina.

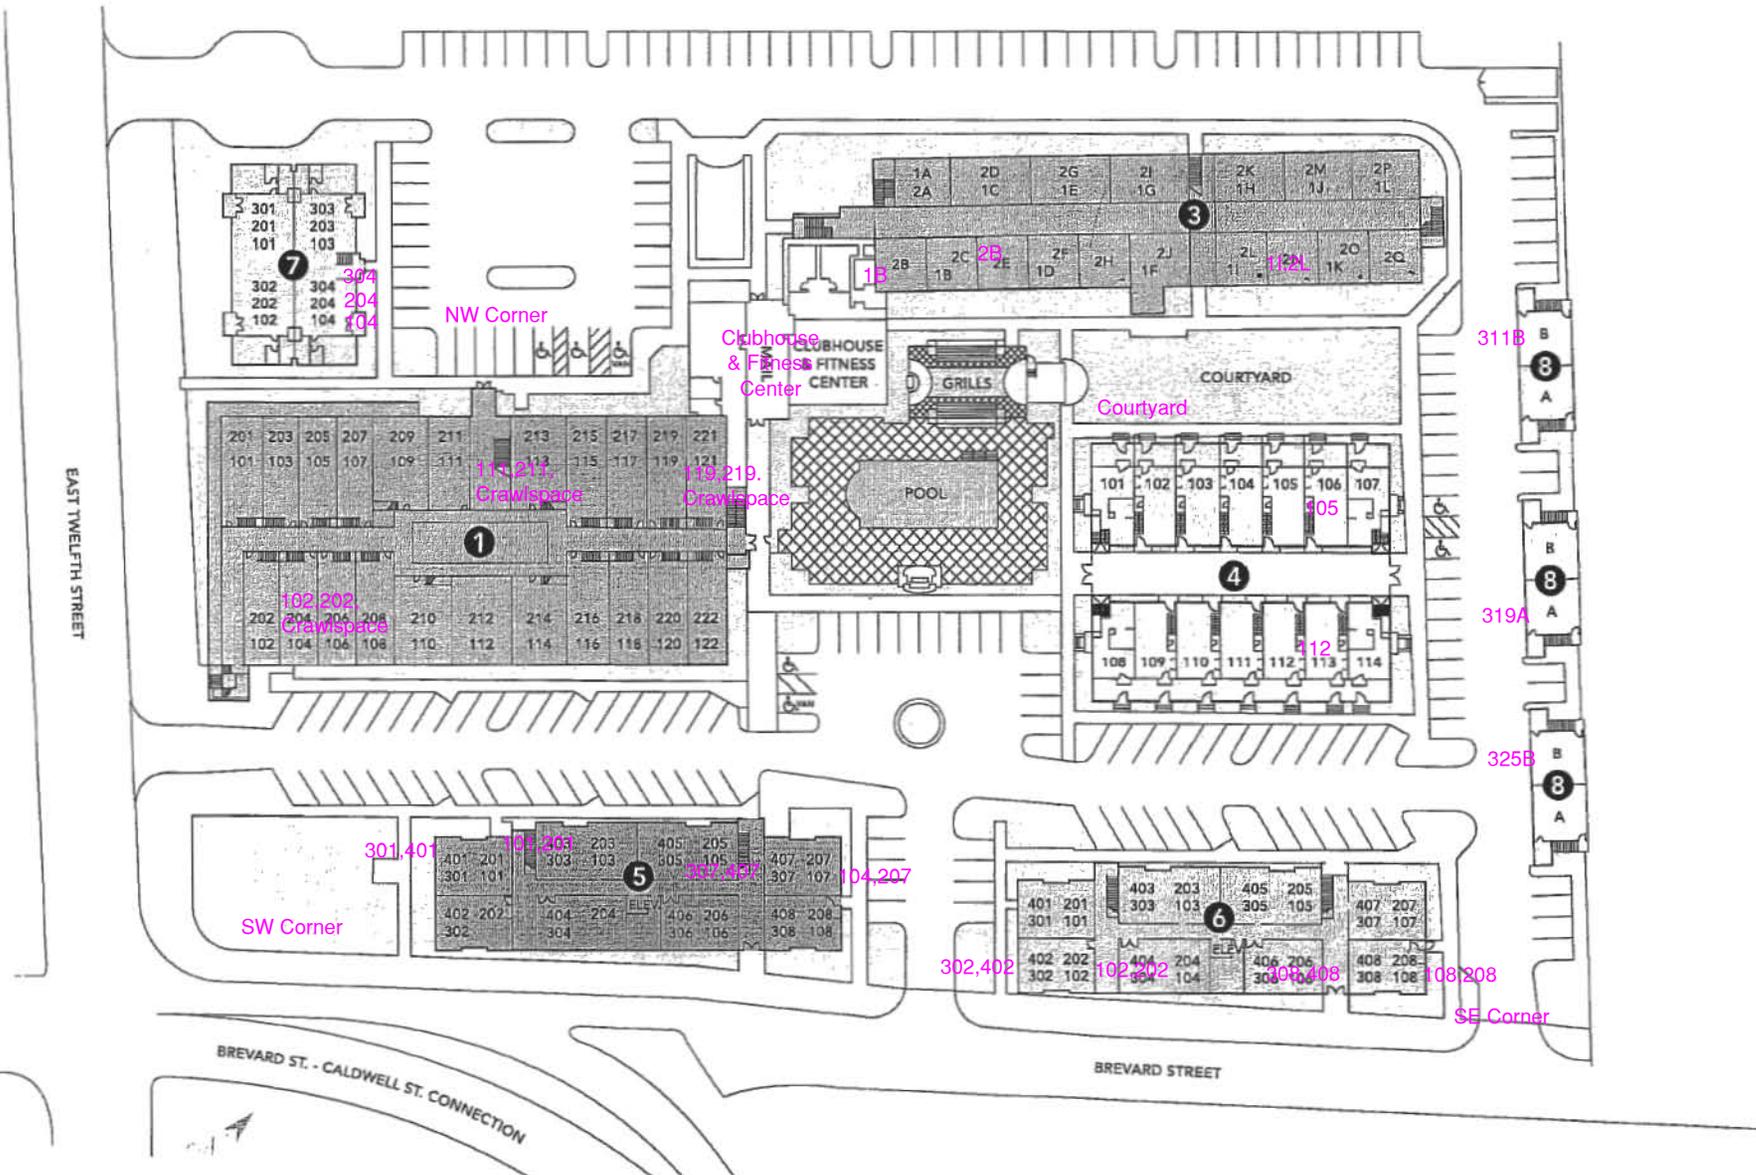
Approximate air sampling location  
Samples collected November 10-11, 2011

# Air Sampling Locations, November 2011

In connection with due diligence activities, ENVIRON conducted two rounds of indoor air sampling – a preliminary screening sampling event in August 2011 and a more comprehensive sampling event in November 2011 (see Figure 1). As a result of these sampling efforts, potential subsurface soil vapor VOC influences in indoor air were identified. Specifically, elevated indoor air concentrations of PCE and TCE and concentration trends potentially indicative of VI were identified in four buildings at the site. It should be noted that no information

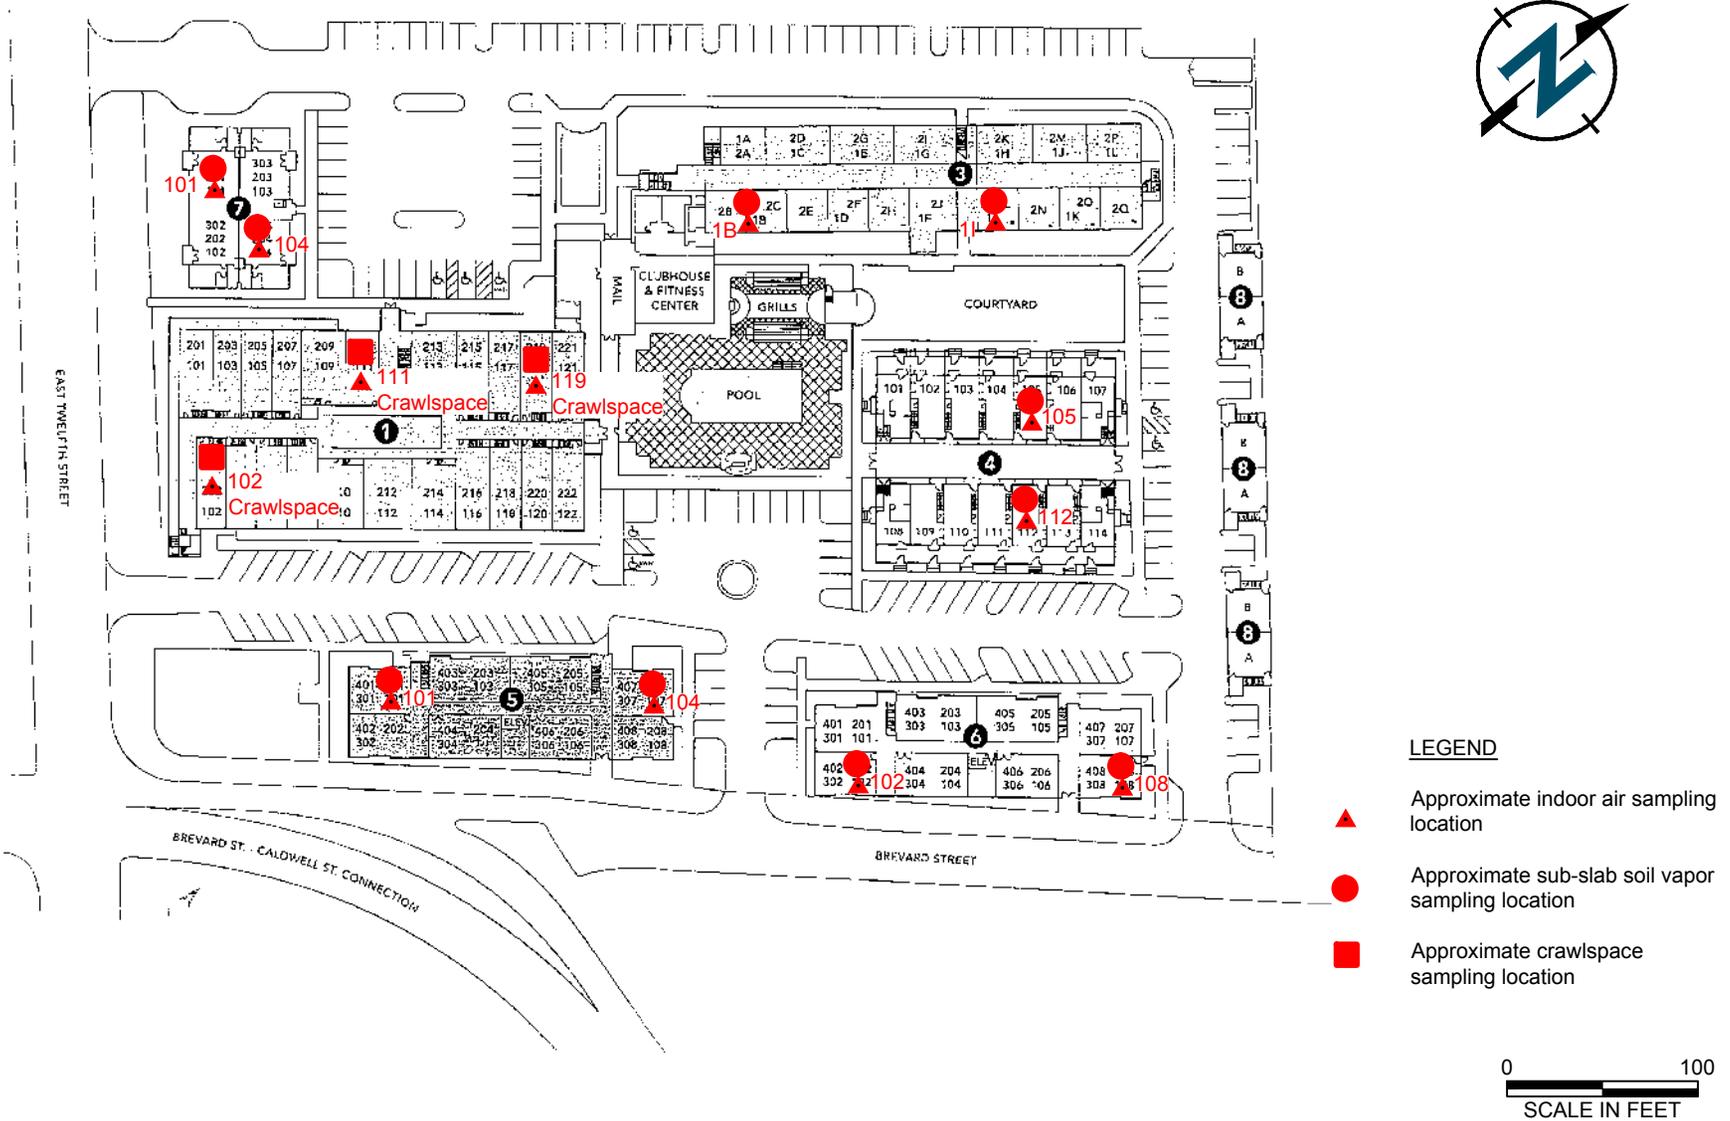
**FIGURE 2**

**Sub-Slab and Indoor Air VOC and Radon Sampling Locations**  
 Alpha Mill Apartments  
 220 Alpha Mill Lane, Charlotte, NC

Indoor air samples were collected from apartments in Building 1 and 3 through 7 (Figure 2 [site-wide] and Figures 2A-2F [building details]). These indoor air samples were analyzed for radon and VOCs. Radon and VOC samples were then collected and analyzed from subslab locations in Buildings 3 through 7 following sampling port installation.

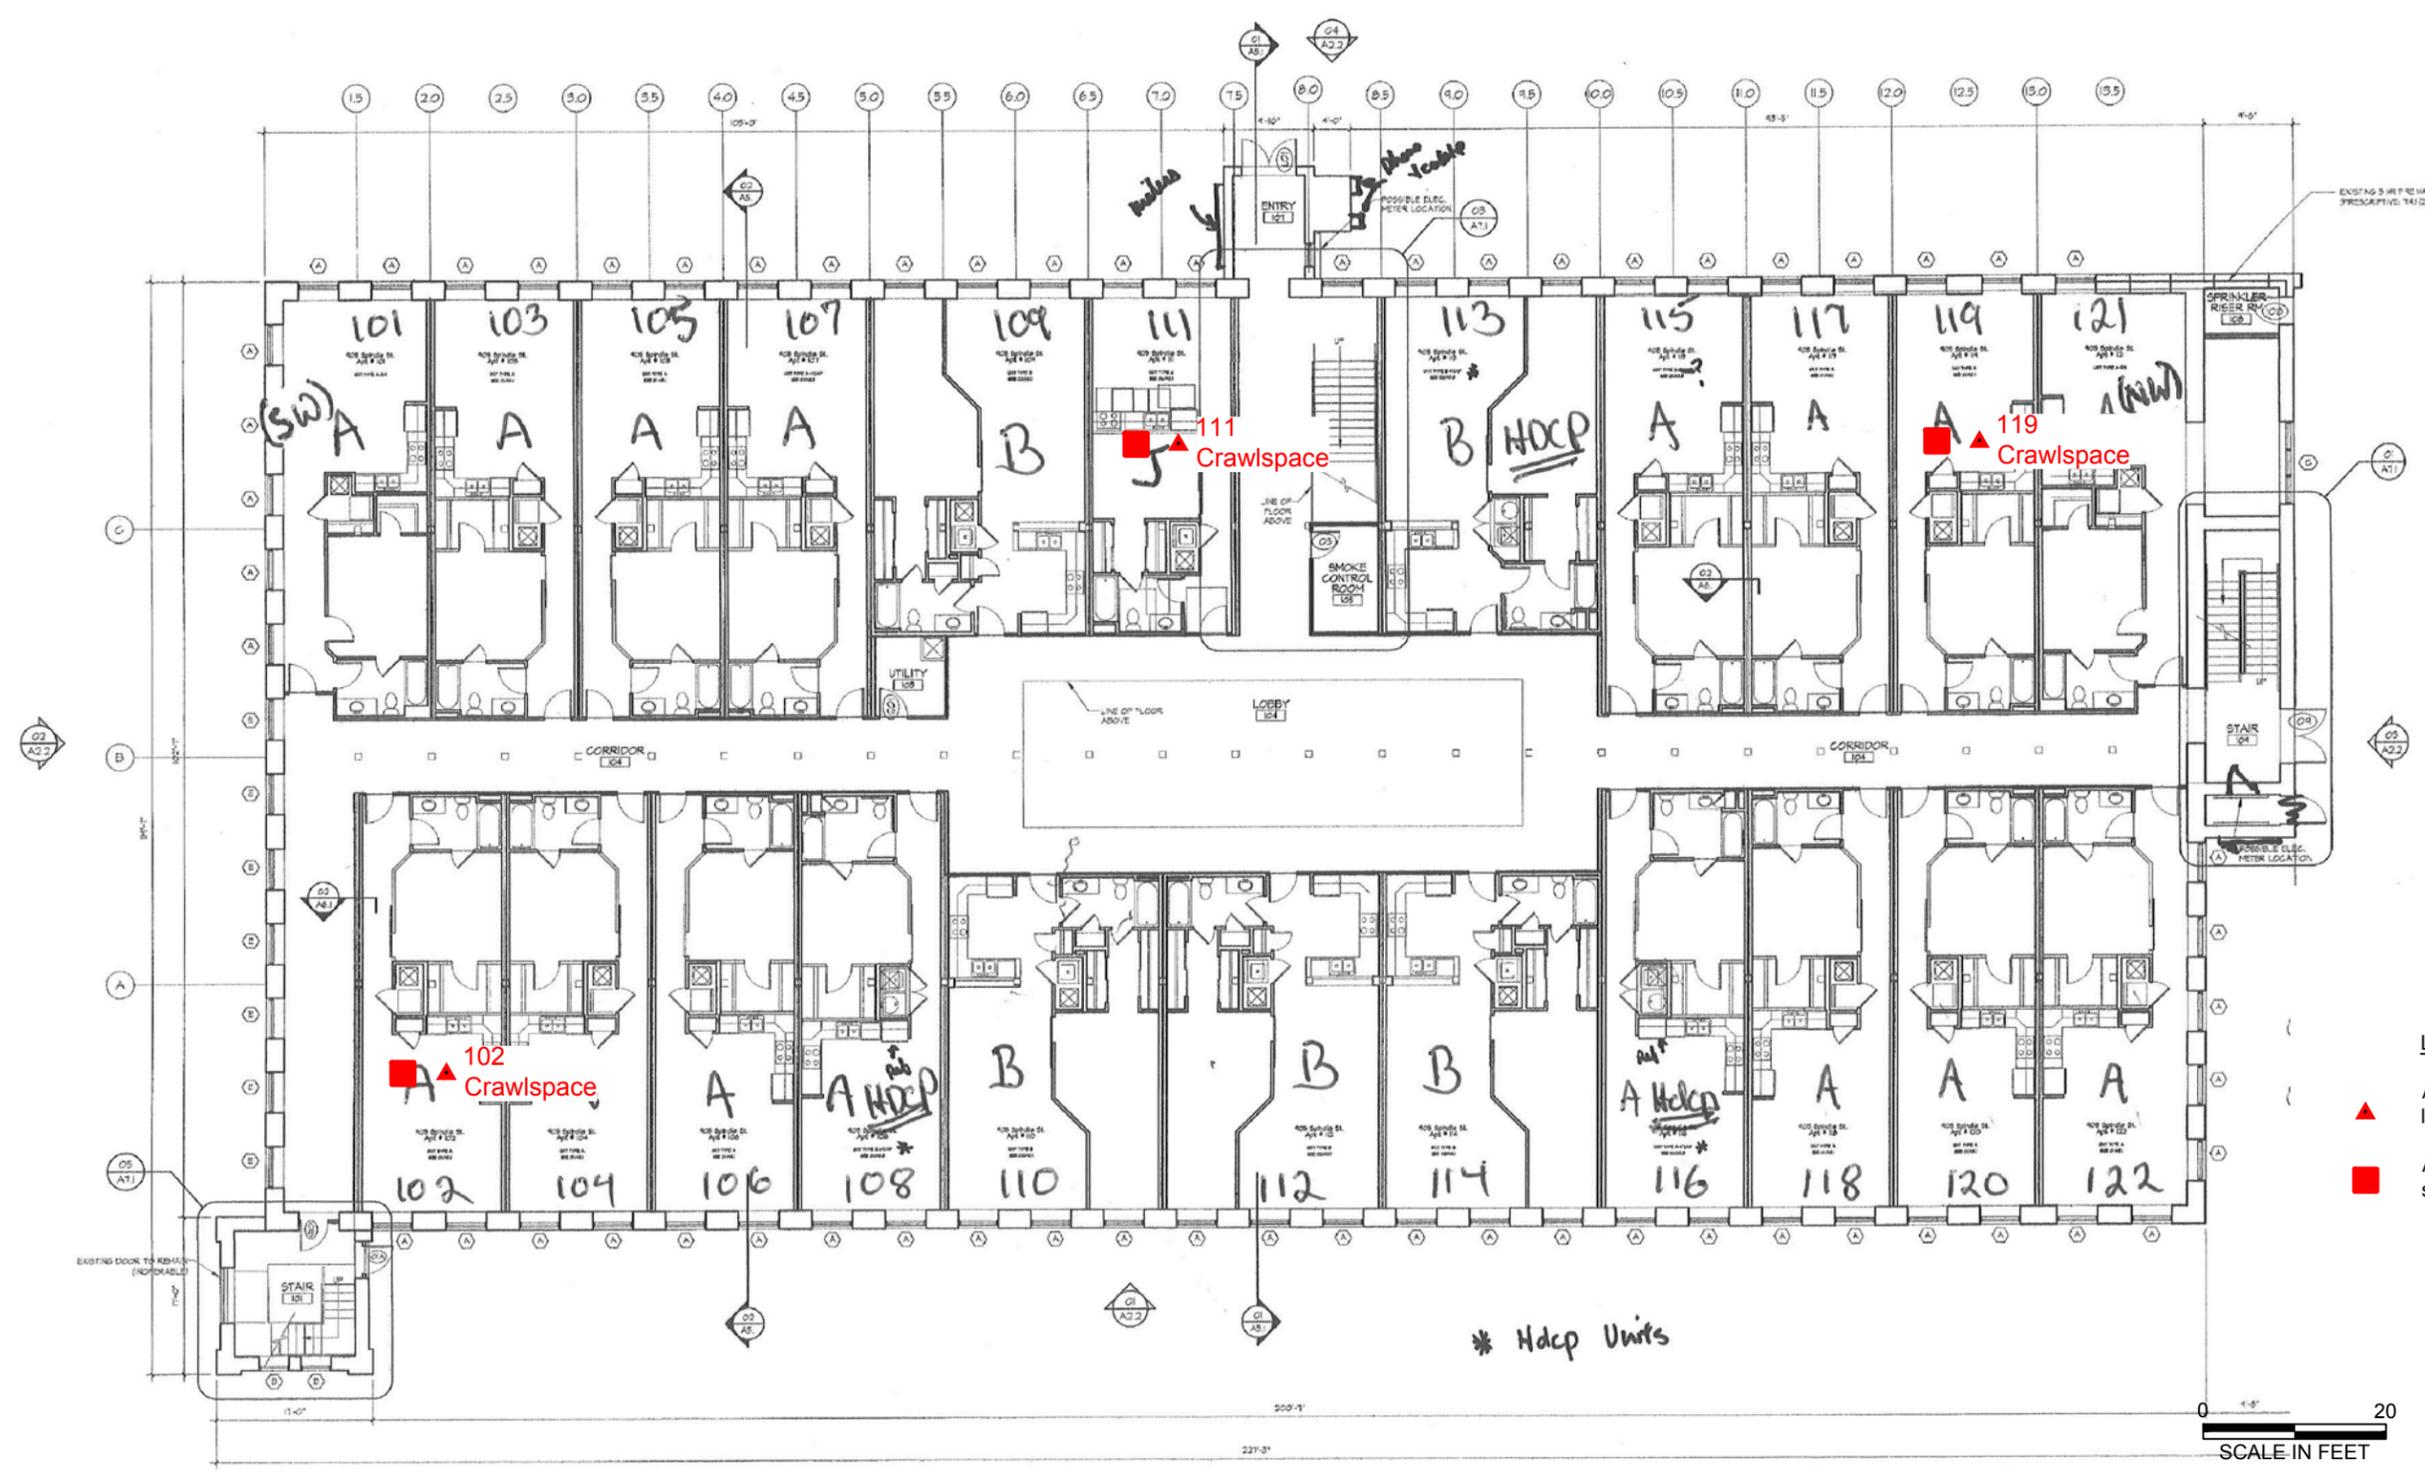
**FIGURE 2A**

**Crawlspace and Indoor Air VOC and Radon Sampling Locations - Building 1**  
Alpha Mill Apartments  
220 Alpha mill Lane, Charlotte, NC

Due to the presence of a crawlspace under Building 1, *in lieu* of subslab sampling, crawlspace air samples were collected from under apartments 102, 111, and 119 in Building 1 (Figure 2A).

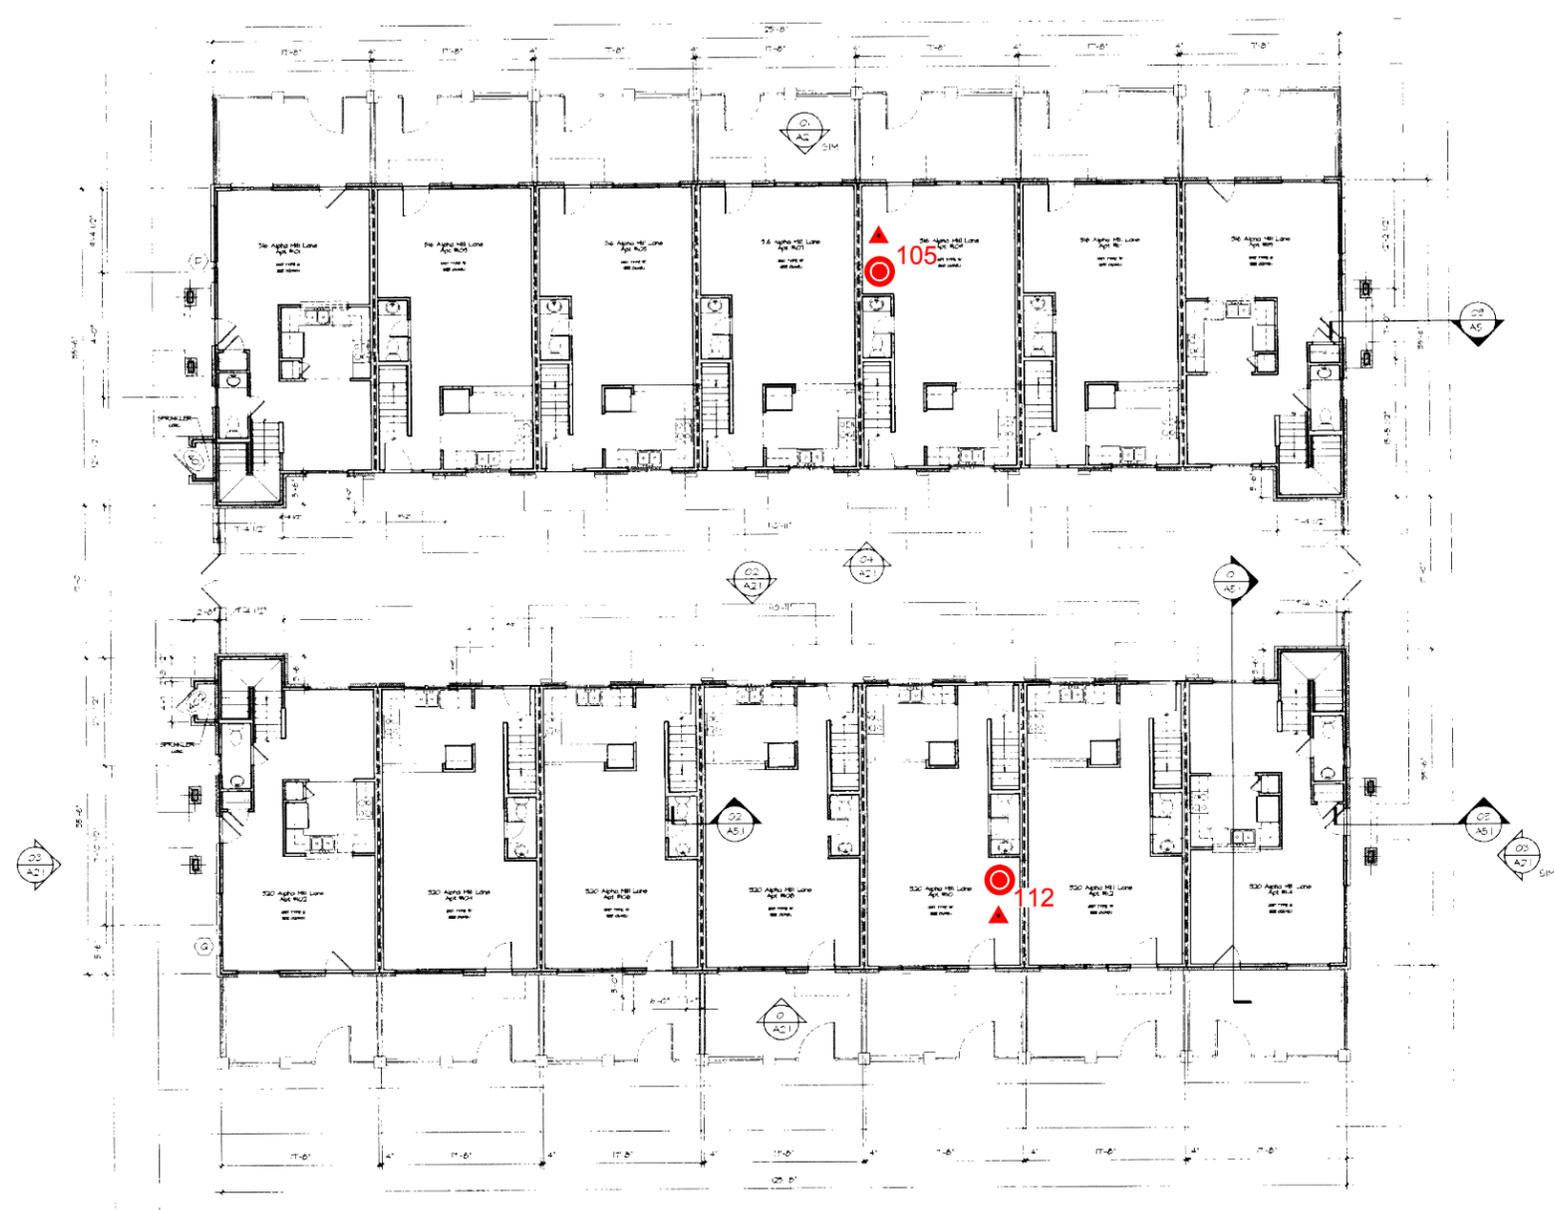
**FIGURE 2C**

**Sub-Slab and Indoor Air VOC and Radon Sampling Locations - Building 4**  
Alpha Mill Apartments  
220 Alpha mill Lane, Charlotte, NC

In order to minimize the impact of sampling port installation on indoor air concentration, the sampling ports were not installed in Buildings 3 through 7 until after the indoor air samples were collected. Subslab soil vapor probes were installed in the following apartments, as shown in Figures 2B-2F:

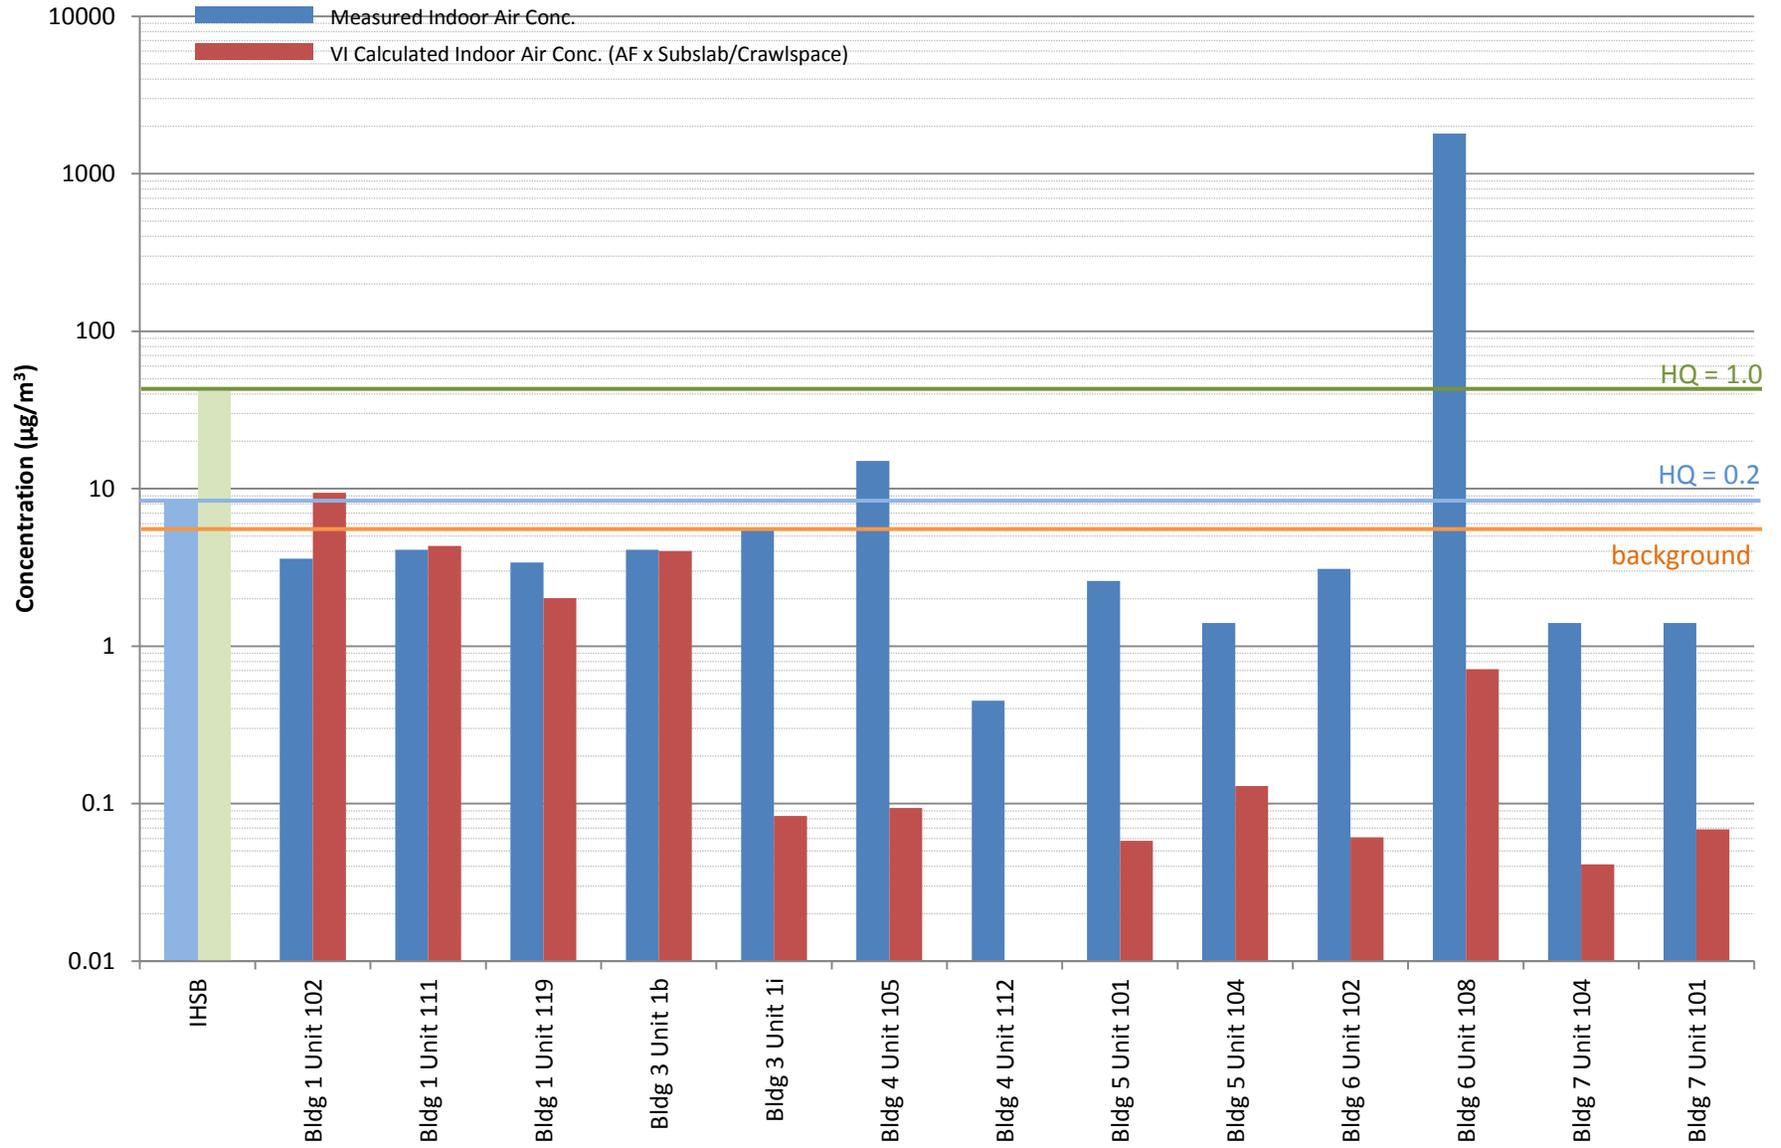
**Figure 3. Measured and Calculated Indoor Air Concentrations - Tetrachloroethene**

Indoor air concentrations were calculated based on measured subslab/crawlspace concentrations and building-specific  $AF_{VI}$ . Measured and calculated indoor air concentrations for each apartment for PCE and TCE are presented in Figures 3a and 3b, respectively.

Measured indoor air PCE concentrations exceeded the IHSB HQ=0.2 risk level in two apartments and the IHSB HQ=1 risk level in one apartment. However, in both cases, the calculated indoor air concentrations using the building-specific  $AF_{VI}$  are well below the HQ=0.2 risk level. The relatively lower calculated indoor air concentrations suggests the elevated levels of PCE in these two apartments are likely attributed, at least in part, to indoor sources and not vapor intrusion.

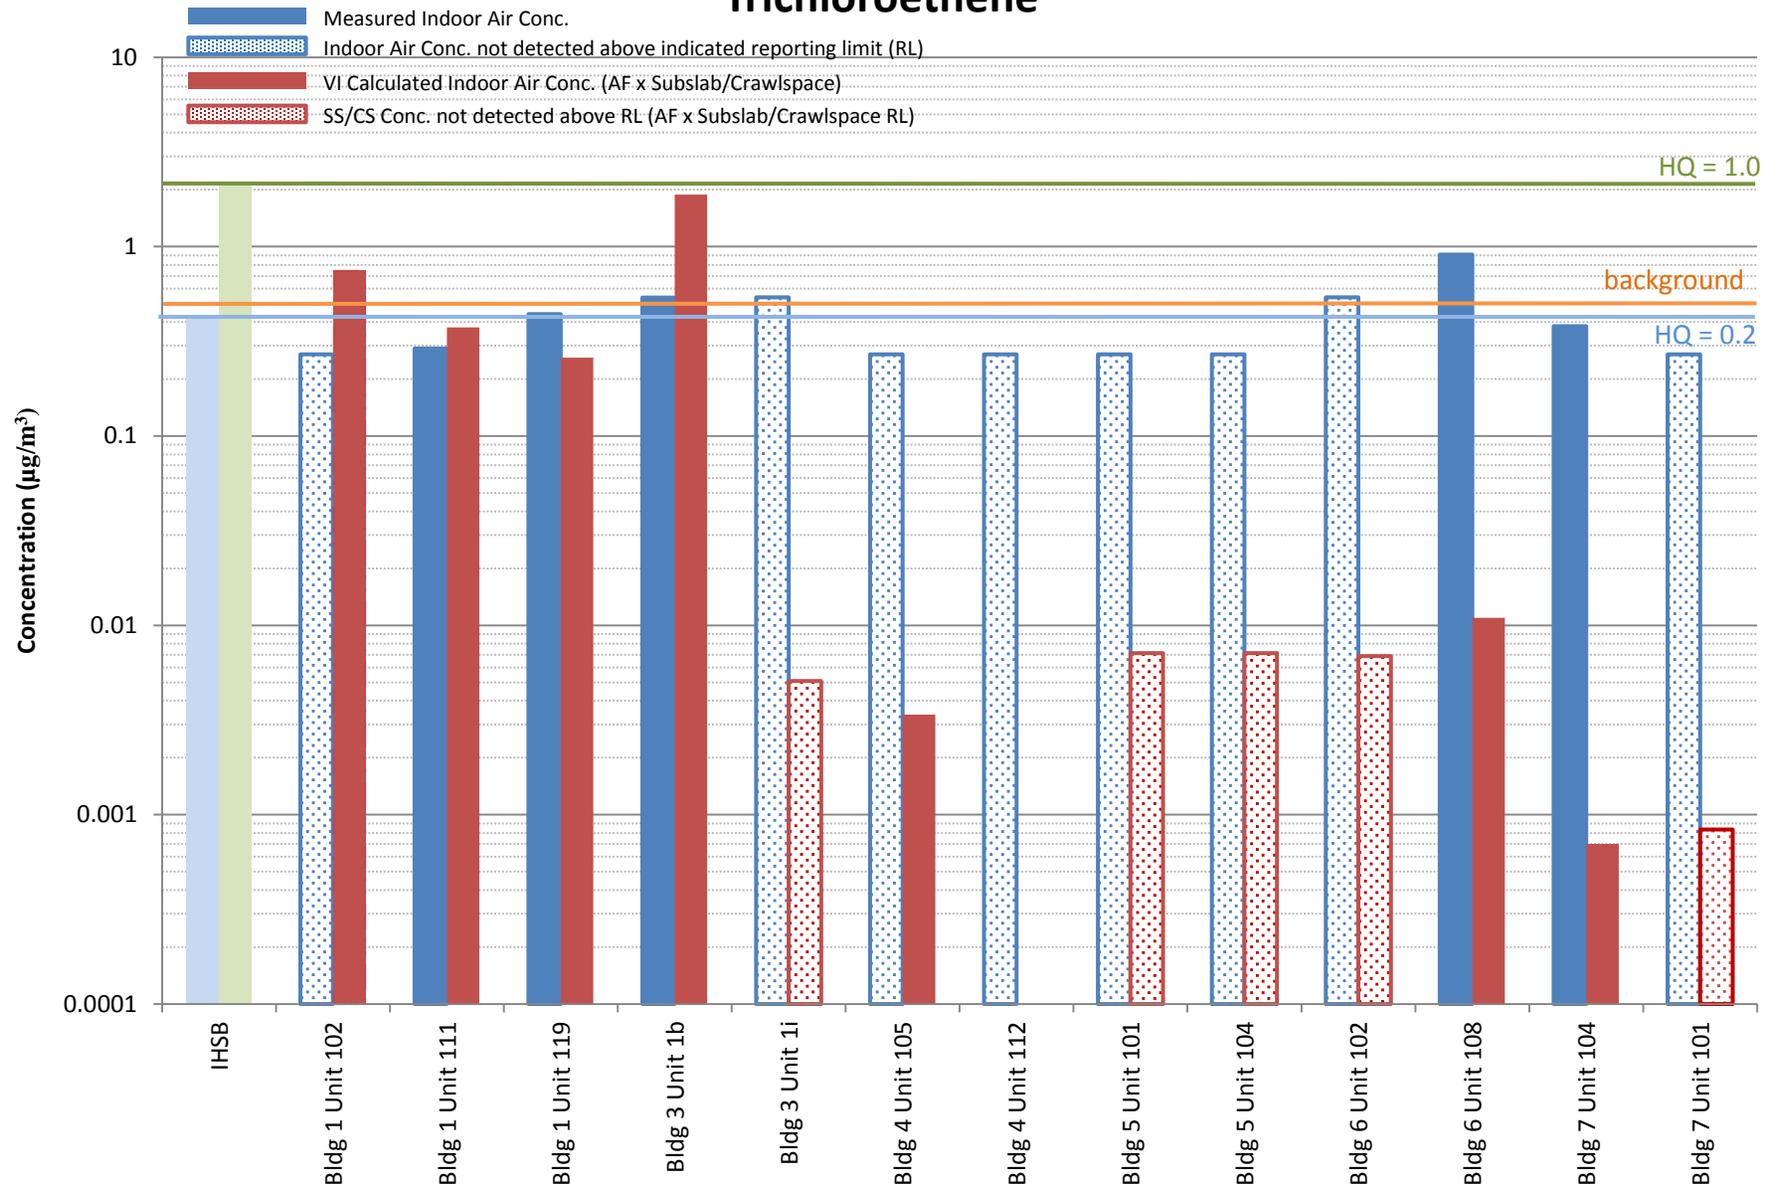
**Figure 4. Measured and Calculated Indoor Air Concentrations - Trichloroethene**

Measured indoor air TCE concentration exceeded the IHSB HQ=0.2 risk level in three apartments; however, the measured TCE concentration is well below the HQ=1.0 risk level. In two of the units, calculated TCE concentrations in indoor air are lower than measured concentrations and below the HQ=0.2 risk level. This difference suggests that the measured levels of TCE in two of these apartments can likely be attributed, at least in part, to indoor sources. In the third apartment, the calculated indoor air TCE concentration was higher than the measured concentration.
