**RE: MMPE & Active Remediation Monitoring Report for the  
Former Don Christian Property  
206 East Main Street, Carrboro, NC 27510  
DENR Incident # 26797**

## ACTIVE REMEDIATION MONITORING REPORT

FORMER DON CHRISTIAN PROPERTY  
206 E. MAIN STREET  
CARRBORO, ORANGE COUNTY, NC

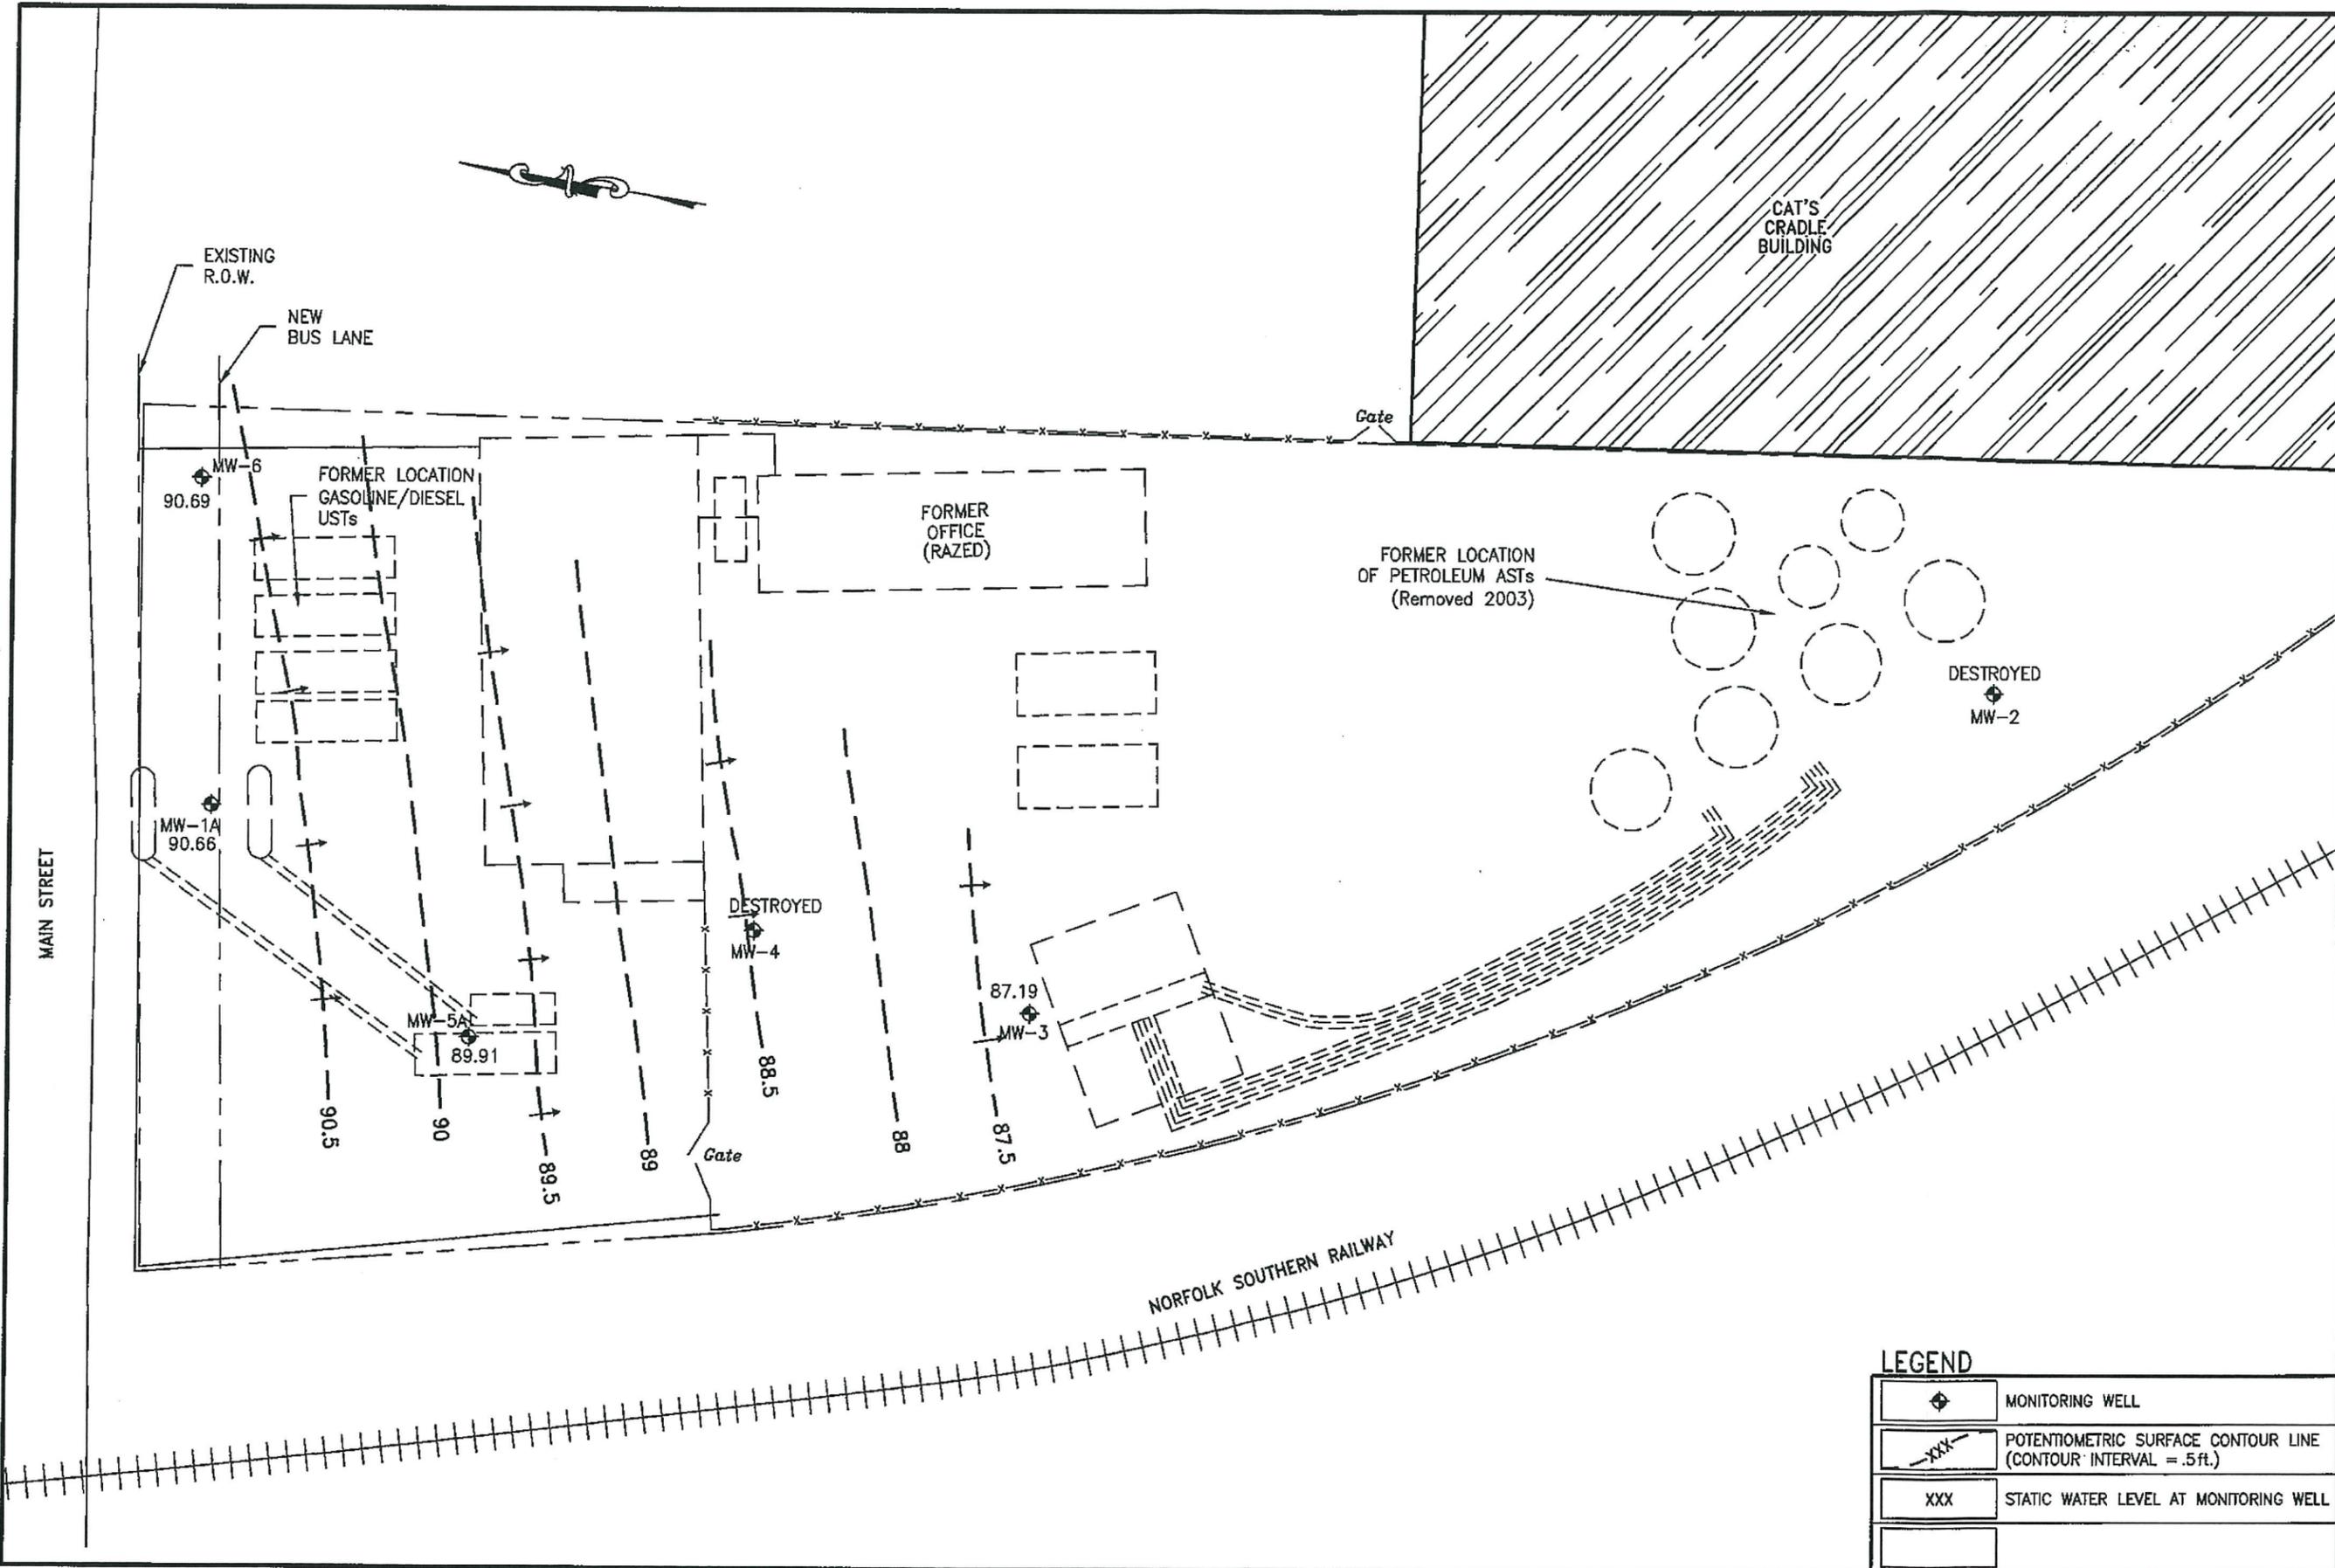
MAIN ST. PROPERTIES OF CHAPEL HILL  
 206 E. MAIN ST.  
 CARRBORO NORTH CAROLINA  
 POTENTIOMETRIC SURFACE MAP (7/30/13)

GEOLOGIC PROVINCE: Carolina Slate Belt  
 BEDROCK TYPE: Metamorphic granites of the Chapel Hill Pluton  
 DEPTH TO BEDROCK: 18 to 20 feet Below Ground Surface (BGS)  
 DEPTH TO WATER TABLE: 4 feet to 14 feet BGS  
 POTENTIOMETRIC GRADIENT: Southeast (see **Figure 3** the Potentiometric Surface Map from July 2013)

MONITORING WELL
	POTENTIOMETRIC SURFACE CONTOUR LINE (CONTOUR INTERVAL = .5ft.)
	STATIC WATER LEVEL AT MONITORING WELL

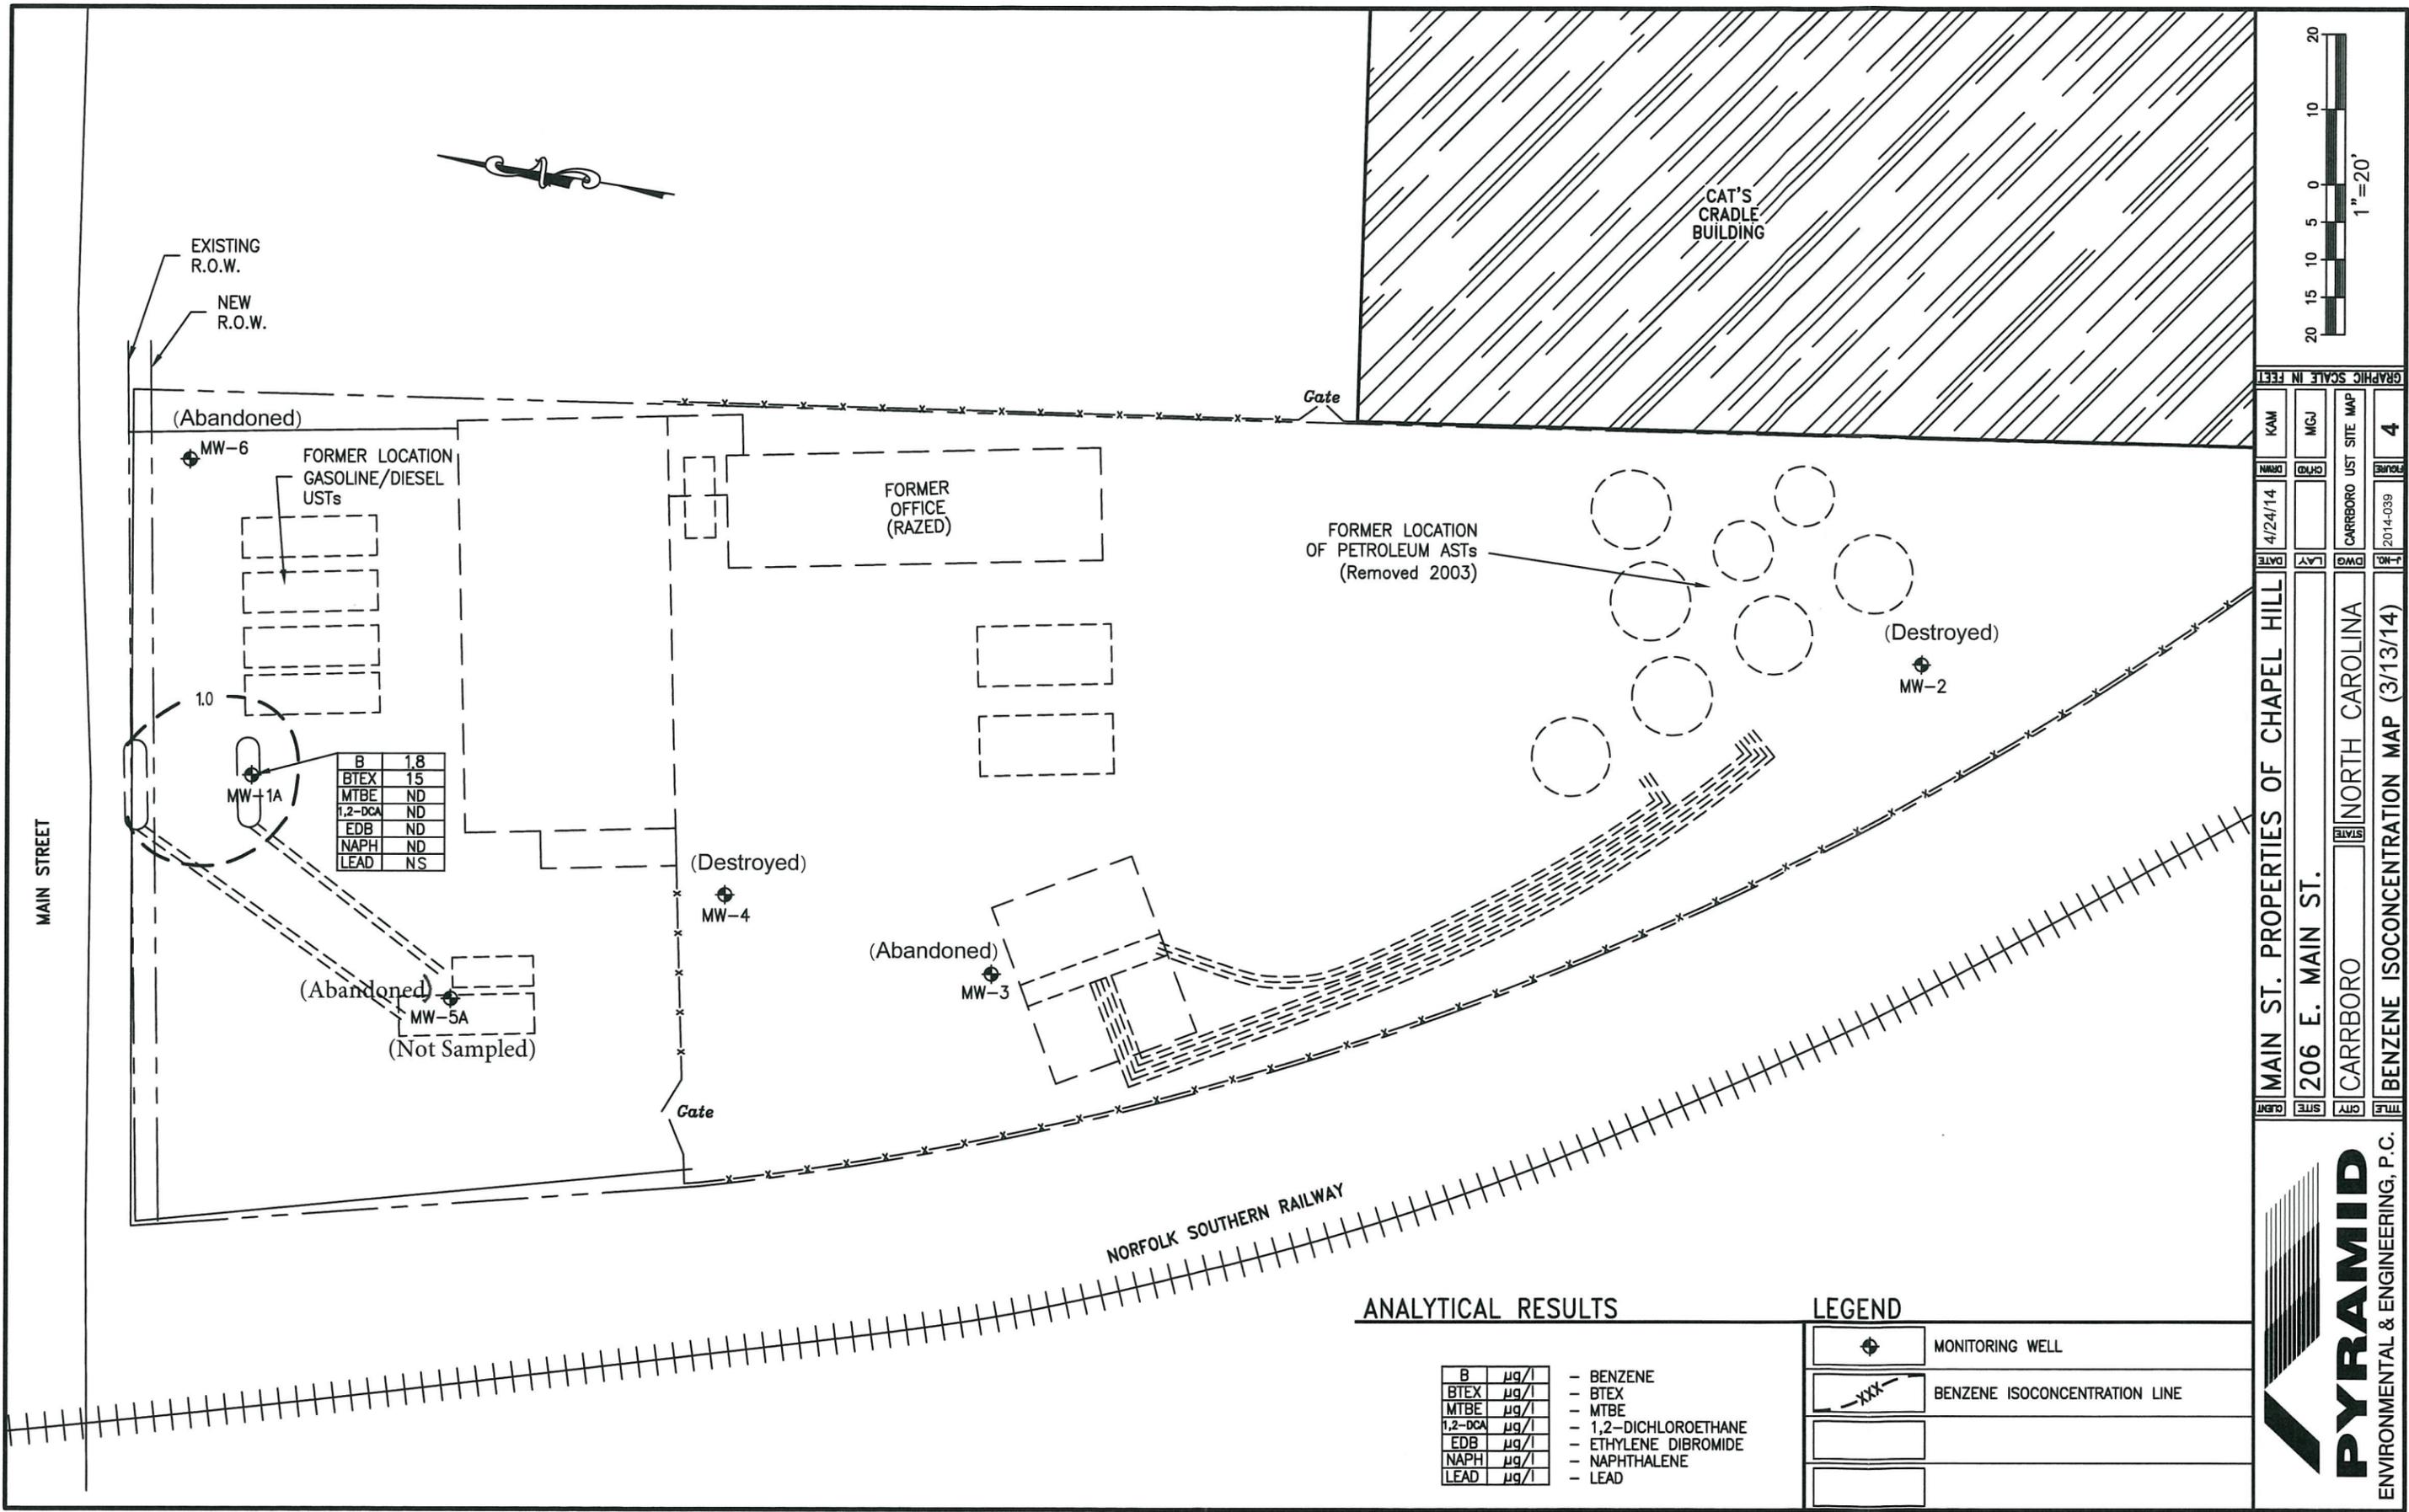
**ANALYTICAL RESULTS**

CURRENT MAXIMUM BENZENE: 1.8  $\mu\text{g/L}$  (MW-1A: 3/13/2014)  
PREVIOUS MAXIMUM BENZENE: 298  $\mu\text{g/L}$  (MW-1A: 2/18/2013)  
HISTORIC MAXIMUM BENZENE: 29,400  $\mu\text{g/L}$  (MW-1: 5/8/2013)

Based on these groundwater analyses, the benzene and other concentrations in groundwater have declined rapidly with soil and groundwater remediation. The soil excavation addressed the source, and the oxygen release compounds increased biological breakdown of petroleum contaminants. The concentrations have declined from 29,400  $\mu\text{g/L}$  in May 2013 to 1.8  $\mu\text{g/L}$  in March 2014. The MMPE event was successful in further reducing localized petroleum contaminants in groundwater. The petroleum concentrations in MW-1A were well below the Gross Contamination Levels (GCLs).

B	1.8
BTEX	15
MTBE	ND
1,2-DCA	ND
EDB	ND
NAPH	ND
LEAD	NS

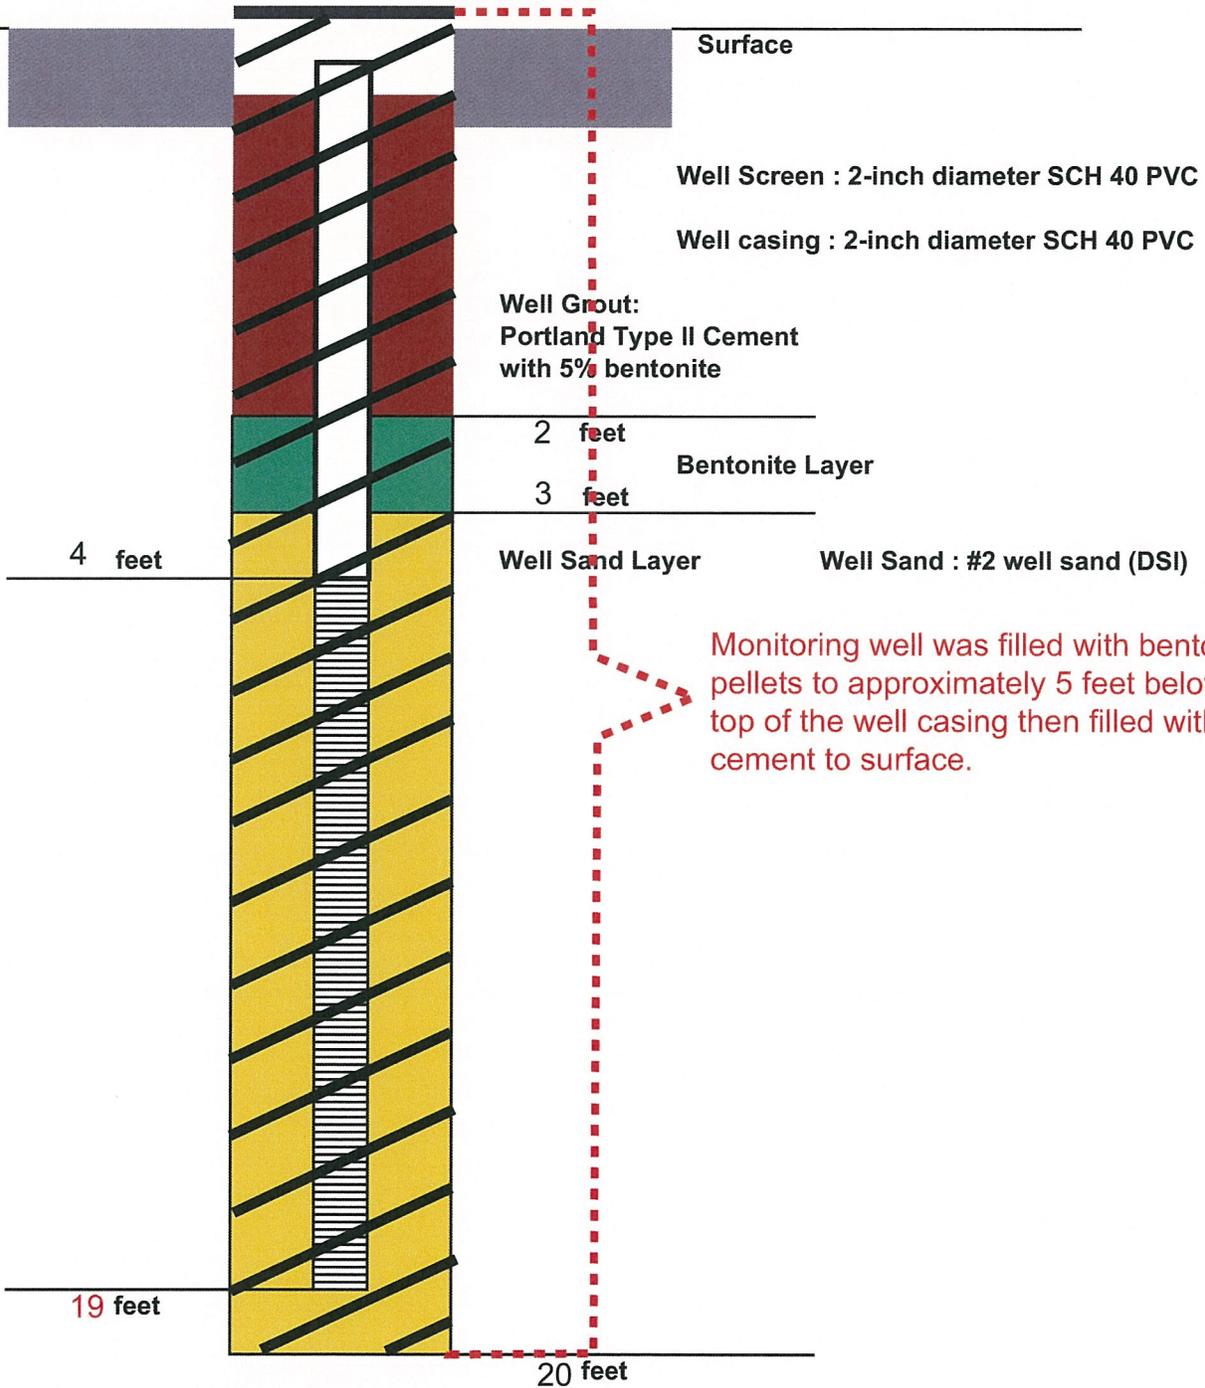
# Monitoring Well Abandonment Detail for monitoring well MW-5A

8-inch Steel Manhole  
Set in 2 foot square pad (8 inches thick)

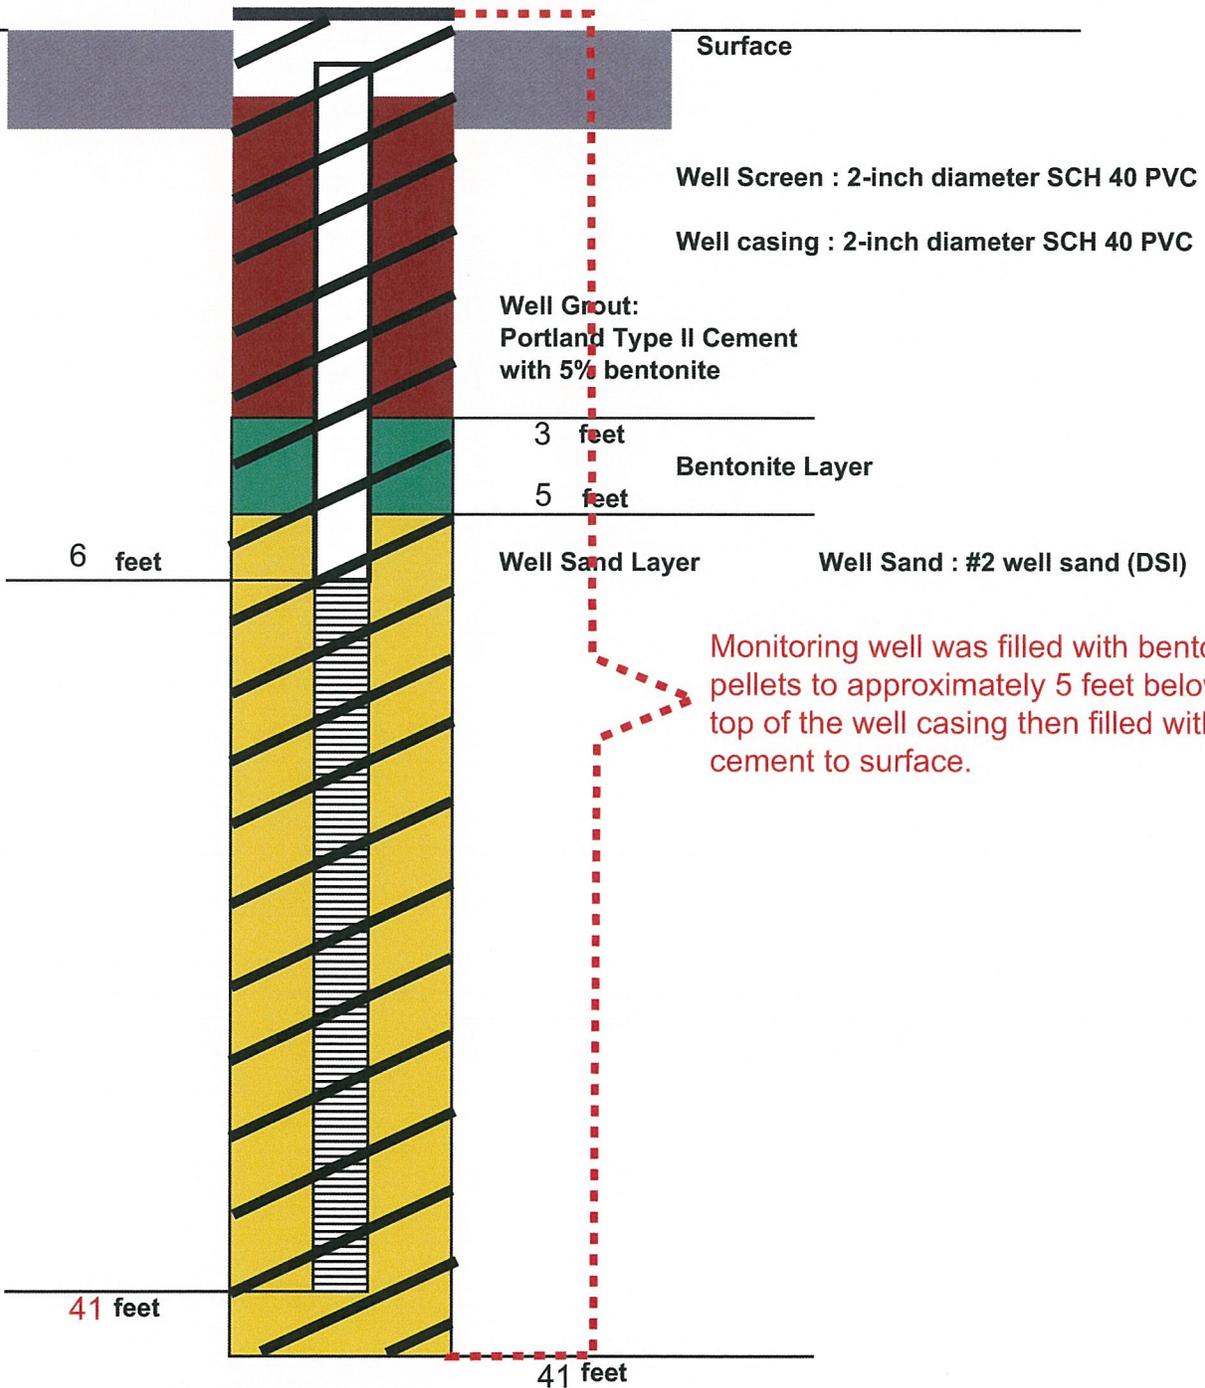
# Monitoring Well Abandonment Detail for monitoring well MW-6

8-inch Steel Manhole  
Set in 2 foot square pad (8 inches thick)
