**BEST GEOLOGICAL AND  
ENVIRONMENTAL CONSULTING, P.A.**

Reference: Letter of Intent to Redevelop a Brownfields Property  
Former Flowserve Facility  
264 Wilson Park Road  
Statesville, North Carolina 28677

Figure 1 Site Location Map Former Flowserve Facility Statesville, North Carolina

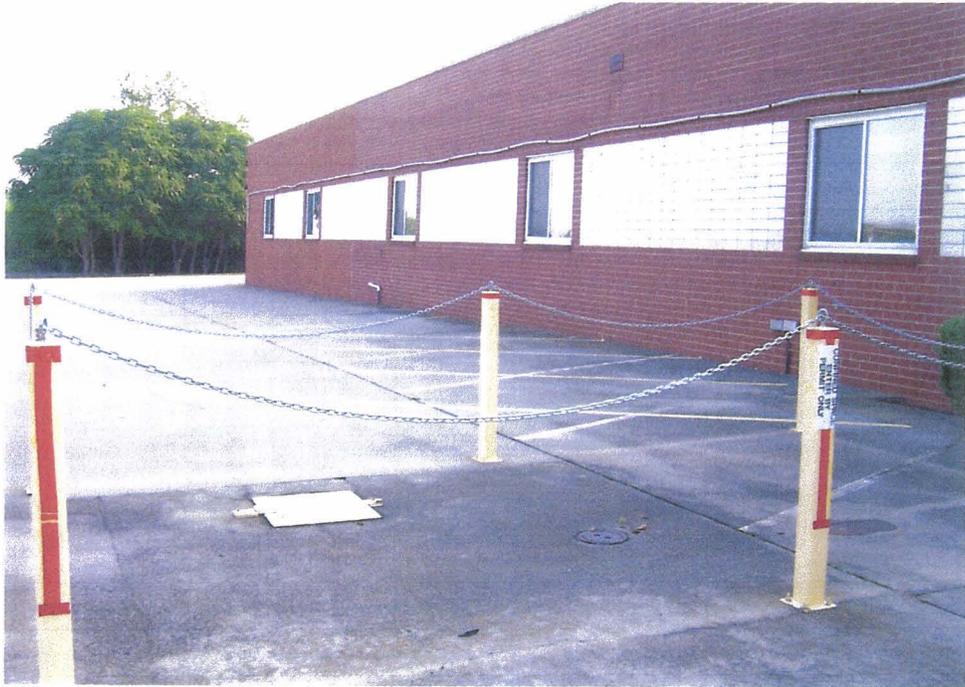
View of the water supply well

Groundwater at the subject site has been impacted by a documented release of chlorinated solvents at the Jantzen Inc. facility located approximately 500 feet east of the subject site. The on-site water supply well has been impacted by tetrachloroethene (PCE), trichloroethene (TCE) and dichloroethene (DCE). The PCE concentrations were detected at a concentration of 43 micrograms per liter ( $\mu\text{g/L}$ ) in 1995 and at a concentration of 19  $\mu\text{g/L}$  in 1997. The North Carolina NCAC 2L Groundwater Quality Standard (2L) for PCE is 0.7  $\mu\text{g/L}$ . The Aquifer Protection Section maintains an open file on the Jantzen site and acknowledges that the groundwater contamination of the Flowserve site originates on the Jantzen property.

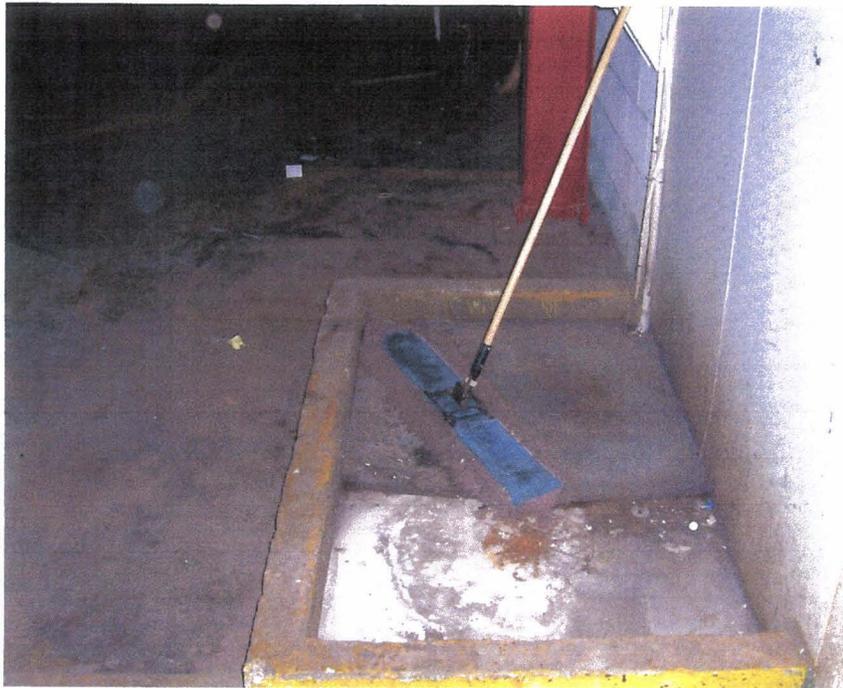
View of a wash basin and floor drain

Prior to the availability of municipal sewer service, the facility was served by an on-site septic system. Due to the possibility that solvents and other products containing regulated compounds were discharged into the septic system, the septic system was identified as a Recognized Environmental Concern (REC) during a Phase I Environmental Site Assessment performed by Best in August 2006. Subsequently, Best performed a soil and groundwater investigation at the site on January 4, 2007. Based on the results of our assessment activities at the site, soil does not appear to have been impacted by a release of regulated compounds. Groundwater contained volatile and semi-volatile organic compounds at concentrations well below the 2L. Groundwater contained mercury at a concentration below the 2L. Groundwater contained arsenic, barium, cadmium, chromium, and lead in concentrations exceeding the 2L but below the Gross Contamination Level (GCL). The soil and groundwater results are summarized in Table 1 and Table 2 contained in Appendix A.
