Prepared by:
AECOM
Raleigh, NC
60240271
January 2012

Phase I ESA

State Line Scrap Metal, Inc.

**5401 South York Highway, 5322 South York Highway, and 160 Wolfpack Road
Gastonia, North Carolina**

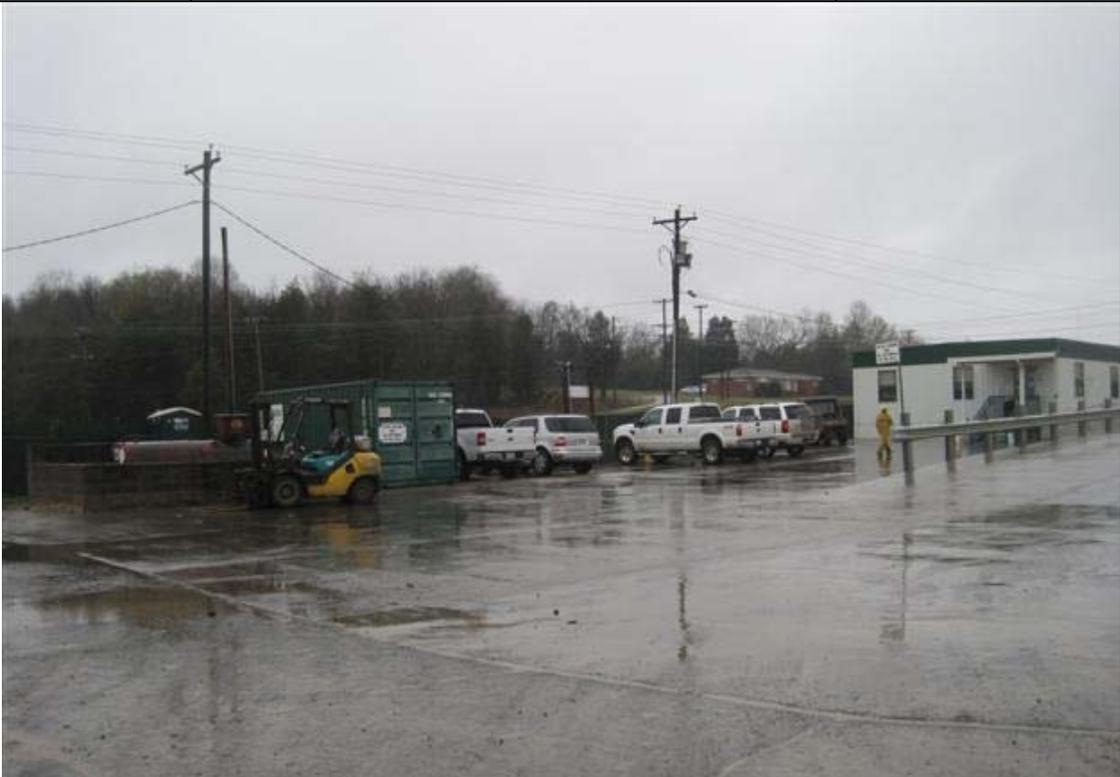
Client Name: The David J. Joseph Company		Site Location: 5401 and 5322 S. York Highway, 160 Wolfpack Road	Project No.: 60240271
Photo No. 1	Date: 12/7/11

Direction Photo Taken: Northwest			
Description: View of the modular office located on the northwestern portion of Parcel A. The 500-gallon used oil AST is visible on the left side of the photo. The inbound ramp to the scales is visible on the right side of the photo.

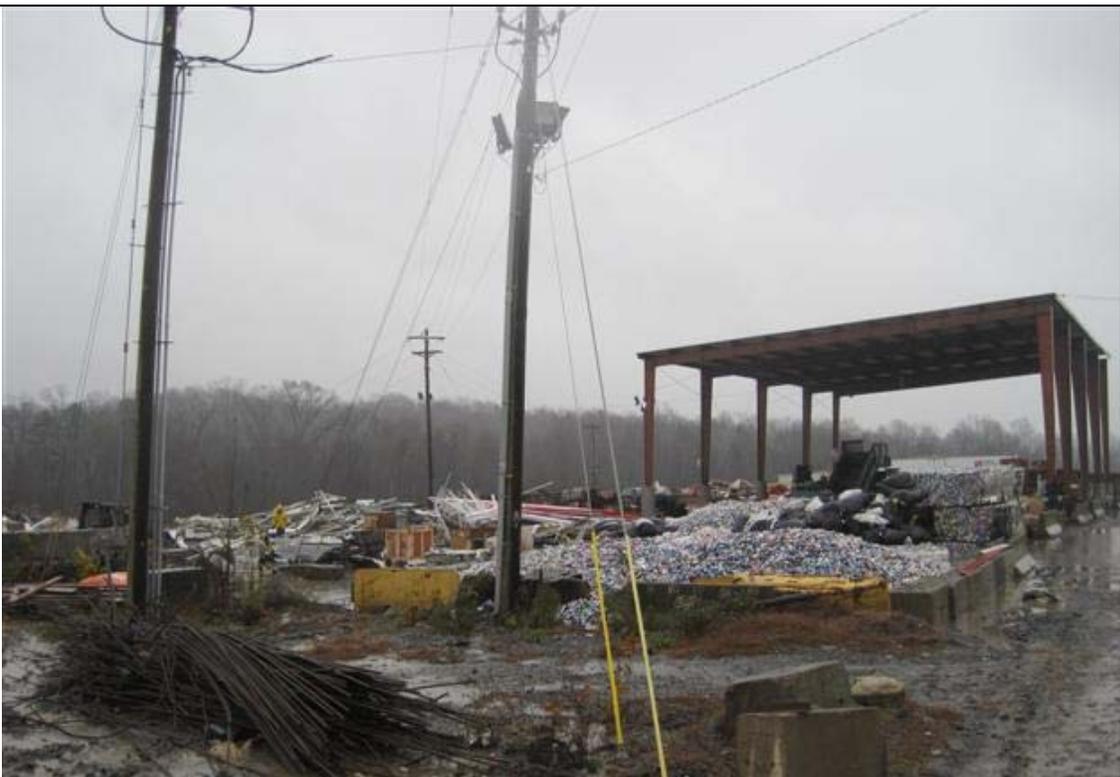
Photo No. 2	Date: 12/7/11

Direction Photo Taken: Southeast		
Description: View of the baler shed and non-ferrous scrap metal storage area on the northwestern portion of the site. A concrete pad is located in this area.

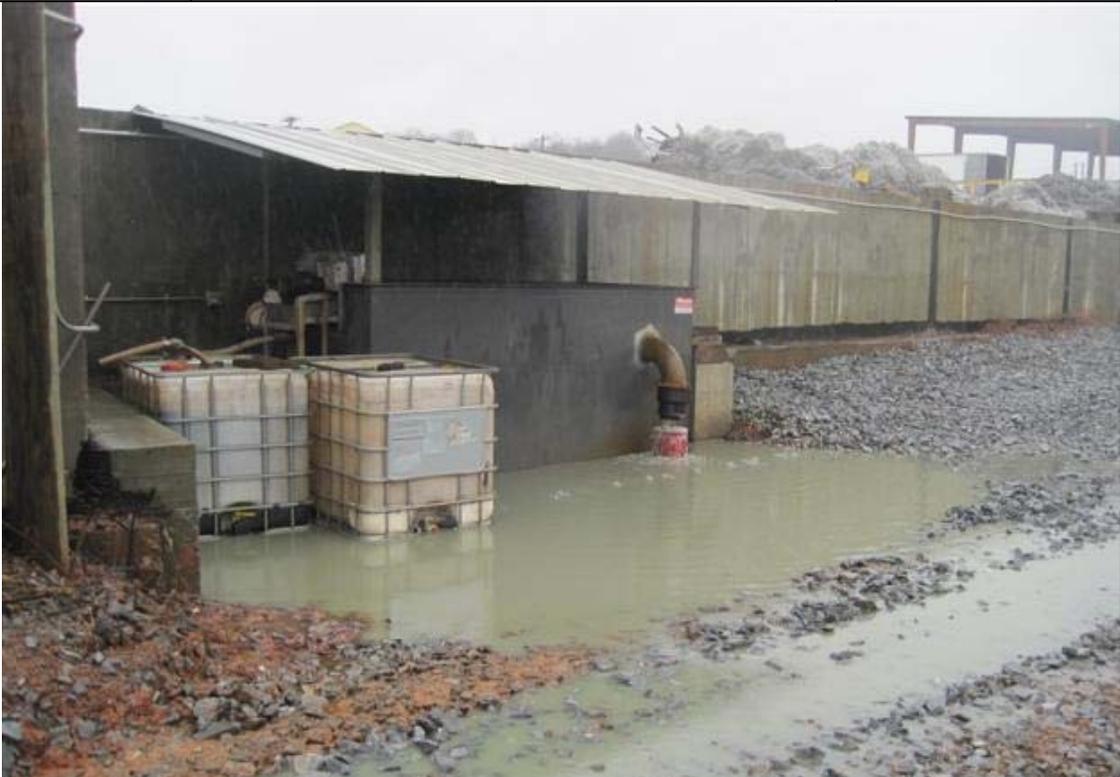
Client Name: The David J. Joseph Company		Site Location: 5401 and 5322 S. York Highway, 160 Wolfpack Road	Project No.: 60240271
Photo No.: 3	Date: 12/7/11

Direction Photo Taken: Northwest			
Description: View of the oil/water separator located adjacent to the turnings storage area, which is visible in the background (north side of the concrete wall). This discharge flows to the retention pond located farther to the south.

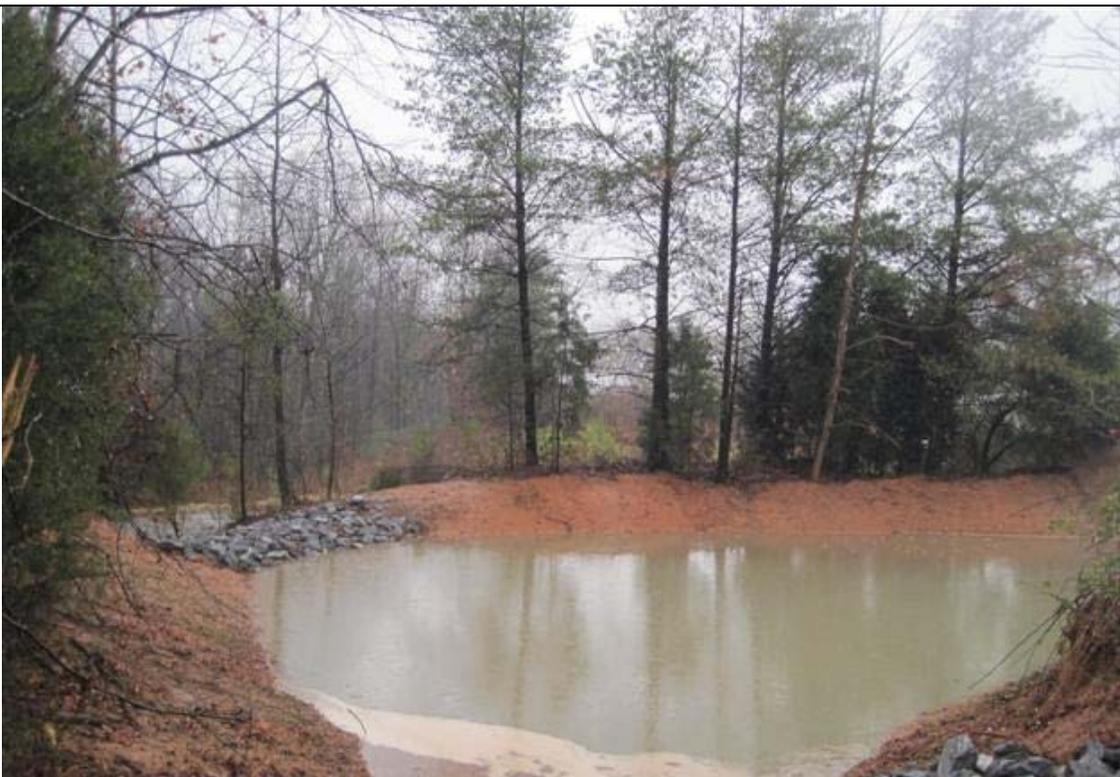
Photo No.: 4	Date: 12/7/11

Direction Photo Taken: South		
Description: View of the retention pond located to the south of the turnings storage area. The storm water discharge from the oil/water separator flows to this pond. Storm water from the retention pond ultimately discharging into the wooded area along the eastern boundary of the site.

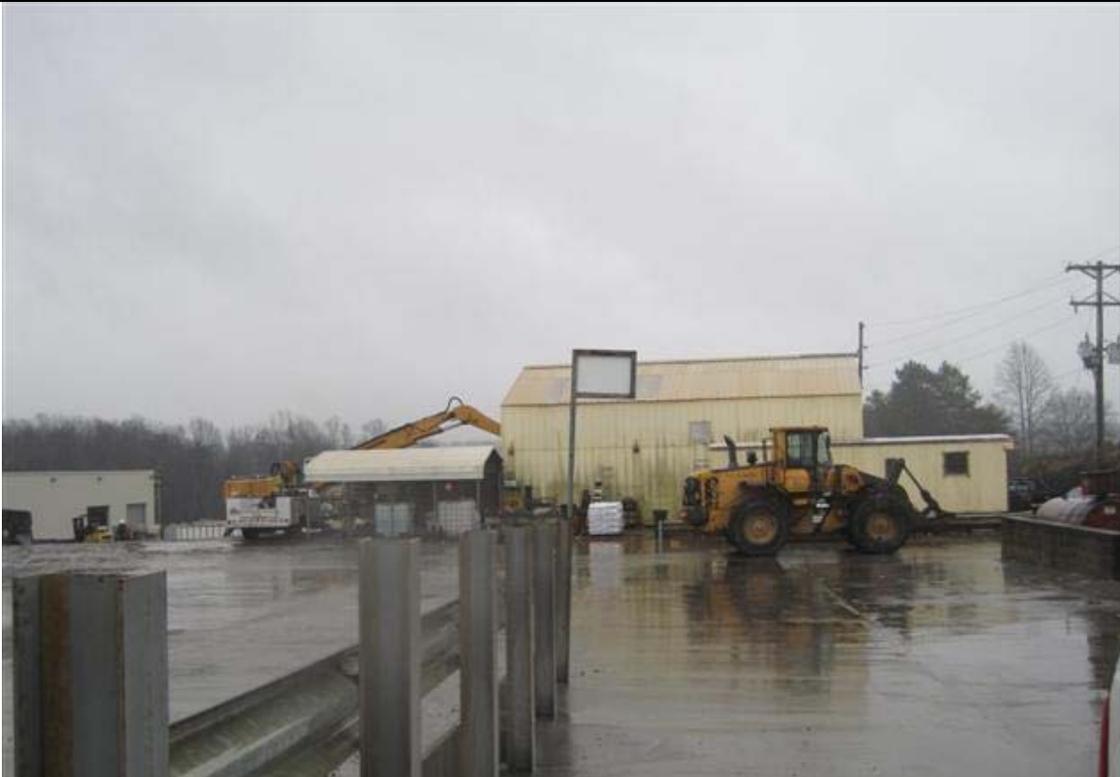
Client Name: The David J. Joseph Company		Site Location: 5401 and 5322 S. York Highway, 160 Wolfpack Road	Project No.: 60240271
Photo No.: 5	Date: 12/7/11

Direction Photo Taken: South			
Description: View of the maintenance building located on the northern portion of Parcel A. The 500-gallon used oil AST is visible on the right side of the photo. The warehouse in the turnings storage area is visible on the left side of the photograph.

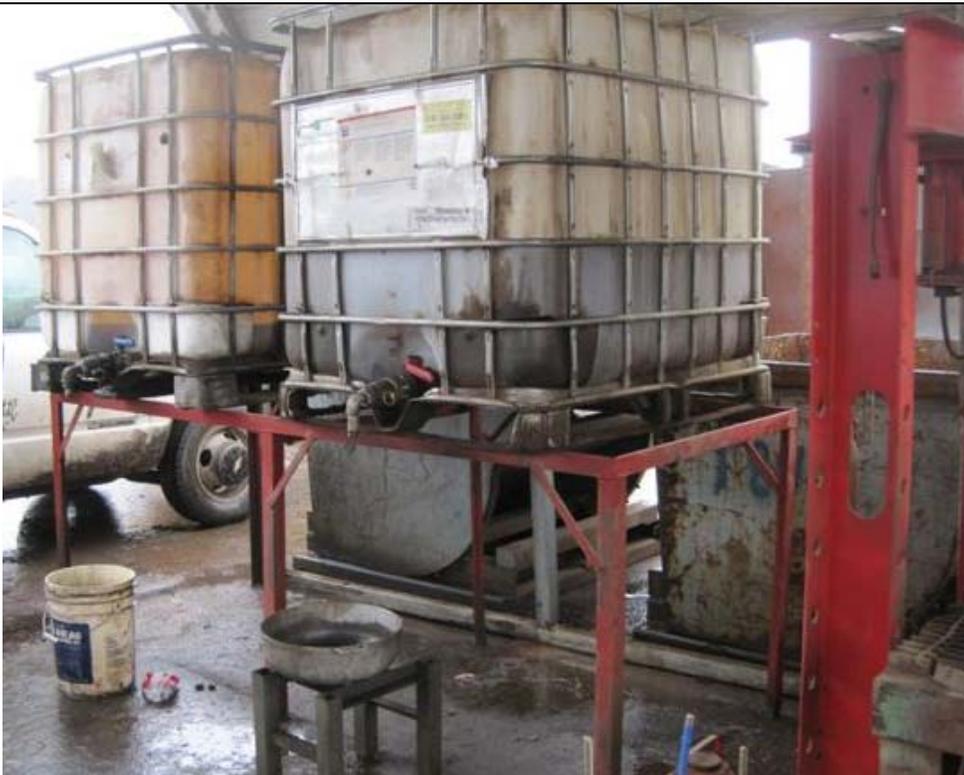
Photo No.: 6	Date: 12/7/11

Direction Photo Taken: N/A		
Description: View of the 275-gallon totes containing used oil and hydraulic fluid located underneath a canopy and adjacent to the maintenance building. De minimis staining was observed on the concrete surface adjacent to the oil storage rack and minor cracks in the concrete were observed in the vicinity of the staining.

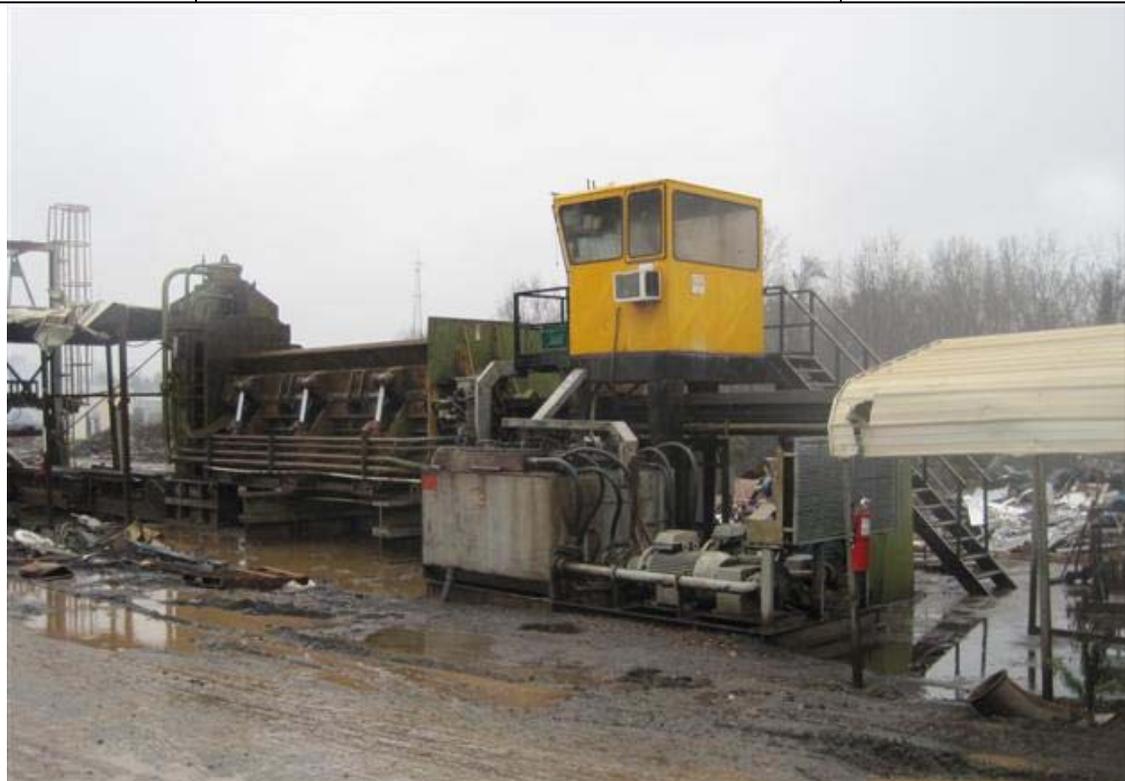
vegetation of the eastern side of the parcel. However, there was heavy rainfall at the time of the site visit and AECOM was able to observe the storm water flow directions and effectiveness of the Best Management Practices (BMP) controls. The BMP controls appeared to be effective and no oily sheens or petroleum odors were noted on the surface water present in the in the detention/retention ponds. It should be noted that an oily sheen was noted on standing water in the vicinity of the shear.

View of the shear equipment located on the southern portion of the site. The 1,500-gallon reservoir for the shear is visible in the background. Staining was observed adjacent to the shear equipment and the hydraulic oil reservoir. An oily sheen was noted on standing water in the vicinity of the shear. A concrete pad is located in this area.

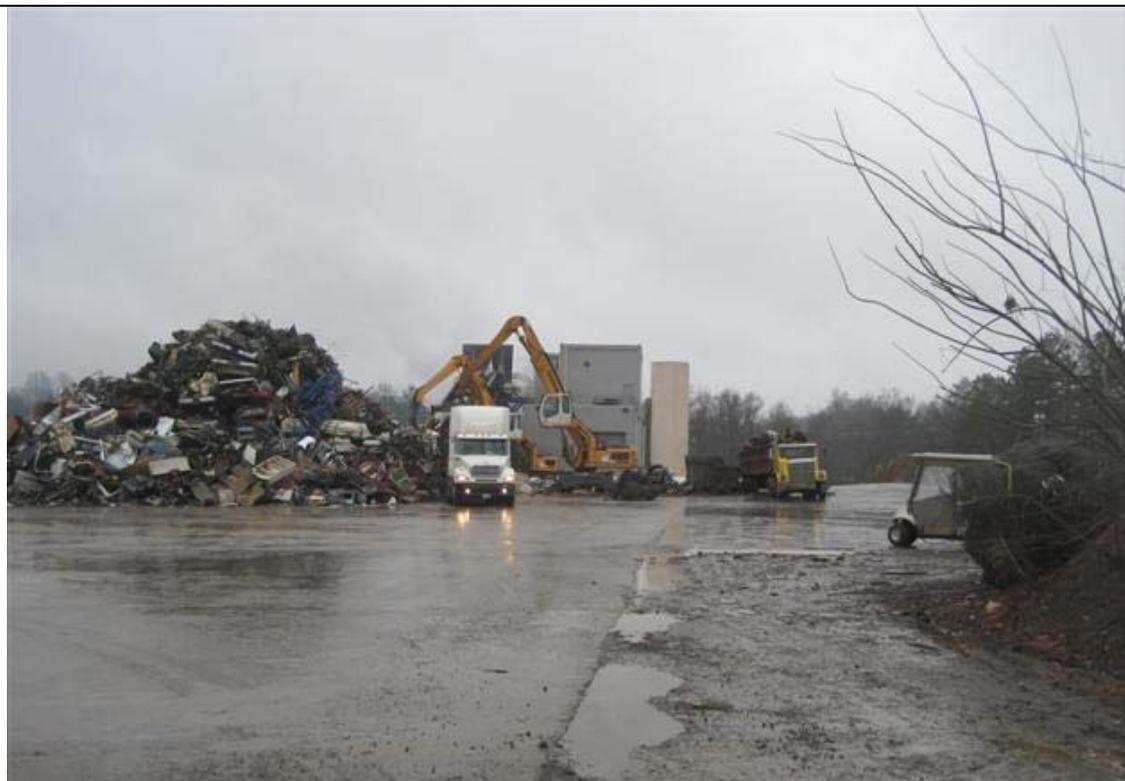
Photo No.: 8	Date: 12/7/11
Direction Photo Taken: South

View of the unprepared scrap stored in the southern portion of the site. The shredder and associated support building and water tank are visible in the background.

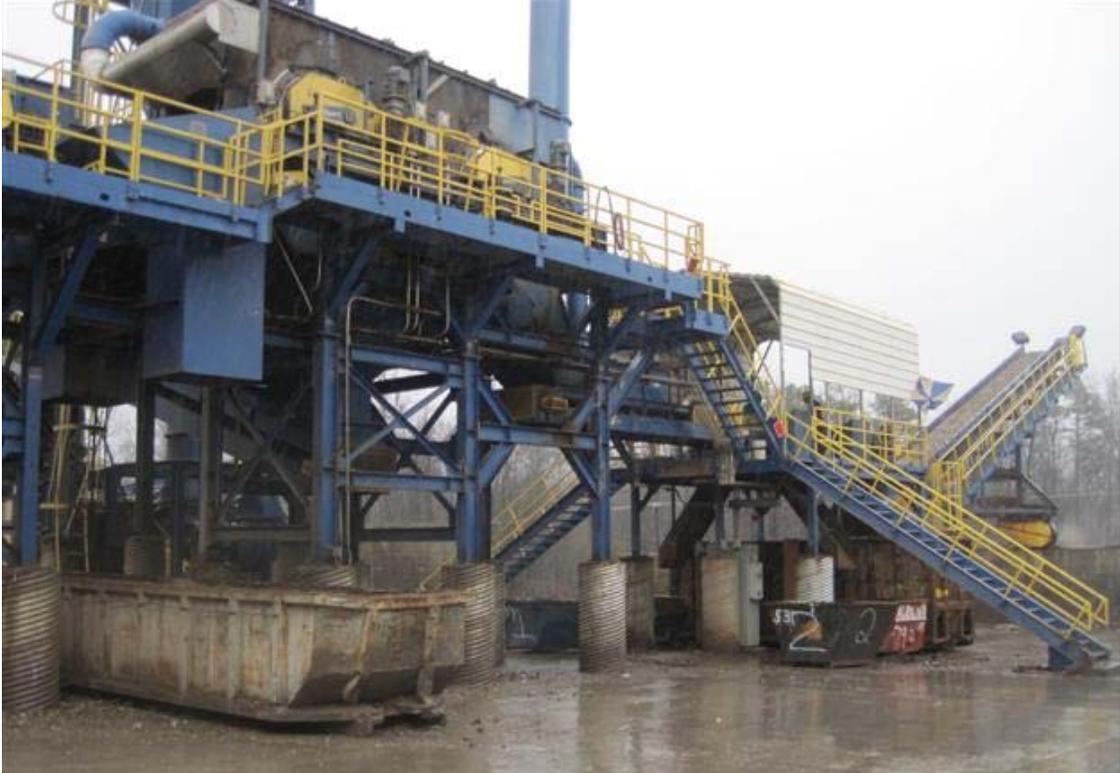
Client Name: The David J. Joseph Company		Site Location: 5401 and 5322 S. York Highway, 160 Wolfpack Road		Project No.: 60240271
Photo No.: 9	Date: 12/7/11

Direction Photo Taken: Southeast				
Description: View of the shredder located on the southern portion of the scrap yard. A concrete pad is located in this area.

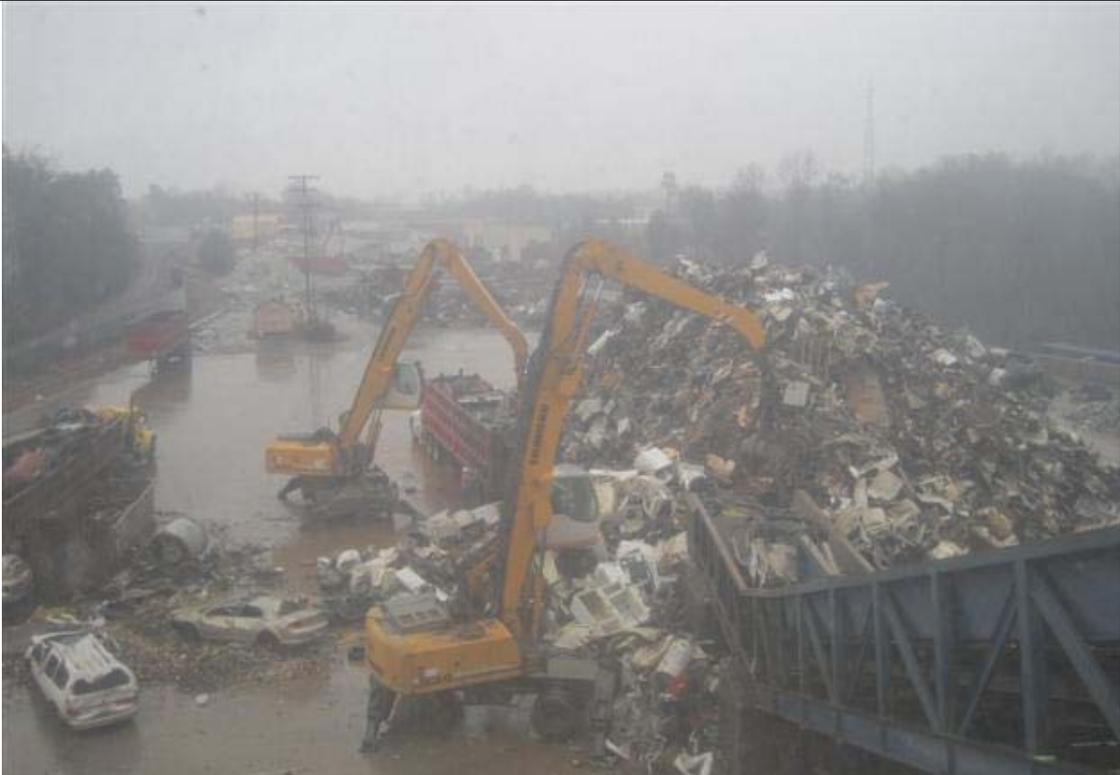
Photo No.: 10	Date: 12/7/11

Direction Photo Taken: North-Northwest		
Description: Overview of the scrap yard from the control tower located in the shredder's support building. The Norfolk Southern railroad (located off-site) is visible on the left side of the photo.

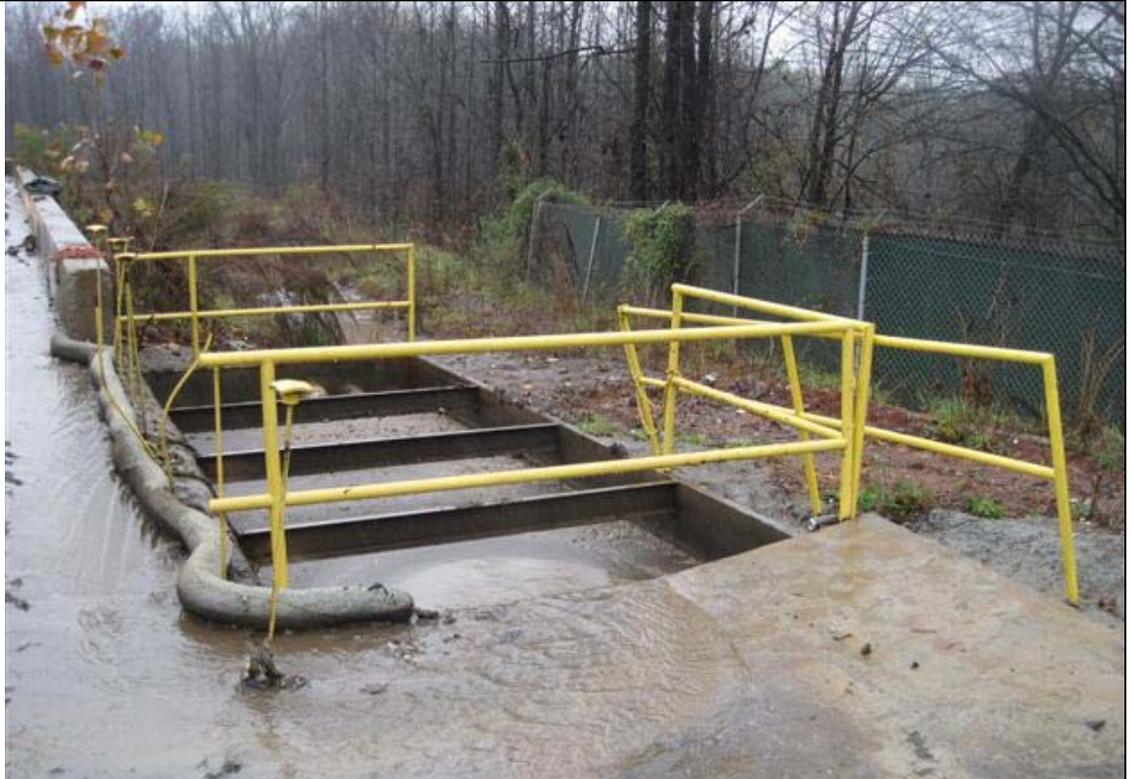
View of the oil/water separator located at the southwest end of the detention pond located adjacent to the shredder area.

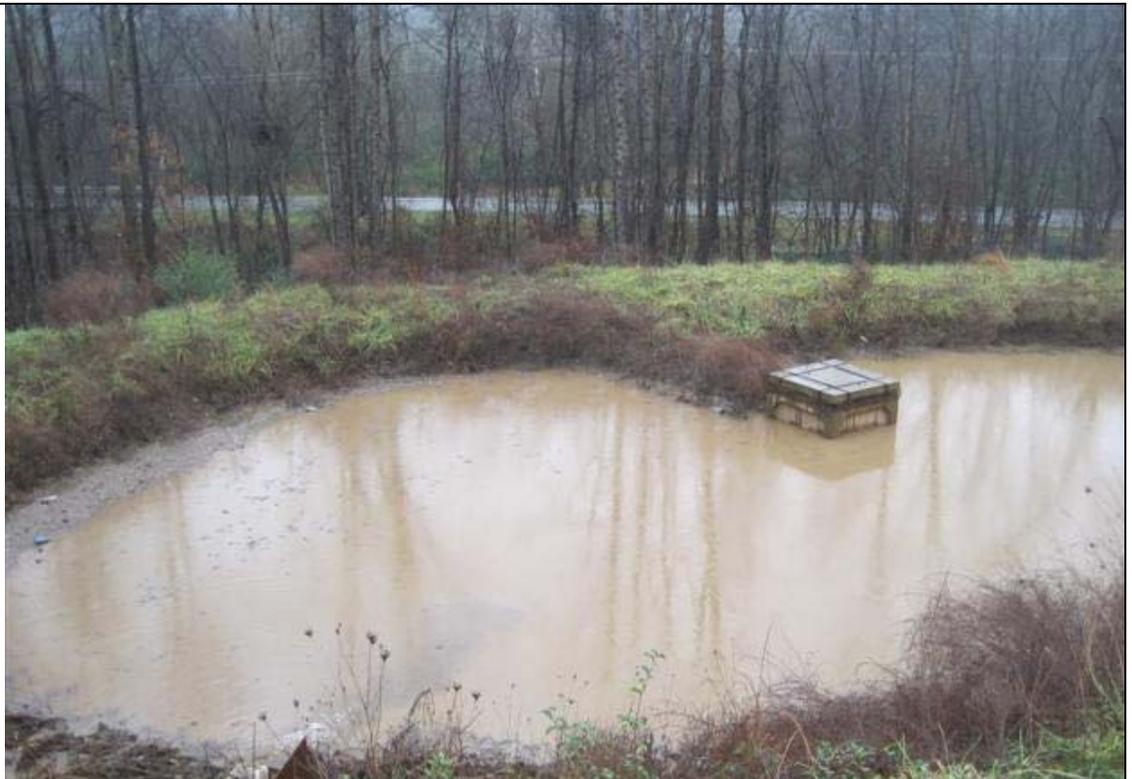
Photo No.
12

View of the northeast end of the detention pond located adjacent to the shredder area. Robinson Road is visible in the background.

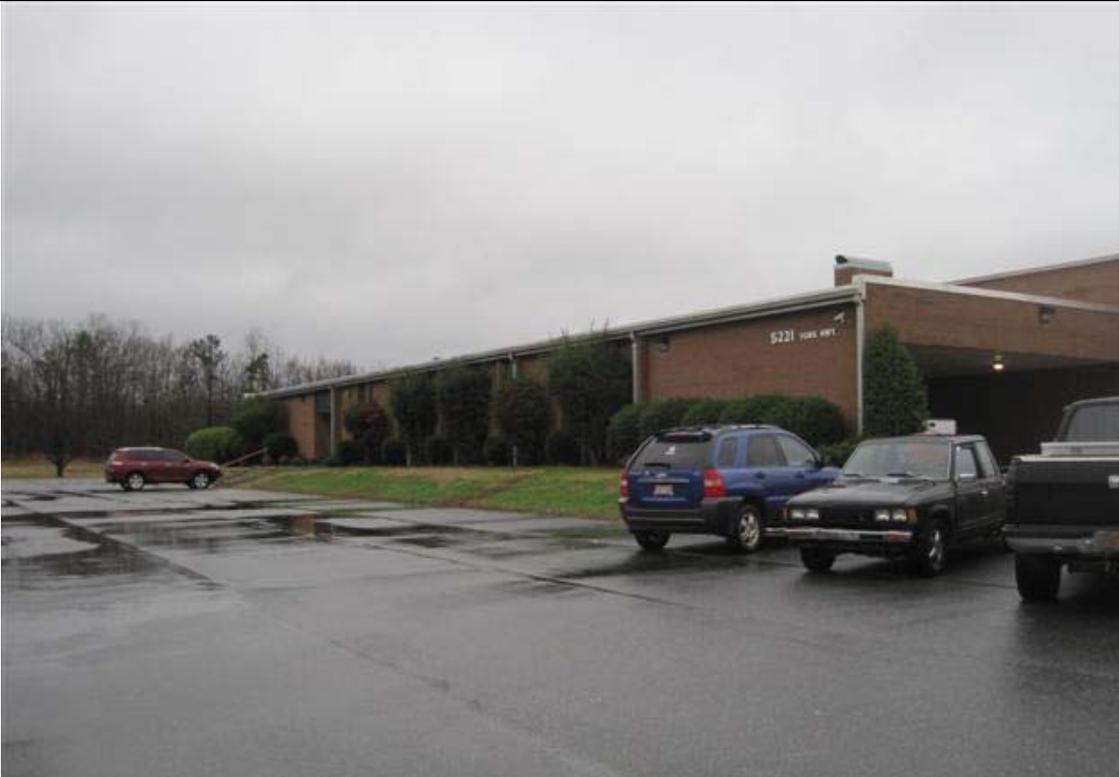
Client Name: The David J. Joseph Company		Site Location: 5401 and 5322 S. York Highway, 160 Wolfpack Road	Project No.: 60240271
Photo No.: 13	Date: 12/7/11

Direction Photo Taken: North			
Description: View along the southwest side (front side) of the office/dry storage warehouse located on Parcel B.

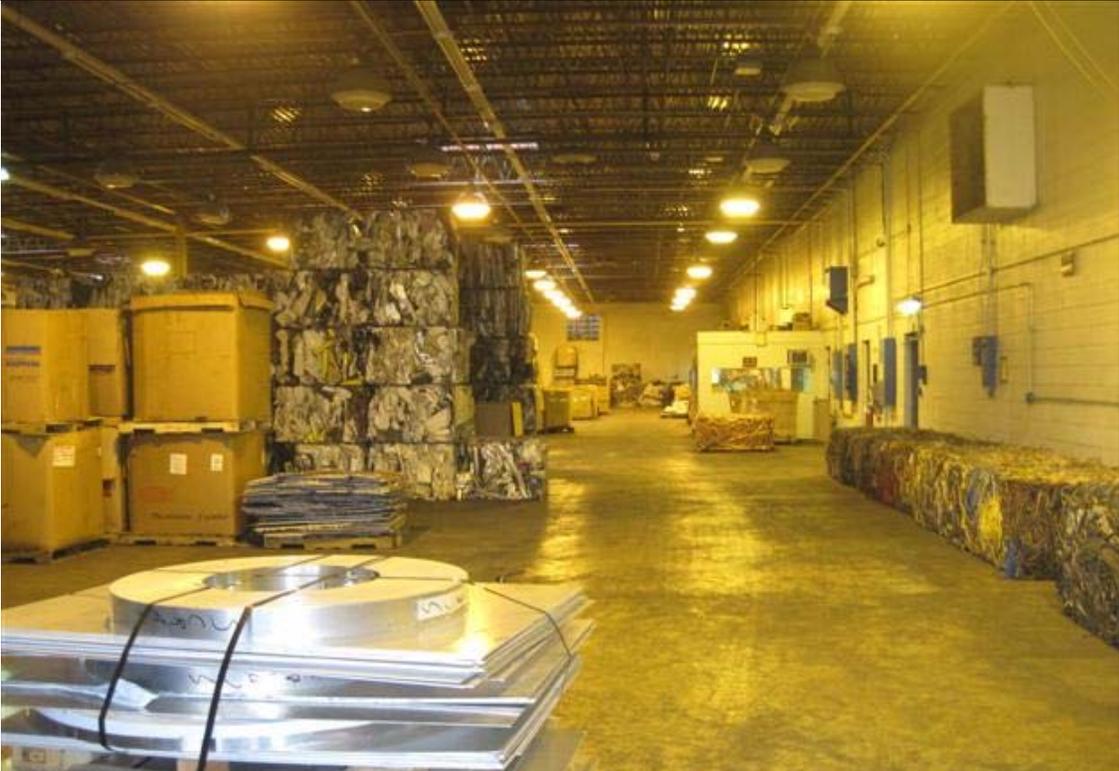
Photo No.: 14	Date: 12/7/11

Direction Photo Taken: N/A			
Description: Interior view of the dry storage warehouse on Parcel B.

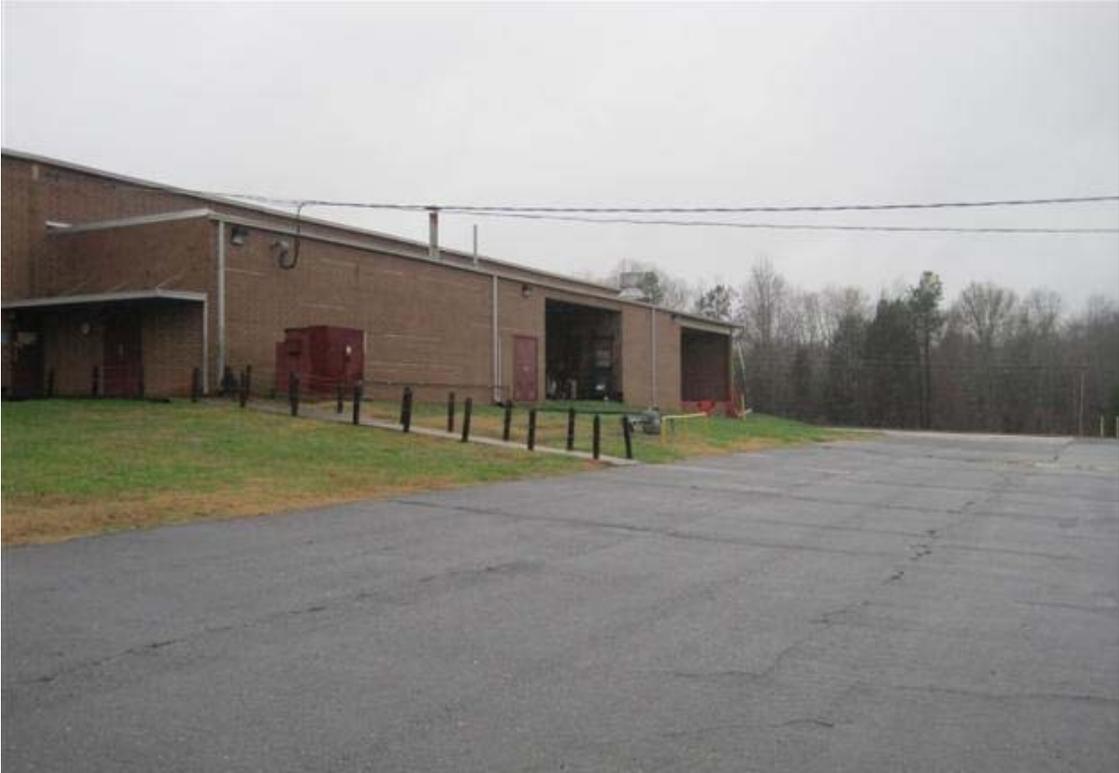
Client Name: The David J. Joseph Company		Site Location: 5401 and 5322 S. York Highway, 160 Wolfpack Road	Project No.: 60240271
Photo No.: 15	Date: 12/7/11

Direction Photo Taken: Northwest			
Description: View along the northeast side of the office/dry storage warehouse. The pad-mounted transformer, the alcove, and the loading docks are visible along the northeast side of the building. The former USTs were located in the grassy area adjacent to the building.

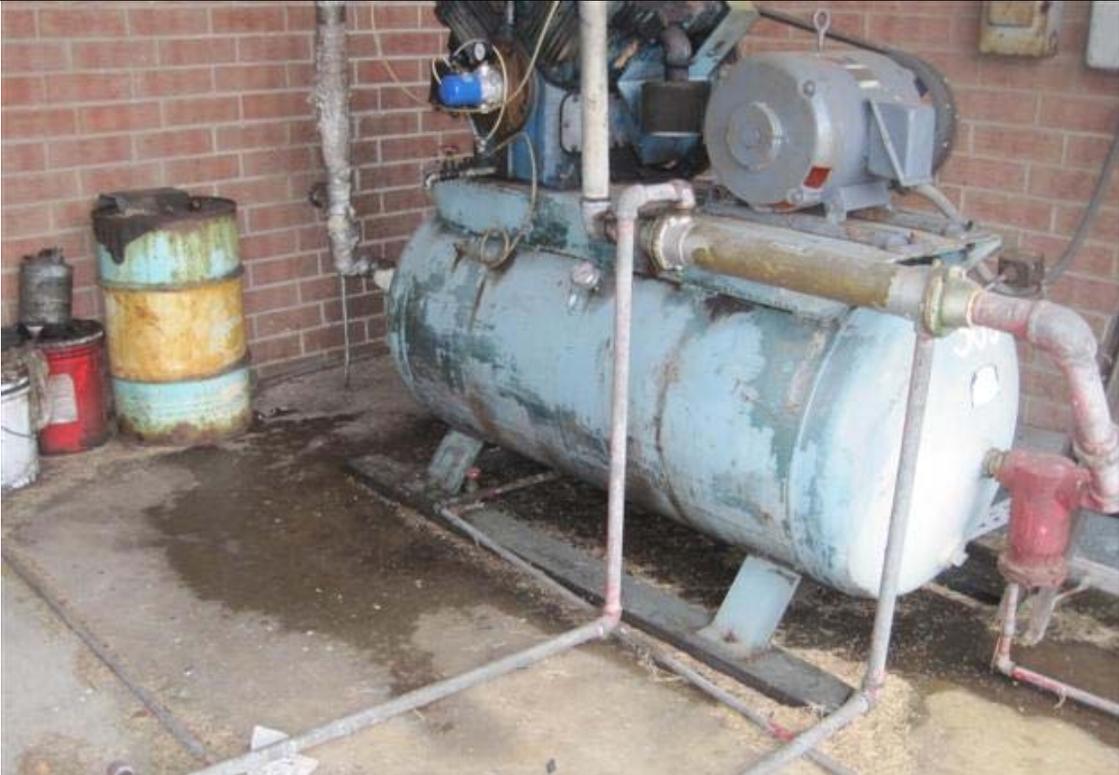
Photo No.: 16	Date: 12/7/11

Direction Photo Taken: N/A		
Description: View of the out-of-use compressor and 55-gallon drum and 5-gallon buckets containing an oily substance located in the alcove of the office/dry storage building. Note de minimis staining on the concrete in the vicinity of the oil storage and underneath the compressor.

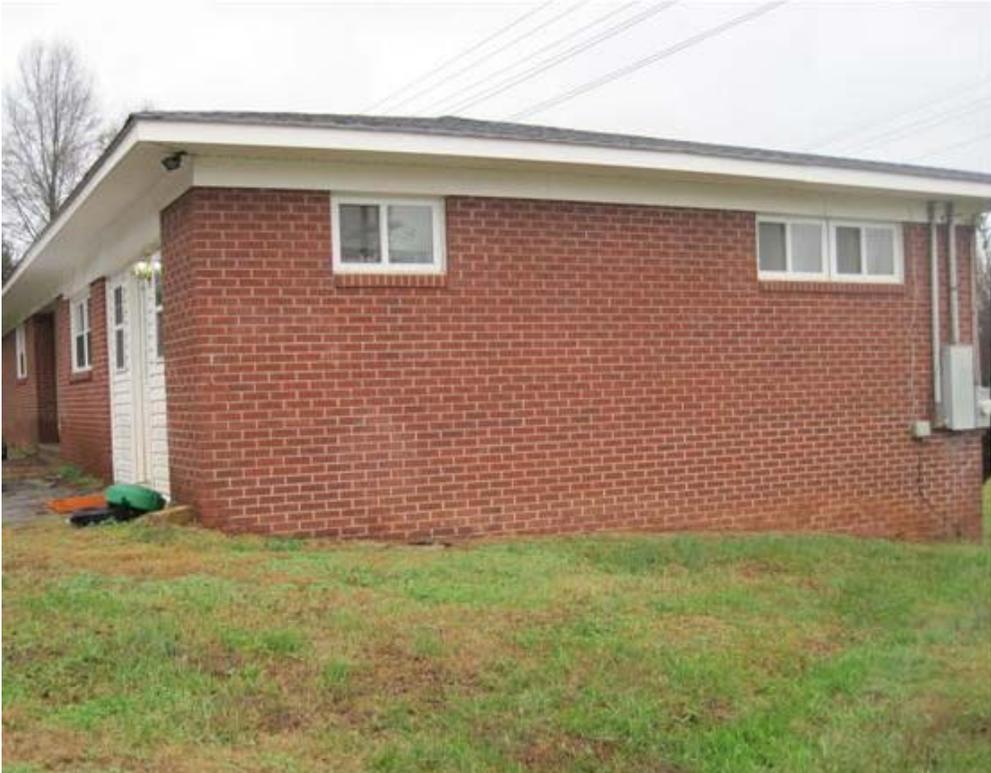
Client Name: The David J. Joseph Company		Site Location: 5401 and 5322 S. York Highway, 160 Wolfpack Road	Project No.: 60240271
Photo No.: 17	Date: 12/7/11

Direction Photo Taken: Northwest			
Description: View of the residence located along the northeastern boundary of Parcel C. Although this residence was occupied at the time of the inspection, the tenant was not available, and AECOM was unable to access the interior.

- As previously mentioned, AECOM was unable to access the interior of the residence during the site reconnaissance. It is likely that the residence contains small quantities of typical household hazardous materials such as cleaners, petroleum products, etc. These materials are likely stored in typical household-sized containers (less than 5 gallons). Reportedly, the residence utilizes a septic system for the discharge of domestic wastewater. A residential

septic system represents a preferential pathway directly to the subsurface of the property, and due to the presence of minor amounts of oils and hazardous materials on-site, the septic system represents a de minimis condition.

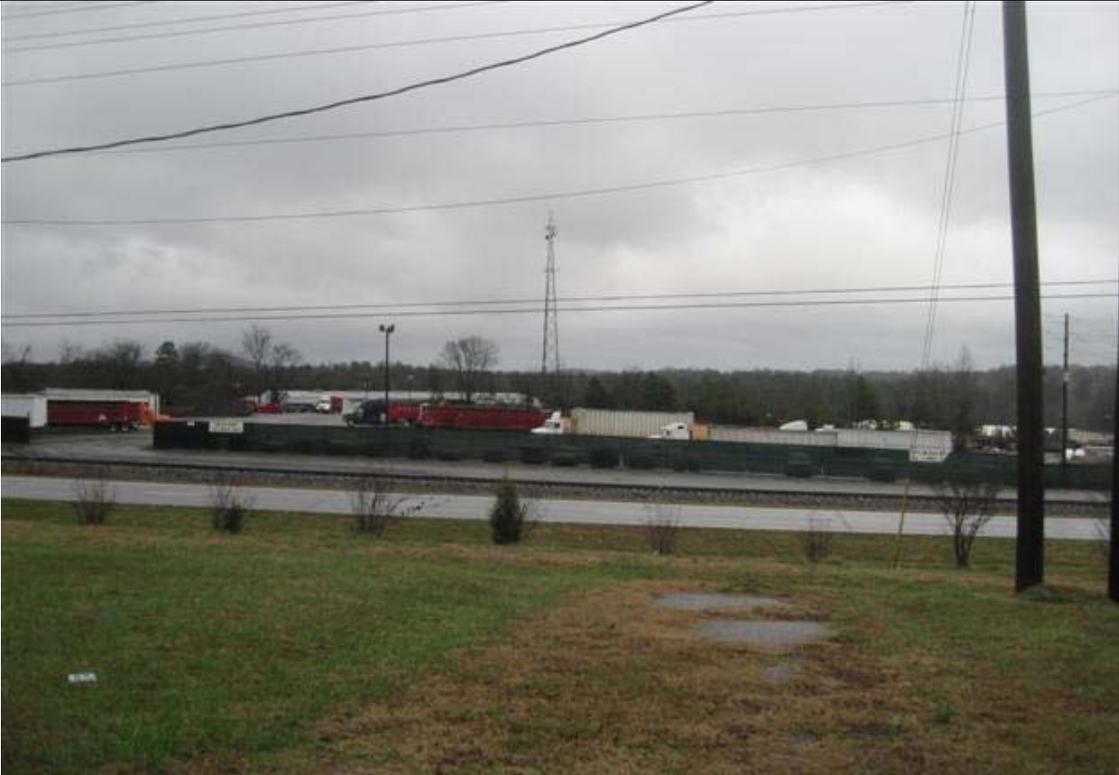
Photo No.: 18	Date: 12/7/11

Direction Photo Taken: East		
Description: View looking east to the metal recycling facility on Parcel A. York Highway is visible in the foreground, beyond which is the Norfolk Southern railroad. Farther to the east is the gravel parking lot used for trailer truck parking (located on the northwestern portion of Parcel A).

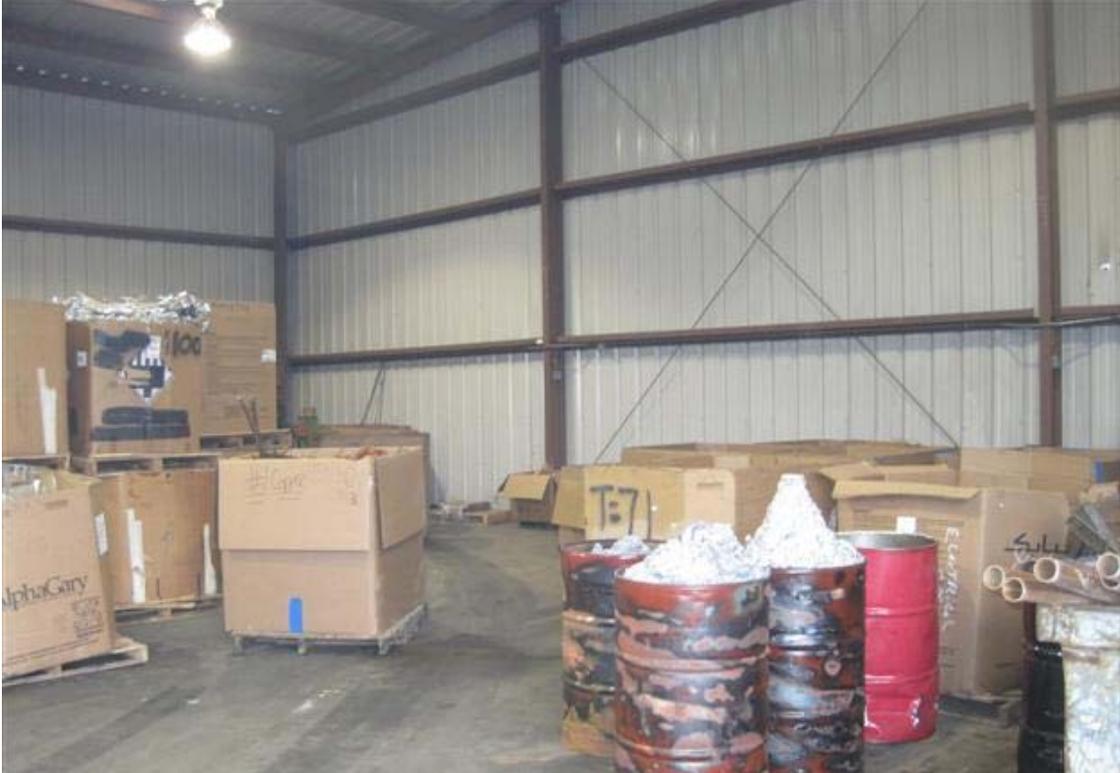
Client Name: The David J. Joseph Company		Site Location: 5401 and 5322 S. York Highway, 160 Wolfpack Road	Project No.: 60240271
Photo No.: 19	Date: 12/7/11

Direction Photo Taken: N/A			
Description: Interior view of the warehouse located in the turnings storage area on Parcel A. Cardboard boxes and 55-gallon drums containing non-ferrous metal, stainless steel solids and turnings, and minimal universal wastes (batteries, capacitors, mercury switches) are stored in the warehouse.

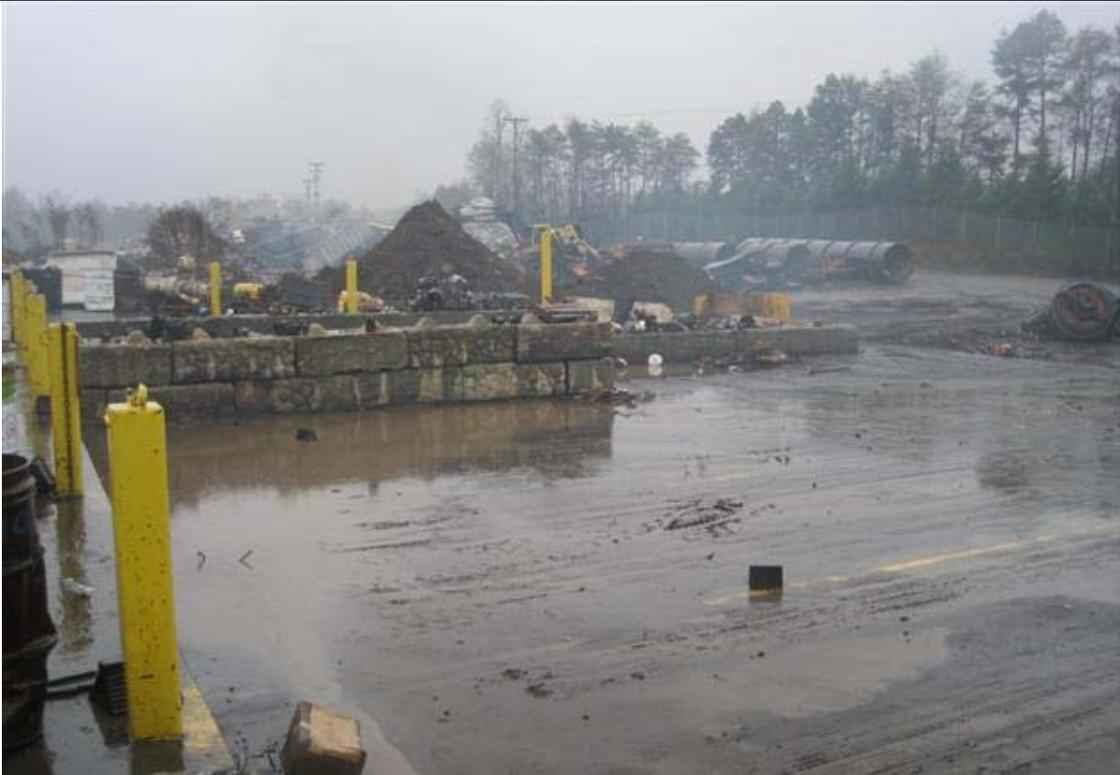
Photo No.: 20	Date: 12/7/11

Direction Photo Taken: South		
Description: View from the warehouse loading dock in the turnings storage area on Parcel A. The torching area is visible in the background.

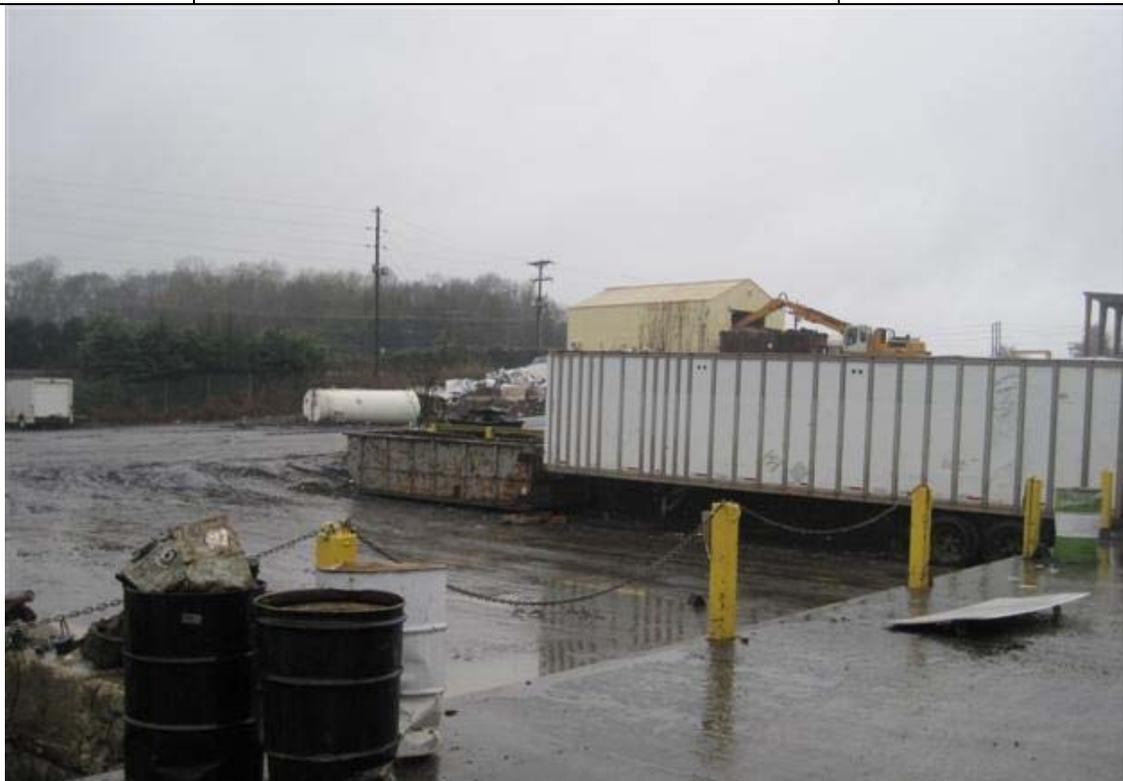
View from the warehouse loading dock in the turnings storage area on Parcel A. The 3,000-gallon diesel fuel AST and the maintenance building are visible in the background.

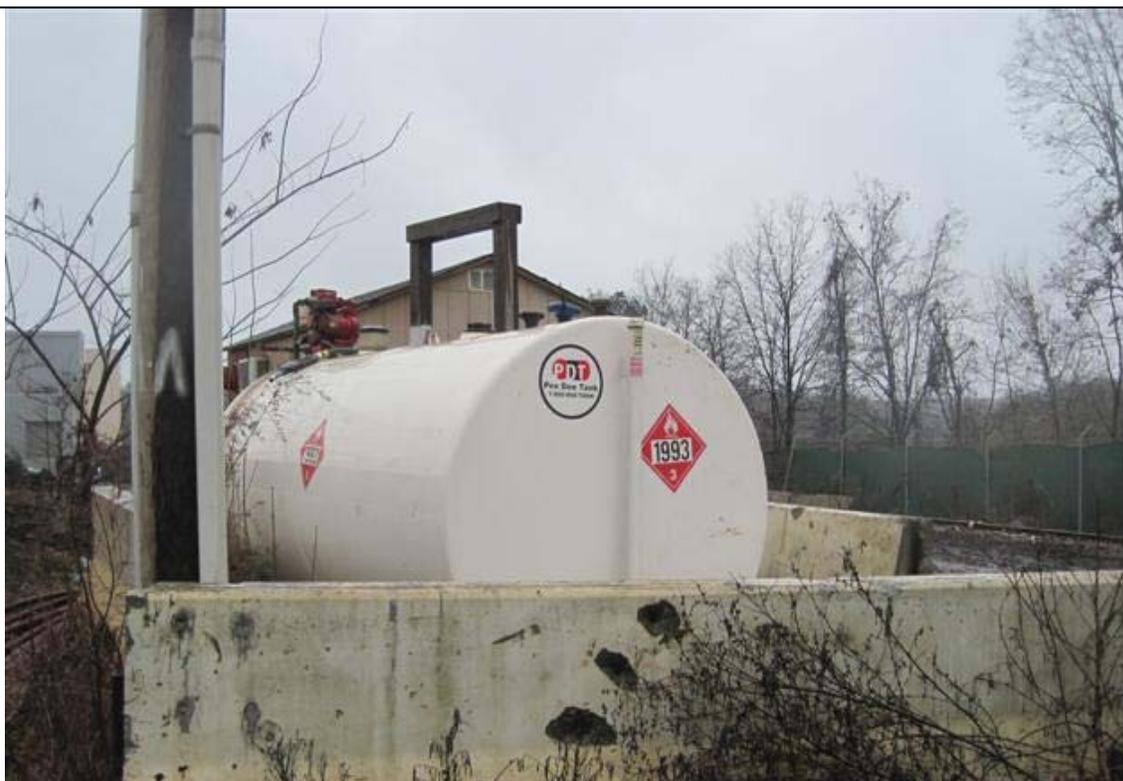
Photo No.: 22	Date: 12/7/11
--------------------------------	-------------------------

View of the 1,200-gallon diesel fuel AST located adjacent to the west of the shear equipment.
