## Trip Report

PROJECT:		<b>FORMER SKF-USA, INC. SITE ASHVILLE, NORTH CAROLIA WORK PLANNING PERMIT</b>	
SHEET TITLE:		<b>GASHES CREEK TRANSECT LOCATIONS</b>	
DRAWN BY:	DMC	SCALE:	PROJ. NO. 70144.53
CHECKED BY:	MBP	DATE PRINTED:	FILE NO.
APPROVED BY:	MBP	<b>FIGURE 1</b>	
DATE:	JANUARY 2010

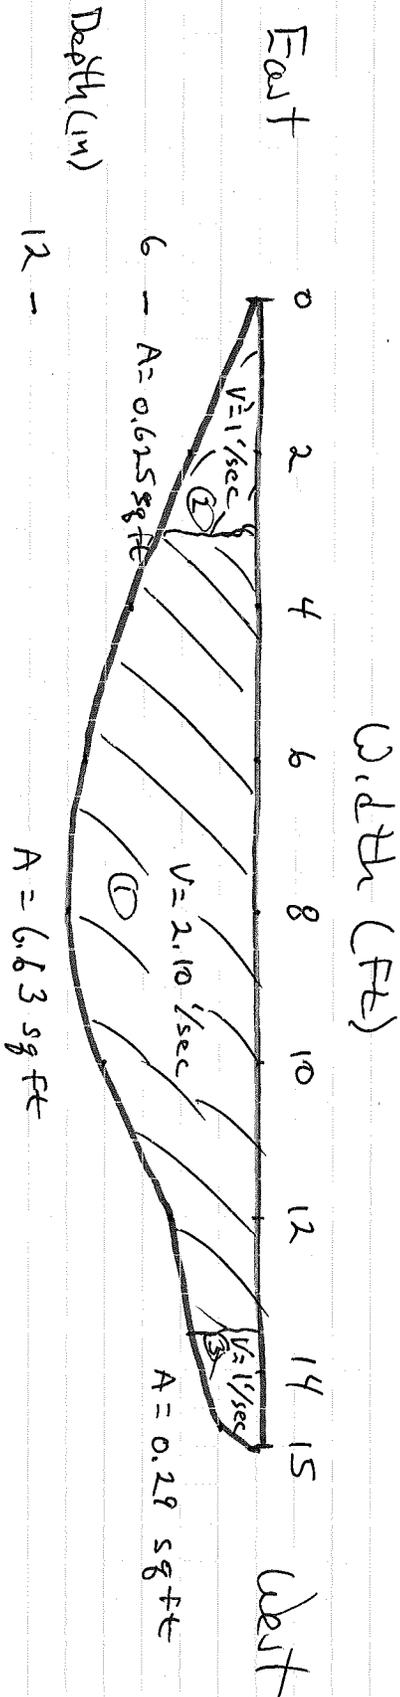
PROJECT/PROPOSAL NAME/LOCATION:		PROJECT/PROPOSAL NO.
SUBJECT: <u>Gashes Creek - Transect 1</u>		
PREPARED BY: <u>M. Parker</u>	DATE: <u>1/20/10</u>	FINAL <input type="checkbox"/>
CHECKED BY:	DATE:	REVISION <input type="checkbox"/>

Transect - Between RD-4 and MW-24

Flow ① =  $V \times A = 6244$  gpm  
 Flow ② =  $V \times A = 280$  gpm  
 Flow ③ =  $V \times A = 131$  gpm

Total Flow @ this transect  $\approx$  6655 gpm  
 or 14.8 cfs

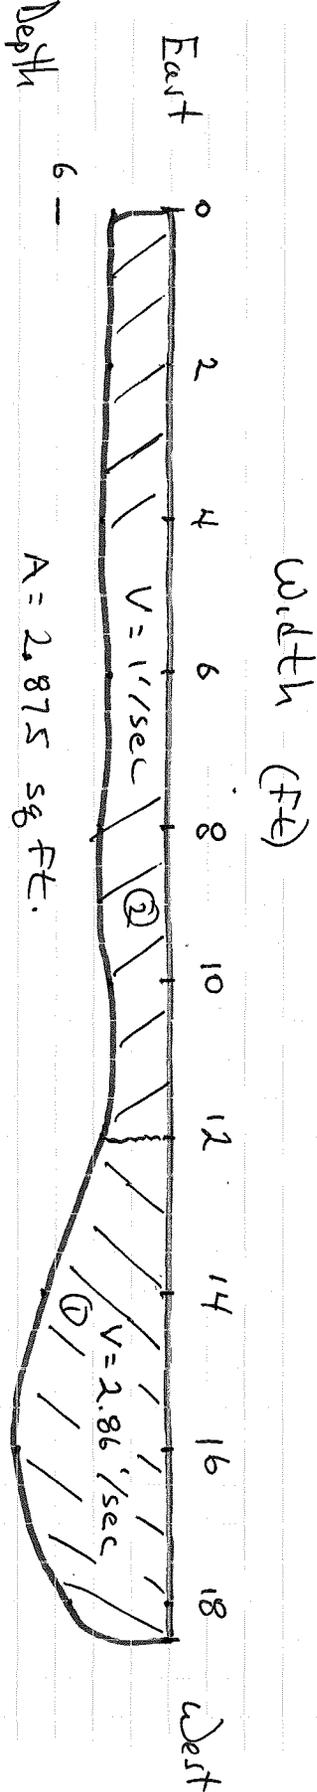
PROJECT/PROPOSAL NAME/LOCATION: SUBJECT: <u>Gashes Creek - Transect 3</u>		PROJECT/PROPOSAL NO.
PREPARED BY: <u>M. Parker</u>	DATE: <u>1/20/10</u>	FINAL <input type="checkbox"/>
CHECKED BY:	DATE:	REVISION <input type="checkbox"/>

Gashes Creek - SK F Givnes Site  
 Asheville, NC  
 Transect - near RW-3

Flow <sup>①</sup> =  $V \times A = 4386 \text{ gpm}$   
 Flow <sup>②</sup> =  $V \times A = 1290 \text{ gpm}$

Total Flow @ this Transect  $\approx 5676 \text{ gpm}$   
 or  $\approx 12.65 \text{ cfs}$

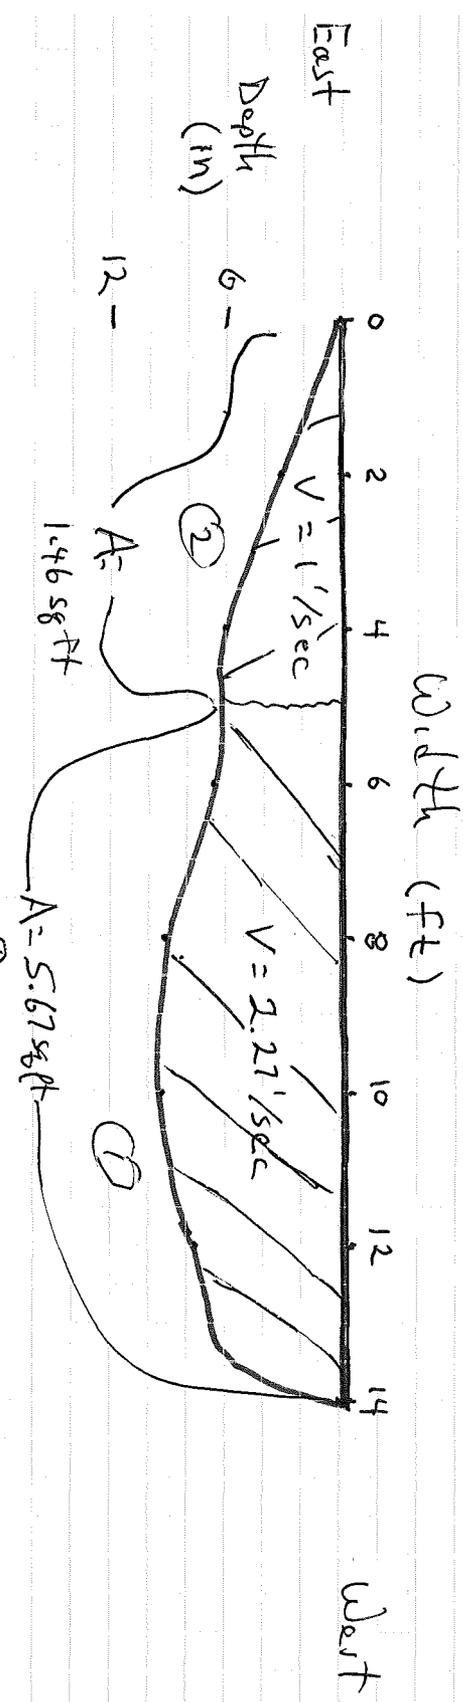
PROJECT/PROPOSAL NAME/LOCATION:		PROJECT/PROPOSAL NO.	
SUBJECT: Gashes Creek - Transect 2			
PREPARED BY: M. Parker	DATE: 1/20/10	FINAL	<input type="checkbox"/>
CHECKED BY:	DATE:	REVISION	<input type="checkbox"/>

Gashes Creek - SK F Gwynes Site  
 Asheville, NC  
 Transect Near RW-1

Flow 1 =  $V \times A = 5776 \text{ gpm}$   
 Flow 2 =  $V \times A = 655 \text{ gpm}$

Total @ this Transect  $\approx 6430 \text{ gpm}$   
 or  $14.3 \text{ cfs}$

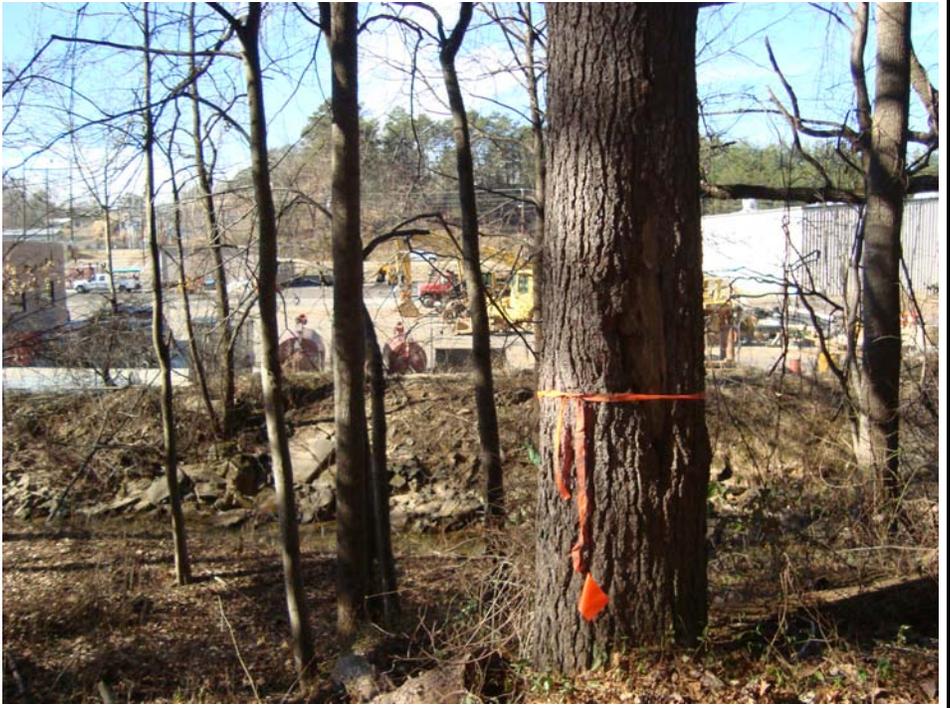
<b>Client Name:</b> SKF		<b>Site Location:</b> SKF Gashes Creek	<b>Project No.:</b> 70144.53
<b>Photo No.</b> 1	<b>Date</b> January 14, 2010

<b>Description</b> Transect 1 located between RW 4 and MW 24. Tree marked with tape and flag.

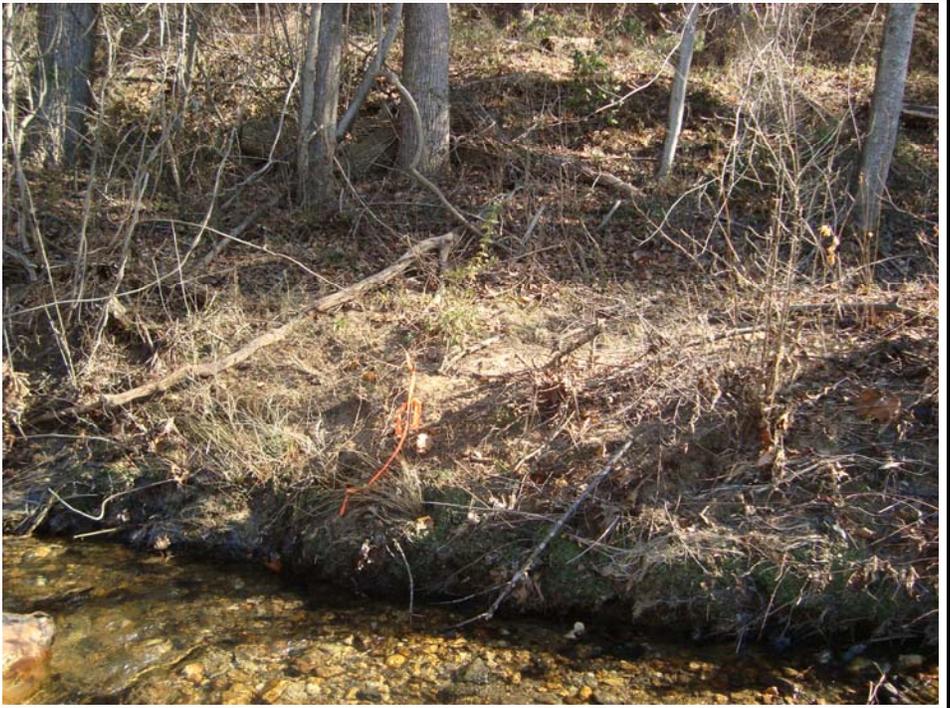
<b>Photo No.</b> 2	<b>Date</b> January 14, 2010

<b>Description</b> Transect 1 located between RW 4 and MW 24. Iron pin in bank marked with tape.

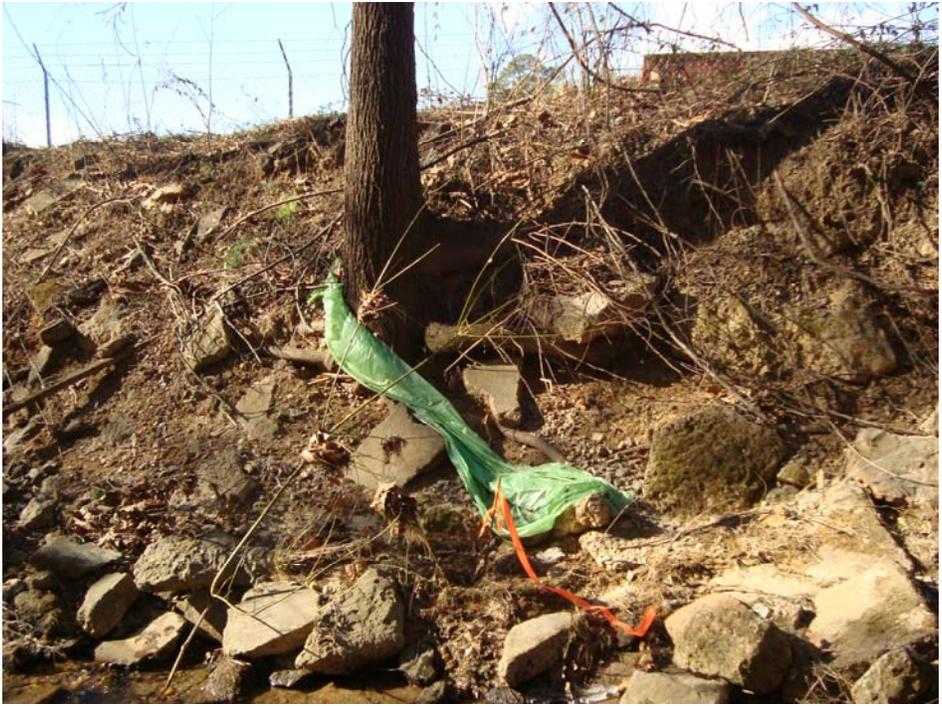
<b>Client Name:</b> SKF		<b>Site Location:</b> SKF Gashes Creek	<b>Project No.:</b> 70144.53
<b>Photo No.</b> 3	<b>Date</b> January 14, 2010

<b>Description</b> Transect 1 located between RW 4 and MW 24. Iron pin in bank marked with tape.

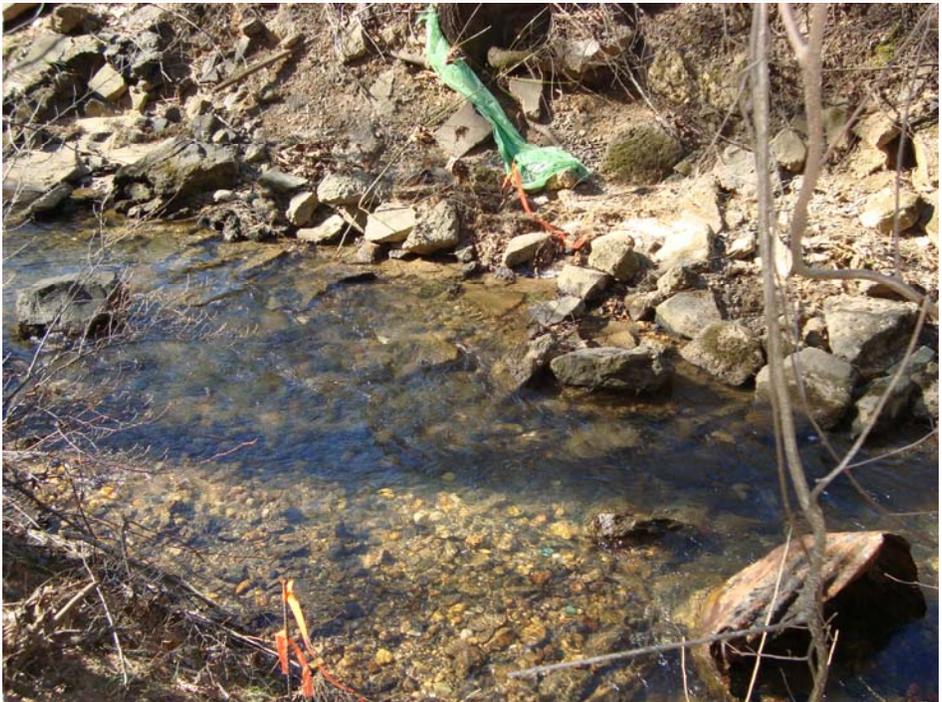
<b>Photo No.</b> 4	<b>Date</b> January 14, 2010

<b>Description</b> Transect 1 located between RW 4 and MW 24. Iron pin in bank marked with tape.

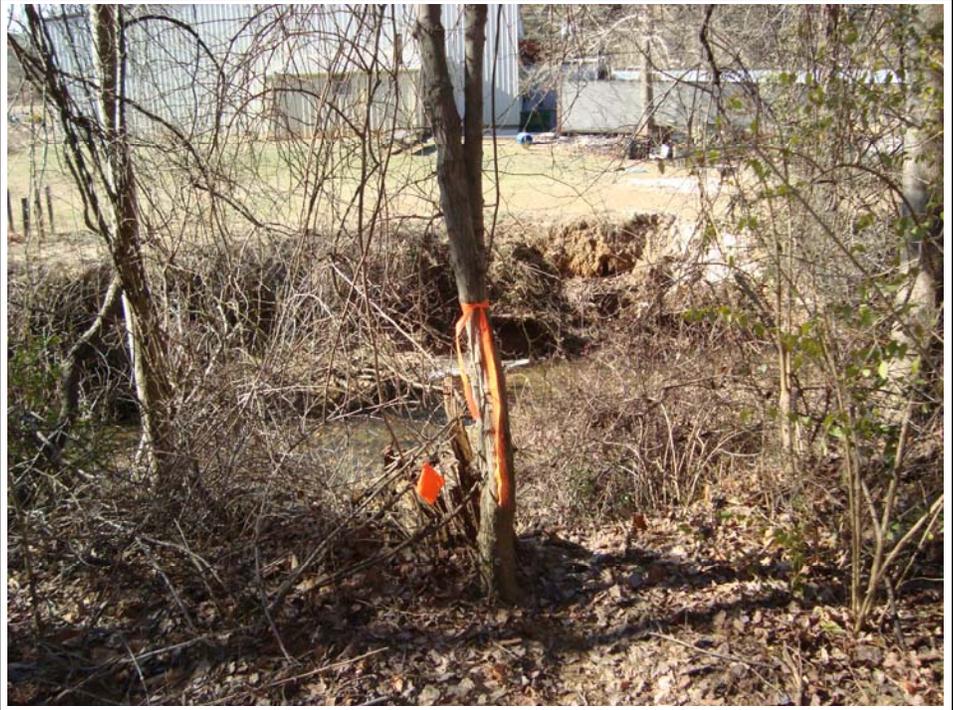
<b>Photo No.</b> 5	<b>Date</b> January 14, 2010
-----------------------	---------------------------------

**Description**  
Transect 2 located near RW 1.  
Tree marked with tape and flag.

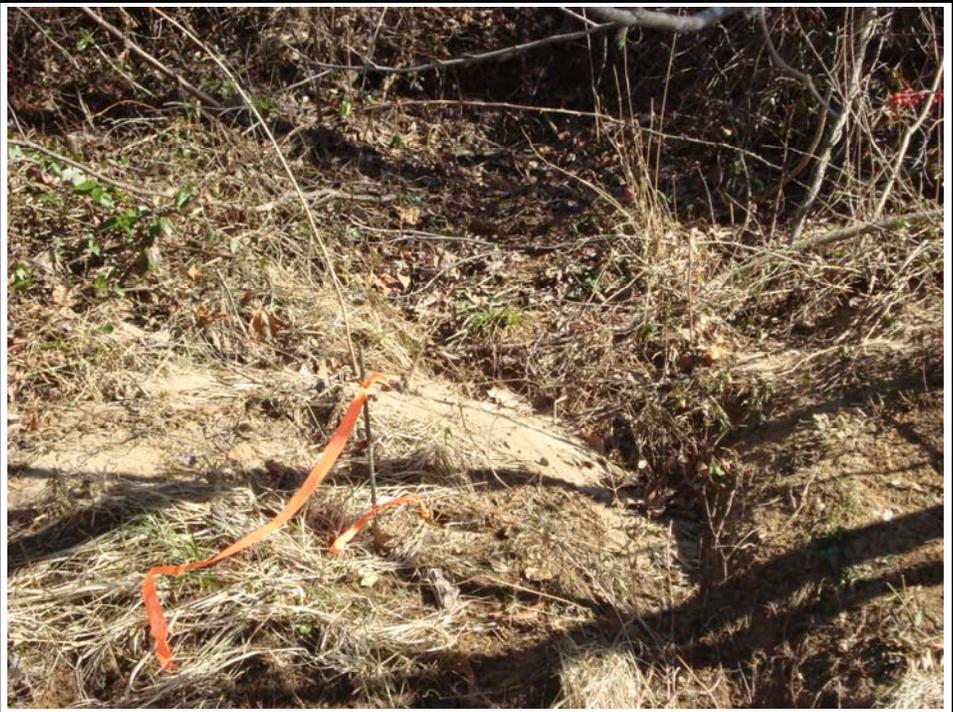
<b>Photo No.</b> 6	<b>Date</b> January 14, 2010
-----------------------	---------------------------------

**Description**  
Transect 2 located near RW 1.  
Iron pin marked with tape.

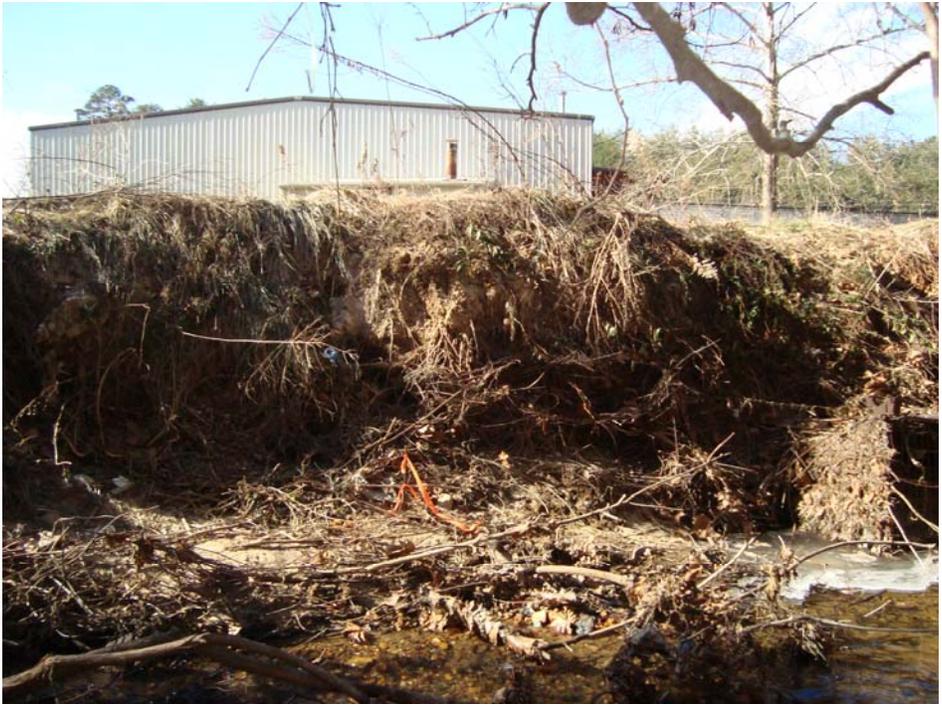
<b>Client Name:</b> SKF		<b>Site Location:</b> SKF Gashes Creek	<b>Project No.:</b> 70144.53
<b>Photo No.</b> 7	<b>Date</b> January 14, 2010

<b>Description</b> Transect 2 located near RW 1. Iron pin marked with tape.

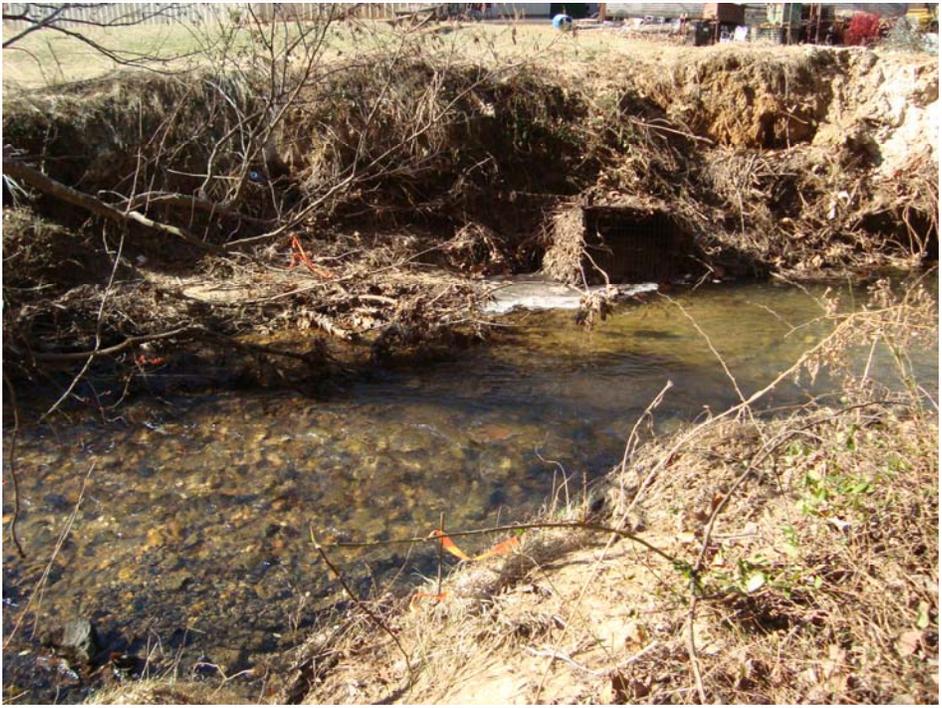
<b>Photo No.</b> 8	<b>Date</b> January 14, 2010

<b>Description</b> Transect 2 located near RW 1. Iron pin marked with tape.

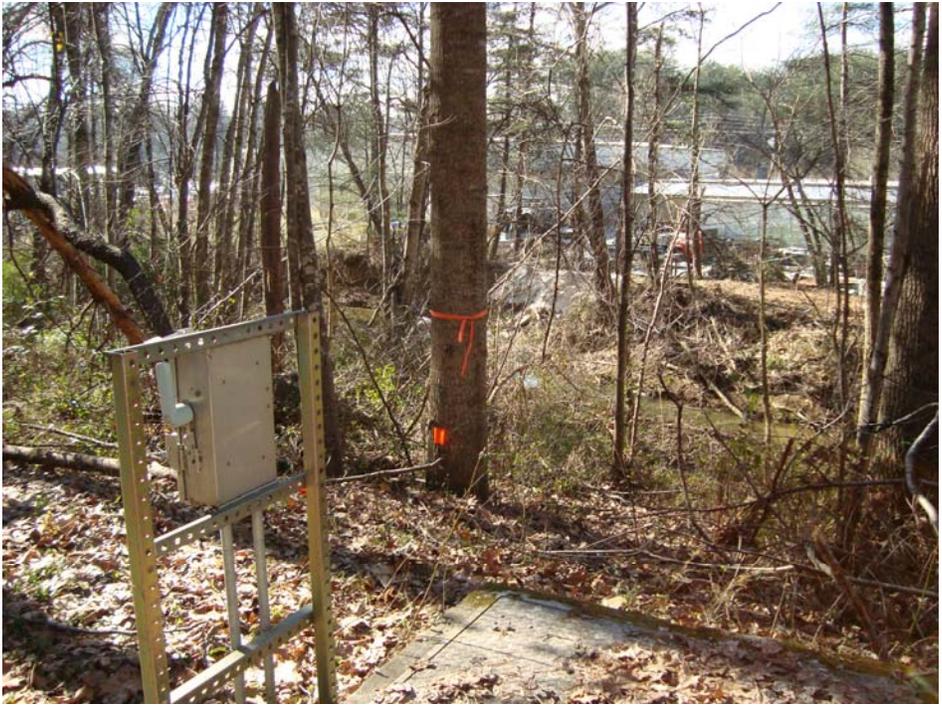
<b>Photo No.</b> 9	<b>Date</b> January 14, 2010

<b>Description</b> Transect 3 located near RW 3. Tree marked with tape and flag.

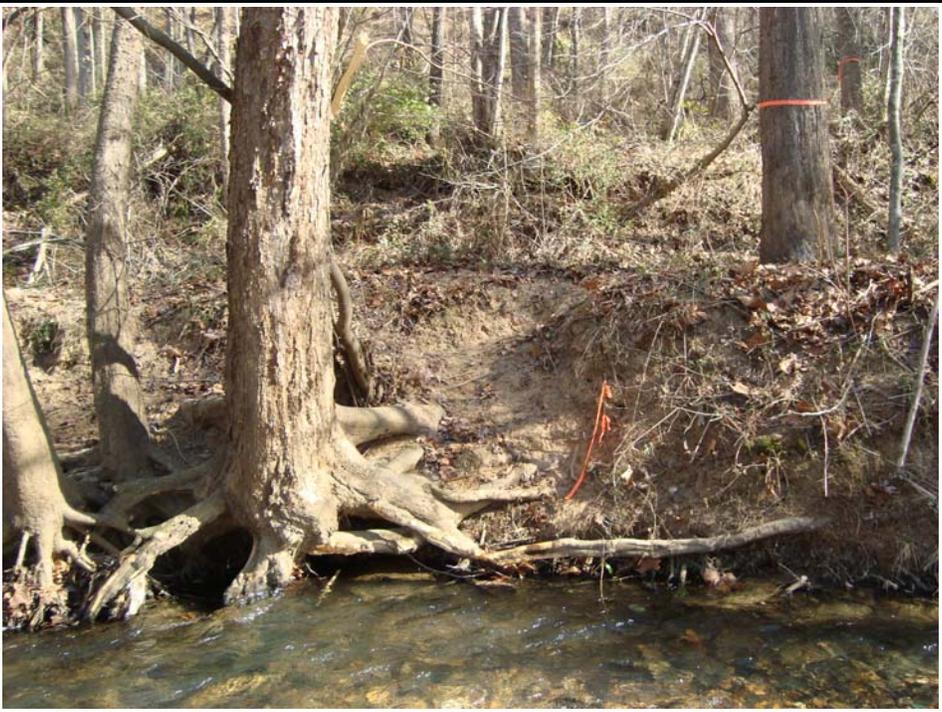
<b>Photo No.</b> 10	<b>Date</b> January 14, 2010

<b>Description</b> Transect 3 located near RW 3. Tree marked with tape and flag. Iron Pin in bank marked with tape.

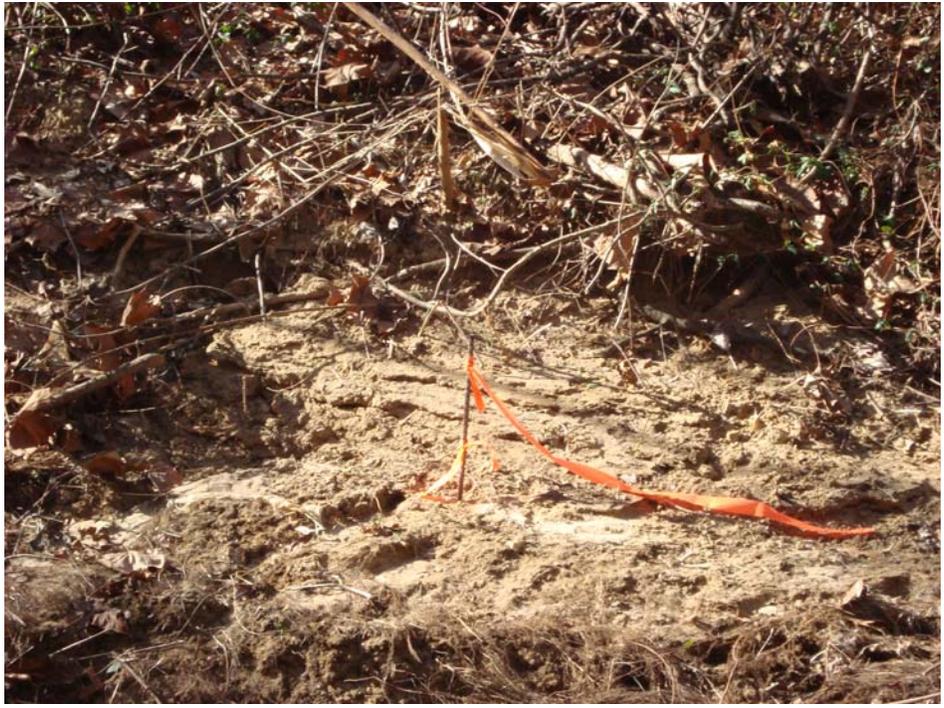
<b>Client Name:</b> SKF		<b>Site Location:</b> SKF Gashes Creek	<b>Project No.:</b> 70144.53
<b>Photo No.</b> 11	<b>Date</b> January 14, 2010

<b>Description</b> Transect 3 located near RW 3. Pin in bank marked with tape.

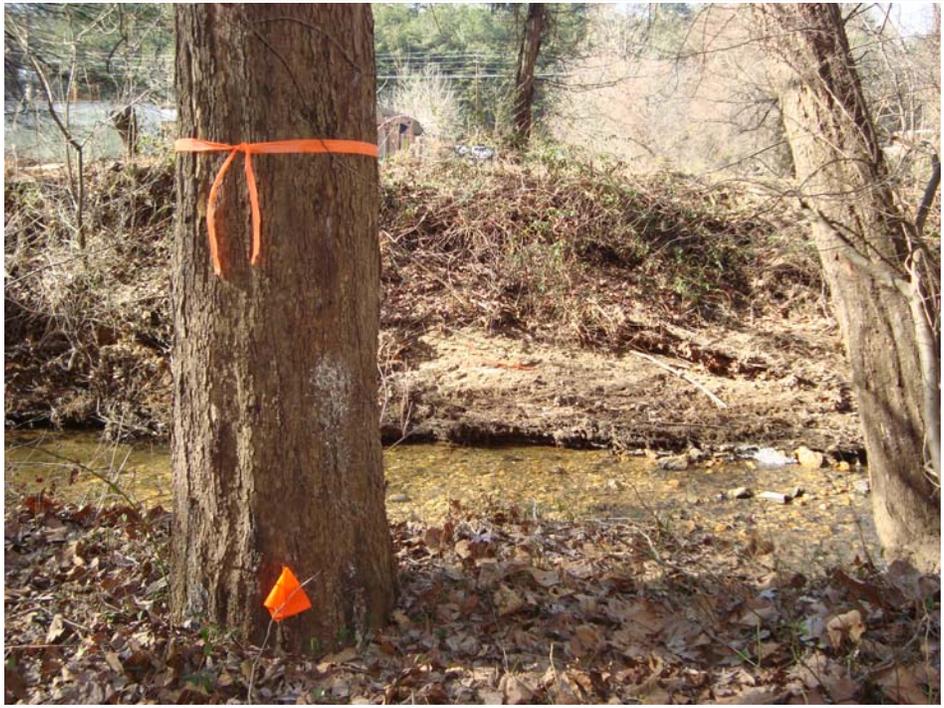
<b>Photo No.</b> 12	<b>Date</b> January 14, 2010

<b>Description</b> Transect 3 located near RW 3. Tree near creek marked with tape and flag.
