Report of Phase I
Environmental Site Assessment
Florian Midrise
Raleigh, North Carolina
prepared for
The Florian Companies

July 29, 2013

**Report of Phase I
Environmental Site Assessment
Florian Midrise
Raleigh, North Carolina
Our Project Number 121-13-71911**

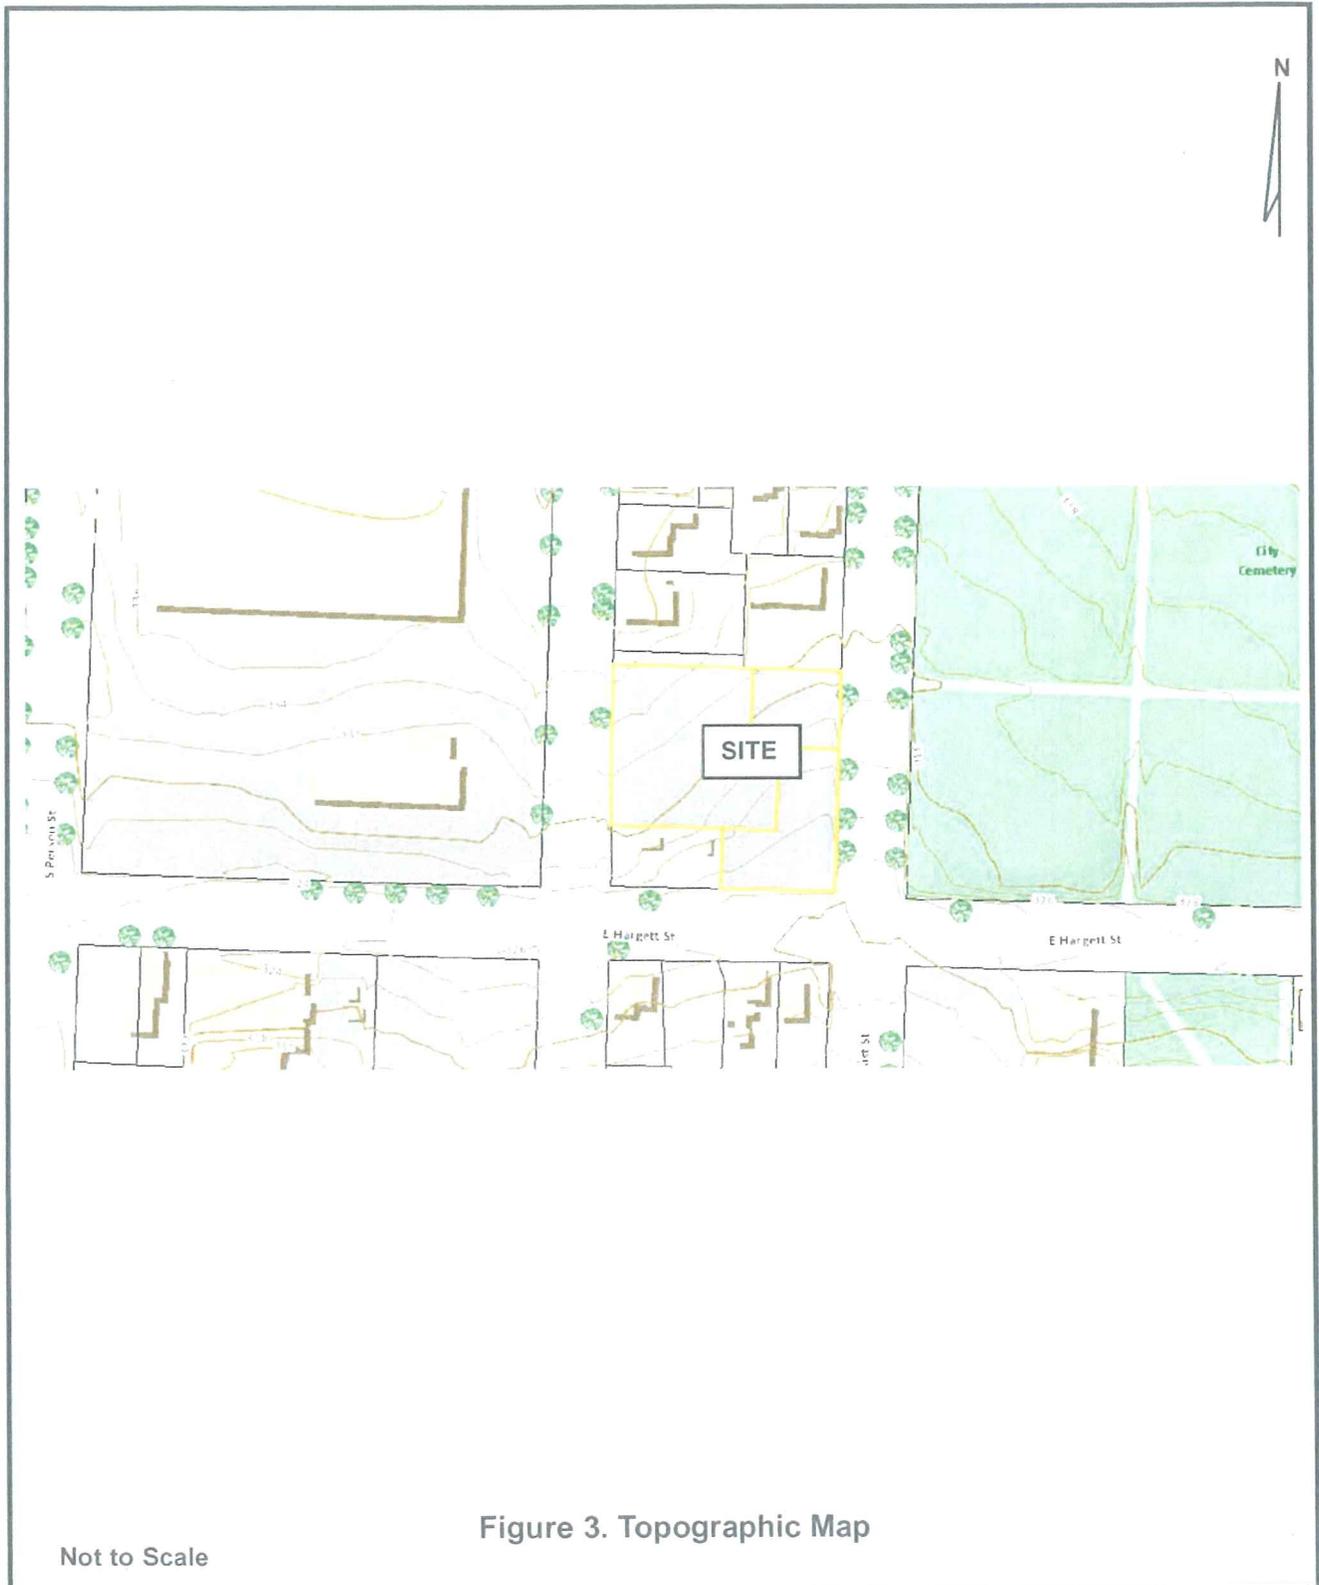
Figure 3. Topographic Map

Based on our review of the listings, and review of topographic map of the area surrounding the subject site, three of the listed properties are located within the surface water drainage area of the subject property. These three sites include two underground storage tank (UST) sites and one RCRA small quantity hazardous waste generator site. There were no reported leaks or spills of hazardous materials or petroleum products at these three sites. Additionally, the US Postal Service, which owns the subject site, has a listing for a leaking underground fuel storage tank. Based on our review of available records, this petroleum incident occurred on the adjoining property to the west across Bloodworth Street. This property appears to be located cross-gradient from the subject site, and not within the surface water drainage area of the subject site.

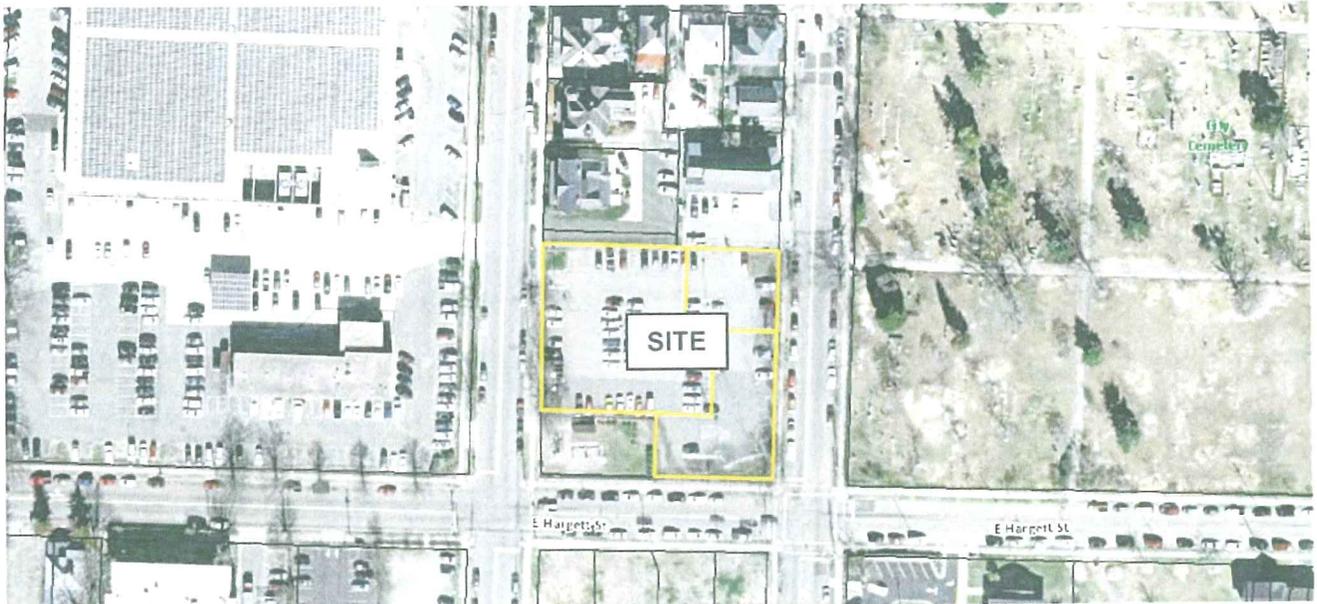
Figure 4. 2012 Aerial Photograph

The subject site consists of three parcels (Wake County PIN#s 1703888477, 1703889581, and 1703889388) located just to the northeast of the intersection of East Hargett Street and South Bloodworth Street in Raleigh, North Carolina. The property location is shown on the enclosed Figure 1 in Appendix I. The property boundaries, as obtained from the Wake County GIS web site, are shown on Figure 2 in Appendix I. The topography of the site and surrounding areas, as noted on the Wake County GIS website, is provided on Figure 3 in Appendix I. An Aerial photograph of the site, obtained from the Wake County GIS website, is enclosed as Figure 4 in Appendix I.

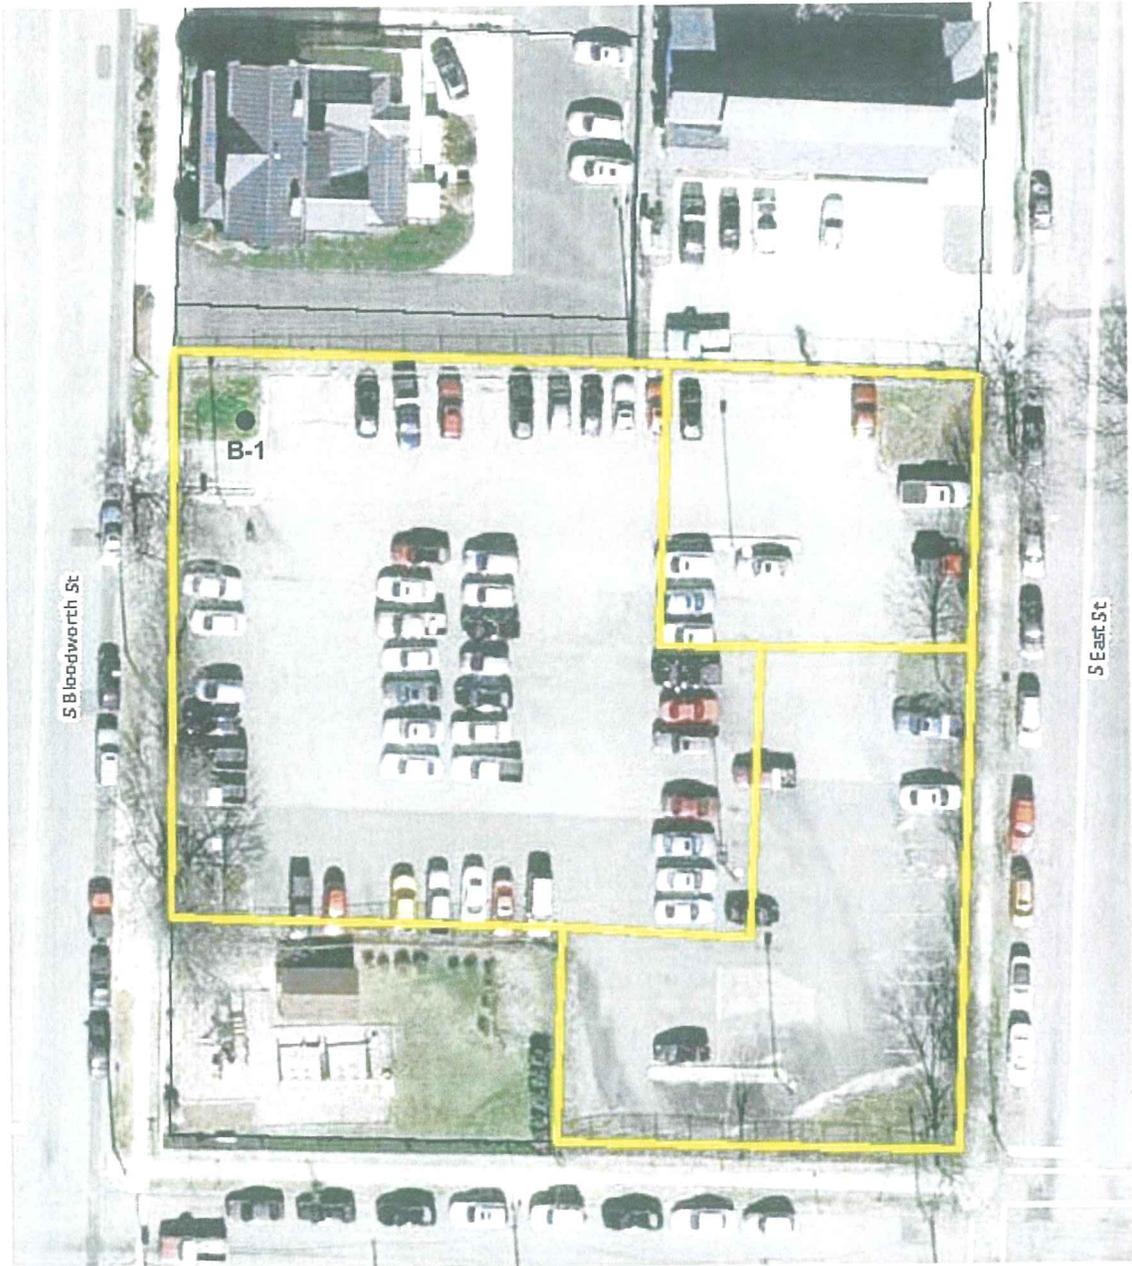
Figure 1. Soil Sample Location

- (1) There are numerous incidents of petroleum spills within close proximity to the subject site. Additionally, the former use of the subject property for residential purposes during the middle of the 20th century indicates that above ground or underground fuel storage tanks have likely been present for fuel oil on the property. There are numerous stains on the pavement surface at the property consistent in appearance with small leaks or petroleum products from vehicles. Due to these potential sources of petroleum, soil samples were obtained and tested for the presence of petroleum hydrocarbons. The soil samples tested exhibited elevated levels of petroleum

hydrocarbons consistent with a release of petroleum products to the environment at the subject site. Further investigation is recommended to determine the horizontal and vertical extent of petroleum contaminated soils at the site. An evaluation of the possible presence of petroleum products in the ground water at the site is also recommended.

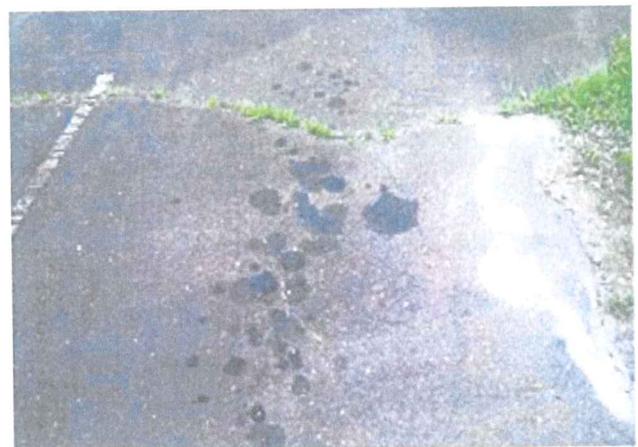
Photo 6 – Asphalt Stains

Appendix IV. There are overhead electrical lines along South Bloodworth Street and East Hargett Street. No pole-mounted electrical transformers were observed on the subject property. Numerous stains on the asphalt, as shown in Photo 6 in Appendix IV, were visible throughout the parking lot. Other than the stained asphalt, none of the other "environmental conditions" described above were observed at the site.
