DocumentType Site Assessment Rpt (SAR)

**ON-SITE ASSESSMENT REPORT  
Hamilton Beach◇Proctor-Silex, Inc.  
Washington, North Carolina**

**Groundwater Incident No. 14338**

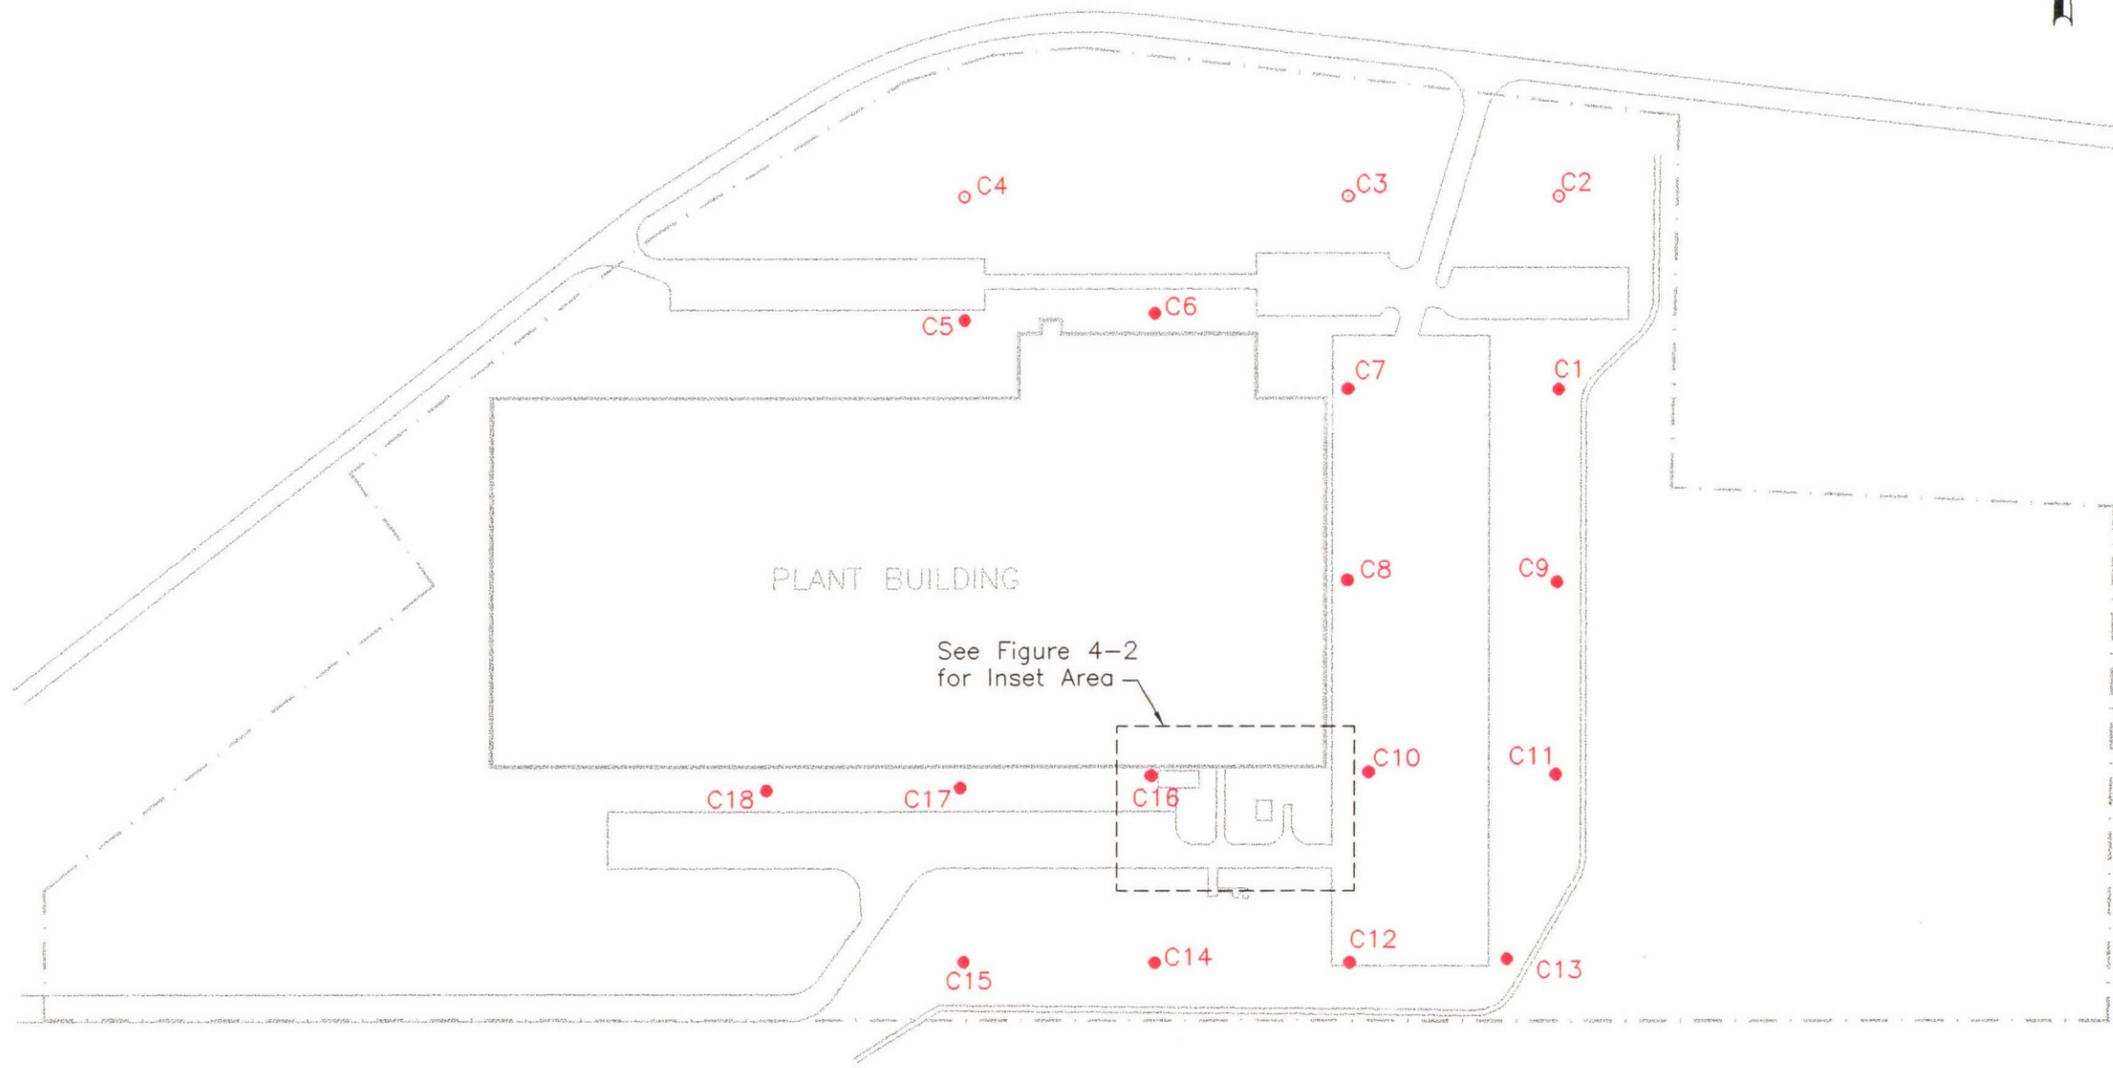
SCALE	AS SHOWN	DESIGNED BY	JN	DATE	27MAY98	DRAWING TITLE	Figure 4-1. Profiling and Soil Sampling Locations Hamilton Beach & Proctor Silex, Inc
		DRAWN BY	TSH	DATE	28MAY98		
		CHECKED BY	BPG	DATE	19JUN98	CONTRACT NO.	650138.0501
		APPROVED BY		DATE		DRAWING NO.	C-CPT
						REV.	0

Soil and geologic conditions were initially assessed by using CPT/FFD to profile the soil stratigraphy and to screen for Total Petroleum Hydrocarbon (TPH) distribution in the soil. The CPT was used to develop detailed geologic logs for interpreting the stratigraphy of the underlying deposits and for identifying the occurrence of potential confining beds, in particular. The CPT is a combination of geotechnical and environmental sensors that is hydraulically pushed into the ground. Data are collected in-situ and transmitted electronically to an on-board computer for analysis and display. The CPT probe measures point resistance, sleeve friction, and pore water pressure. From this data, the computer determines a range of soil parameters based on established correlations. Soil type is identified from the ratio of sleeve friction to point resistance, and soil strength is related to point resistance. Similarly, water table depth can be estimated by correlating the instrument depth with the measured hydraulic head, and measurement of excess pore pressure generated by the penetration process can identify low permeability layers. Use of a CPT equipped with a FFD can simultaneously measure TPH concentrations in the soil as the tool is advanced into the ground.

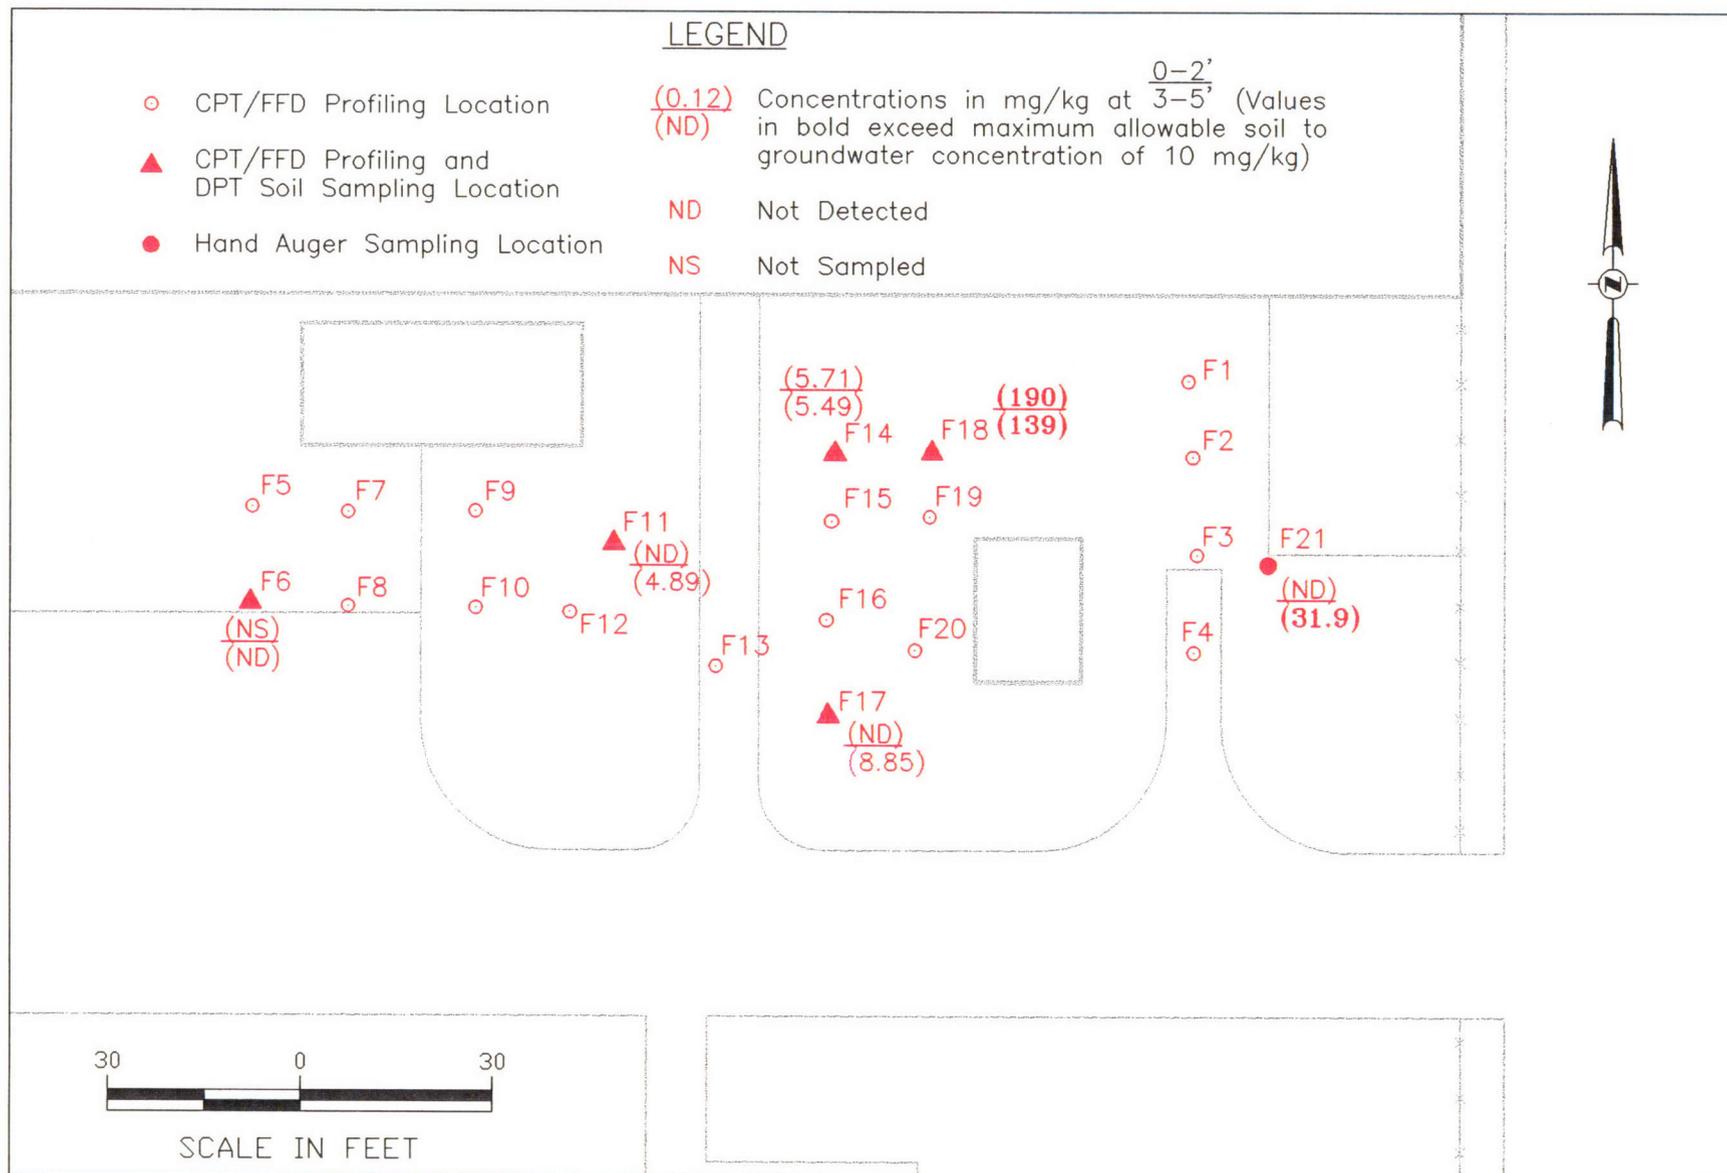
Figure 4-7. Distribution of Purgeable Total Petroleum Hydrocarbons in Source Area Soil Hamilton Beach ◊ Proctor Silex, Inc.

appeared to be weathered, causing the laboratory to report "unidentified organics" in conjunction with, or instead of, TPH in the standard gasoline or diesel ranges. For several of the purgeable TPH analyses, the laboratory noted the presence of a multi-component hydrocarbon eluting in the established integration range for gasoline which did not correspond to known gasoline patterns. Likewise, for some of the extractable TPH analyses, the laboratory noted the presence of heavy, multi-component hydrocarbons eluting late in the specified integration range for diesel or lube oil, but not matching the profile of any known standard. Consequently, a conservative approach was adopted in evaluating the TPH data. In this report, purgeable TPH represents the sum of gasoline species and other unidentified organics. Similarly, extractable TPH represents the sum of all listed species and other unidentified organics.

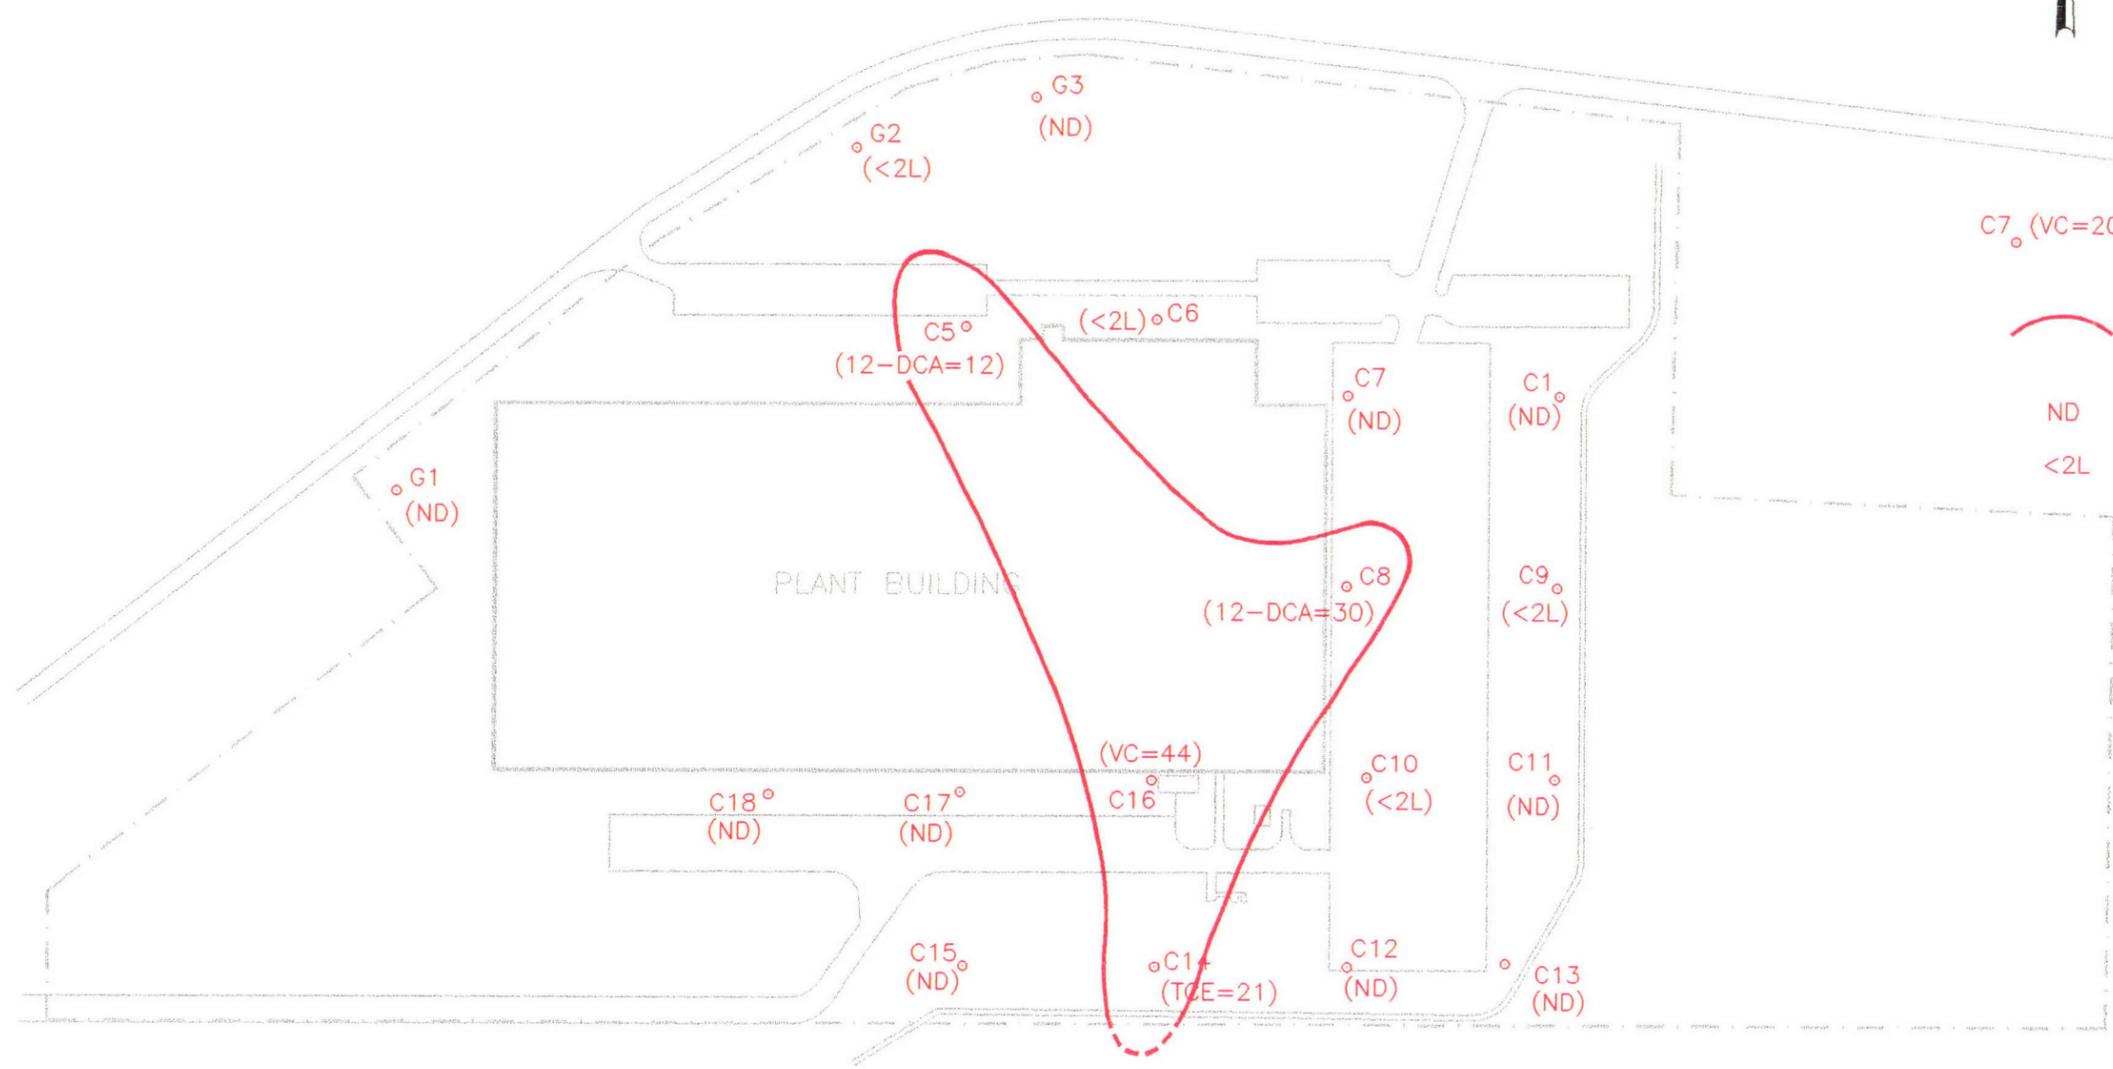
SCALE	AS SHOWN	DRAWN BY	JN	DATE	27MAY98	DRAWING TITLE	Figure 5-25. Extent of Chemicals Exceeding 2L Standard in Unit A		
		CHECKED BY	TSH	DATE	28MAY98		Hamilton Beach & Proctor-Silex Inc.		
		APPROVED BY	BPG	DATE	19JUN98	CONTRACT NO.	650138.0501	DRAWING NO.	COM-2L-S
						REV.			0

The screening results indicate that fourteen VOCs were detected in groundwater at the site. Six of the VOCs were reported in a single sample or at a trace concentration below the detection limit. Of the remaining eight VOCs, the reported concentrations of six exceeded their respective groundwater standards in at least one sample each. The four most frequently detected VOCs were TCE, cDCE, 11-DCE, and 11-DCA. Figures 5-5 through 5-24 are maps and cross-sections illustrating the approximate areal and vertical extent of these four VOCs. Due to the wide range in concentration of these VOCs across the site, only the contour line representing the inferred limits of the VOCs has been illustrated. Figures 5-25 and 5-26 depict the extent of VOCs exceeding the groundwater standards in Units A and B, respectively. These figures represent the inferred extent of dissolved VOC concentrations exceeding groundwater standards, irrespective of a specific VOC. At locations where the concentrations of more than one VOC exceeded the standards, the VOC exhibiting the greatest exceedance is represented.

- C7 (VC=20) Sampling Location, Chemical, and Reported Concentration in ug/L
-
