PHASE I ENVIRONMENTAL SITE ASSESSMENT

**WETSIG YACHTS FACILITY
WILMINGTON, NORTH CAROLINA**

CES PROJECT NO. 02106

AUGUST 21, 2002

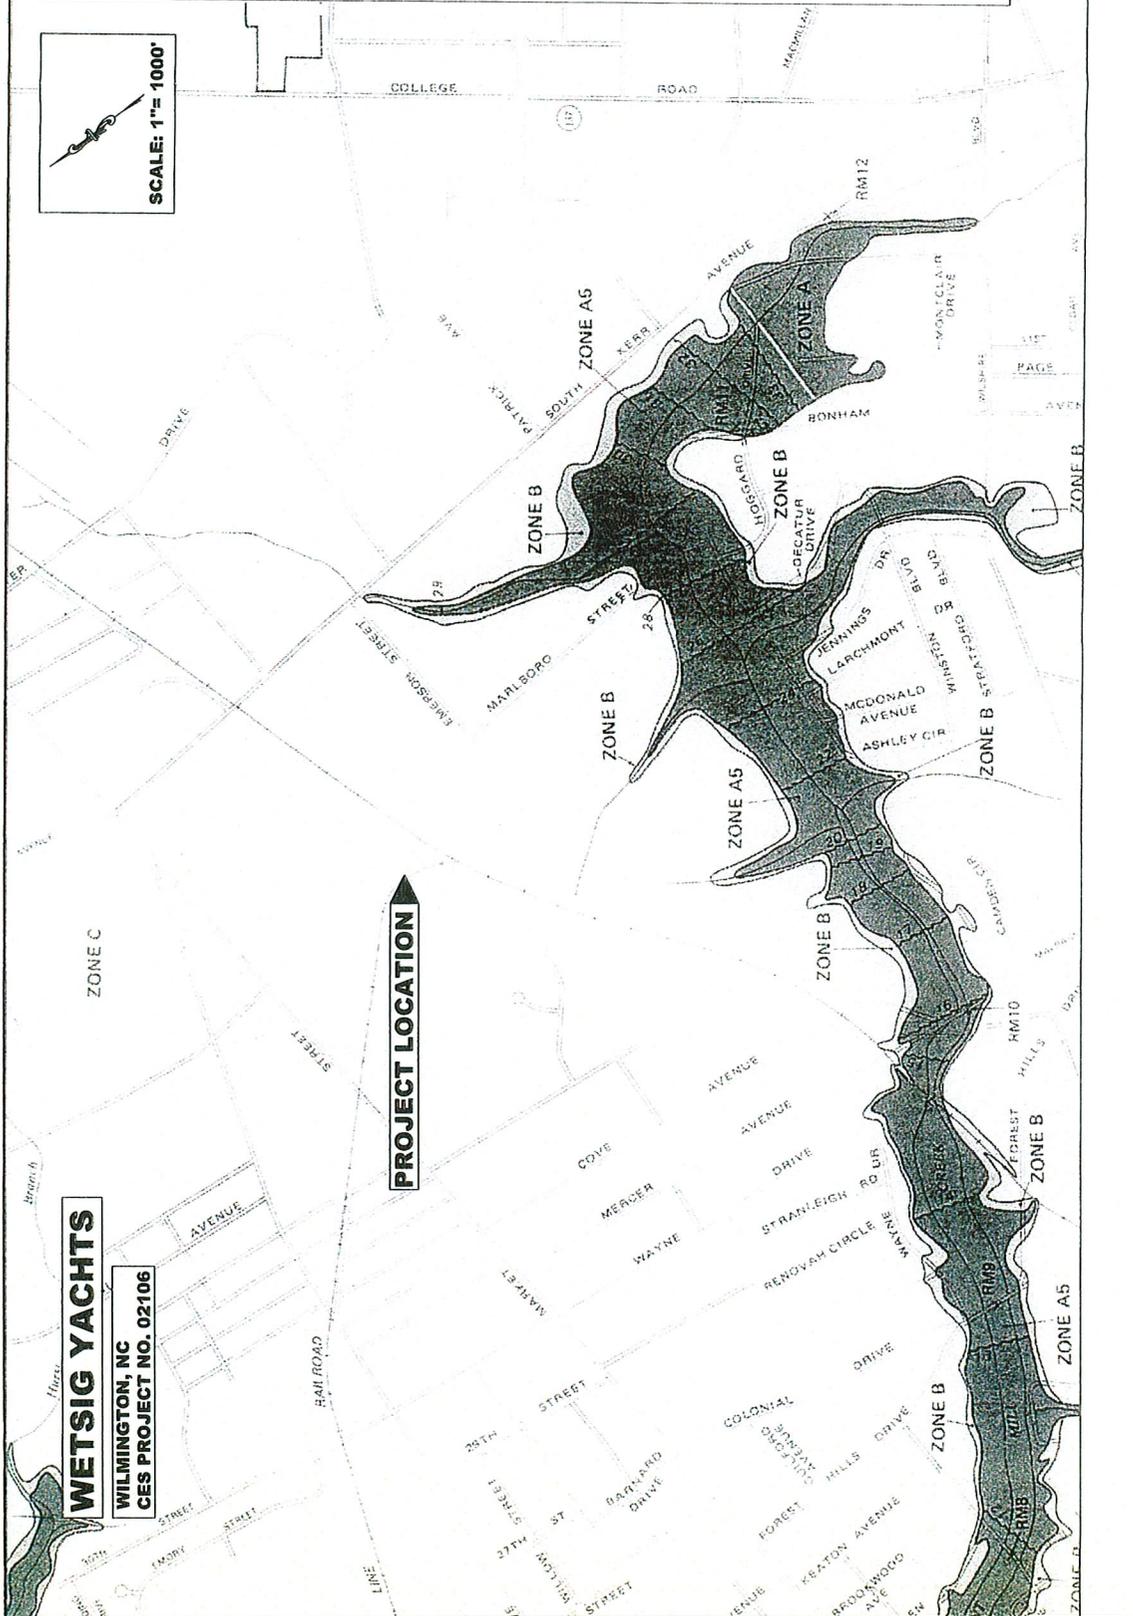
FLOOD HAZARD MAP
FIGURE 4

The topographic map indicates that the nearest surface waters include small tributaries located to the south, which discharge to Burnt Mill Creek. A recently installed storm water pond exists on the adjoining property to the north, beyond the railroad track. The FEMA Flood Hazard Map of the area shows that the site is not located adjacent to a flood hazard zone (**Figure 4**).

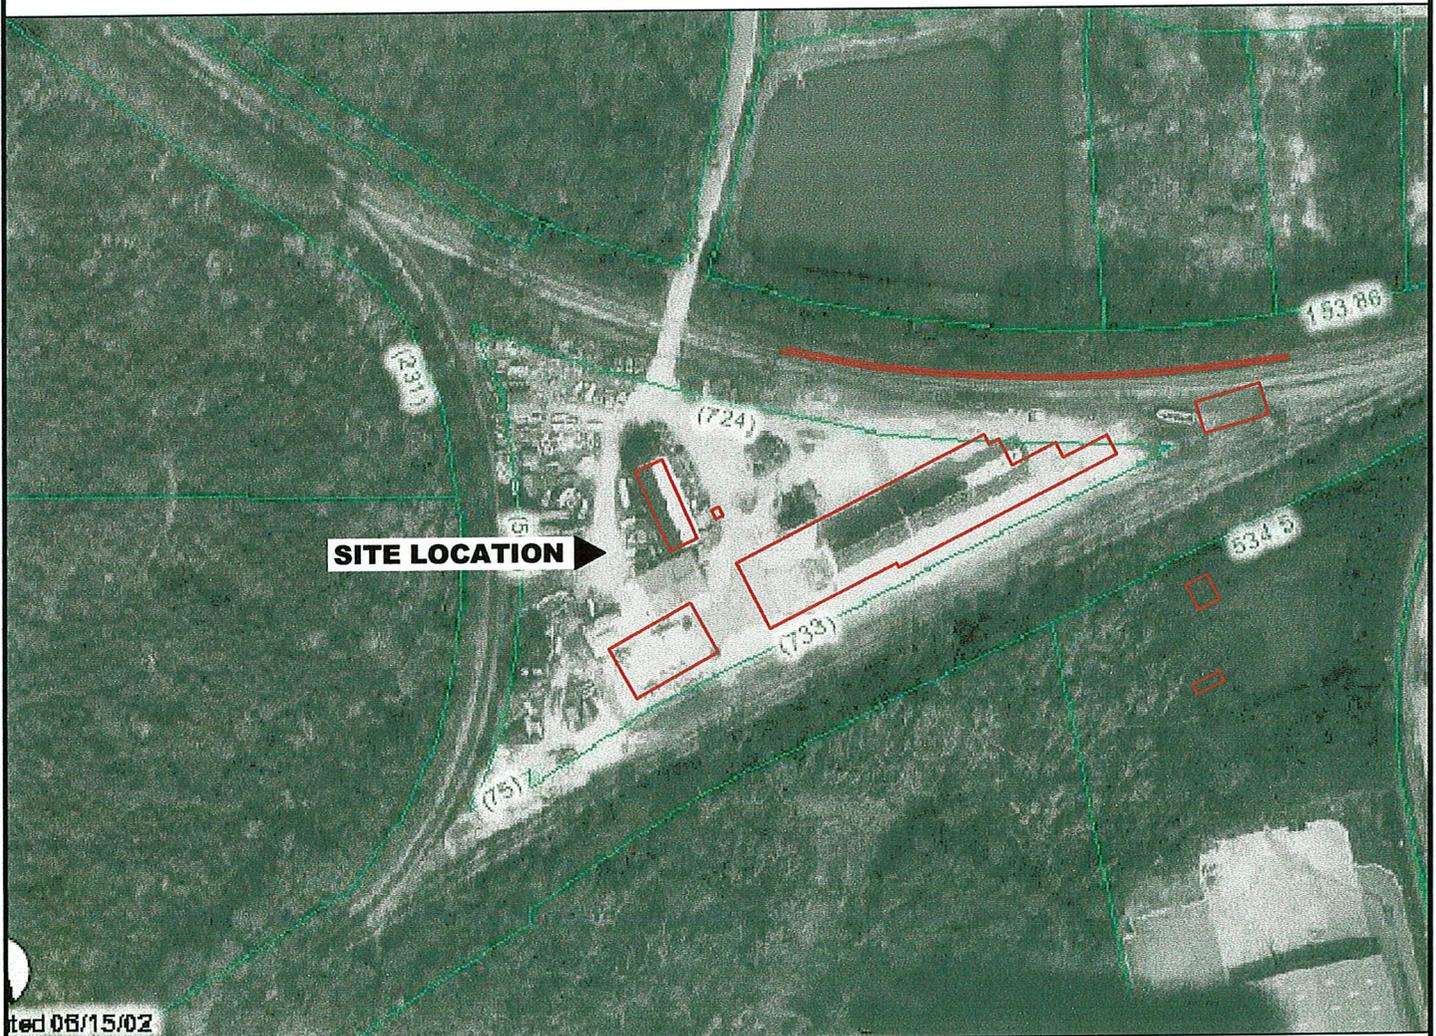
FIGURE 6

RECENT (1998) AERIAL
PHOTOGRAPH WITH SUPERIMPOSED
PRIOR BUILDING LOCATIONS AS
TAKEN FROM 1915 SANBORN MAP

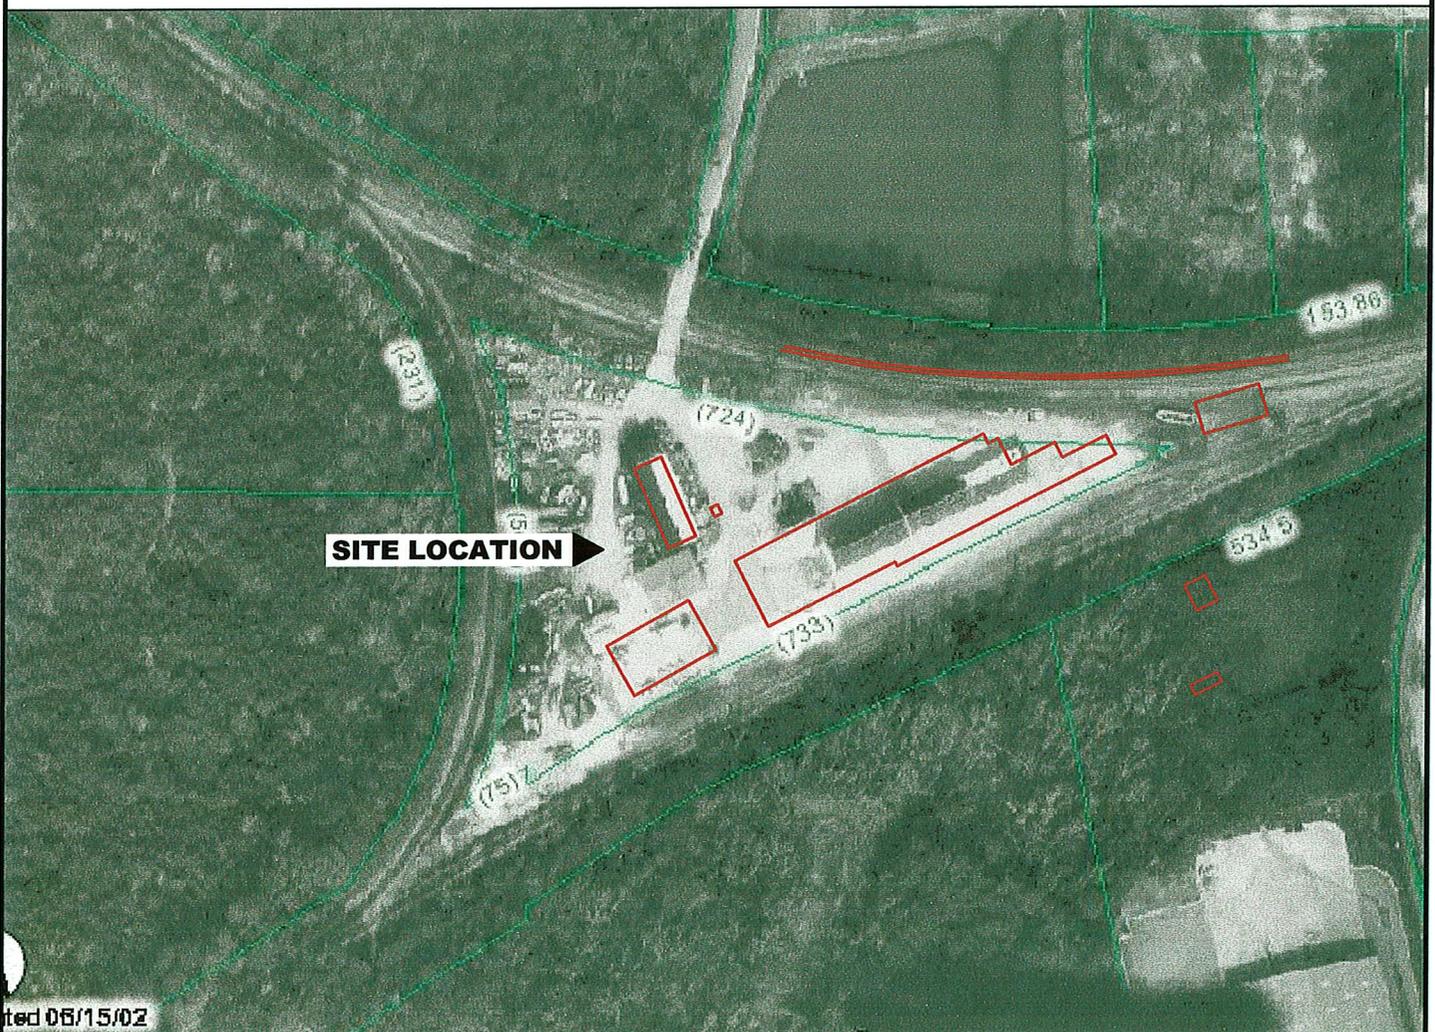
The 1998 aerial photograph depicts the subject site and surrounding areas in essentially the current condition. A recently installed storm water pond exists to the north across the railroad track. There are several noteworthy differences when comparing the 1994 image to the 1998 image. The 1998 image depicts, in total, all six of the existing buildings, as well as the two storage units. The prior main building appears (and is known) to have been replaced with the currently present structure, leaving much of the prior building “footprint” vacant and as open space. A large warehouse building was constructed just west of the main building and is known to overlap the prior location of two smaller buildings (as documented on some Sanborn land use maps). The entire west side of the property is shown to be utilized for outside storage of numerous small and large items.

NOTE:
IMAGE INCLUDES PRIOR
BUILDING LOCATIONS AS
TAKEN FROM 1915 SANBORN
MAP.
