Re: Soil Management Plan  
3<sup>rd</sup> & Poplar Project Brownfields Site  
Charlotte, Mecklenburg County, NC  
NC Brownfields Program  
Project No: 18017-14-060  
H&H Job No. GSL-001

**Soil Management Plan**  
**3<sup>rd</sup> & Poplar Project Brownfields Site**  
**NC Brownfields Program**  
**Project No. 18017-14-060**

**W. 3<sup>rd</sup> Street and S. Poplar Street**  
**Charlotte, North Carolina**

**H&H Job No. GSL-001**  
**December 30, 2014**

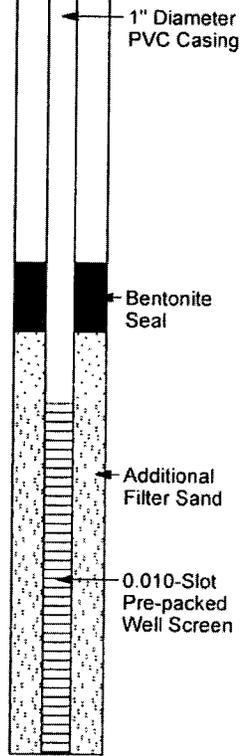
DEPTH (ft)	RECOVERY (%)	BLOW COUNT	OVA (ppm)		LITHOLOGY	MATERIAL DESCRIPTION	WELL DIAGRAM	DEPTH (ft)
			BKG.	SAMP.				
0					Concrete			0
					Gravel			
50			0	0	Very moist, dense, brown and orange, clayey fine SAND			
5			0	0	Very moist, stiff, brown, fine sandy CLAY			5
100			0	0	Moist, stiff, brown/orange/gray, clayey SILT w/ fine sand, slight petroleum-like odor			10
10			0	0				10
100			0	0				15
15			0	0				15
100			0	9.4	Moist, stiff, greenish gray and brown, fine sandy SILT w/ weathered quartz, petroleum-like odor			20
20			0	91.4				20
75			0	571				25
25			0	1405	Wet, very stiff, greenish brown and brown, silty fine SAND w/ clay			25
75			0	133				30
30								30
Bottom of borehole at 32.0 feet.

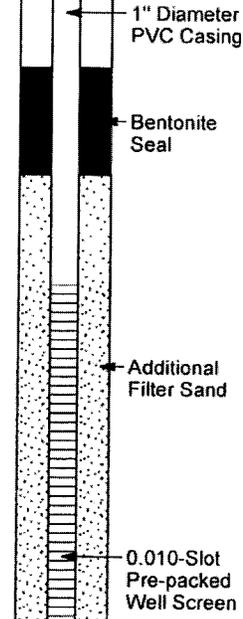
DEPTH (ft)	RECOVERY (%)	BLOW COUNT	OVA (ppm)		LITHOLOGY	MATERIAL DESCRIPTION	WELL DIAGRAM	DEPTH (ft)
			BKG.	SAMP.				
0					Asphalt			0
0-80			0.9	39.6	Moist, stiff, dark brown, fine sandy CLAY, petroleum-like odor			0
80-5			0.9	15.4	Moist, stiff, tan, fine sandy CLAY			5
5-100			0.9	4.5				5
100-10			0.9	4.4				10
10-100			0.9	4.6	Moist, very dense, brown/tan/orange, silty fine-medium SAND			10
100-15			0.9	9.3				15
15-100			0.9	6.6	Very moist-wet, soft, brown, fine sandy SILT			15
20					Bottom of borehole at 20.0 feet.			20

BORING STARTED: 11/2/10  
 BORING COMPLETED: 11/2/10  
 TOTAL DEPTH: 20  
 SURFACE ELEV:  
 DEPTH TO WATER:

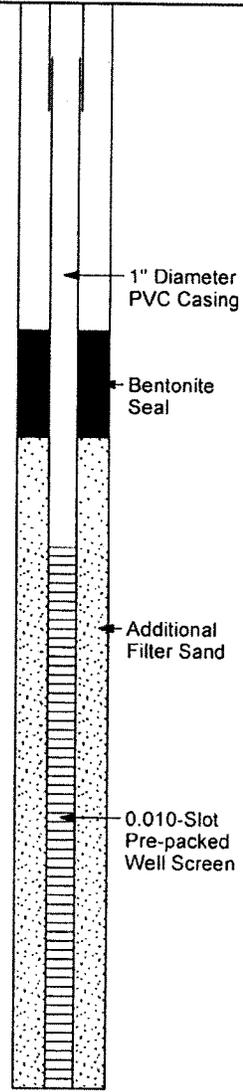
DEPTH (ft)	RECOVERY (%)	BLOW COUNT	OVA (ppm)		LITHOLOGY	MATERIAL DESCRIPTION	WELL DIAGRAM	DEPTH (ft)
			BKG.	SAMP.				
0					Asphalt			0
0-5			0	0	Slightly moist, stiff, dark brown, fine sandy CLAY			0-5
5-10			0	0.5	Moist, medium dense, brown, clayey fine SAND			5-10
10-15			0	0	Moist, medium stiff, orange/tan/gray, silty CLAY w/ fine sand			10-15
15-20			0	0	Moist, medium stiff, orange/tan/gray, clayey SILT			15-20
20			0	0		Bottom of borehole at 20.0 feet.		20

BORING STARTED: 11/2/10  
 BORING COMPLETED: 11/2/10  
 TOTAL DEPTH: 20  
 SURFACE ELEV:  
 DEPTH TO WATER:

Remarks:  
 Soil sample collected from 2-4 ft

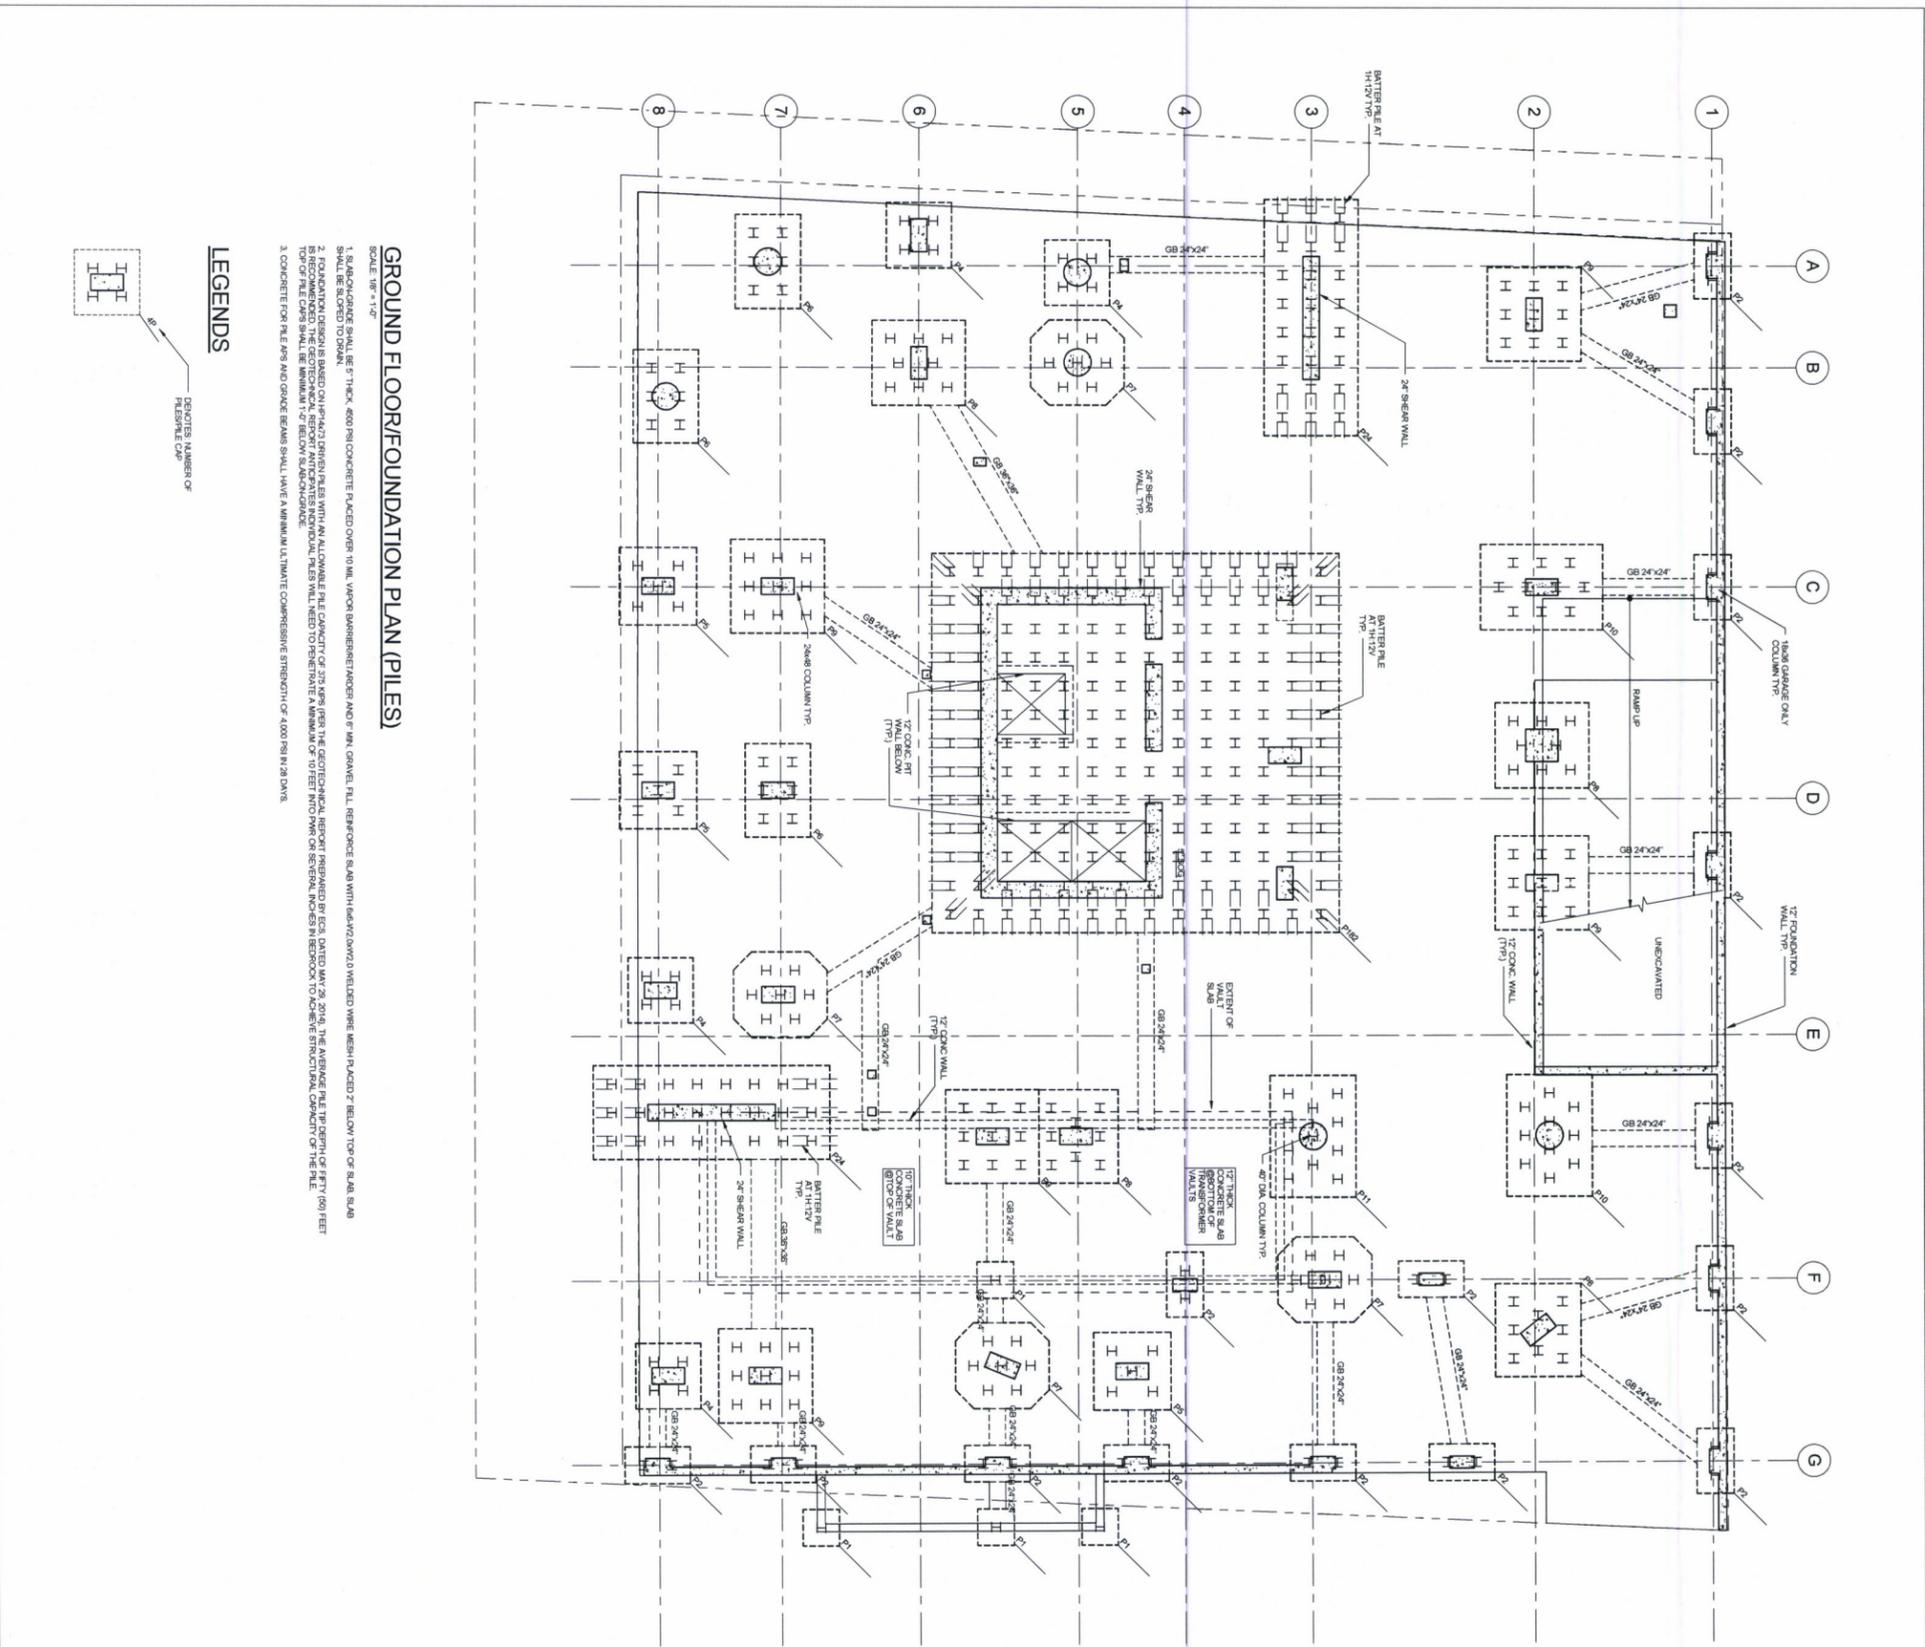
**GROUND FLOOR/FOUNDATION PLAN (PILES)**

- SCALE: 3/8" = 1'-0"
1. SUBGRADE SHALL BE 5" THICK, 4000 PSI CONCRETE PLACED OVER 10" MIN. UNIFORM BARRIER (AGGREGATE AND 7" MIN. GRAVEL, FILL, REFERENCE SLAB WITH 6#4 @ 24" ON CENTER) WELDED WIRE MESH PLACED 7" BELOW TOP OF SLAB. SLAB SHALL BE SLOPED TO DRAIN.
  2. FOUNDATION DESIGN IS BASED ON HP-42 PILES WITH AN ALLOWABLE PILE CAPACITY OF 375 KIPS PER THE GEOTECHNICAL REPORT PREPARED BY E.C.S. DATED MAY 29, 2014. THE ALLOWABLE PILE TIP DEPTH OF FIFTY (50) FEET OF THE CAPS SHALL BE MINIMUM 1'-0" BELOW SUBGRADE.
  3. CONCRETE FOR PILES AND GRADE BEAMS SHALL HAVE A MINIMUM ULTIMATE COMPRESSIVE STRENGTH OF 4000 PSI IN 28 DAYS.

- As many as 45 reinforced concrete pile caps will be constructed below the ground surface as foundations for the building's steel support columns. The pile caps will be constructed to depths up to 6 ft below the ground surface and the dimensions of the pile caps will vary based on the pile cap's anticipated load.

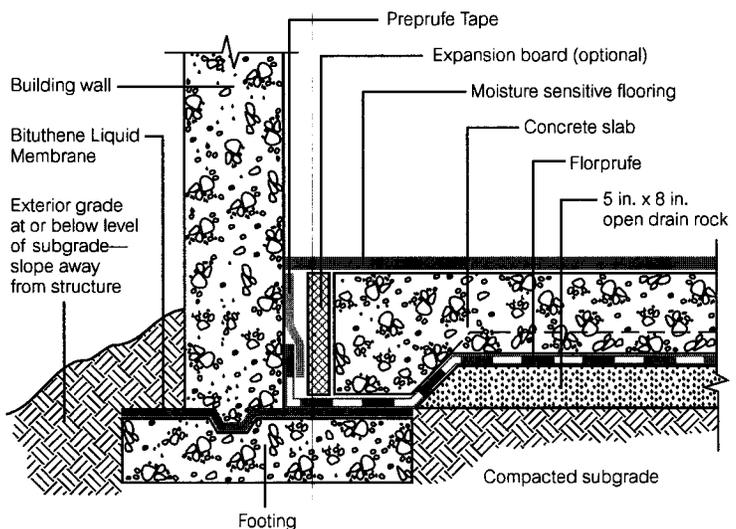
#### Typical Assembly

Drawings are for illustration purposes only. Please refer to [www.graceconstruction.com](http://www.graceconstruction.com) for specific application details.

Florprufe 120 can be applied at temperatures of 25°F (-4°C) or above. Membrane installation is unaffected by wet weather. Installation and detailing of Florprufe 120 are generally in accordance with ASTM E1643-98.

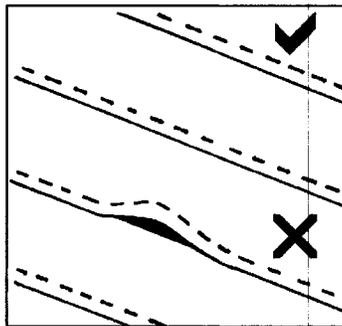
Figure 1

To prevent the membrane from moving and gaps opening, the laps should be fastened together at 39 in. (1.0 m) maximum centers. Fix through the center of the lap area using 0.5 in. (12 mm) long washer-head, self-tapping, galvanized screws (or similar) and allowing the head of the screw to bed into the adhesive compound to self-seal. It is not necessary to fix the membrane to the substrate, only to itself. Ensure the membrane lays flat and no openings occur. (See Figure 1.) Additional fastening may be required at corners, details, etc. Continuity is achieved once the slab is poured and the bond to concrete develops.
