Your Name: Kathleen Z. Lawson
EPA ID: NCD049773245
Facility Name: Trex Properties
Document Group: Corrective Action (CA)
Document Type: Other (O)
Description: Results of Additional Indoor Air and Outdoor Air Analyses - Leather Trimmings, LTD Building
Date of Doc: 4/28/2016
Author of Doc: Withers and Ravenel

RE: **Results of Additional Indoor Air and Outdoor Air Analyses**
Leather Trimmings, LTD Building
3110 Cullman Avenue, Charlotte NC
WR Project Number: 03130430.03

**Photo Documentation – April 2016
Leather Trimmings: 3110 Cullman Avenue, Charlotte, NC**

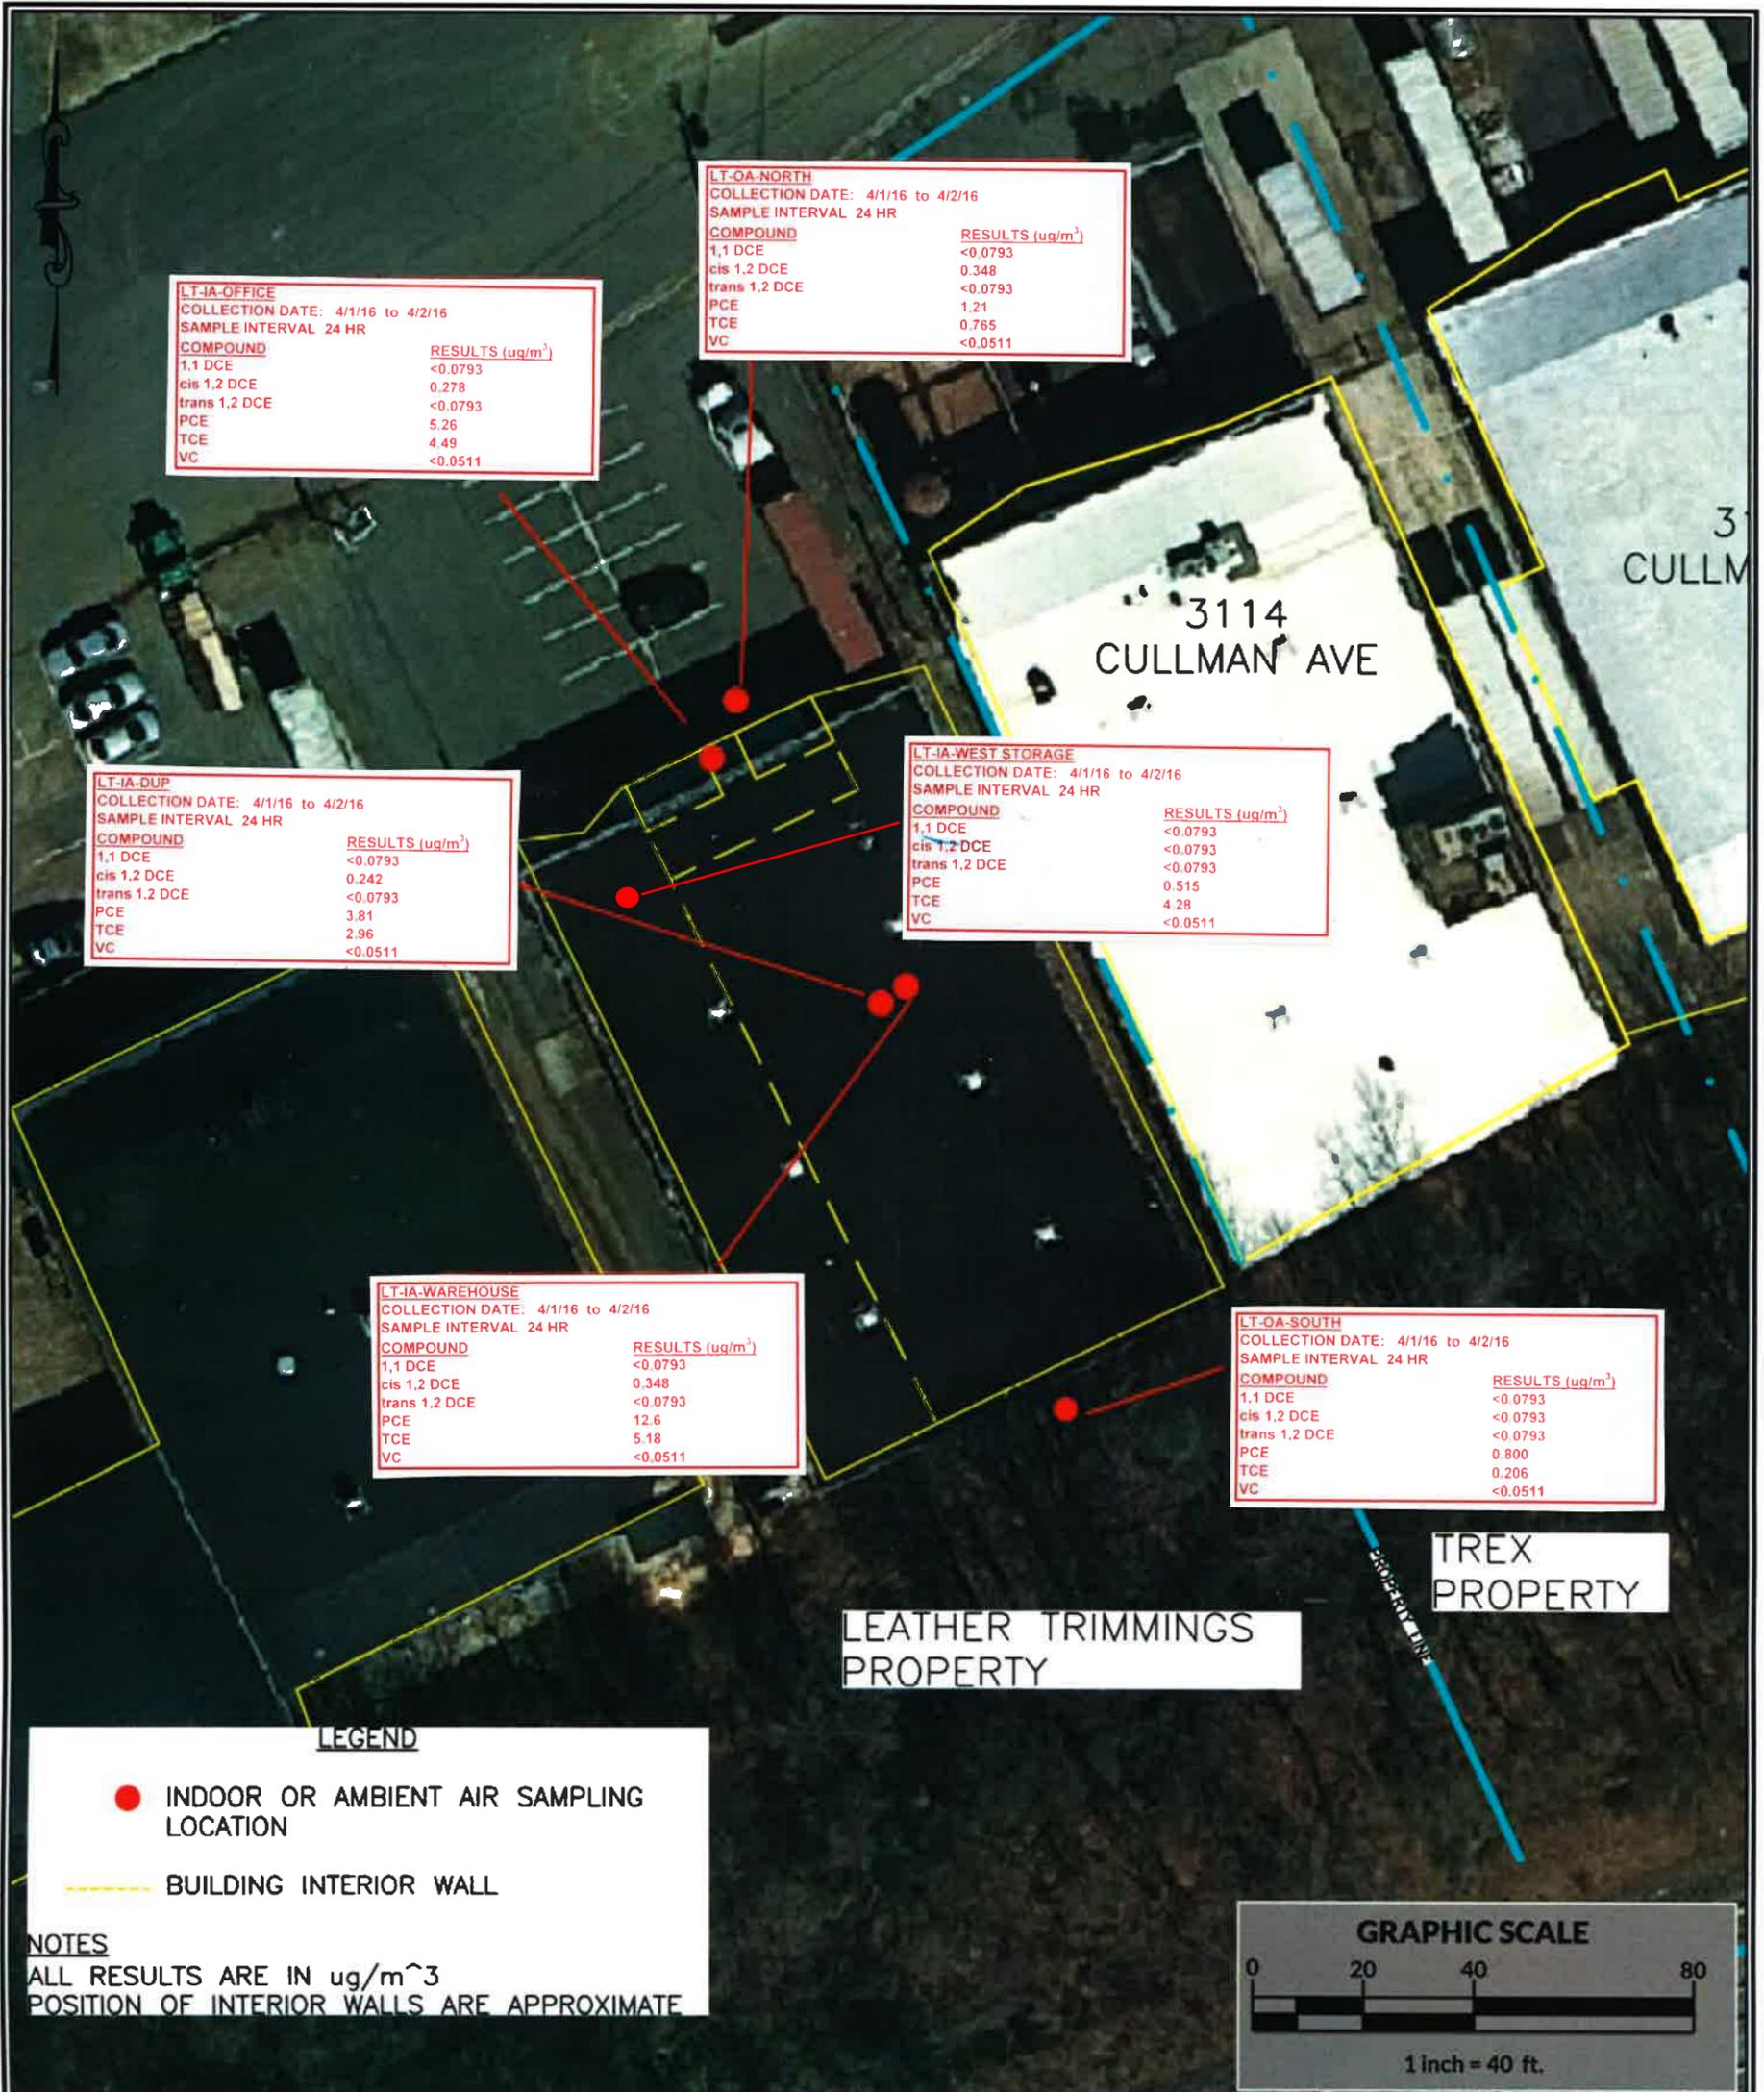
Figure 1: Indoor Air and Ambient Air Locations and Analytical Results

LT-OA-NORTH
 COLLECTION DATE: 4/1/16 to 4/2/16
 SAMPLE INTERVAL 24 HR

COMPOUND	RESULTS (ug/m ³)
1,1 DCE	<0.0793
cis 1,2 DCE	0.348
trans 1,2 DCE	<0.0793
PCE	1.21
TCE	0.765
VC	<0.0511

LT-IA-OFFICE
 COLLECTION DATE: 4/1/16 to 4/2/16
 SAMPLE INTERVAL 24 HR

COMPOUND	RESULTS (ug/m ³)
1,1 DCE	<0.0793
cis 1,2 DCE	0.278
trans 1,2 DCE	<0.0793
PCE	5.26
TCE	4.49
VC	<0.0511

LT-IA-DUP
 COLLECTION DATE: 4/1/16 to 4/2/16
 SAMPLE INTERVAL 24 HR

COMPOUND	RESULTS (ug/m ³)
1,1 DCE	<0.0793
cis 1,2 DCE	0.242
trans 1,2 DCE	<0.0793
PCE	3.81
TCE	2.96
VC	<0.0511

LT-IA-WEST STORAGE
 COLLECTION DATE: 4/1/16 to 4/2/16
 SAMPLE INTERVAL 24 HR

COMPOUND	RESULTS (ug/m ³)
1,1 DCE	<0.0793
cis 1,2 DCE	<0.0793
trans 1,2 DCE	<0.0793
PCE	0.515
TCE	4.28
VC	<0.0511

LT-IA-WAREHOUSE
 COLLECTION DATE: 4/1/16 to 4/2/16
 SAMPLE INTERVAL 24 HR

COMPOUND	RESULTS (ug/m ³)
1,1 DCE	<0.0793
cis 1,2 DCE	0.348
trans 1,2 DCE	<0.0793
PCE	12.6
TCE	5.18
VC	<0.0511

LT-OA-SOUTH
 COLLECTION DATE: 4/1/16 to 4/2/16
 SAMPLE INTERVAL 24 HR

COMPOUND	RESULTS (ug/m ³)
1,1 DCE	<0.0793
cis 1,2 DCE	<0.0793
trans 1,2 DCE	<0.0793
PCE	0.800
TCE	0.206
VC	<0.0511

These results are summarized by location in **Figure 1**, and the ESC analytical reports and chain of custody records are provided in **Attachment C**.

Results of the additional indoor air sampling work discussed in this report indicate that sealing of the cracks and gaps in the building floor and continuous operation of the positive pressure ventilation system had the intended and desired result of mitigating the vapor intrusion situation effectively because none of the detected concentrations of PCE and TCE exceeded applicable vapor intrusion screening levels.

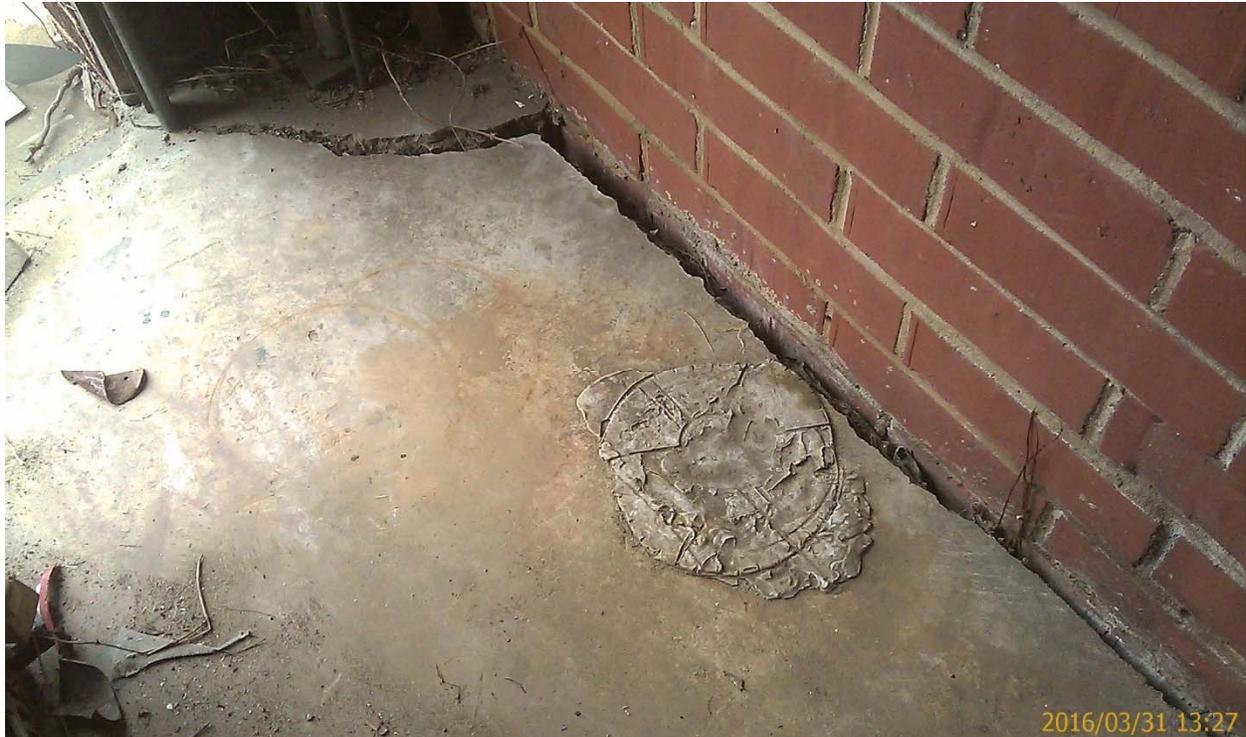
Photo #1: Floor crack near northeast corner of Leather Trimmings building.

One of the recommendations contained in our February 29, 2016 report of indoor and outdoor air sampling at the subject site was to survey the floor of the building and seal any significant cracks or gaps discovered. On March 31, 2016 WR representative Brian Bellis returned to the Leather Trimmings site to survey the floor of the Leather Trimmings building at 3110 Cullman Avenue, and to seal significant cracks or gaps discovered in the floor. Mr. Bellis was met by Mr. Patrick Speckman, who is the owner of the business and building and who provided access to the inside of the building. Photographs of the cracks and gaps observed during the survey are provided in **Attachment A**. Mr. Bellis used professional grade hydraulic cement mortar mix to seal the larger cracks and gaps in the floor, and a commercial concrete crack filler to seal the smaller cracks and gaps. Photographs of the repaired cracks and gaps are also provided in **Attachment A**.

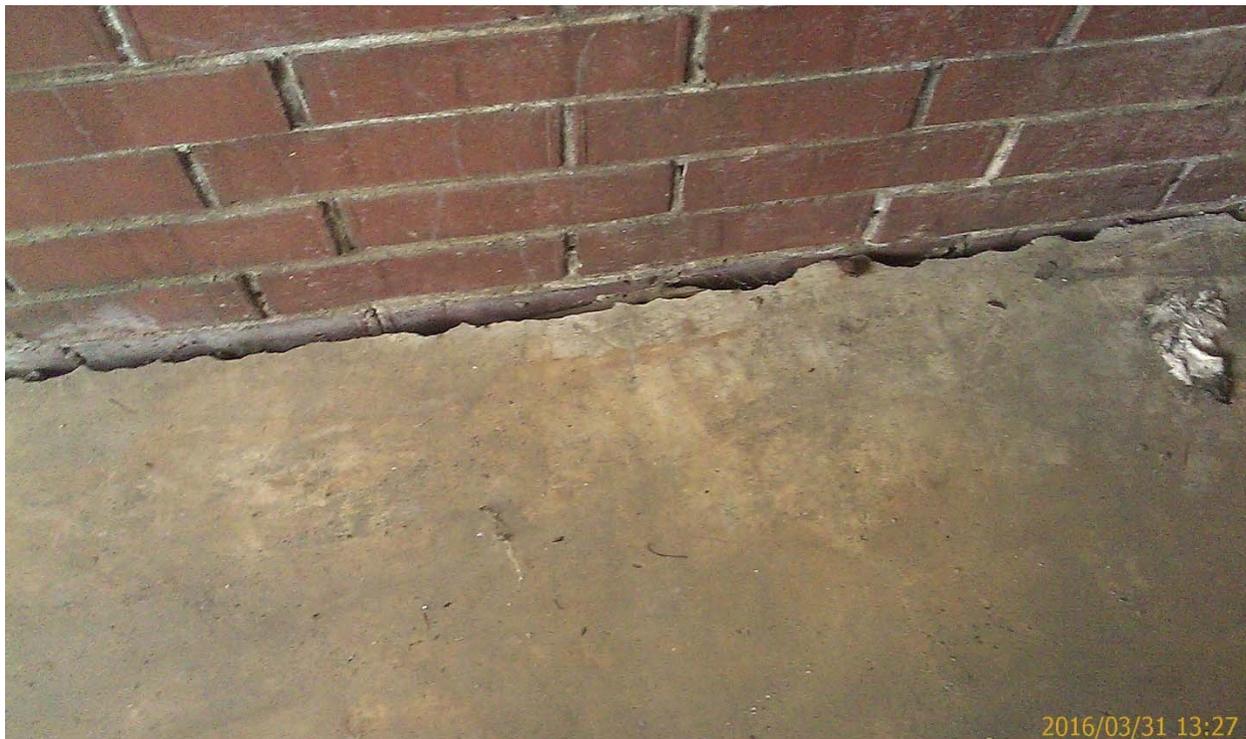
Photo #2: Gap between floor slab and eastern wall of Leather Trimmings building.

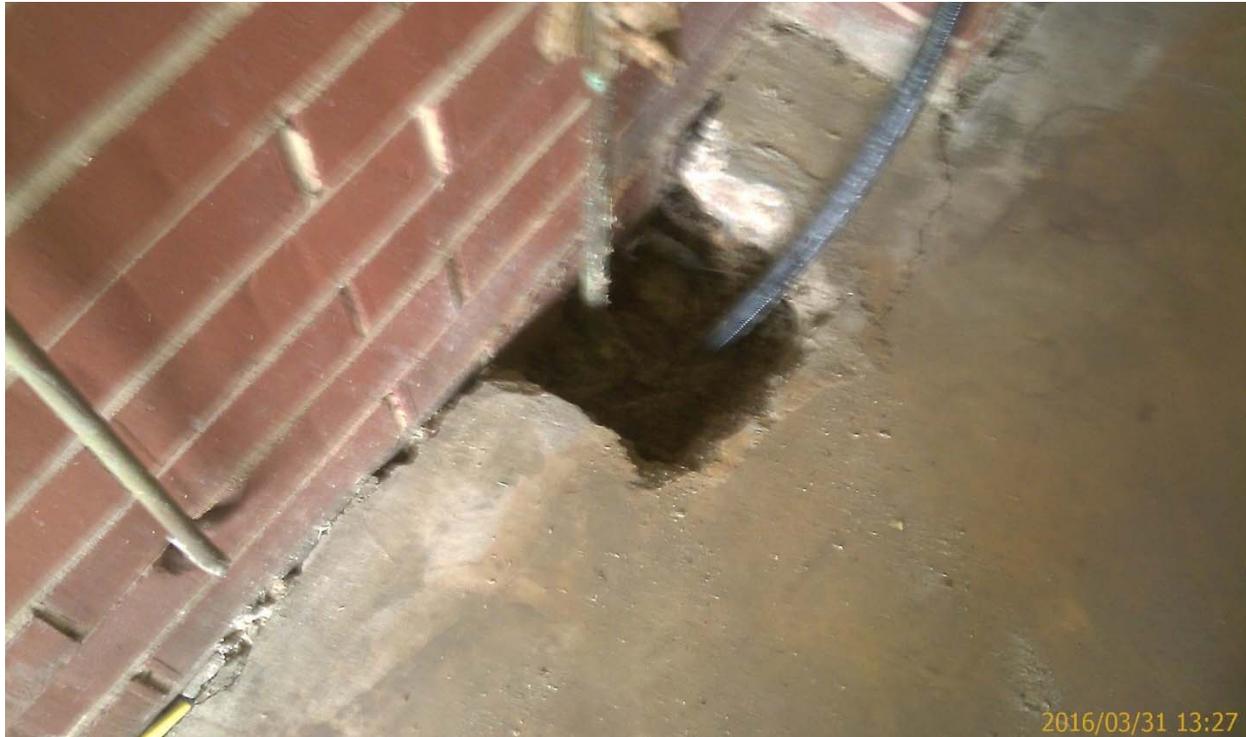
Photo #3: Hole in floor slab and gap between slab and floor and eastern wall of Leather Trimmings building.

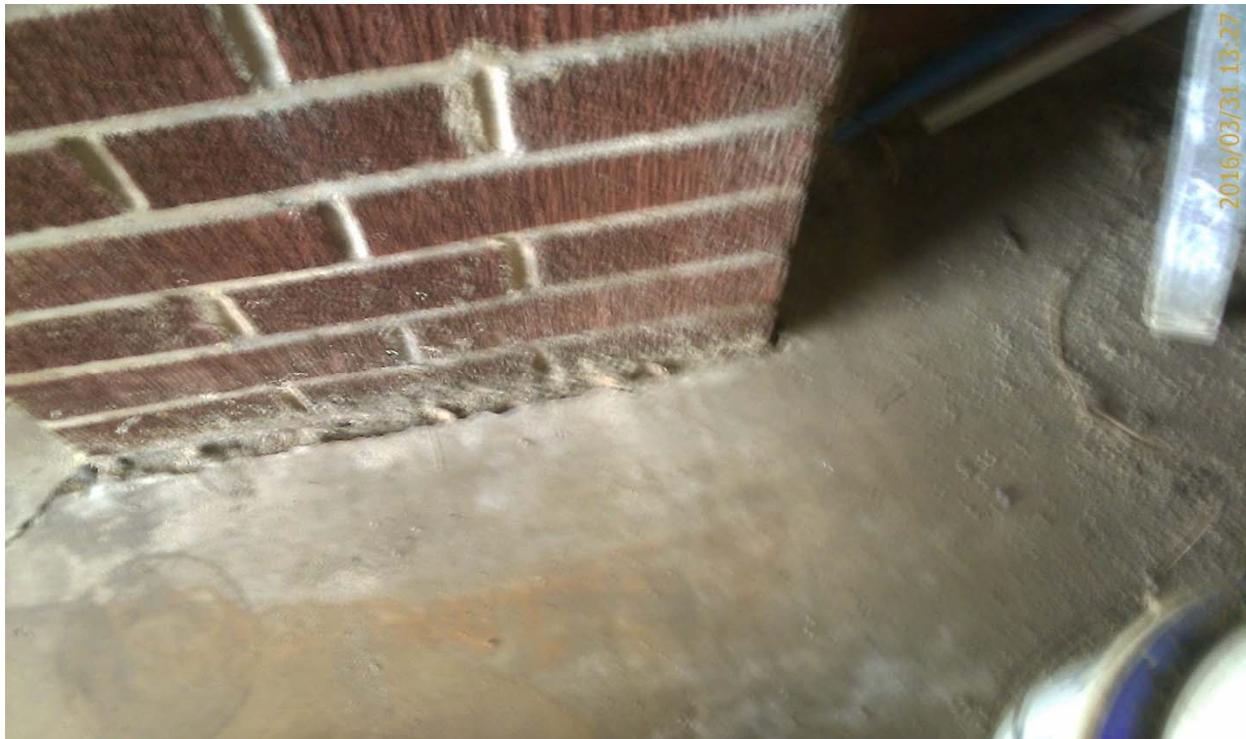
Photo #4: Gap between floor and eastern wall of Leather Trimmings building.

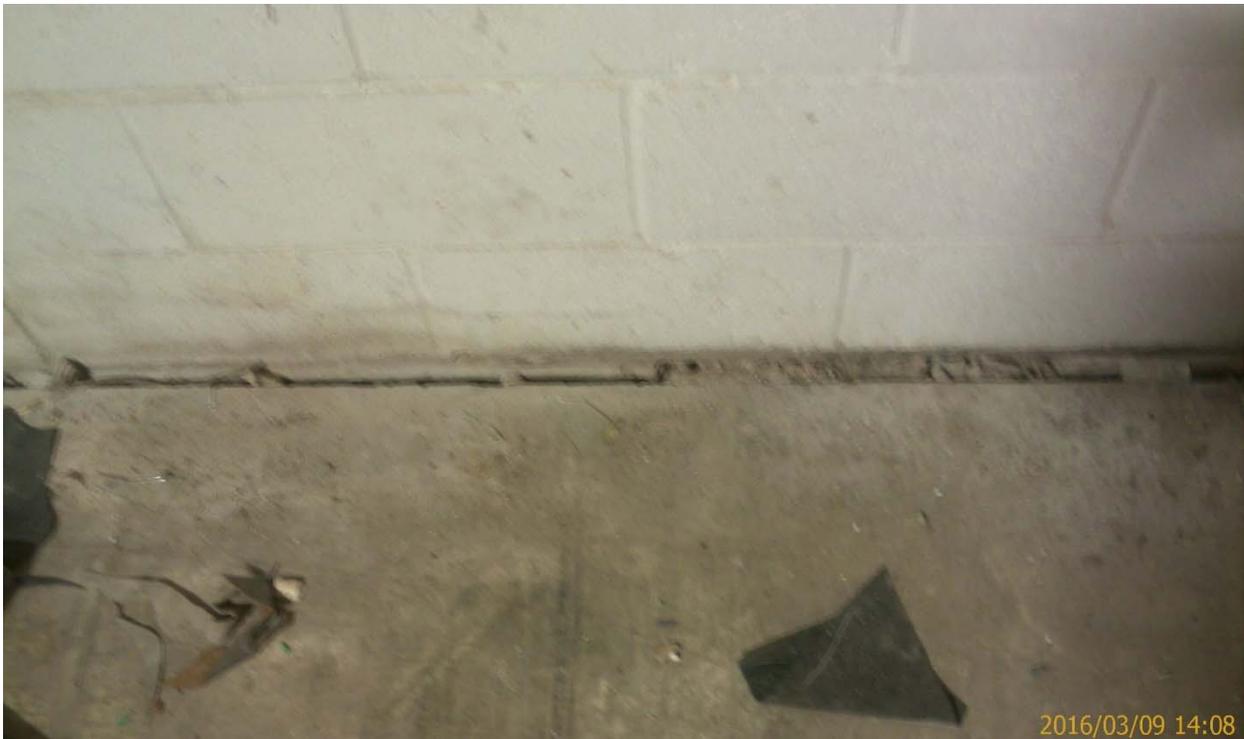
Photo #6: Gap between floor slab and southern wall of Leather Trimmings building.

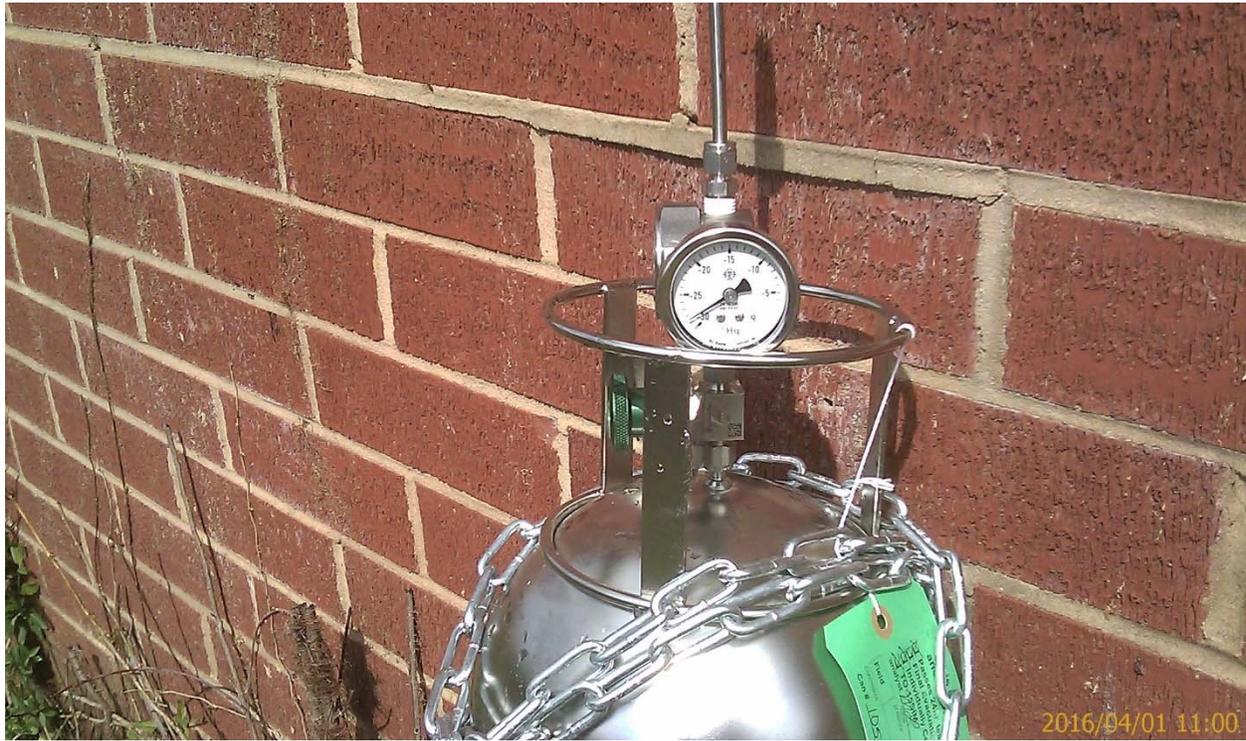
Photo #15: Outdoor air sample LT-OA-South at start of 24-hour composite sampling.

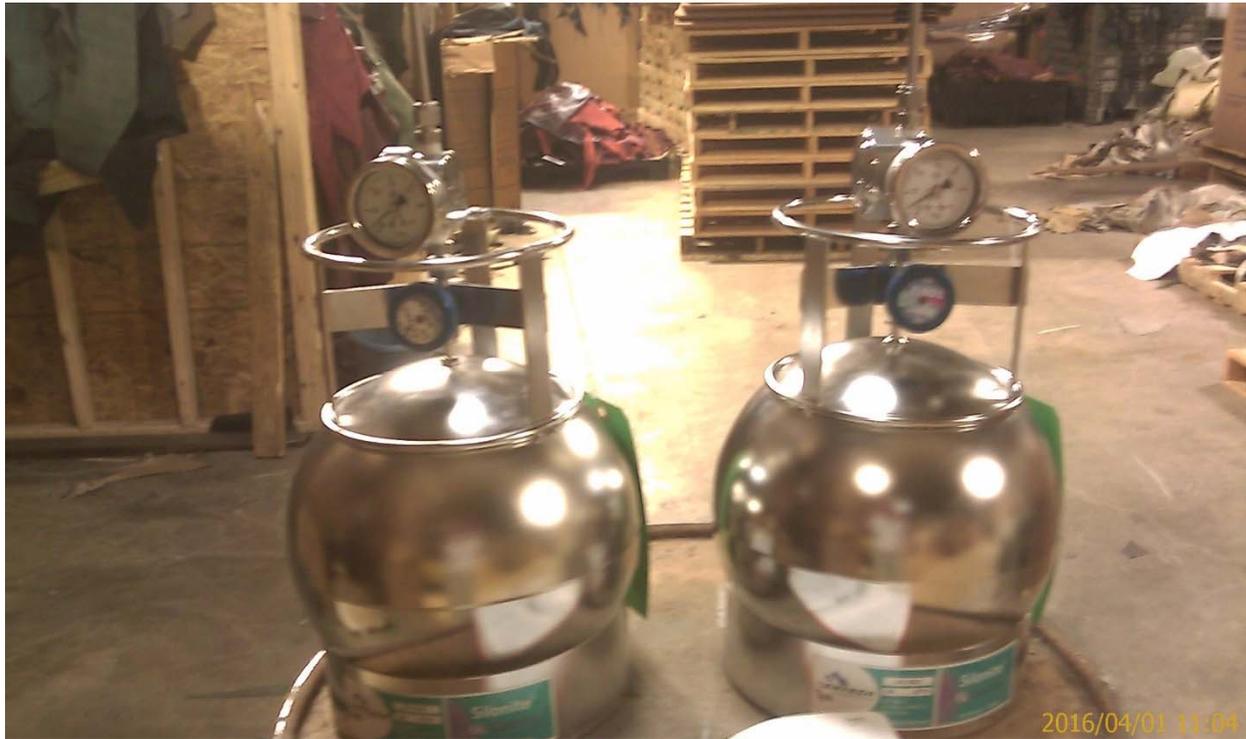
Photo #17: Indoor air samples LT-IA-Warehouse and LT-IA-Dup at start of 24-hour composite sampling.

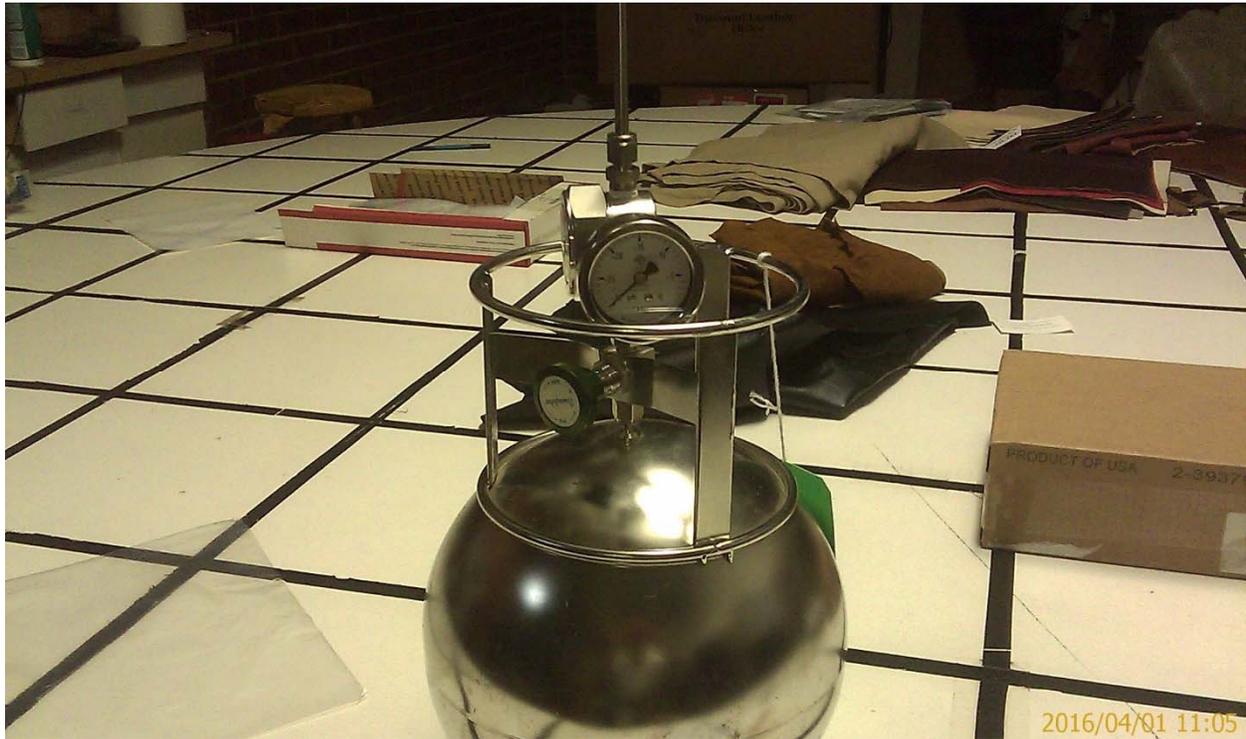
Photo #19: Indoor air sample LT-IA-West Storage at start of 24-hour composite sampling period.

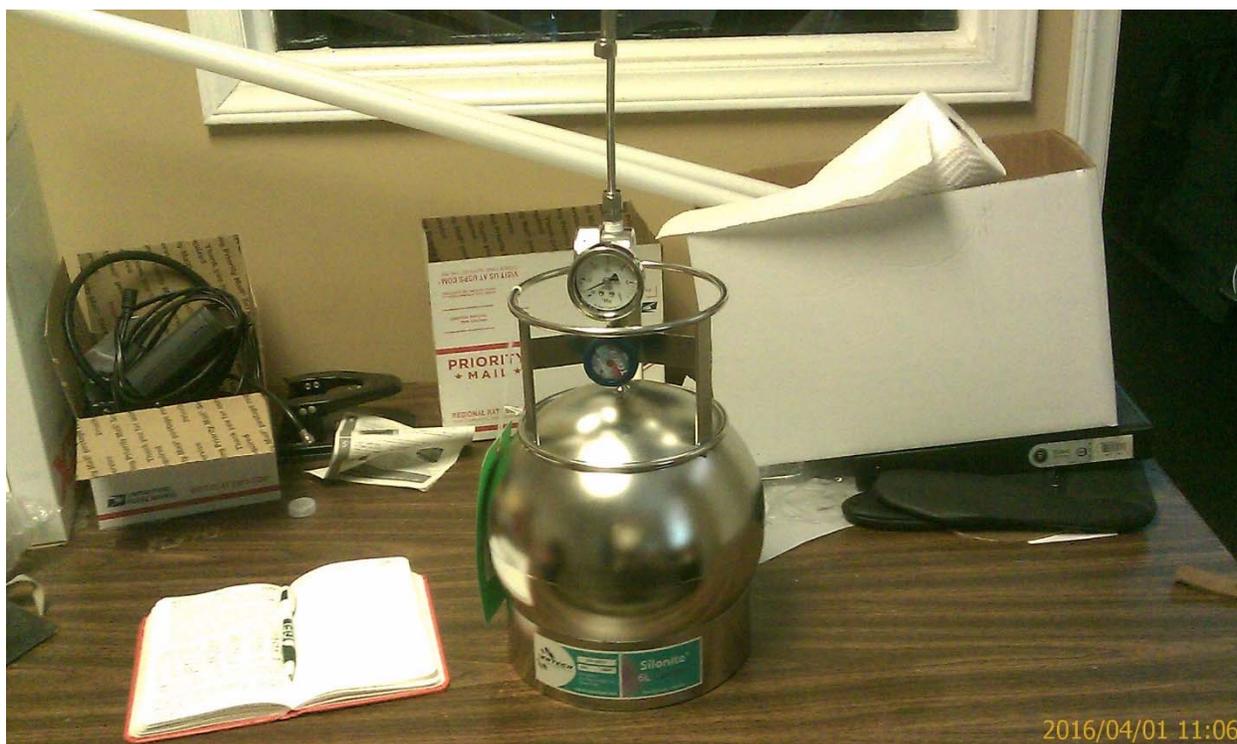
Photo #21: Indoor air sample LT-IA-Office at start of 24-hour composite sampling period.

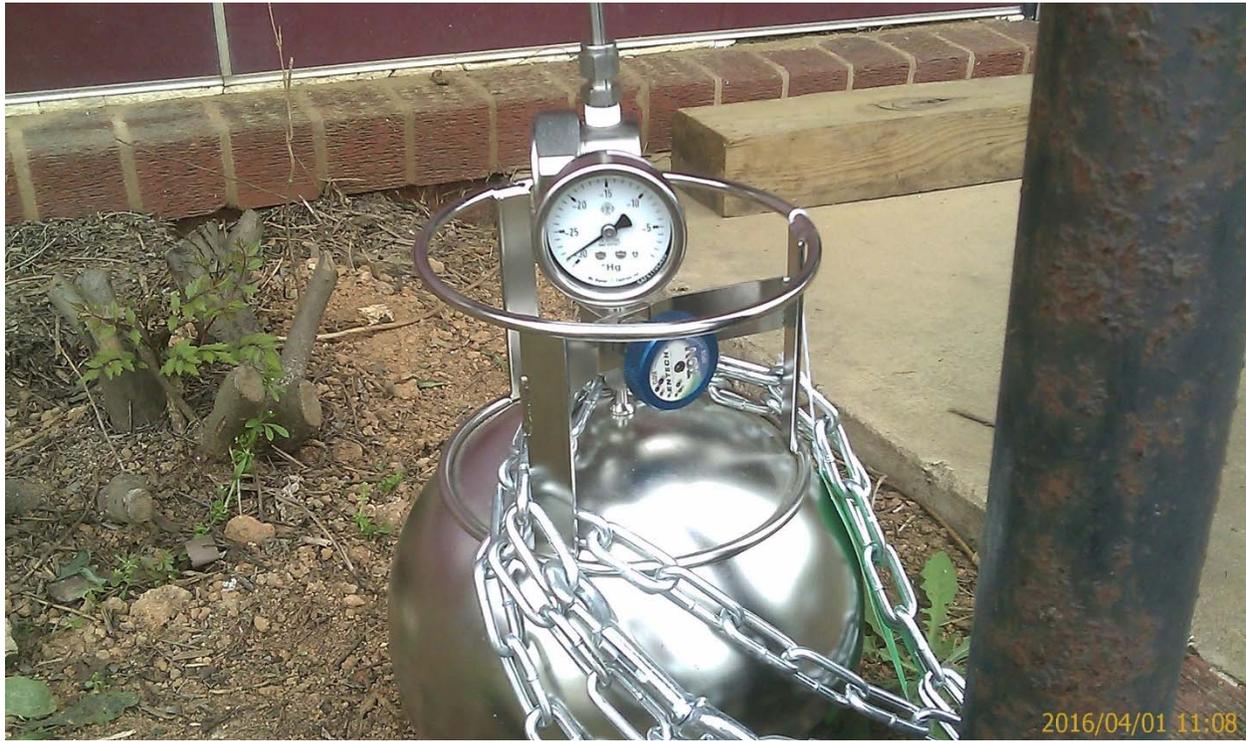
Photo #23: Outdoor air sample LT-OA-North at start of 24-hour sampling period.
