FACILITY COMPLIANCE INSPECTION REPORT
Division of Waste Management
Solid Waste Section

Date of Site Inspection: May 25, 2016

Coble's Sandrock, Inc. C&D Landfill
5833 Foster Store Road
Liberty, NC 27298

Comprehensive Inspection

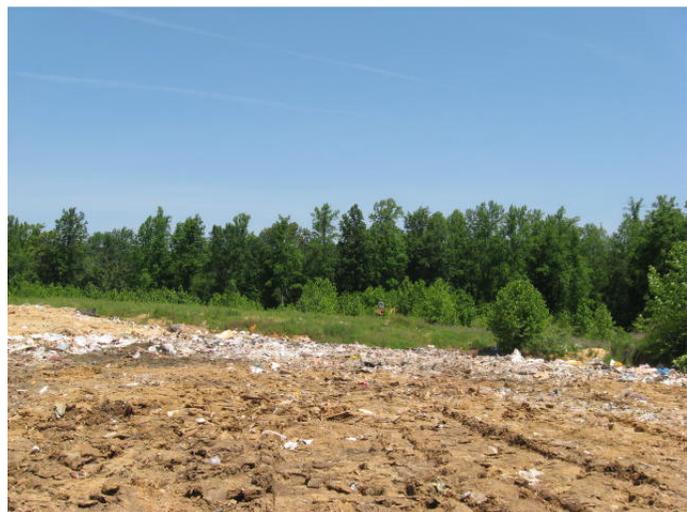
C&D landfill working face (Phase 3A)

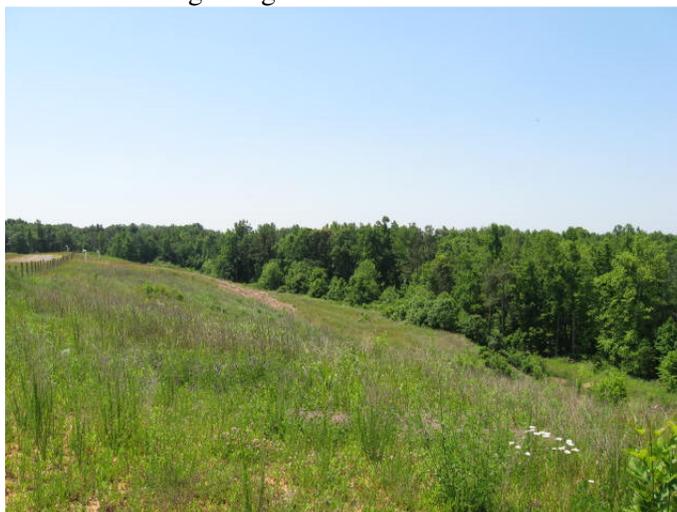
39. Facility financial assurance is up to date.
40. The facility has installed wooden posts and fencing encompassing an area of ~ 2.4 acres atop the landfill cap of Phase 1 (primarily, the rear external side slope) in order to graze livestock. Mr. Coble stated that he intends to graze goats along the side slope area as it is difficult to access with machinery.

Phase 1A rear external side slope and purposed livestock grazing area

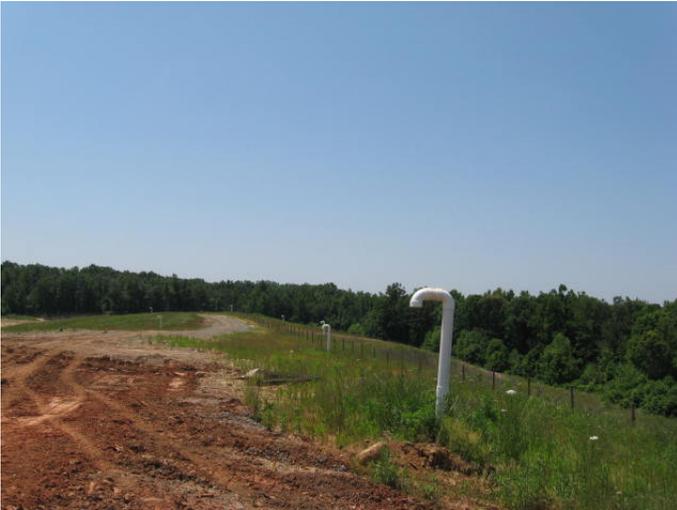
28. The landfill gas (LFG) vents atop Phases 1 and 2 each terminate with a 90° elbow. The facility has updated the six vertical vent pipe elbows, required to be updated, to the appropriate size.

Landfill gas vents with 90° elbow and livestock fence atop landfill cap

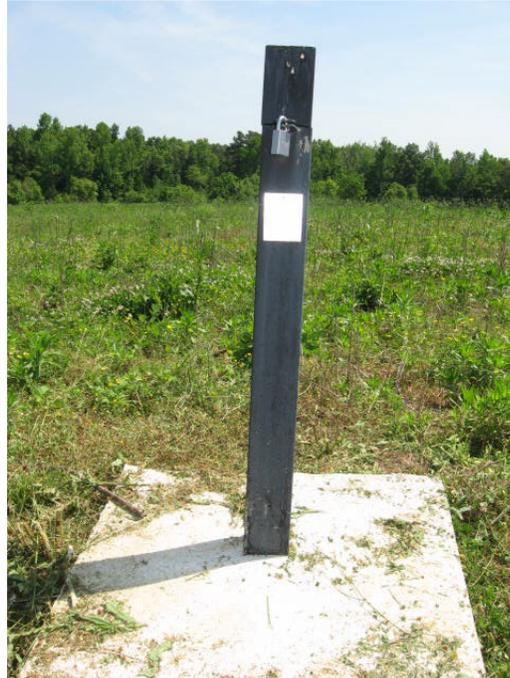
26. During the 2015 inspection, groundwater monitoring well MW-6 had surface water intrusion into the outer casing and was missing the identification plate. It has been repaired/updated accordingly.

Groundwater well MW-6 repair/upgrade

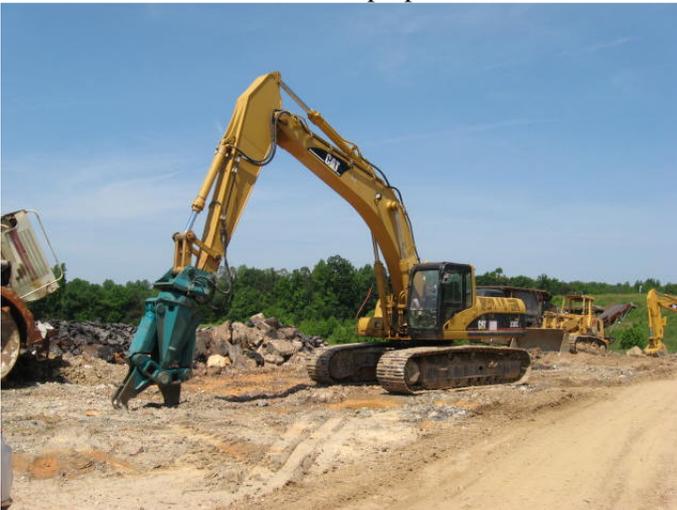
Concrete shear for excavator – prepares concrete for crusher

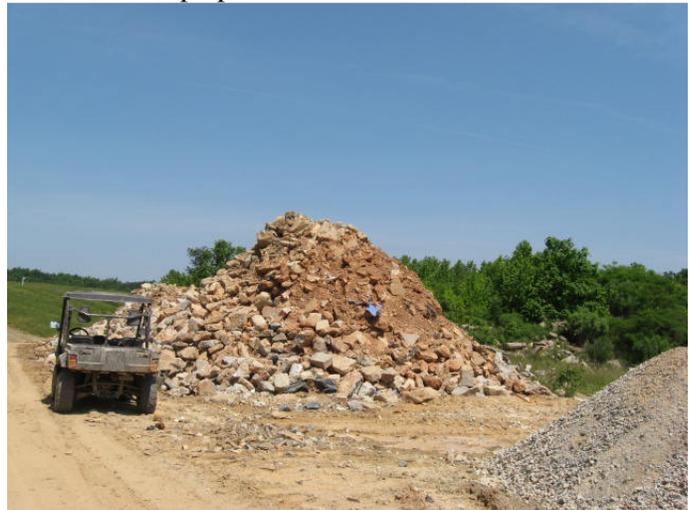
18. The amount of recyclable materials on site is estimated to be: 500 tons of scrap metal, 75 tons of mulch and 25 tons of unprocessed LCD, and 300 tons of crushed concrete. Mr. Coble stated that concrete stored on site will be crushed routinely over the next few months.

Sheared/prepared concrete
