# FACILITY COMPLIANCE INSPECTION REPORT

**Date of Site Inspection:** 5/24/2016

Cherokee County MSW Landfill  
10160 US 19/74/129  
Marble, NC 28905

#### Operations Inspection of MSWLF Unit (20-02)

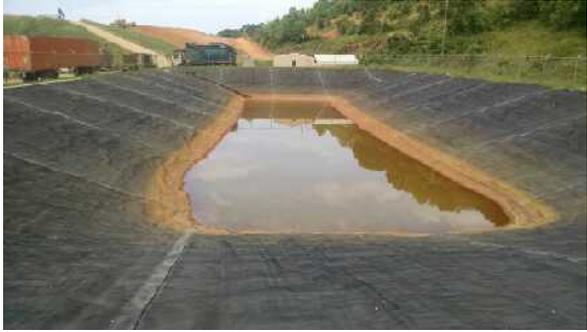
<p data-bbox="799 632 1040 657">NOTES Leachate Lagoon</p>
Photo 2	Photo 3

- The leachate lagoon is located to the east of the landfill. The lagoon is within a chain link enclosure and groundcover is being maintained. The liner was observed and no visual deficiencies were noted. The leachate lagoon is connected to the Town of Andrews Sanitary Sewer.

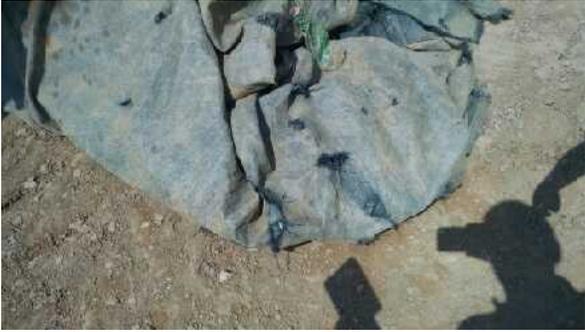
<p data-bbox="164 1188 386 1213">NOTES Damaged Tarp</p>

- Filling is currently occurring in cell #2 of phase 3. The working face was small and compact at the time of inspection.
- The facility is approved to use a tarp for alternative daily cover. Waste is covered with soil once per week. The tarp that was observed on top of the landfill appeared to be heavily damaged with holes and rips. Mr. Clark stated that they have been using soil instead of the tarp recently. **\*\*The heavily damaged tarp should not be used and replaced.\*\*** Mr. Clark stated that they had a new tarp on site and would replace the damaged one.

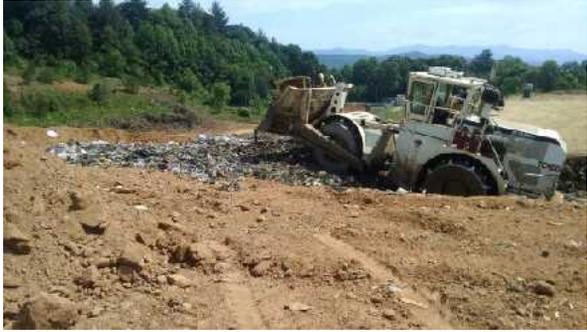
<p data-bbox="799 1188 1008 1213">NOTES Working Face</p>
Photo 4	Photo 5

- No unacceptable waste was observed on the working face. Multiple tires were observed set to the side of the working face. Tires and other unacceptable materials are taken to proper locations at the end of the working day.

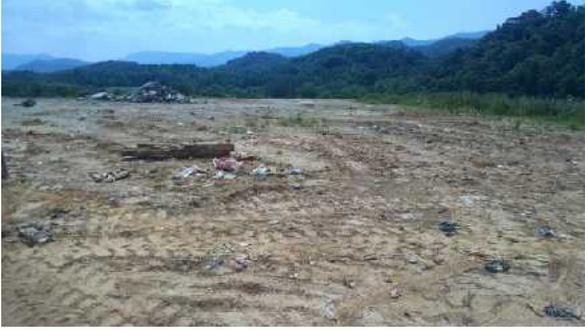
<p data-bbox="164 1734 607 1759">NOTES Windblown mixed with Cover Material</p>

- Windblown material was observed on the top of the landfill and appeared to be getting worked into cover, giving the appearance of inadequate cover. **\*Please note that windblown material must be picked up at the end of each day and returned to the working face.\*** Facility staff were actively policing the facility for windblown material at the time of inspection. A majority of the windblown material was located inside the landfill footprint with a small amount on the north side of the facility.

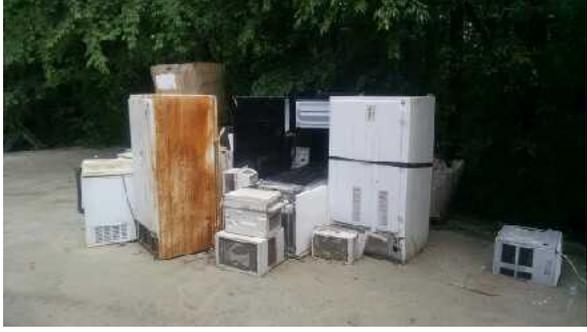
<p data-bbox="799 1734 1052 1759">NOTES White Goods Area</p>

- White goods containing refrigerants are stored on a concrete pad to the east of the scale house. Other white goods and scrap metal is stored to the south of the scale house.
- Some white goods containing refrigerants were observed laying on their sides. **\*\*White goods containing refrigerants should be stored upright until the refrigerant has been removed.\*\*** The facility contracts to have refrigerants removed onsite prior to sending the material for recycling.
- Scrap metal and white goods are sent to Sharp Auto Salvage in Marble, NC for recycling.
