# Vapor Mitigation System Installation Nottingham Apartments

## Market Street Storage Brownfields Project Greensboro, North Carolina

DENR BF Project #17057-13-041  
H&H Job No. MSS-002  
April 8, 2016

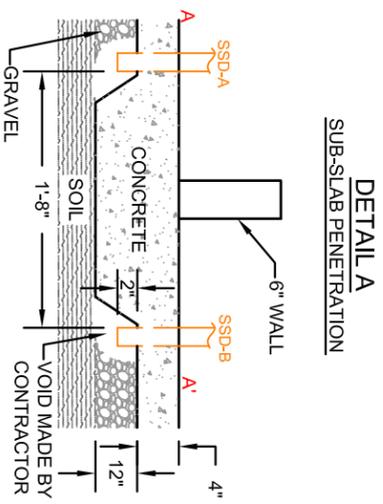
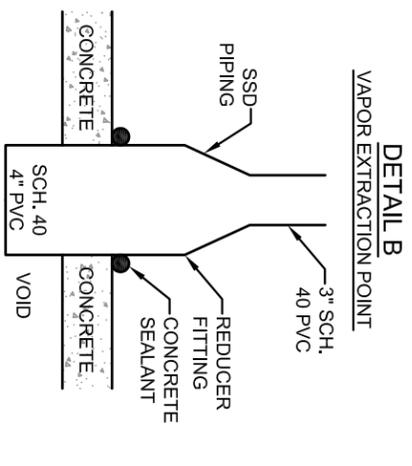
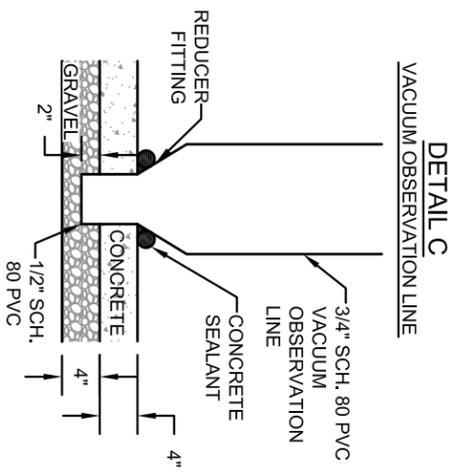
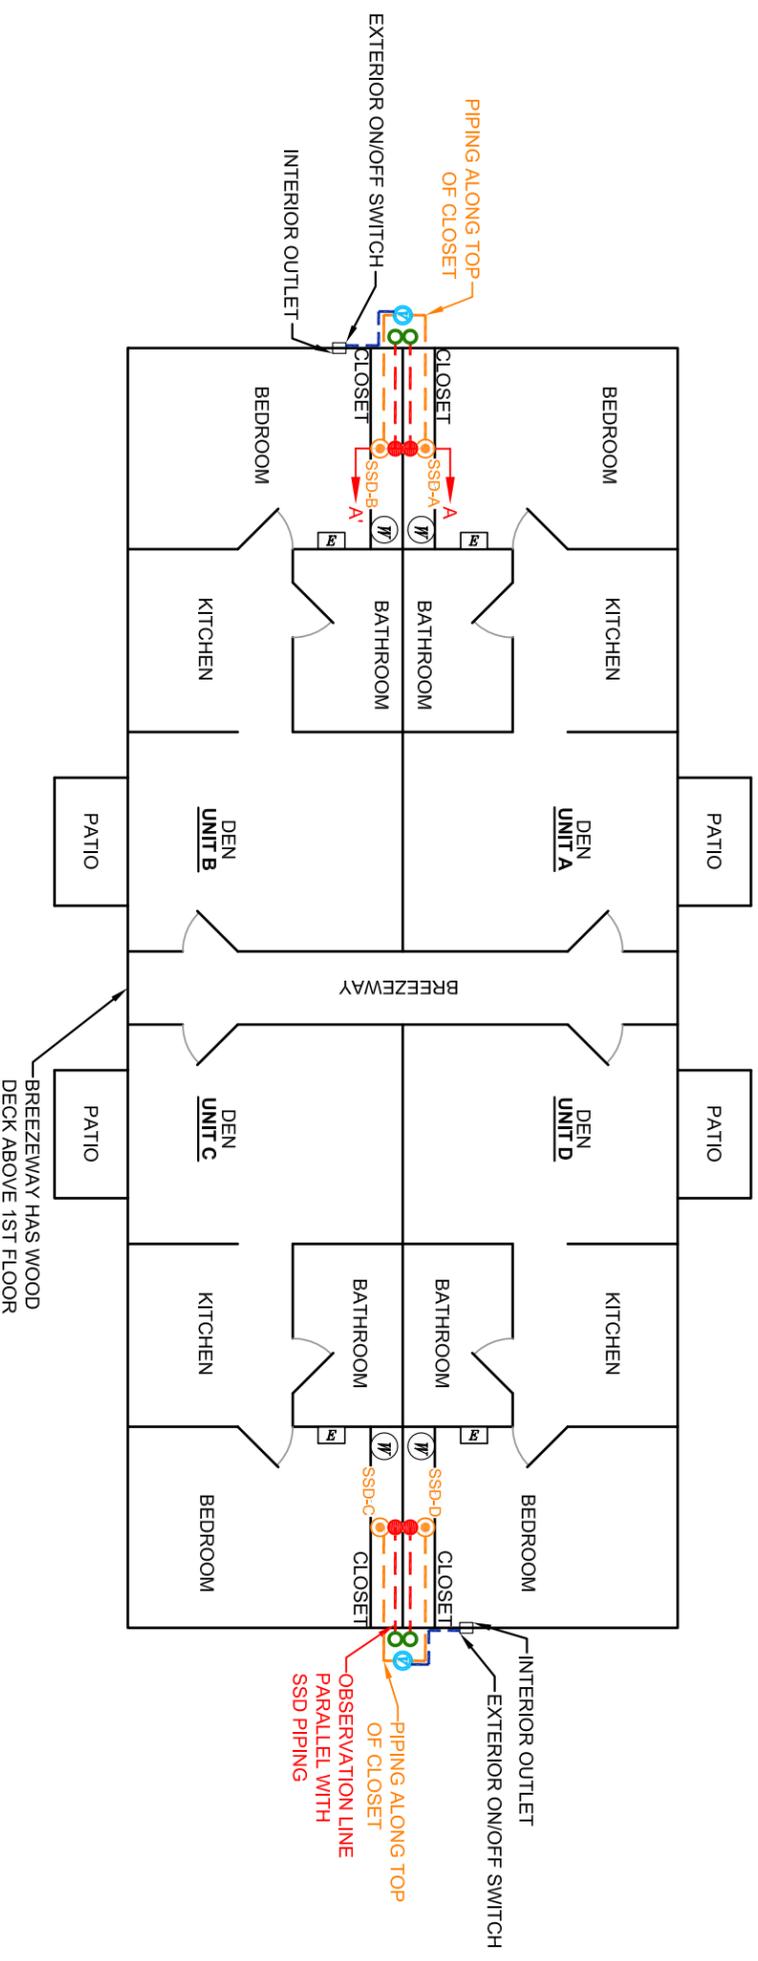
DATE: 4-12-16  
JOB NO. MSS-003  
REVISION NO. 0  
FIGURE NO. 2

On February 25, 2016, H&H installed a SSD system inside apartment building 4250. The system was installed in accordance with the approved work plan and a layout of the system is included as Figure 2. The SSD system consisted of two fans which drew sub-slab vapor from four sub-slab vapor extraction points located inside the apartment building. The fans used are known as AMG Legend, and fan specifications are provided in Appendix A. As shown in Figure 2 a sub-slab vapor extraction point was installed in each of the four first floor units (4250A, 4250B, 4250C, and 4250D). The sub-slab vapor was discharged to the atmosphere through an exterior exhaust stack.

TITLE  
**SUB-SLAB DEPRESSURIZATION SYSTEM LAYOUT**

The system was constructed by first drilling through the building's slab with a rotary hammer drill to install 4-inch diameter sub-slab penetrations (SSPs) extending approximately 2 inches beneath the slab. Following installation of the SSP, the contractor removed approximately 1 cubic ft of subsurface material from beneath the floor to create a void space around the end of the pipe for collection of air/vapor. H&H field personnel observed that the subsurface material removed from below the slab primarily consisted of gravel. This indicated that the gravel layer in the vicinity of the SSP was up to 1 ft in thickness. A 4-inch diameter PVC pipe connected to a 3-inch reducer was then installed and sealed at each penetration using Loctite Proline S10 Masonry Sealant. Each penetration was then connected via 3-inch PVC pipe to a fan that mounted to the exterior of the site building. Exhaust lines from the fans were bracketed to the exterior wall of the site building to height equal to or greater than 3 ft above the roof edge. The exhaust piping was finished with 90 degree turnout fittings equipped with vermin screens. Photographs of the SSD system installation are included in Appendix B.

To allow for future monitoring without disturbing the tenants, a vacuum gauging line was also installed (Figure 1). The vacuum gauging line was connected to the vacuum observation point installed through the slab at a location in the same closets as the SSPs. The observation point is 0.5-inch diameter schedule 80 PVC pipe which expanded to 0.75-inch schedule 80 PVC pipe.

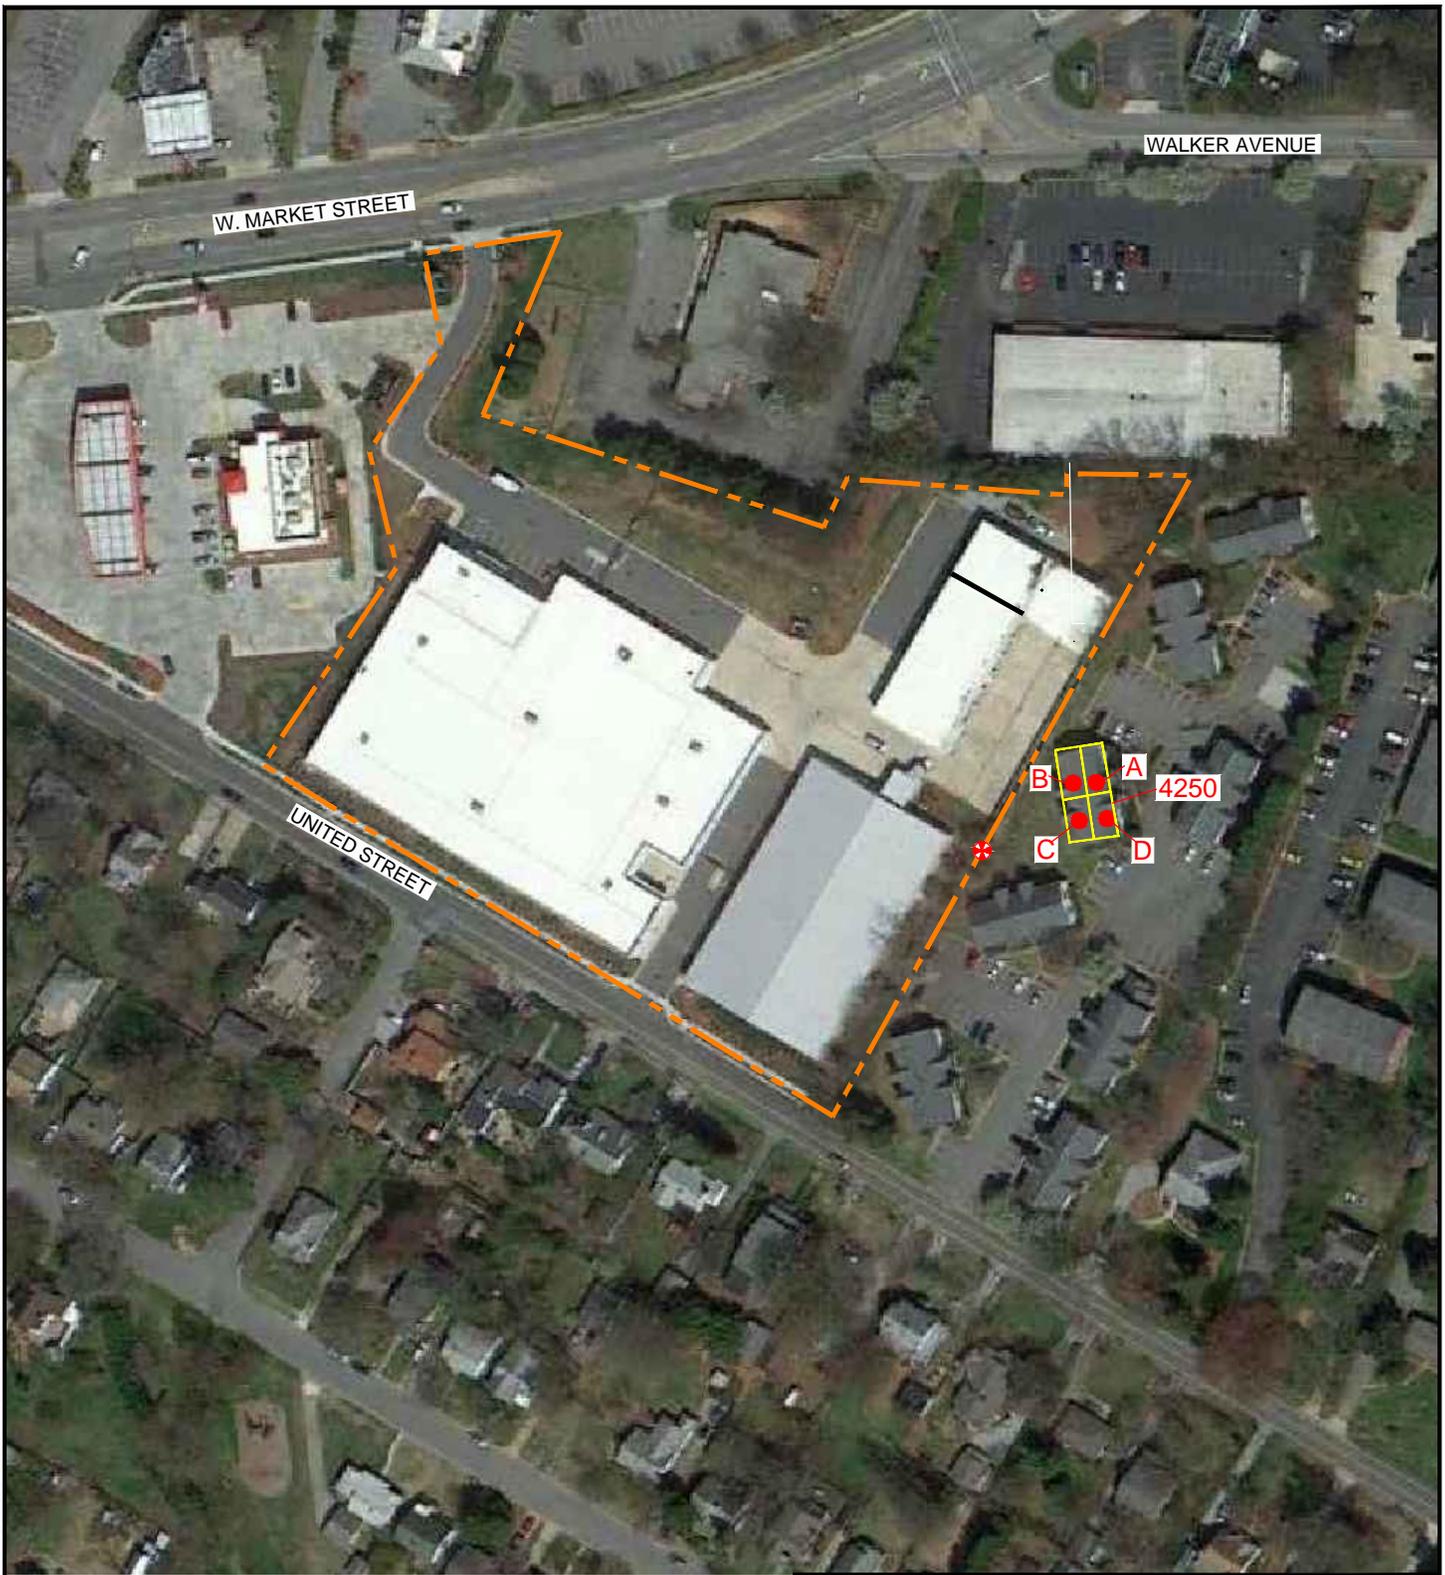
2923 South Tryon Street-Suite 100 Charlotte, North Carolina 28203 704-586-0007(p) 704-586-0373(f) License # C-1269 / #C-245 Geology	
DATE: 04-07-16	REVISION NO. 0
JOB NO. MSS-003	FIGURE NO. 3

TITLE <b>INDOOR AIR SAMPLE LOCATION MAP</b>	
PROJECT <b>NOTTINGHAM APARTMENTS MARKET STREET BROWNFIELDS PROJECT GREENSBORO, NORTH CAROLINA</b>

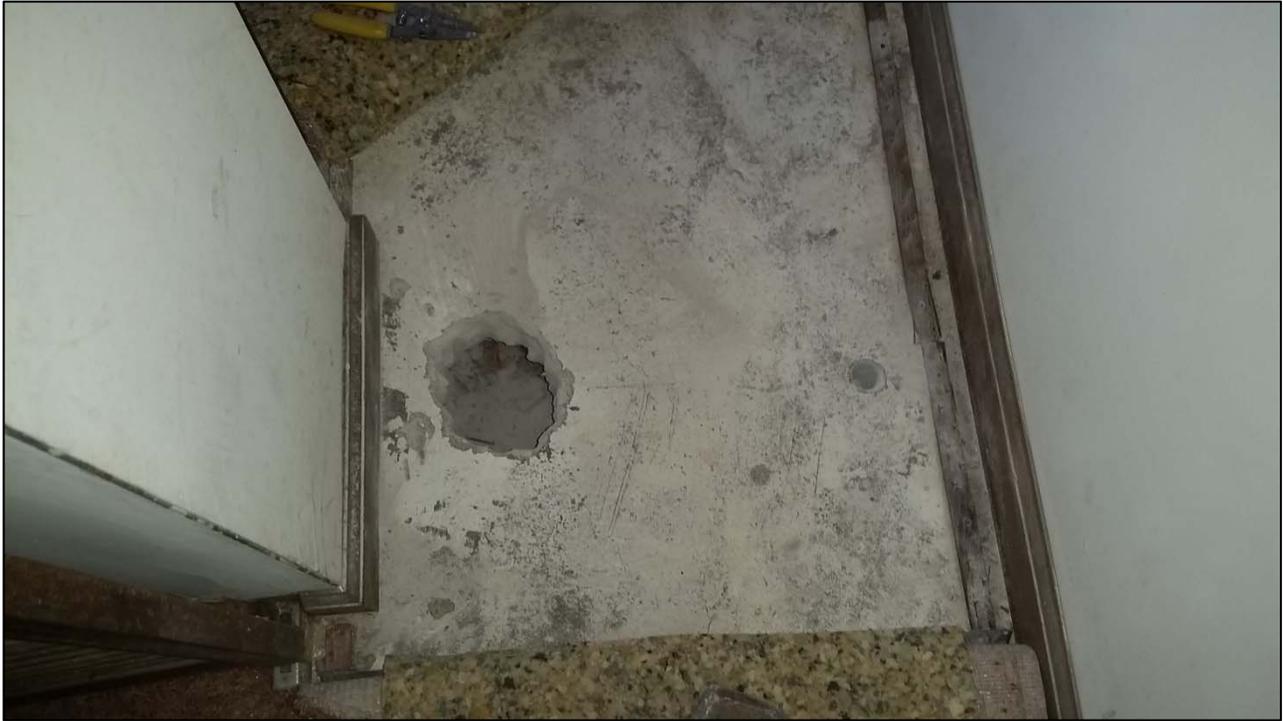
Photograph 1: View of sub-slab penetration.

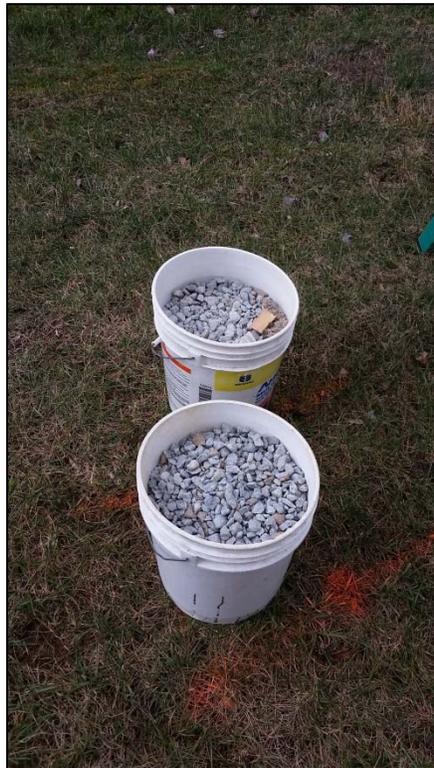
Photograph 2: View of gravel removed from sub-slab penetration

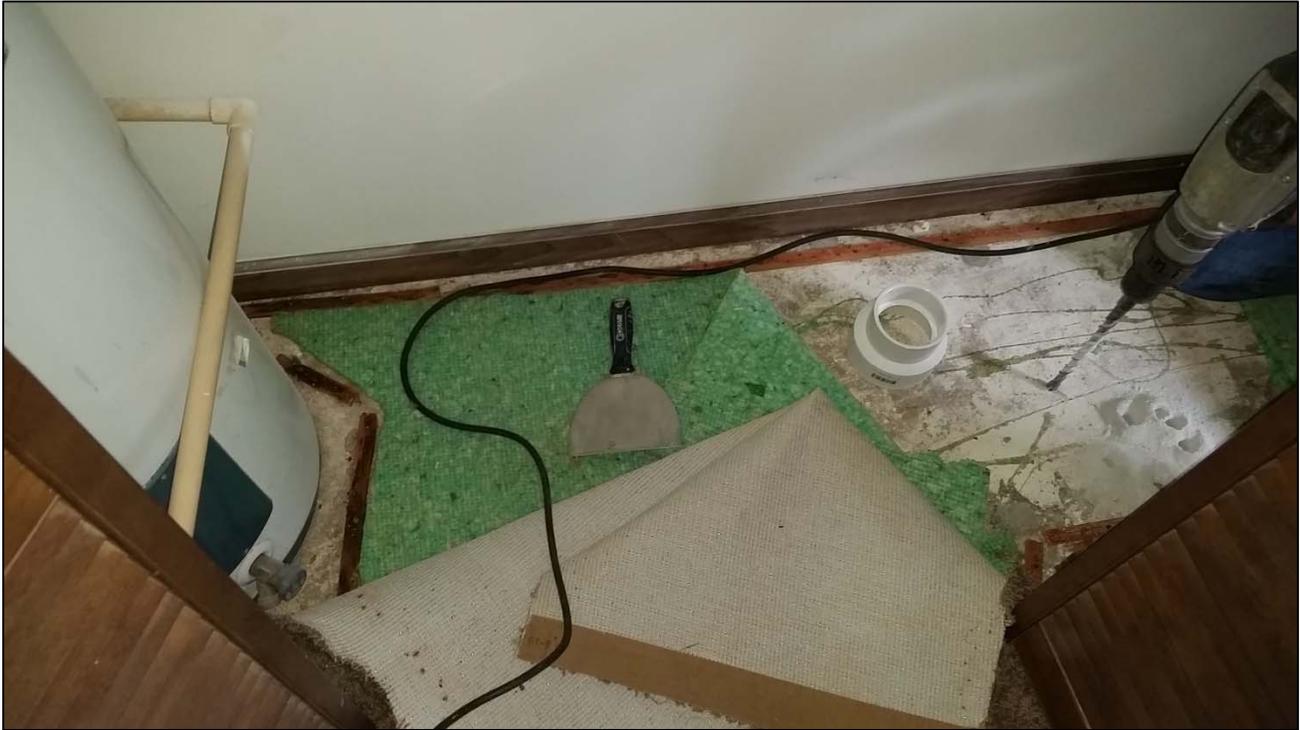
Photograph 3: View of soil vapor extraction point with reducer fitting.

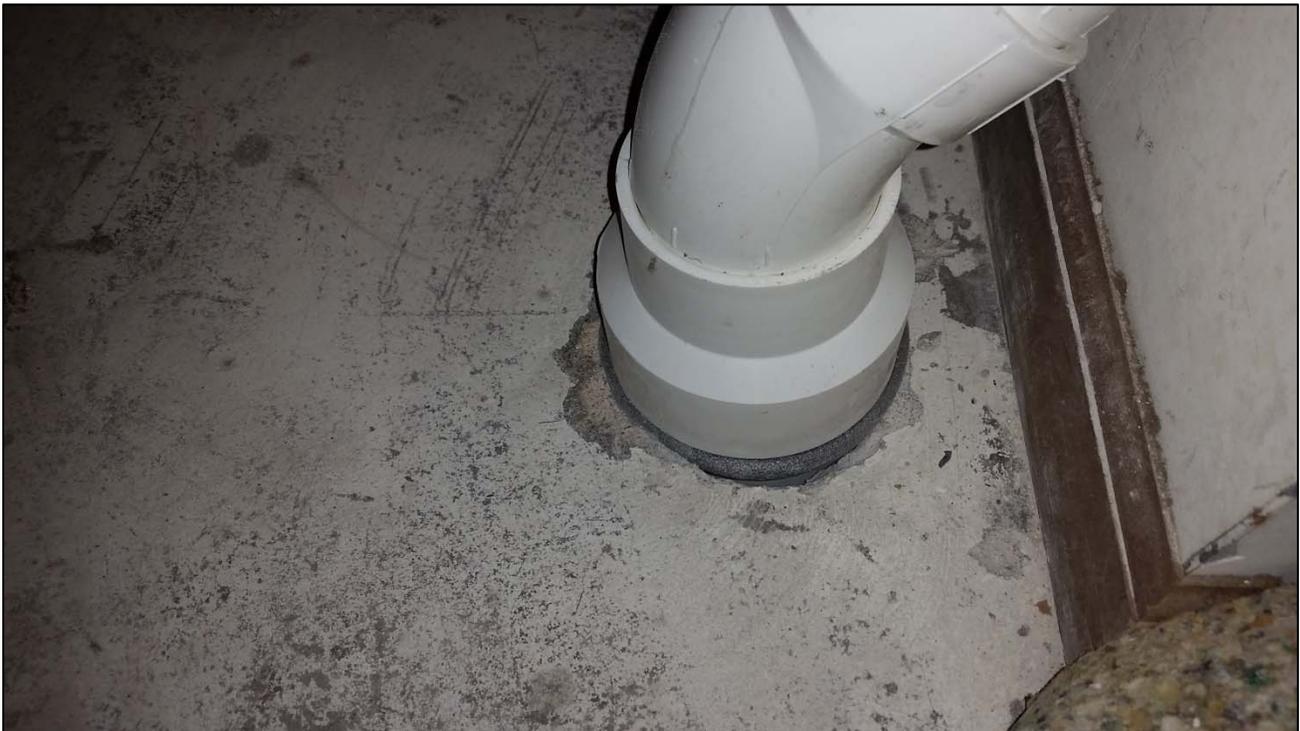
Photograph 4: View of soil vapor extraction point with foam backer installed.

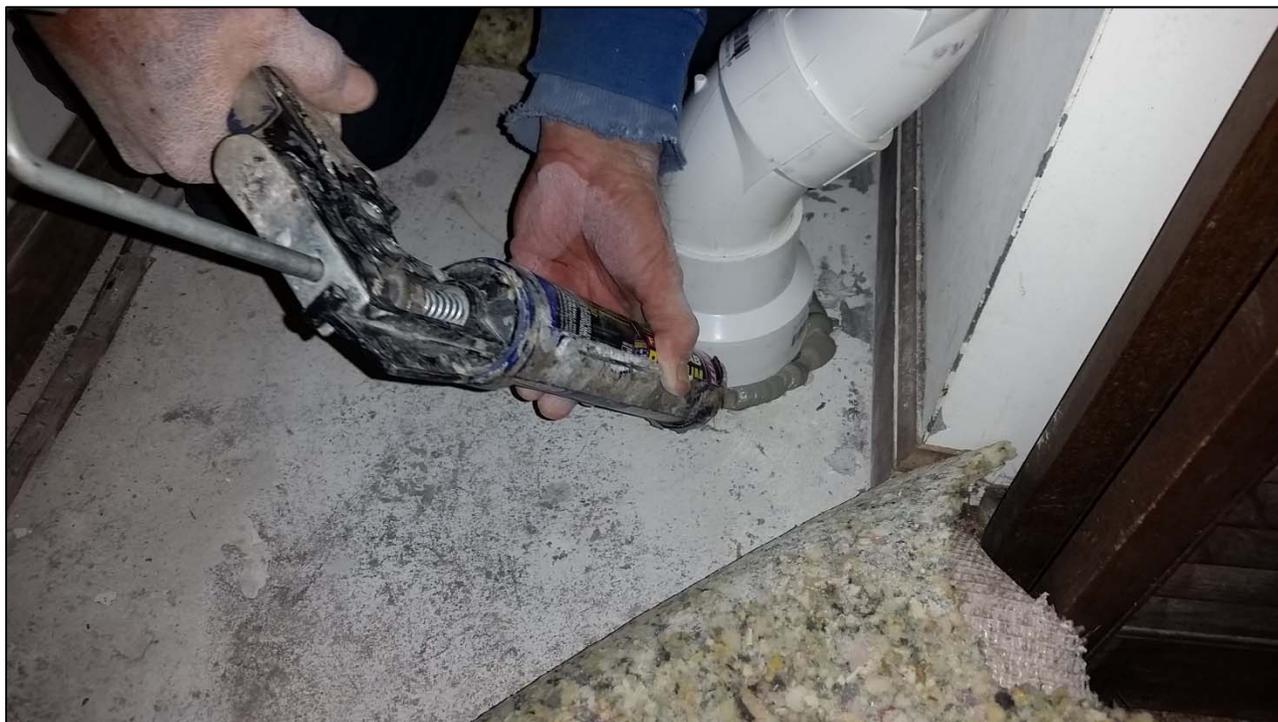
Photograph 5: View of masonry sealant installed around soil vapor extraction point.

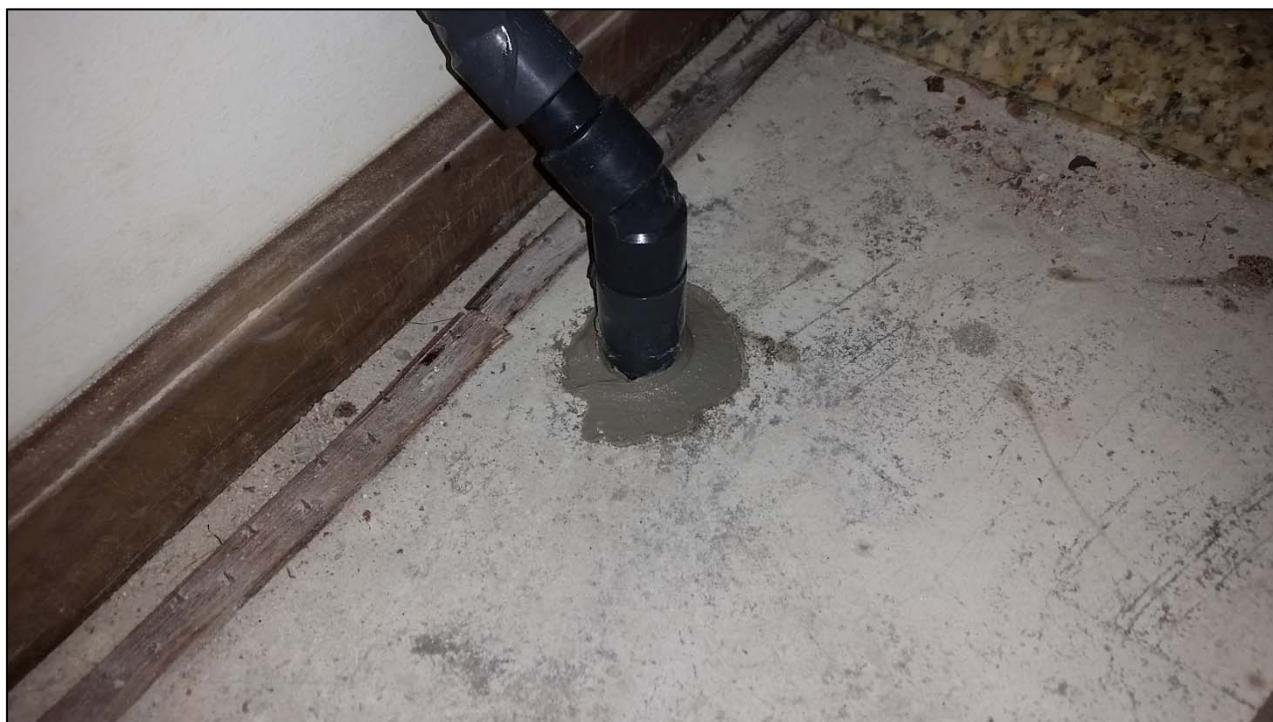
Photograph 6: View of vacuum observation point.

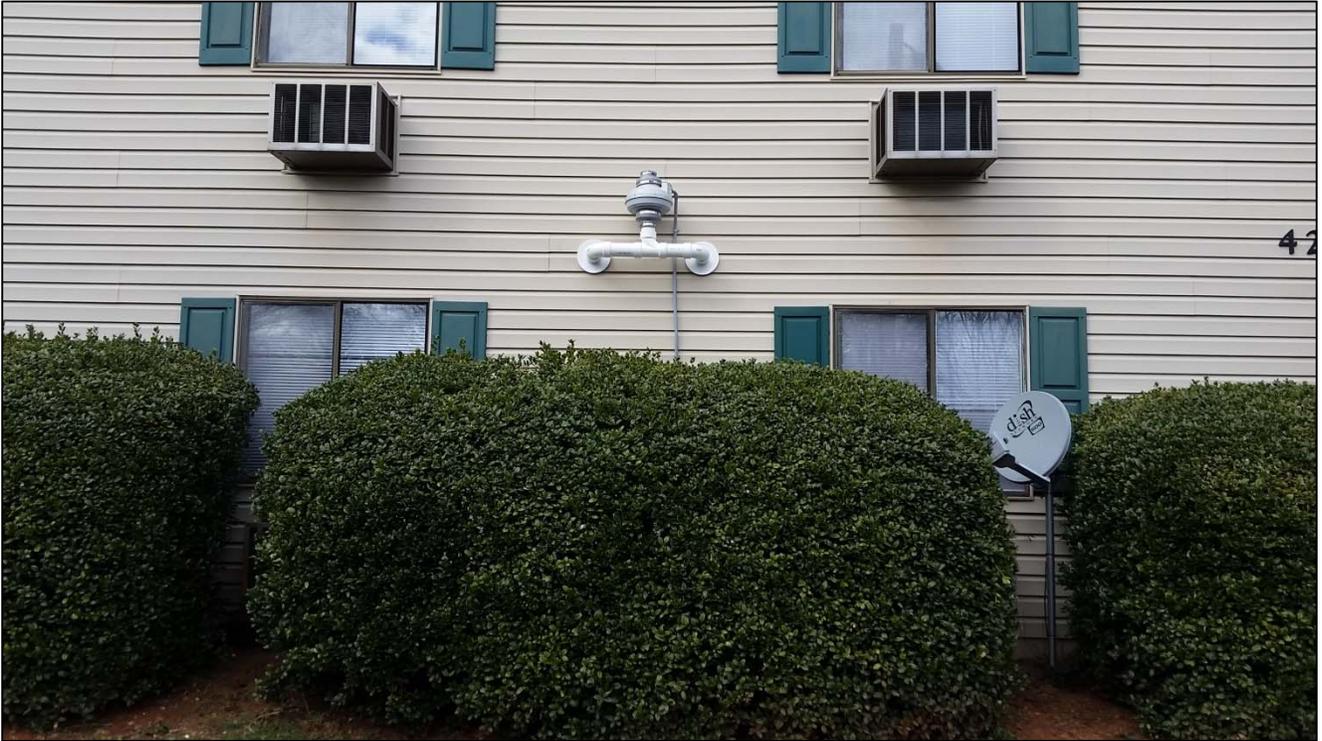
Photograph 7: View of vacuum motor on exterior wall

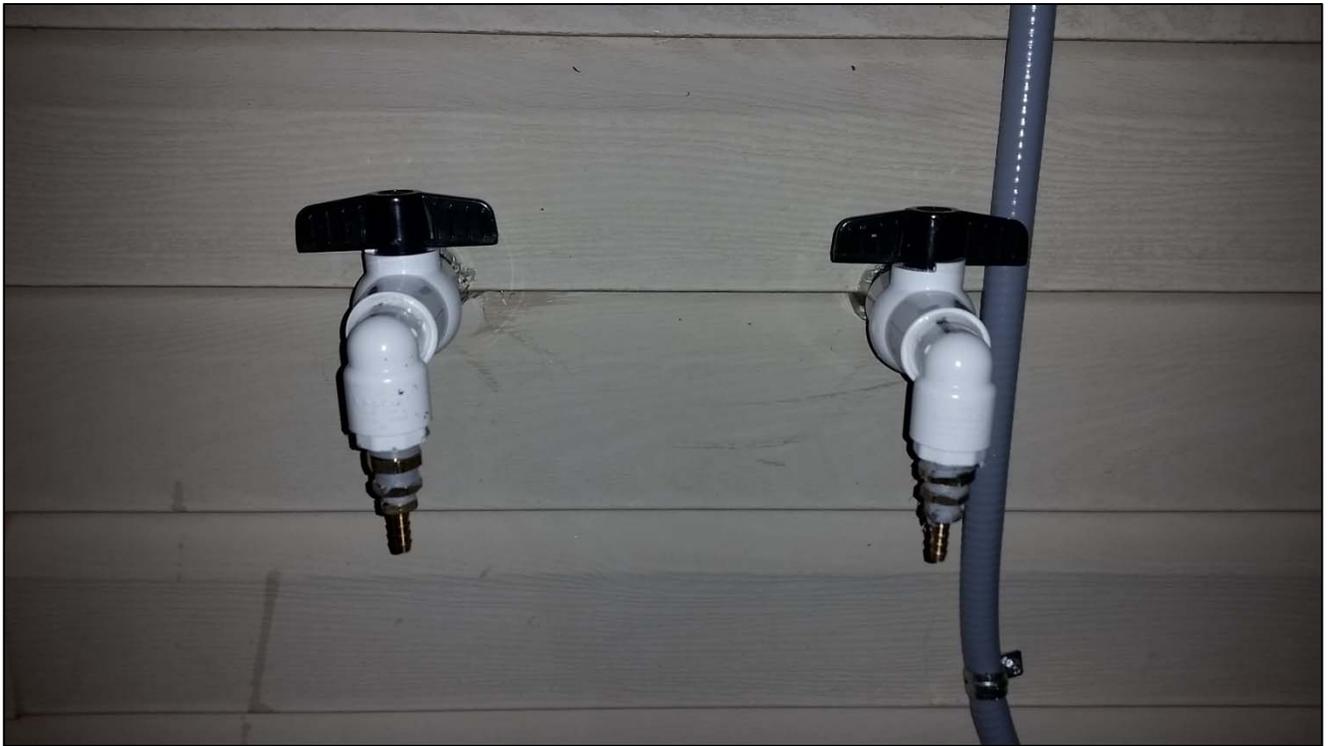
Photograph 8: View of exterior vacuum observation points.

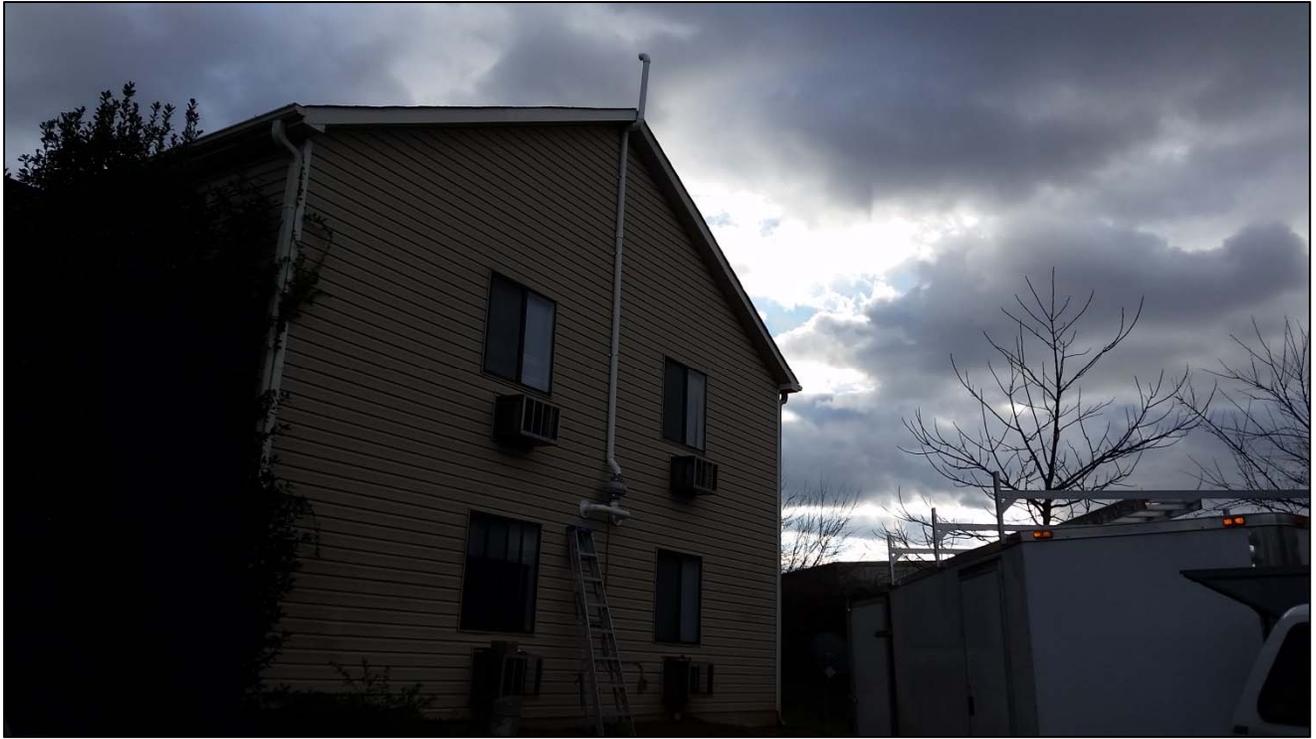
Photograph 9: View of exhaust piping
