**FACILITY COMPLIANCE INSPECTION REPORT**  
**Division of Waste Management**  
**Solid Waste Section**

**Date of Site Inspection:** May 26, 2016

Alamance County Austin Quarter Road Solid Waste Management Facility  
2701 Austin Quarter Road  
Graham, NC 27253

Comprehensive Inspection

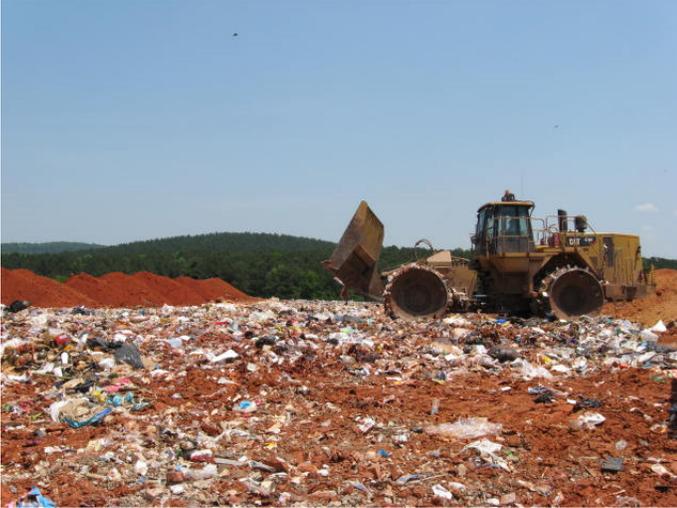
16. The facility Industrial User Pretreatment (IUP) Permit No. 0025 was issued (by the WWTP) on July 1, 2011 and expires on June 30, 2016.
17. The working face appeared adequate, small and compact. The area adjacent to the working face, along the internal side slope, is covered with Posi-Shell. Mr. Foust stated that Posi-Shell is reapplied as needed and is being used to achieve maximum compaction along the side slope.

MSW landfill working face

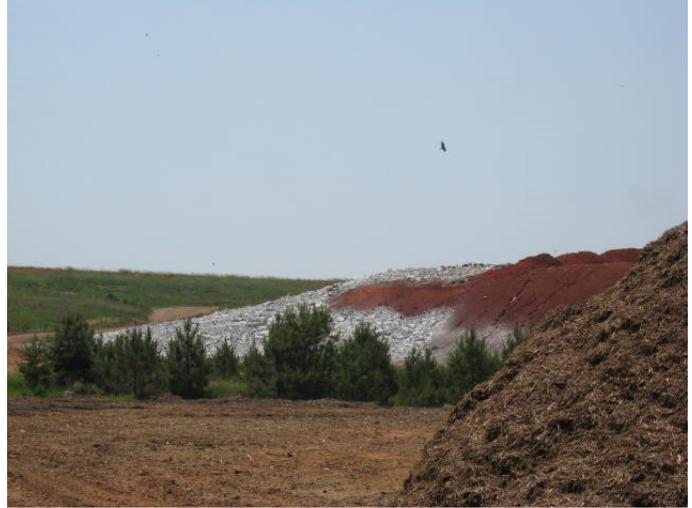
MSW landfill Posi-Shell applied to internal side slope

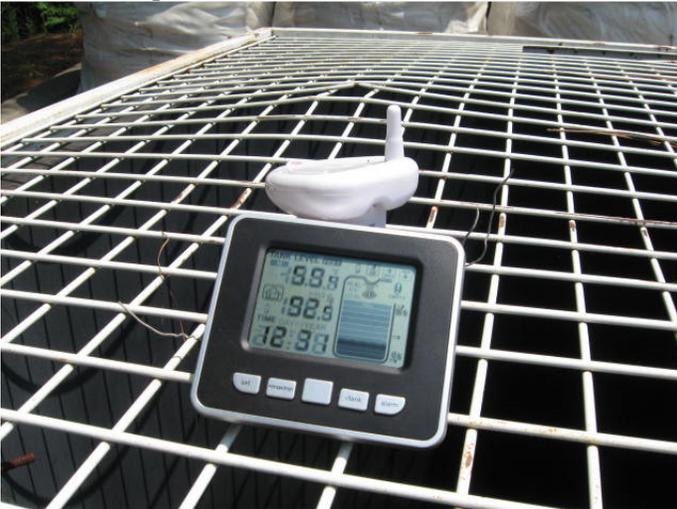
12. The facility has installed an electronic overflow prevention system at the leachate storage tank sump. The overflow prevention system is a level sensor that sends a signal to a tank level data readout pad. At the time of the inspection, the leachate storage tank sump depth was 6 feet indicating that there is 3 feet of leachate in each storage tank.

Leachate storage tank sump level sensor and tank level data readout pad.

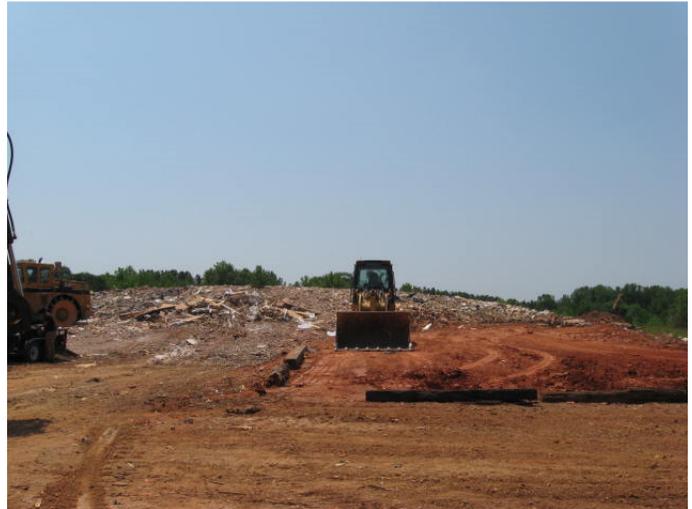
6. The FAR dated July 17, 2015 was received by the SWS. Facility throughput for July 2014 through June 2015 is 9,690.55 tons.
7. The working face appeared adequate.

C&D landfill working face

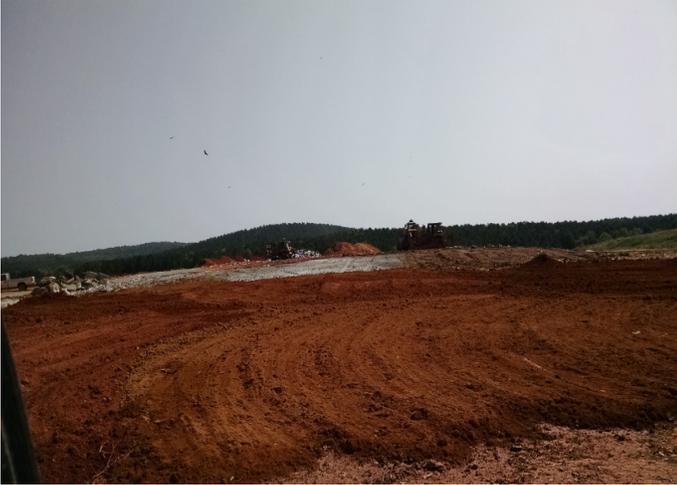
MSW landfill – area adjacent to working face (facility picture 05/26/16)

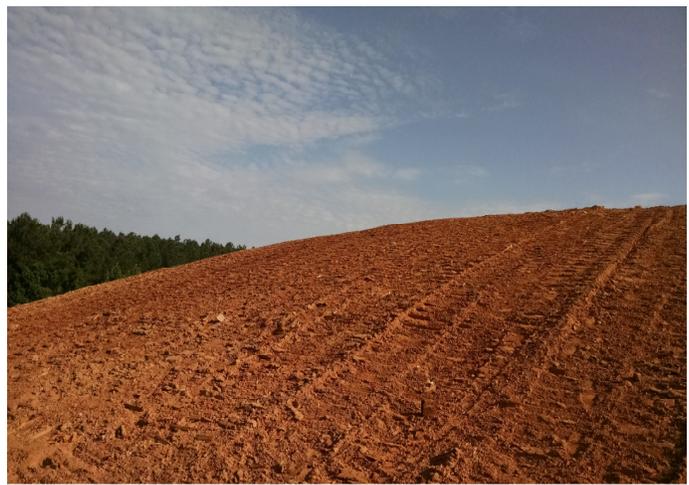
8. Material is being placed on the external side slopes to capture additional airspace. The side slopes are then being covered with soil and graded accordingly.

C&D landfill external side slope intermediate soil cover (facility picture 06/03/16)

11. Mr. Foust stated that grass seed will be sown in bare areas/areas of recent soil cover.
12. Mulch from the YW management operation is temporarily stored for public giveaway in future Phase 3.
