PHASE II SUBSURFACE INVESTIGATION REPORT

500 West 5th Street
Winston-Salem, North Carolina 27101

March 4, 2015
Partner Project Number: 14-131345.4

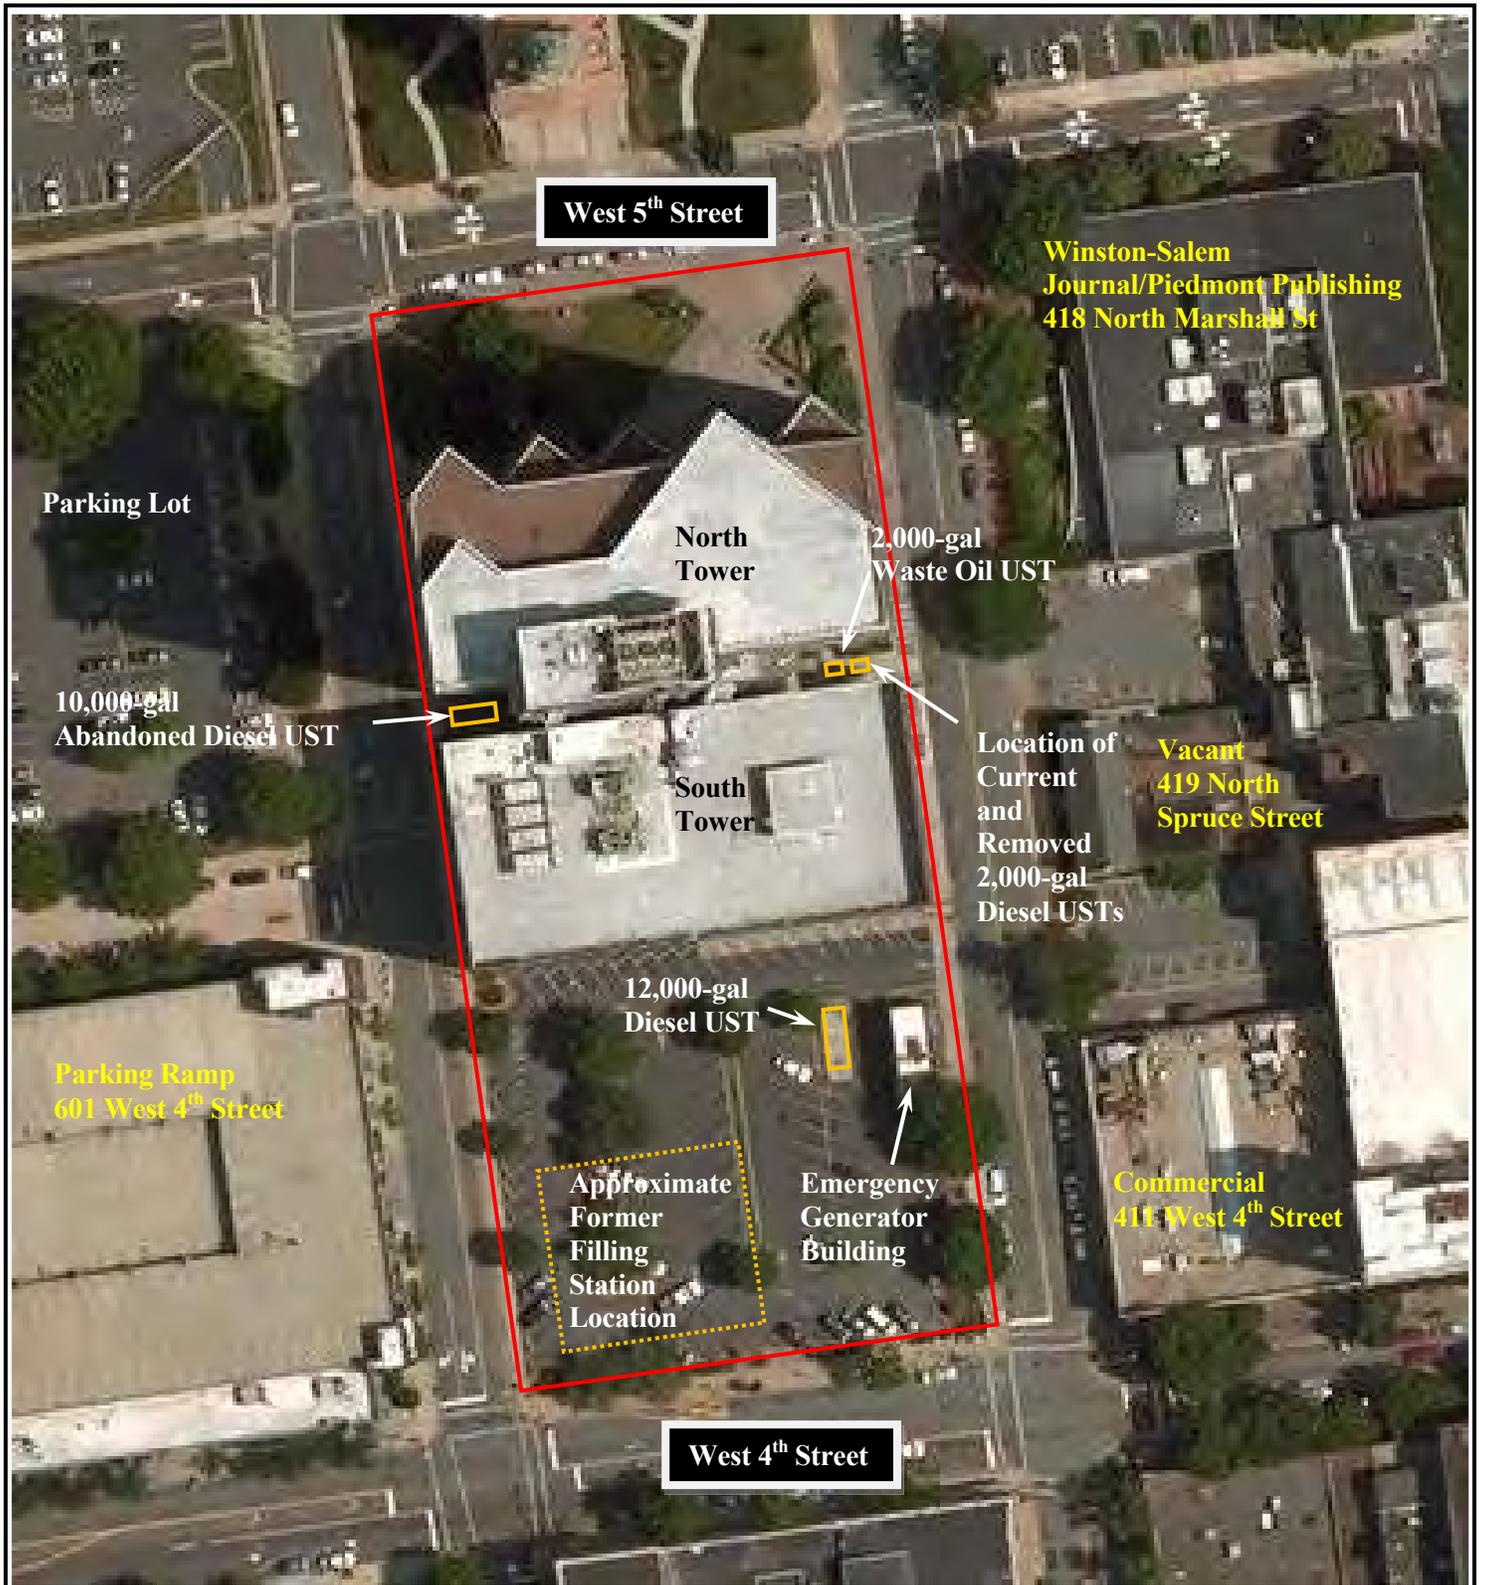
FIGURE 1: SITE PLAN

The subject property is bound by First Baptist Church across West 5th Street to the north; The Lowrey Building across West 4th Street to the south, the Winston-Salem Journal, an unoccupied historic domicile, and Chamber Plaza retail building across Spruce Street to the east, and a paved asphalt parking lot and a concrete parking structure across Poplar Street Northwest to the west. Refer to Figure 1 for a site plan showing site features and surrounding properties.

Key Subject Property Former Filling Station

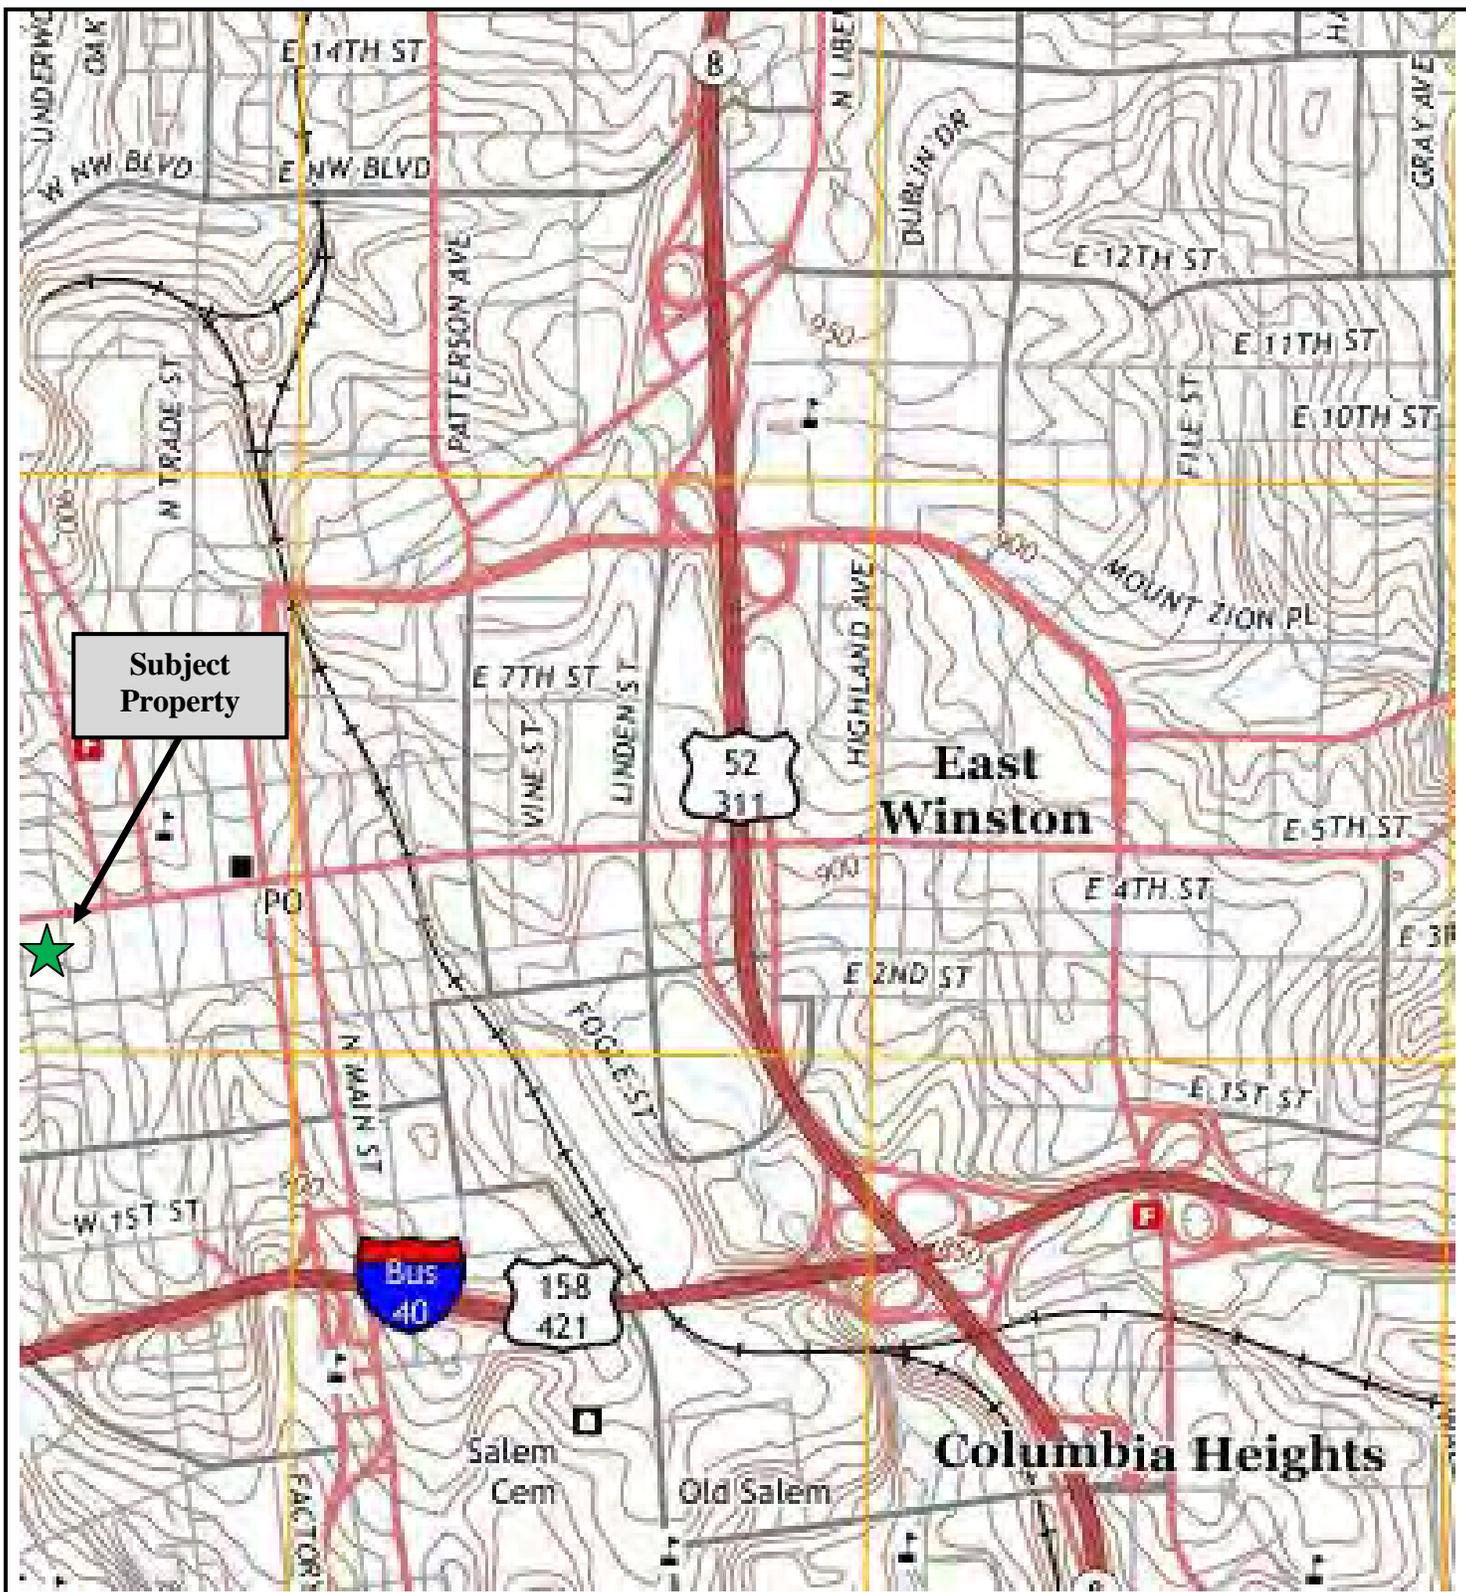
FIGURE 2: TOPOGRAPHIC MAP

According to the Geologic Map of North Carolina (1985), the project site is located within the Milton Belt Region. The Milton Belt consists of gneisses, schist, and metamorphosed intrusive rocks. The Milton Belt Region lies in the Piedmont Province which is characterized by gently rolling well rounded hills and long low ridges with a few feet of elevation difference between the hills and the valleys. More specifically, the site is underlain by the biotite and gneiss schist. Refer to Figure 2 for a topographic map of the site vicinity.

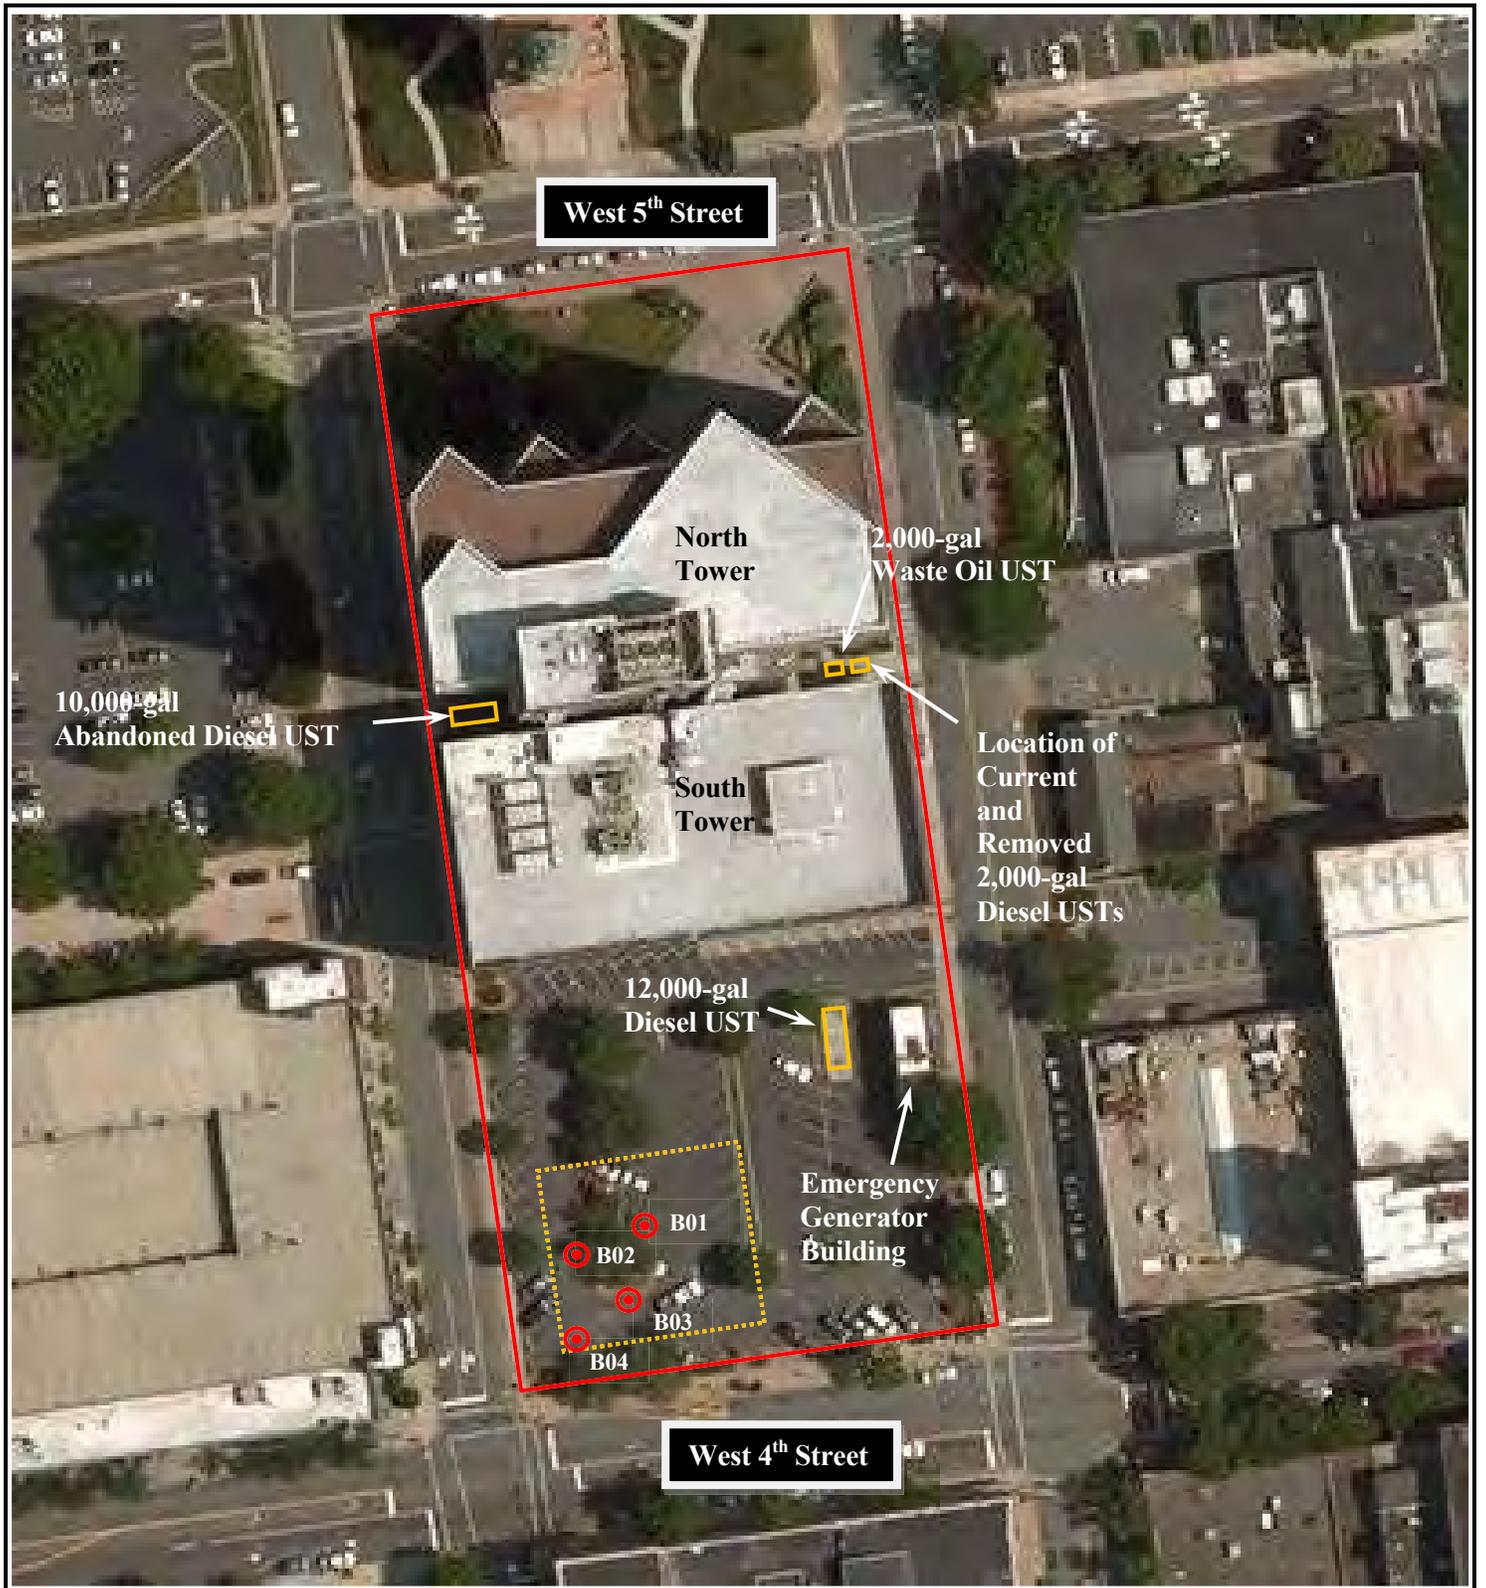
FIGURE 3: BORING LOCATIONS

Borings B01 through B04 were advanced in the southwest portion of the parking lot on the south end of the subject property, in the area formerly occupied by a filling station. Boring B01 was advanced near a subsurface anomaly on the east side of the inferred former filling station building location, and boring B02 was advanced on the west side of the area inferred to have been occupied by the former filling station building. Boring B03 was advanced next to the linear feature on the south end of the former filling station area, and boring B04 was advanced on the southwest corner of the former filling station area, in the inferred downgradient direction. Refer to Figure 3 for a map depicting boring locations.

- Subject Property
- Former Filling Station
- Soil Boring Location
