PHASE I ENVIRONMENTAL SITE ASSESSMENT

6.0 Acre Erwin Square/ Former Burlington Industries 2109 Hillsborough Road Durham, North Carolina 27605 S&ME Project No. 1054-10-288 B (rev.)

S&ME, Inc. 3201 Spring Forest Road, Raleigh, North Carolina 27616

September 28, 2011

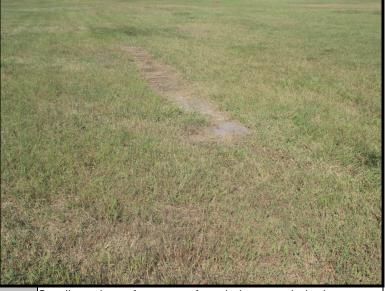
View facing north or eastern boundary of the subject site. 5 Adjacent area to the east is the Duke University Student Housing Apartments.

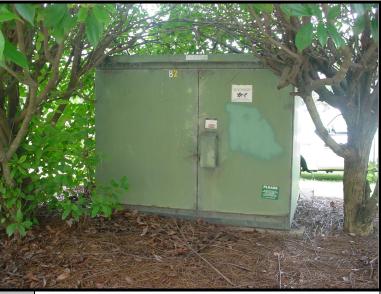
Close-up of sign on transformer, "Mineral Oil Filled" 11

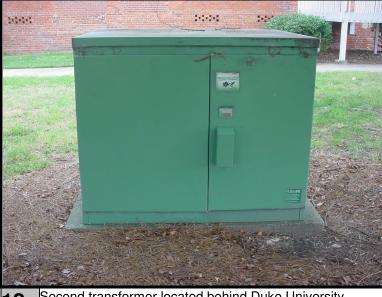
Two transformers were observed east of the subject site, 10 behind the Duke University Student Housing. This one was labeled as "Mineral Oil Filled".
