FACILITY COMPLIANCE INSPECTION REPORT
Division of Waste Management
Solid Waste Section

Date of Site Inspection: 06/02/2016 and 6/10/2016

Davidson County Integrated Solid Waste Management Facility
220 Davidson County Landfill Road
Lexington, NC 27292

Comprehensive Inspection

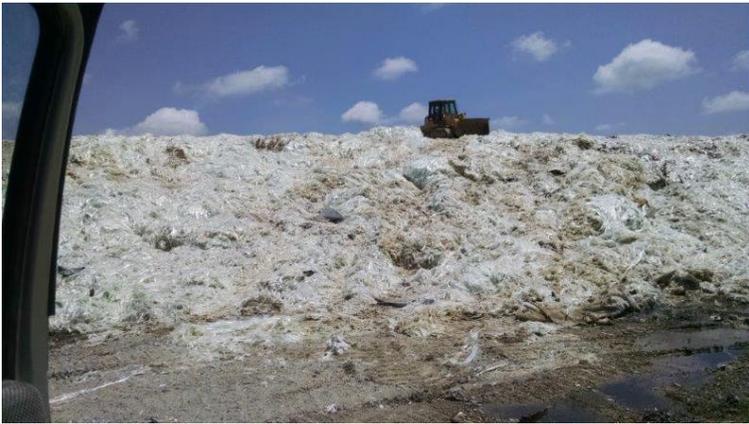
Upon initial inspection on 6/2/2016, the working face of the C&D landfill was observed to have inadequate cover, thus allowing waste to remain exposed and to become windblown. (Note that the waste stream is composed of large loads fiberglass strands.)

C&D landfill working face - observed 6/2/2016.

To achieve compliance, Davidson County must immediately apply cover to areas where waste is exposed to achieve a 6 inch layer of soil, as required by 15A NCAC 13B. 05042(f)(1).

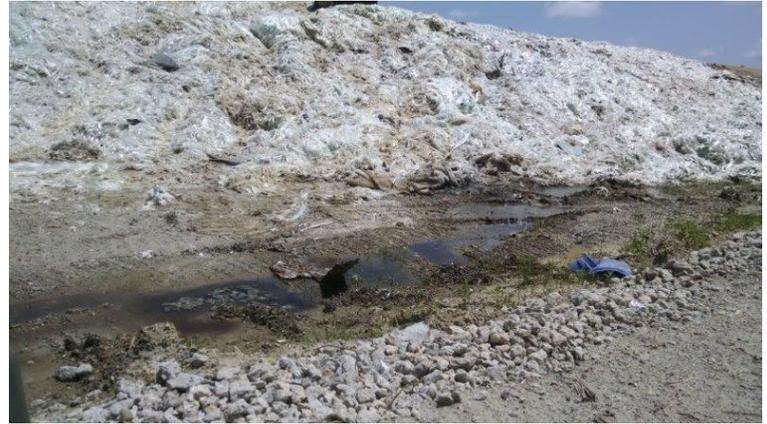
Upon initial inspection on 6/2/2016, ponding liquid was observed at the toe of the working face, along with a trail of liquid flow along the access roadway following the edge of waste downhill to an inert debris stockpile area, then out into the open area between the closed Phase 1 MSWLF and the active CDLF.

Close up view of leachate runoff at C&D landfill working face -- observed 6/2/2016.

To achieve compliance, Davidson County must contact Jaclynne Drummond, Solid Waste Section Hydrogeologist, at 828-296-4706 within ten (10) days of receipt of this report to present a sampling plan, to be implemented immediately upon her approval, which will evaluate the extent of any potential environmental impact resulting from these leachate releases. The results of this evaluation will dictate any additional corrective measures to be required. Please see the attached Notice of Violation letter for additional information about required corrective measures.

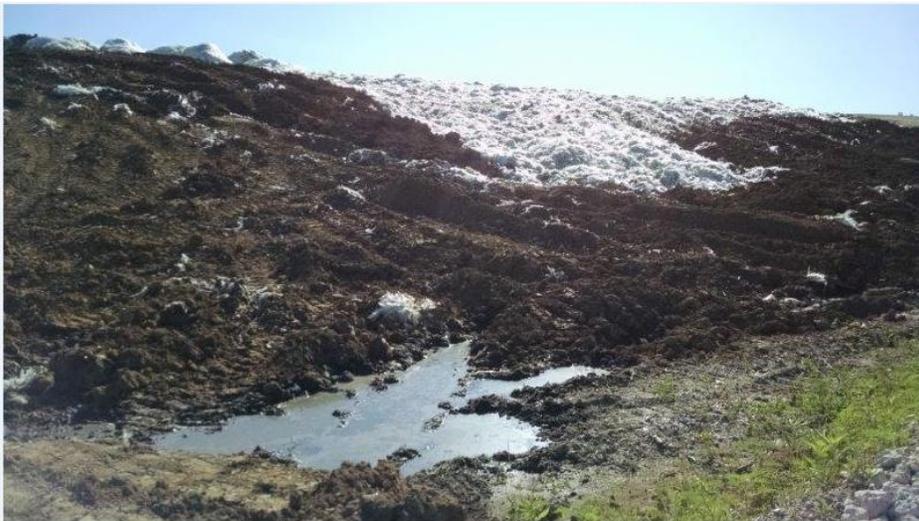
During the completion of the inspection on 6/10/2016, some progress had been made through the construction of a temporary berm which appeared to be containing much of the leachate emanating from the C&D landfill unit.

Improved cover and temporary berm to prevent leachate runoff at C&D landfill working face – observed 6-10-2016.

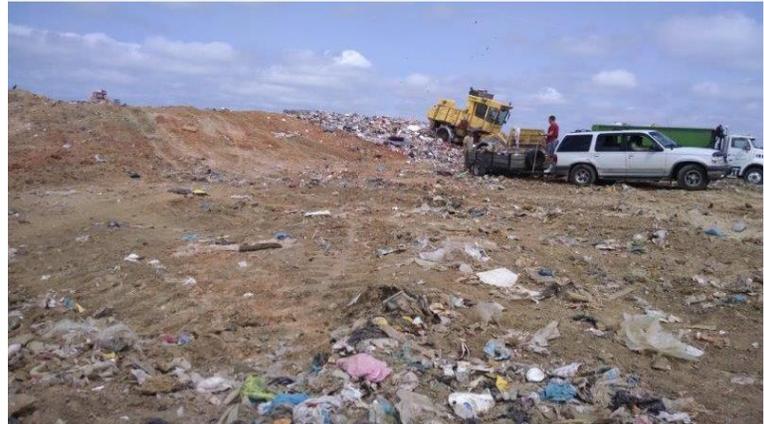
Upon initial inspection on 6/2/2016, the working face of Phase 2, Cell 2A of the MSW landfill was observed to have inadequate cover, thus allowing waste to remain exposed and to become windblown. In addition, the operating record indicating dates and times of placement of daily cover showed that the last time daily cover had been applied was the previous week.

Inadequate cover of waste, looking up the side slope toward the working face 6/2/2016.

To achieve compliance, Davidson County must apply cover to areas where waste is exposed to achieve a 6 inch layer of soil as required by June 30, 2016.

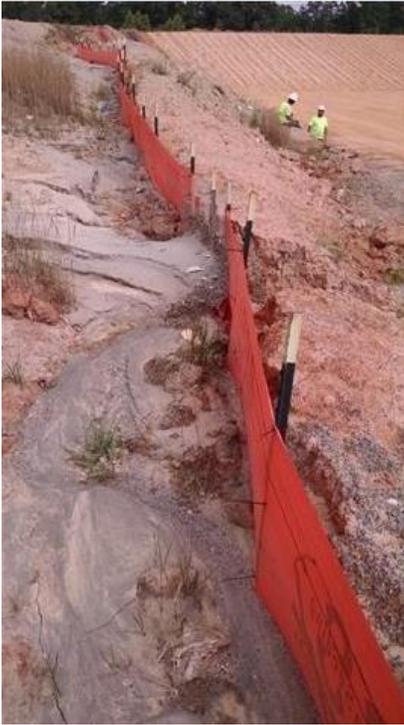
Upon initial inspection on 6/2/2016, the entire northern slope of the active landfill (Ph. 2, Area 2, Cell 1B) showed evidence of severe erosion, where silt containing exposed waste had flowed through the silt fencing and into the area of the as yet unlined portion of the new cell (Ph. 2, Area 2, Cell 2A and 2B) which is currently under construction.

View of erosion and sediment flow along the silt fence protecting the area of new cell construction.

To achieve compliance, Davidson County must ensure that erosion control measures are sufficient to prevent silt from leaving the MSWLF facility and to prevent on-site erosion.

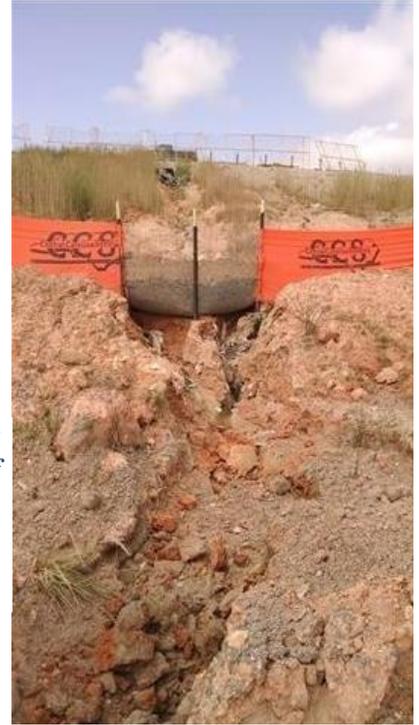
Upon initial inspection on 6/2/2016, the entire northern slope of the active landfill (Ph. 2, Area 2, Cell 1B) showed evidence of severe erosion, which had resulted in the development of deep ruts and gullies along the entire slope leading directly to the unlined portion of the new cell (Ph. 2, Area 2, Cell 2A and 2B) which is currently under construction.

View of erosion and sediment flow as seen from the berm of the new landfill cell looking up the slope to the protective silt fence.

To achieve compliance, Davidson County must ensure that erosion control measures are sufficient to prevent on-site erosion. The slope must be inspected regularly to ensure it remains intact as the vegetative cover sprouts and becomes established.

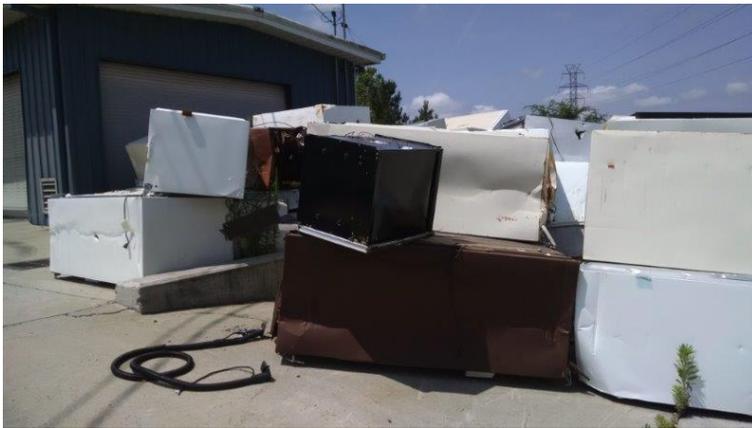
61. At the time of the inspection, the white goods area was observed to be full. Units containing CFCs were not properly staged to ensure that gas lines remained intact and the CFCs safely contained. Mr. Sink stated that a contact was currently being negotiated to provide for CFC evacuation and removal of the accumulated white goods and scrap metals.
62. **Please ensure that white goods are handled and stored properly to eliminate the unintentional release of CFC gases at the site. In addition, please ensure that white goods are removed from the site in a timely manner so that adequate space is available for safe storage of the materials received.**

White goods collection and storage area.
