Phase I Environmental Evaluation And Comprehensive Regulatory Compliance Audit

Metal Plating & Fabricating Inc.
High Point, North Carolina

February 4, 1993

Brett S. Higgins
Staff Geologist

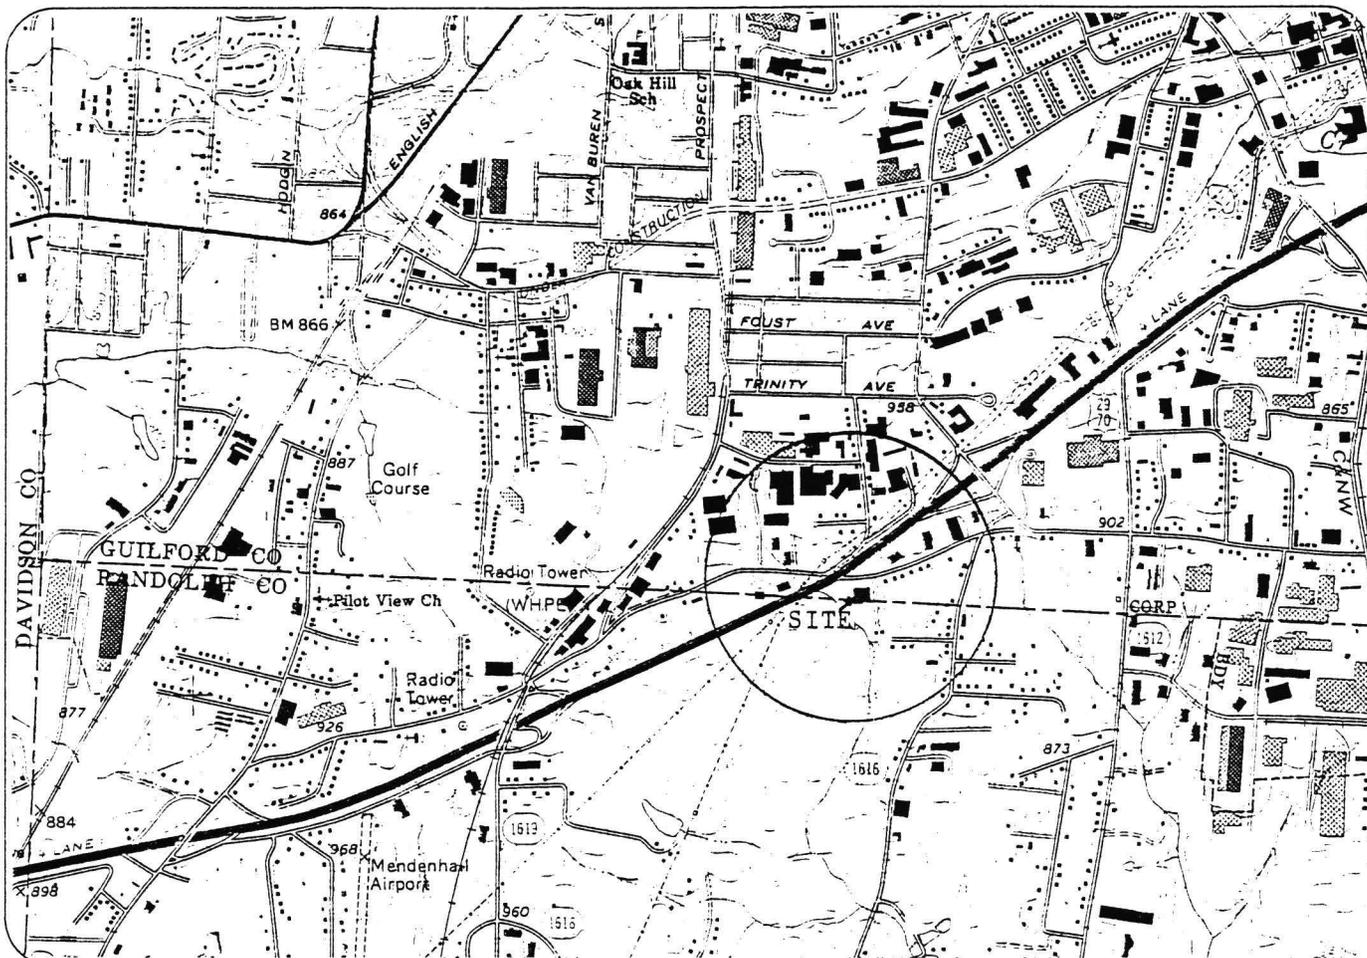
FOR:	METAL PLATING & FABRICATING	CITY:	HIGH POINT
TITLE:	TOPOGRAPHICAL MAP		
SCALE:	1" = 2000'	DWN BY:	DJ
DATE:	12/15/92	DWG NAME:	USGS-1
CK BY:	BSH	FIGURE:	1
		JOB #:	AH14-006

USGS HIGH POINT WEST 7.5 MINUTE QUADRANGLE
 DATE OF MAP: 1969 PHOTOREVISION DATE: 1987
 PHOTOREVISION DENOTED IN PURPLE (COLOR MAPS ONLY)

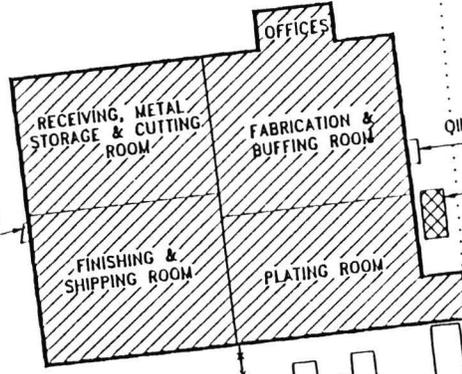
OIL STAINING AT
COMPRESSOR
BLOWDOWN

- A considerable amount of oil staining was noted beneath the compressor blow down pipe on the east side of the building.
- Oil staining was noted adjacent to an electrical transformer on the east side of the building.

- Assess oil staining at compressor blow down and electrical transformer locations.
- Remove and dispose of abandoned 55 gallon drums on the south area of the property.

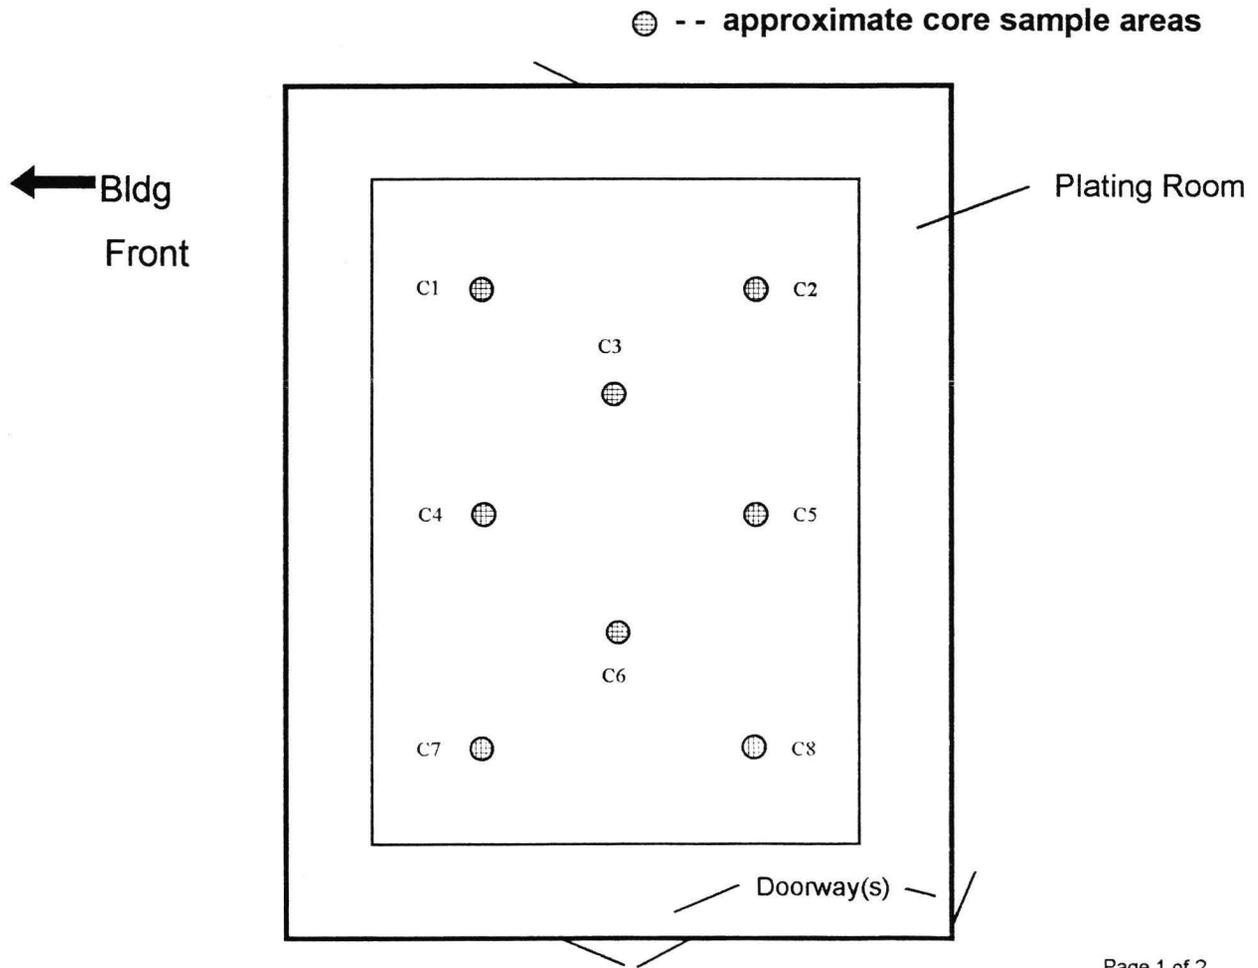
The purpose of this environmental assessment is to determine the environmental conditions in connection with the former plating operation at the site. Eight (8) cores (⊕) will be taken of the concrete, and soils underneath at levels of one(1), three (3) and six (6) feet. The concrete and soil cores will be analyzed for eight RCRA metals, copper, nickel, zinc and cyanide according to EPA analysis protocol.

The eight cores will be taken from the plating floor as described in the diagram below:

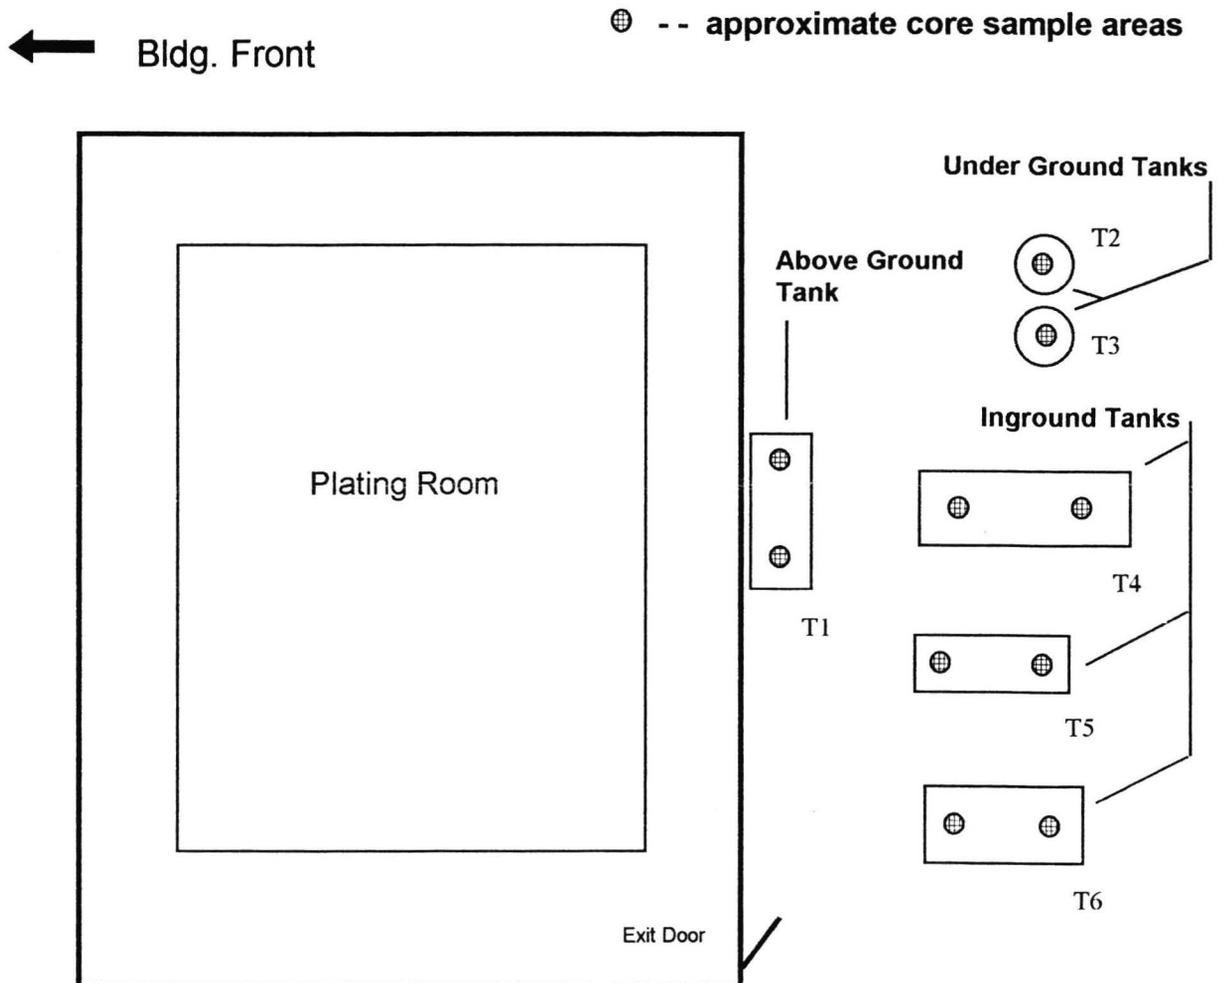
The former Metal Plating and Fabricating located at 2309 Dunmore Court, High Point, NC operated an exterior waste treatment plant consisting of one (1) above ground (#1), two (2) underground tanks, (#'s 2 & 3) and four inground tanks (#'s 4, 5, & 6).

The purpose of this environmental assessment is to determine the environmental conditions in connection with the waste treatment operation at the site. Ten (10) cores will be taken of the soils underneath at levels of one(1), three (3) and six (6) feet. The soil cores will be analyzed for eight RCRA metals, copper, nickel, zinc and cyanide according to EPA analysis protocol.

The ten (10) cores (⊕) will be taken from the waste treatment area as described in the diagram below:
