**FINAL REPORT
RCRA FACILITY ASSESSMENT
RALEIGH, WAKE COUNTY, NORTH CAROLINA**

**U.S. Environmental Protection Agency
Region IV
Atlanta, Georgia**

Work Assignment No.	: R04031C04073
EPA Region	: IV
Site No.	: NCD003185238
Contract No.	: 68-W9-004
CDM Federal Programs Corporation Document No.	: TES7-R04031-FR-DBHT
Prepared by	: CDM Federal
Work Assignment Project Manager	: Robert Rose
Telephone No.	: (404) 952-7393
EPA Work Assignment Manager	: Roberta Howes
Telephone No.	: (404) 347-3433
Date Prepared	: September 18, 1992

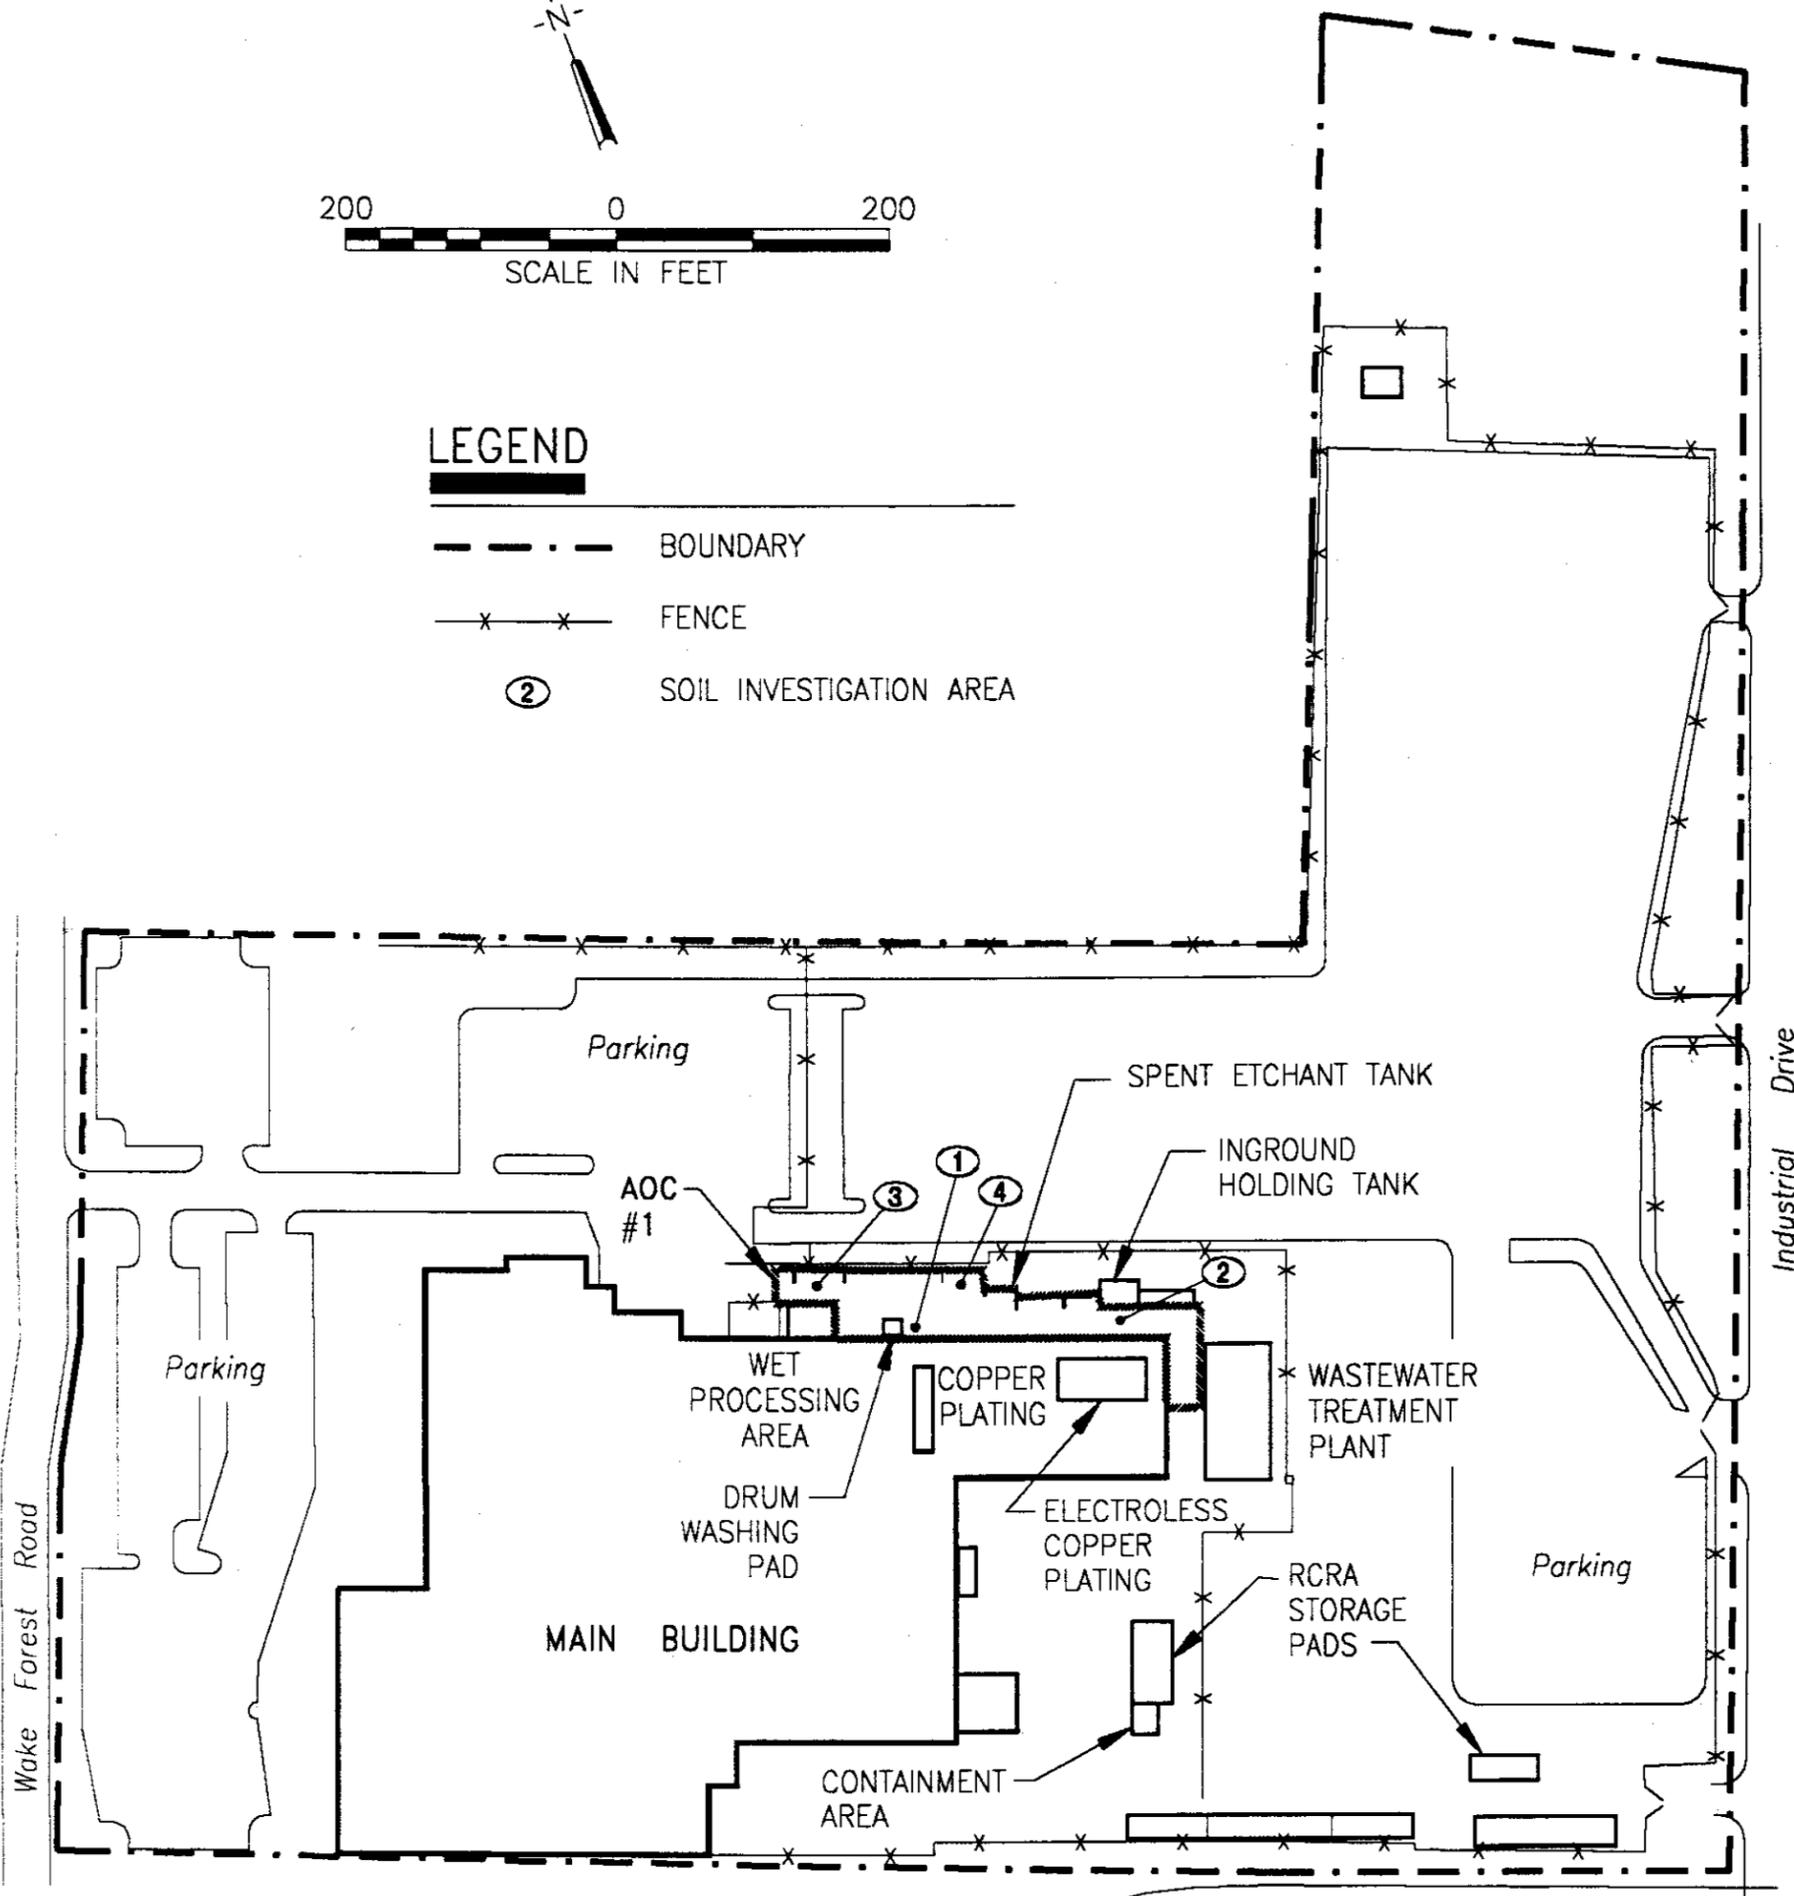
**CDM FEDERAL PROGRAMS CORPORATION
SITE LAYOUT**

The second area was 145 feet east of Area 1 (Figure 2). Soil discoloration was noted at a depth of 2.5 feet bls. Excavation went to eight feet. Several abandoned two- and four-inch chemical transfer lines were located in this area, which may be the source of contamination. Soil samples were found to be acidic, increasing the probability of leaching due to the increased mobility of metal ions under acidic conditions.

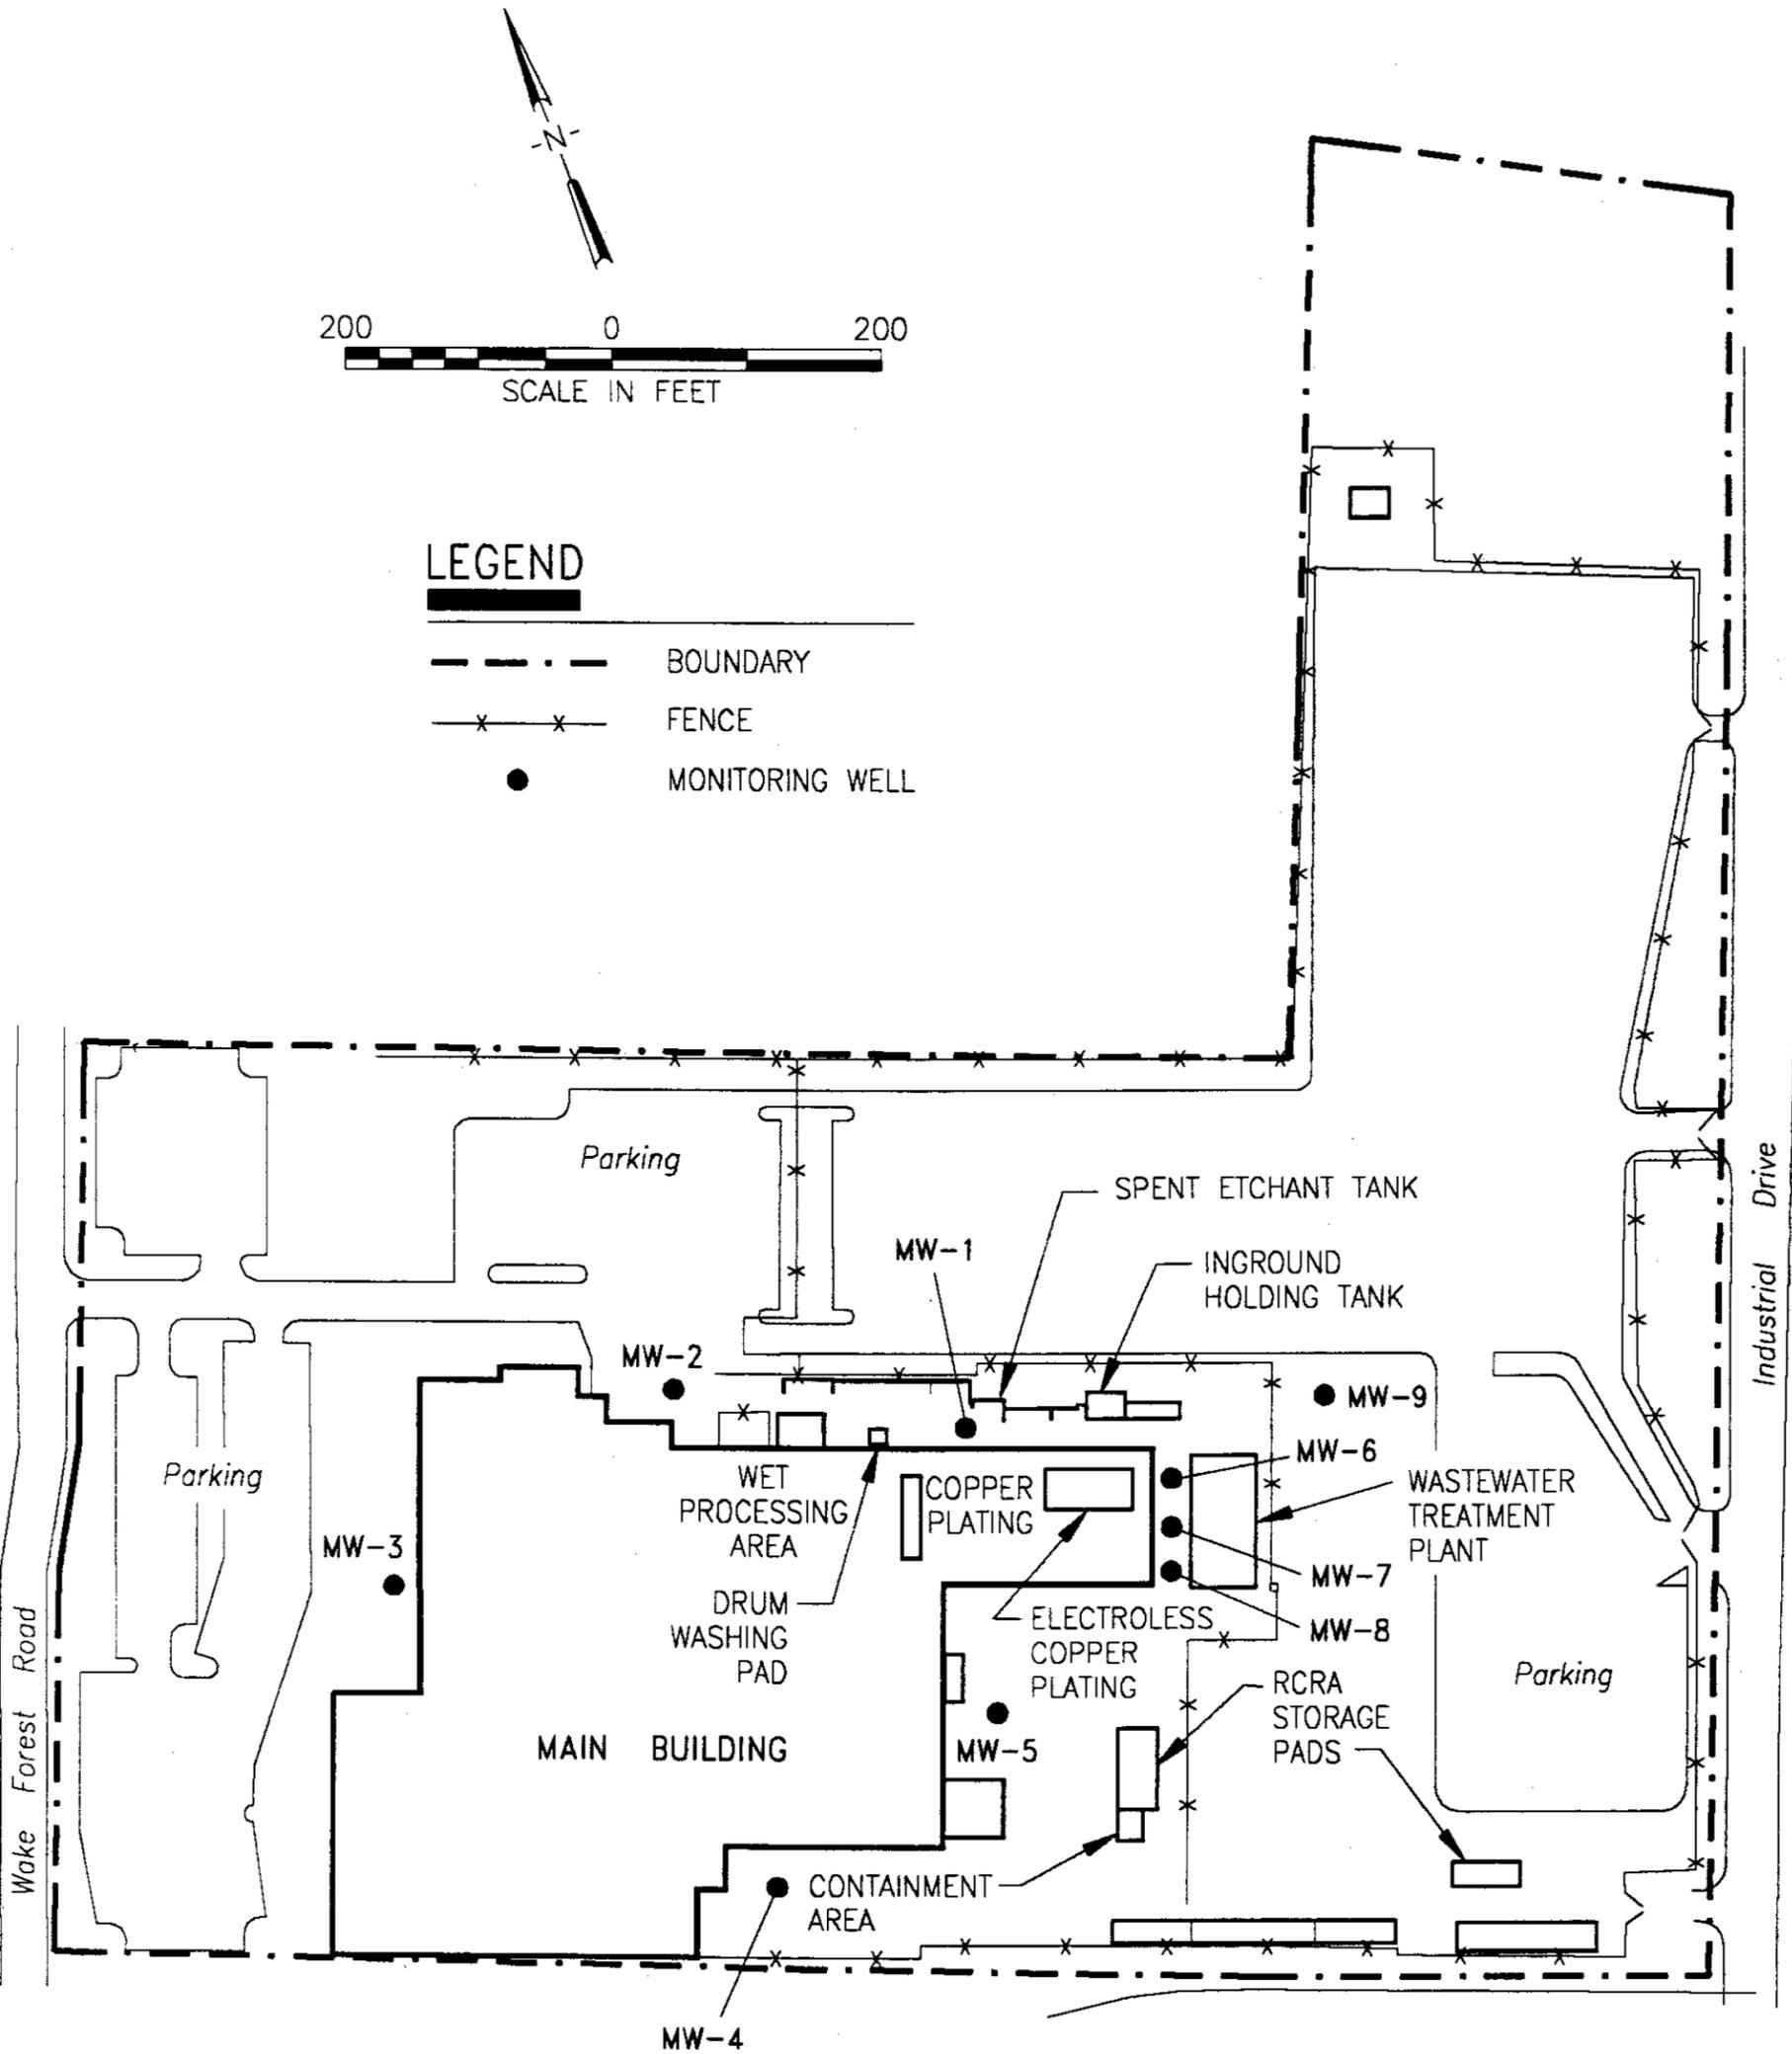
**CDM FEDERAL PROGRAMS CORPORATION
MONITORING WELL LOCATIONS**

Alcatel carried out a groundwater impact investigation in 1990 through National Environmental Technical Inc. (NET) in the vicinity of the wastewater equalization basin. Four groundwater monitoring wells were installed upgradient and downgradient of the basin. Well locations are shown in Figure 3. Three of the wells, MWs 6,7, and 8, were located 20-30 feet downgradient and MW 9 was installed 50 feet upgradient of the basin. Each of the wells were screened within the top ten feet of the aquifer and averaged a total depth of about 20 feet. Wells are constructed of two-inch diameter PVC with ten feet of 0.01 inch slotted screen. Filter packs, bentonite seals and concrete collars were used. Wells were purged with three volumes and allowed to recover before sampling. Well logs are included in Appendix E.

The depth to groundwater is approximately 12 feet bls. Water table elevations are lowest in September and October due to low infiltration. Shallow groundwater exhibits horizontal flow generally to the southwest.

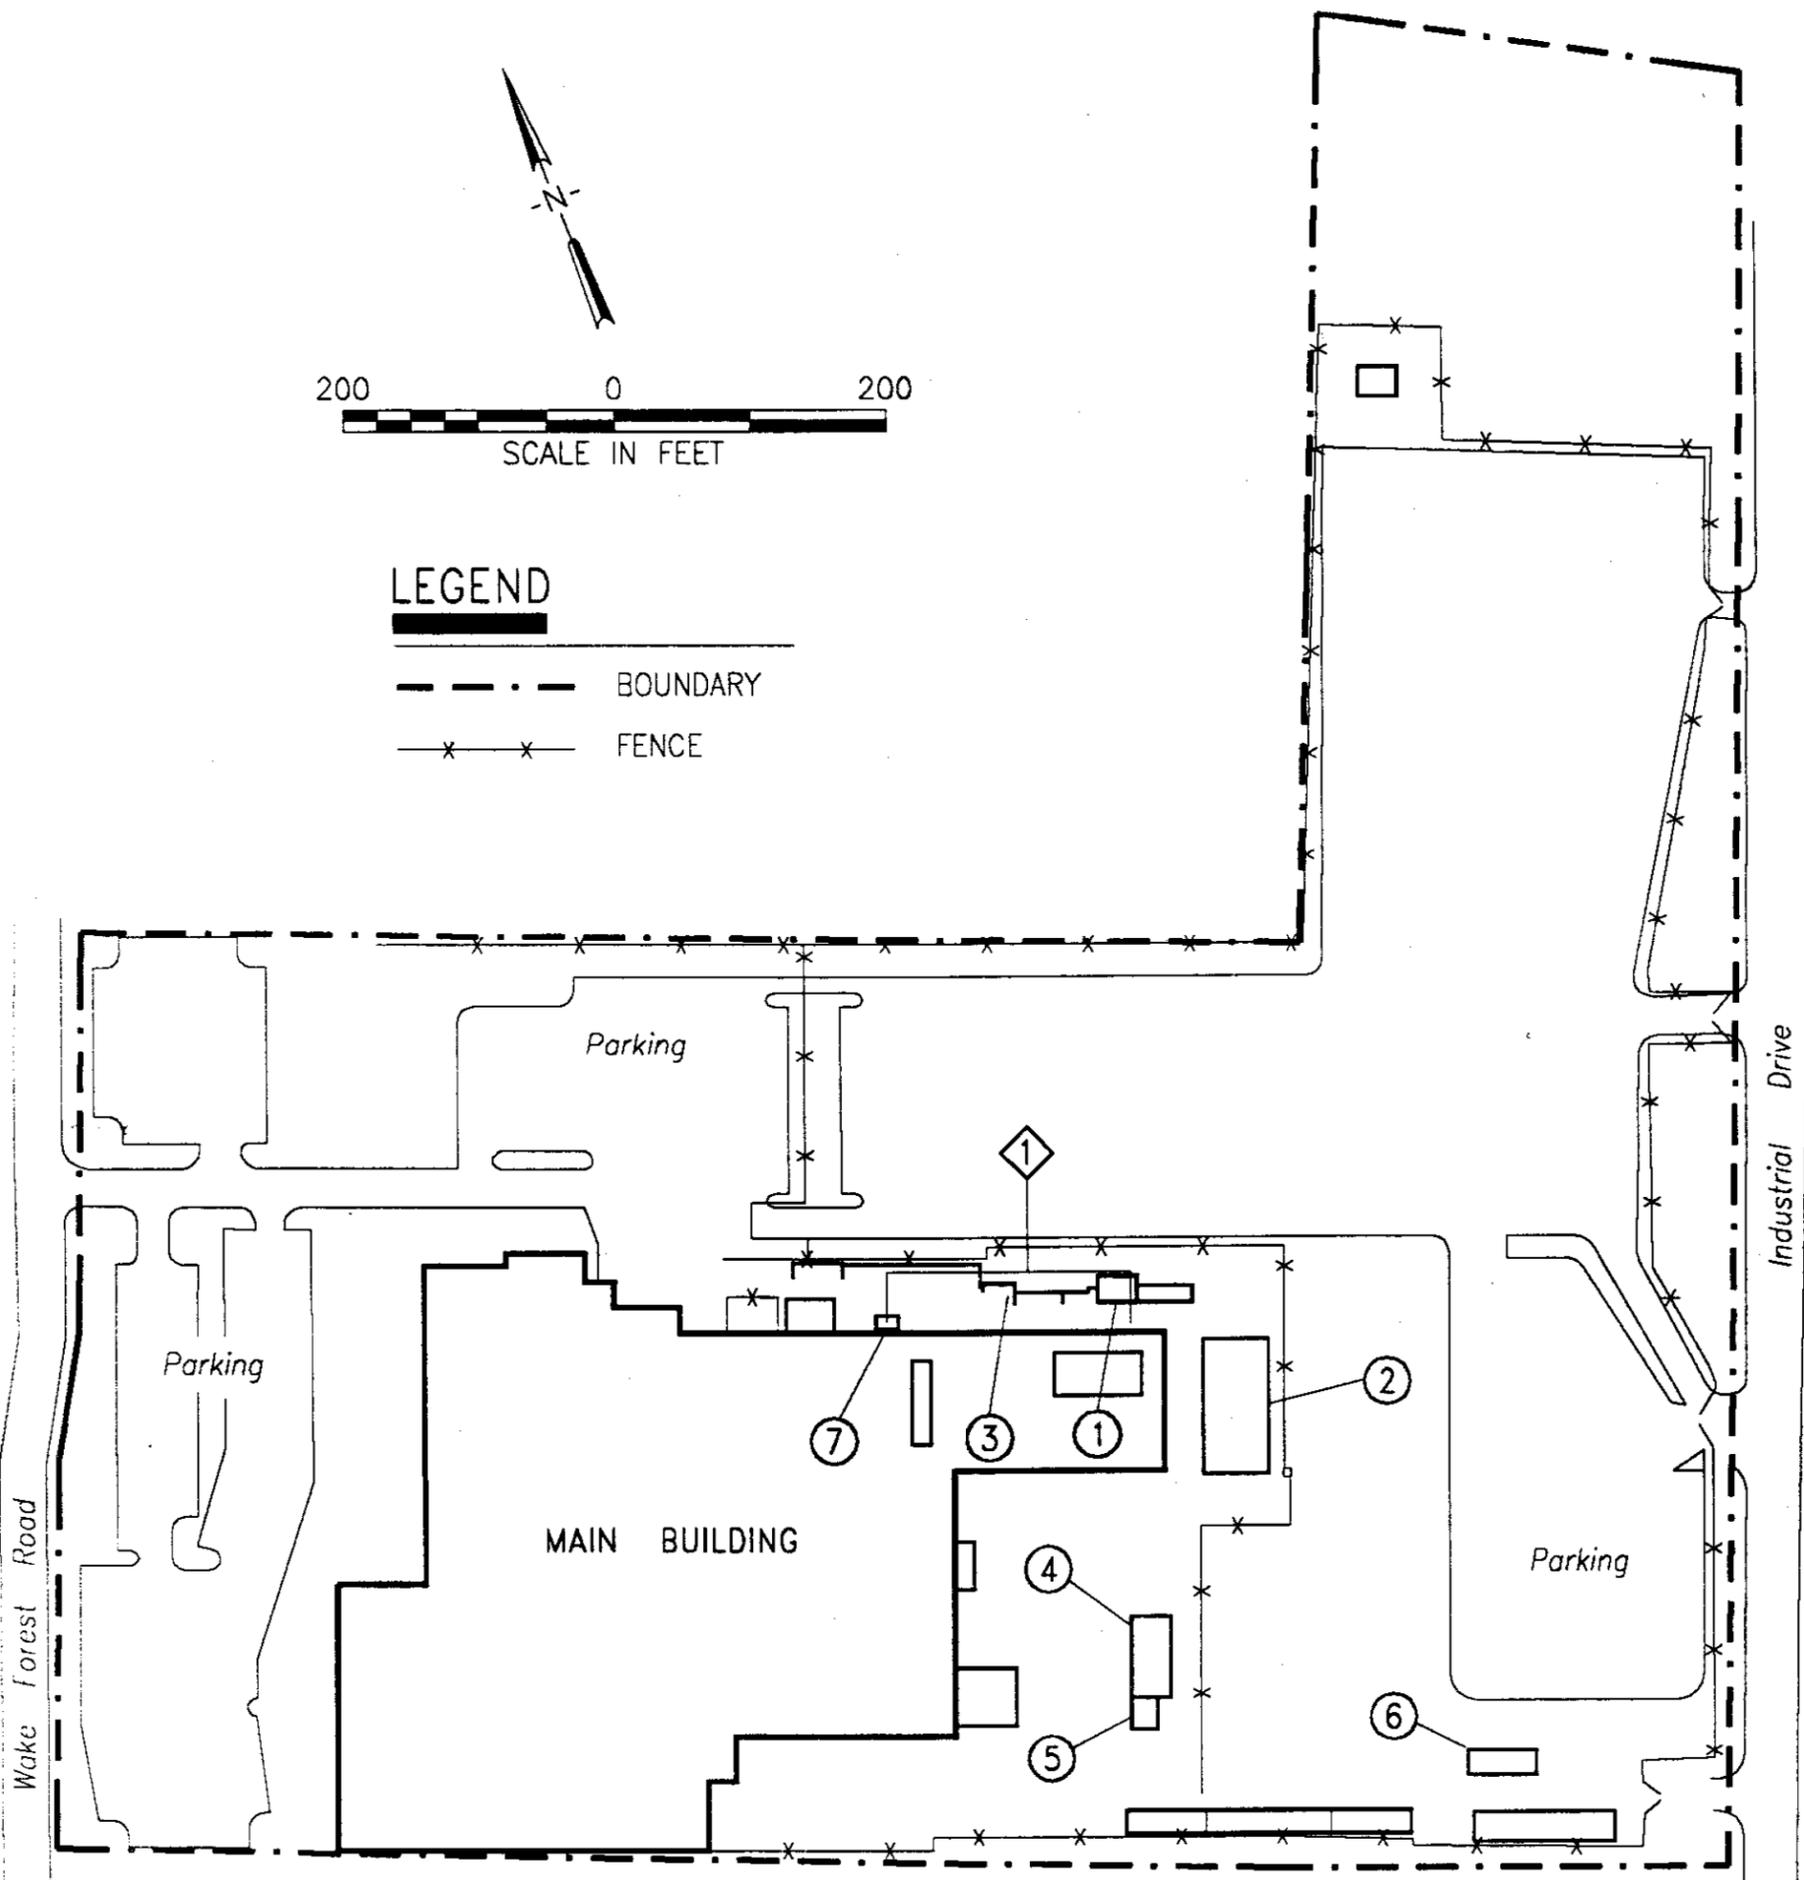
SOLID WASTE MANAGEMENT UNITS

- ① INGROUND HOLDING TANK
- ② WASTEWATER TREATMENT PLANT
- ③ SPENT ETCHANT TANK
- ④ RCRA DRUM STORAGE PAD #1

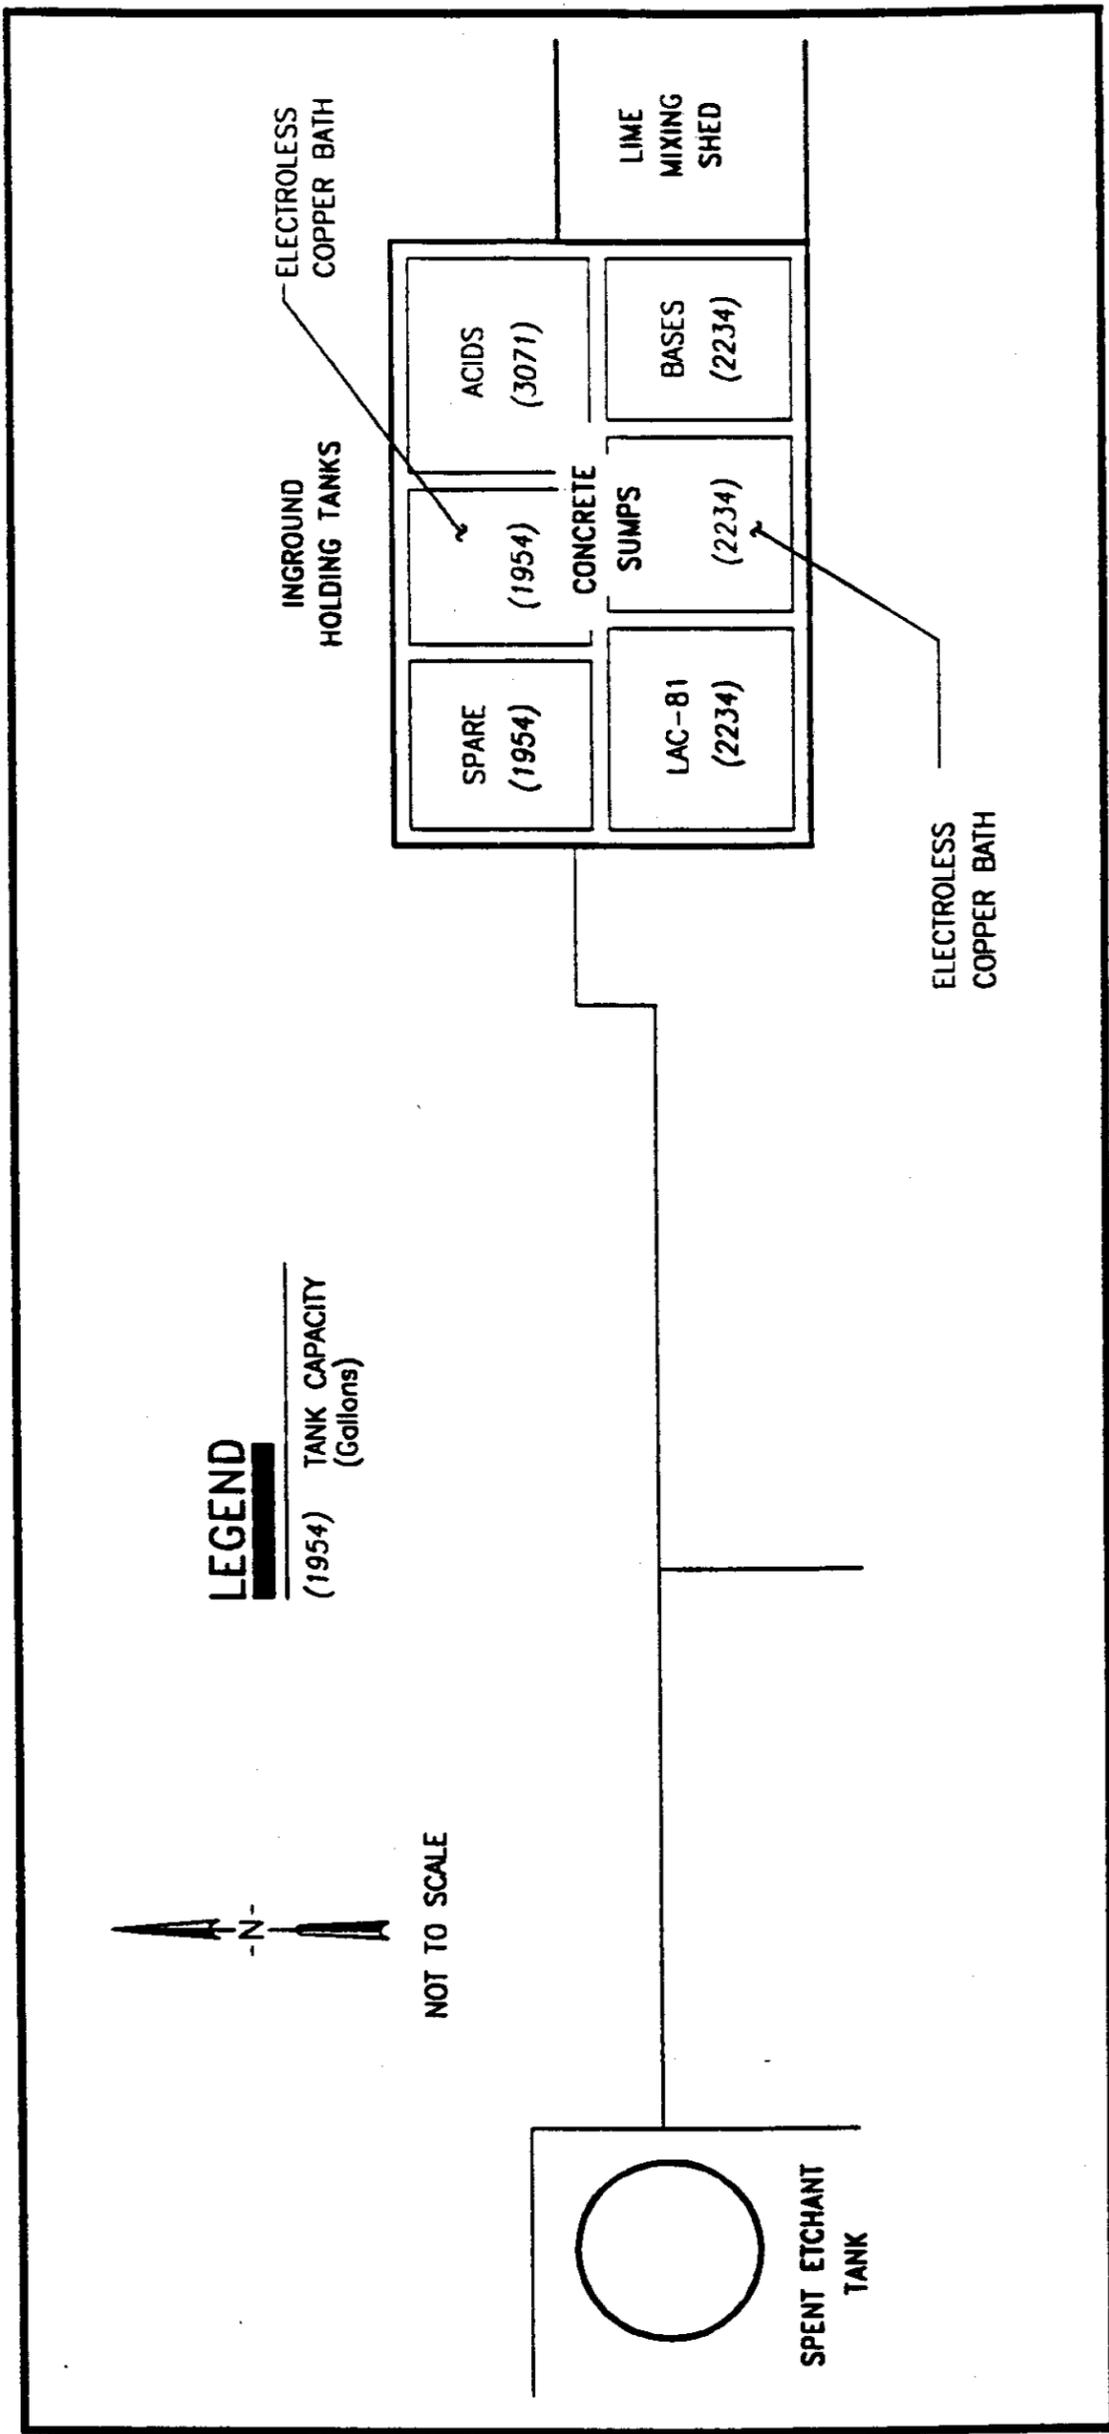
CDM FEDERAL PROGRAMS CORPORATION
SPENT ETCHANT TANK & INGROUND HOLDING TANK LAYOUT
 ALCATEL NETWORK SYSTEMS
 RALEIGH, NORTH CAROLINA

Physical Description and Condition: The holding tanks located northeast of the main building are bounded by the wastewater treatment plant to the east, the old drainage system to the south, the storage shed to the west, and an earthen embankment to the north (Figure 5). The holding tank area consisted of a rectangular 34 feet long by 20 feet wide by 6 feet deep concrete sump compartmentalized into six enclosed sections. Each section is concrete walled and custom fitted with PVC liners.

Physical Description and Condition: The spent etchant tank, located 15 feet north of the main facility, was a 6,000-gallon aboveground tank set within a reinforced concrete structure (Figure 5). The containment structure was bounded by the tank holding area to the east, the alleyway to the south, a storage shed to the west, and an earthen embankment to the north. The reinforced fiberglass tank received spent copper etchant through an underground 2-inch diameter PVC pipe. The pipes extended from the wet processing area inside the main facility building. Fresh etchant was pumped along the conveyer belt line to remove copper deposits from the circuit boards. At the end of the closed system, the spent copper etchant was pumped to the tank for storage.

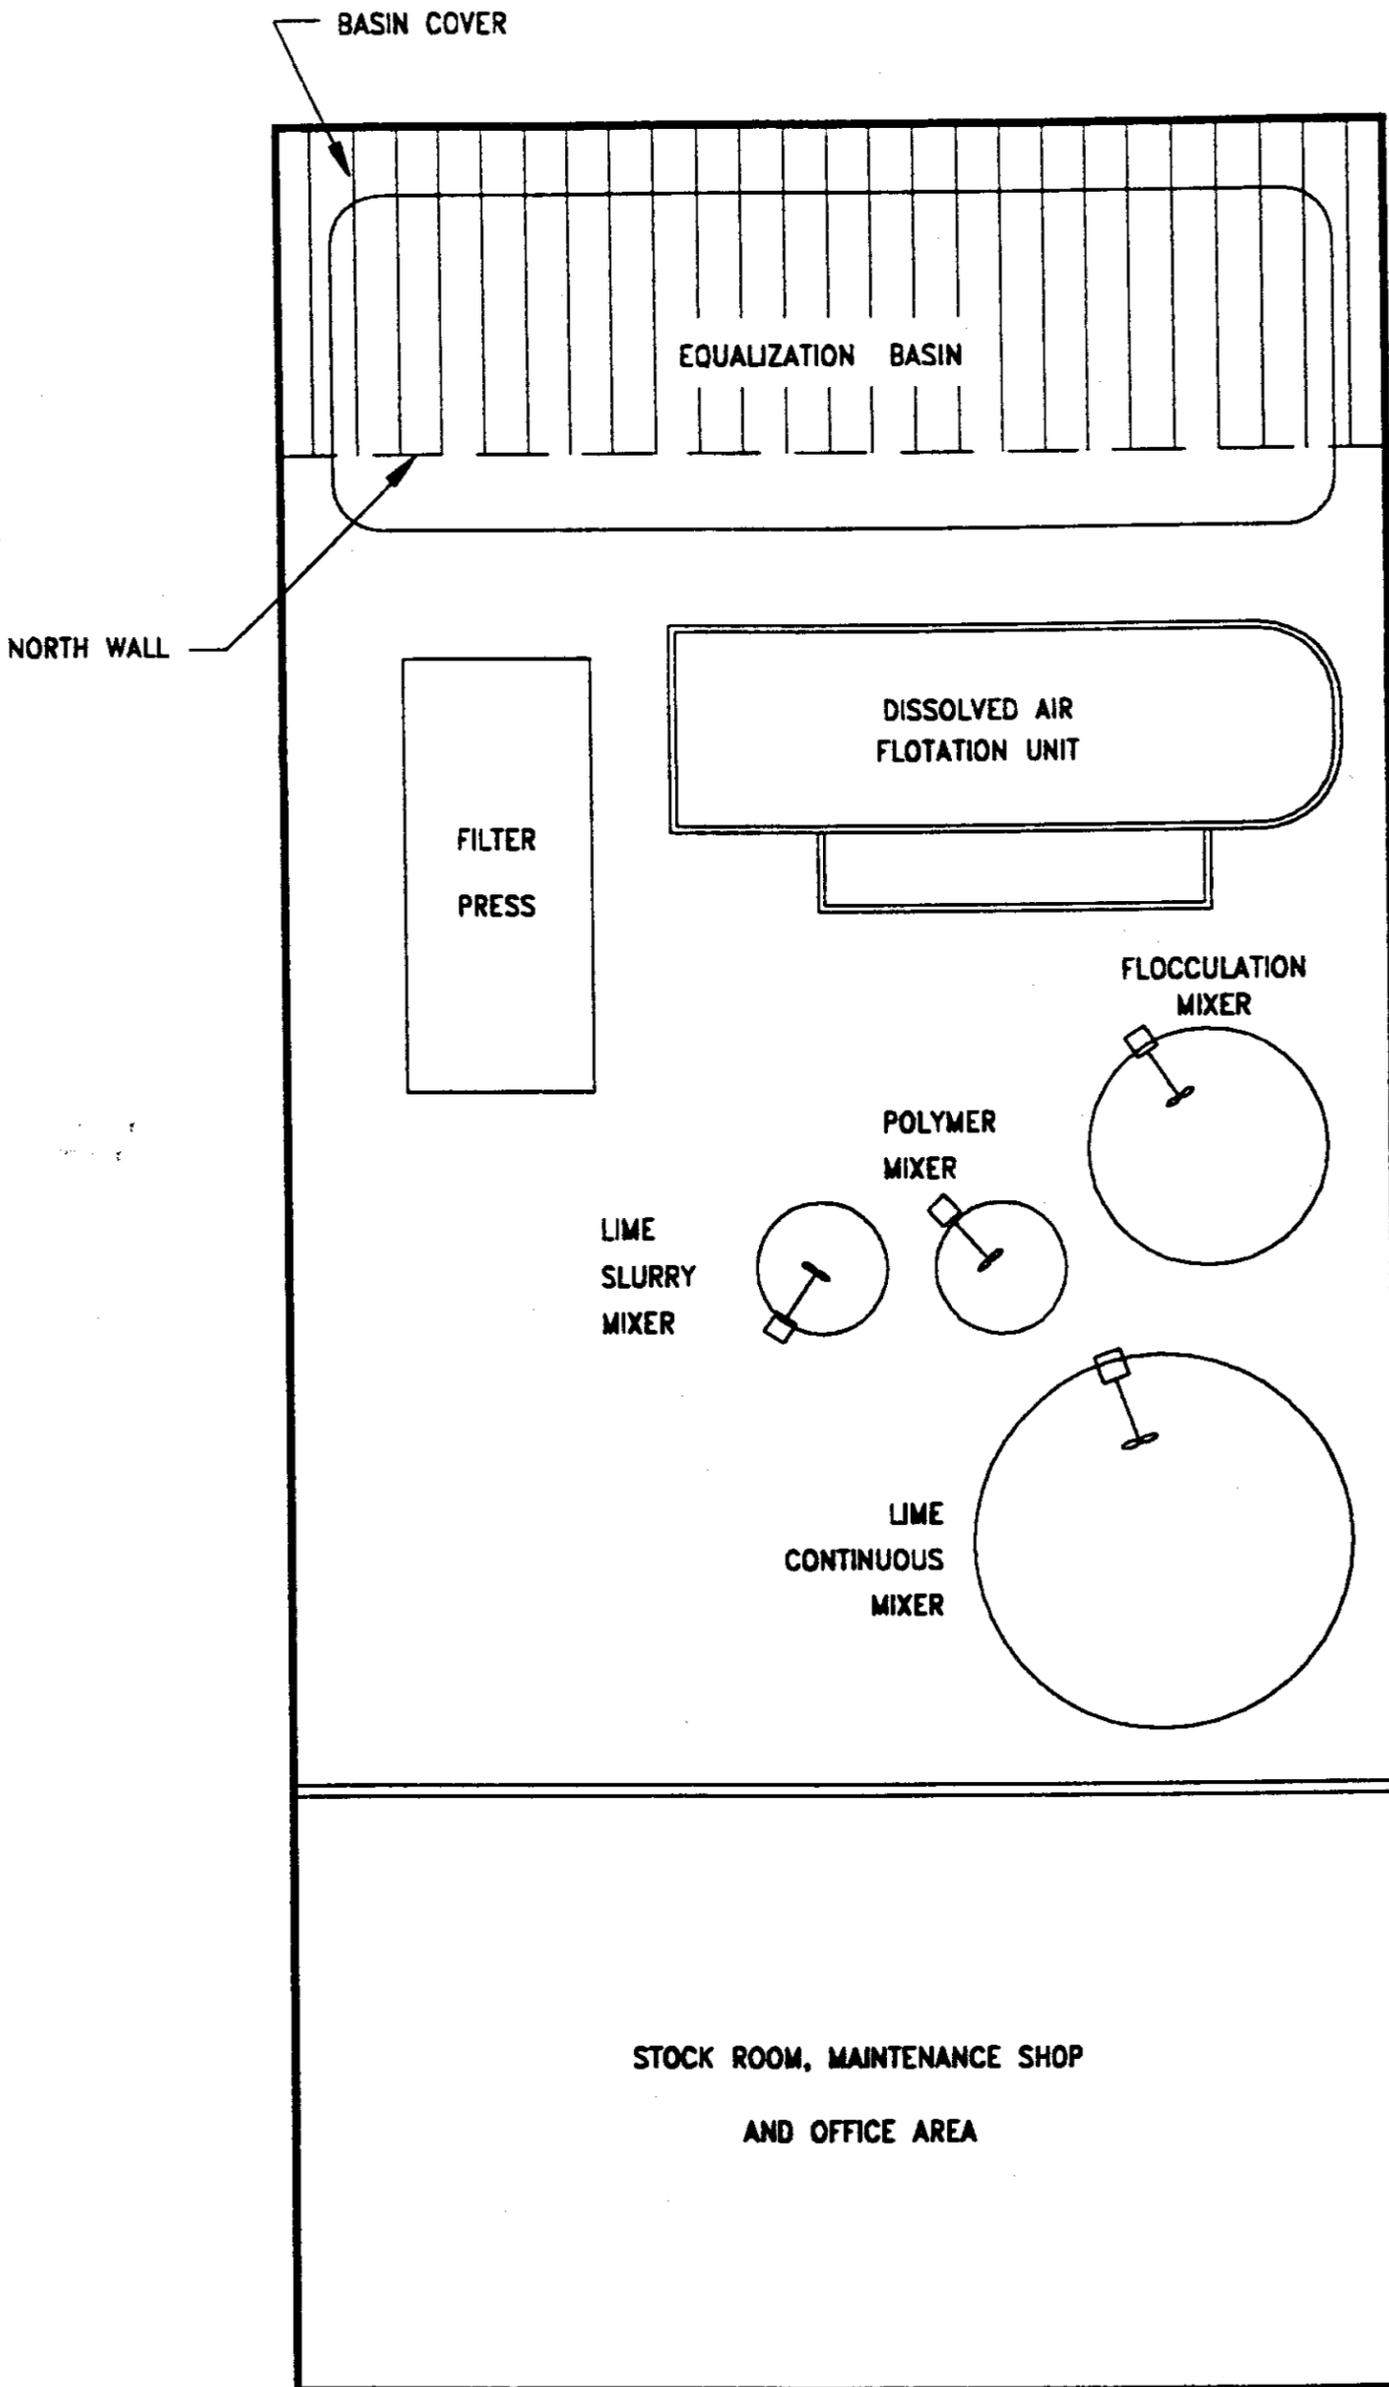
**CDM FEDERAL PROGRAMS CORPORATION
WASTEWATER TREATMENT PLANT LAYOUT**

Physical Description and Condition: The wastewater treatment plant (WWTP) occupies 3,563 square feet which includes the underground equalization basin in the northeastern corner of the facility (Figure 6). The WWTP was comprised of a series of tanks, basins, filter press, mixers and treatment components used to separate, stabilize, and neutralize wastes into manageable components. The entire treatment process area was housed within a metal two-story roofed building with equalization basin, clarified water basin, and sludge basin, (total basin capacity of 262,000 gallons), underneath the 3-inch concrete floor. All basins and in-ground tanks were constructed of concrete, and were coated with impermeable materials. When Alcatel closed all the assembly lines in 1990, the WWTP was closed and converted to a storage area for office equipment with the equalization basin, clarified water basin, and sludge basin converted to chilled water holding basins. Most of the wastewater treatment equipment was dismantled and shipped off to Payson Associates, Inc. in Southfield, Michigan. No evidence of spills, leaks, stains, cracks or structural damage was observed inside or outside the building and all concrete structures were in sound condition.

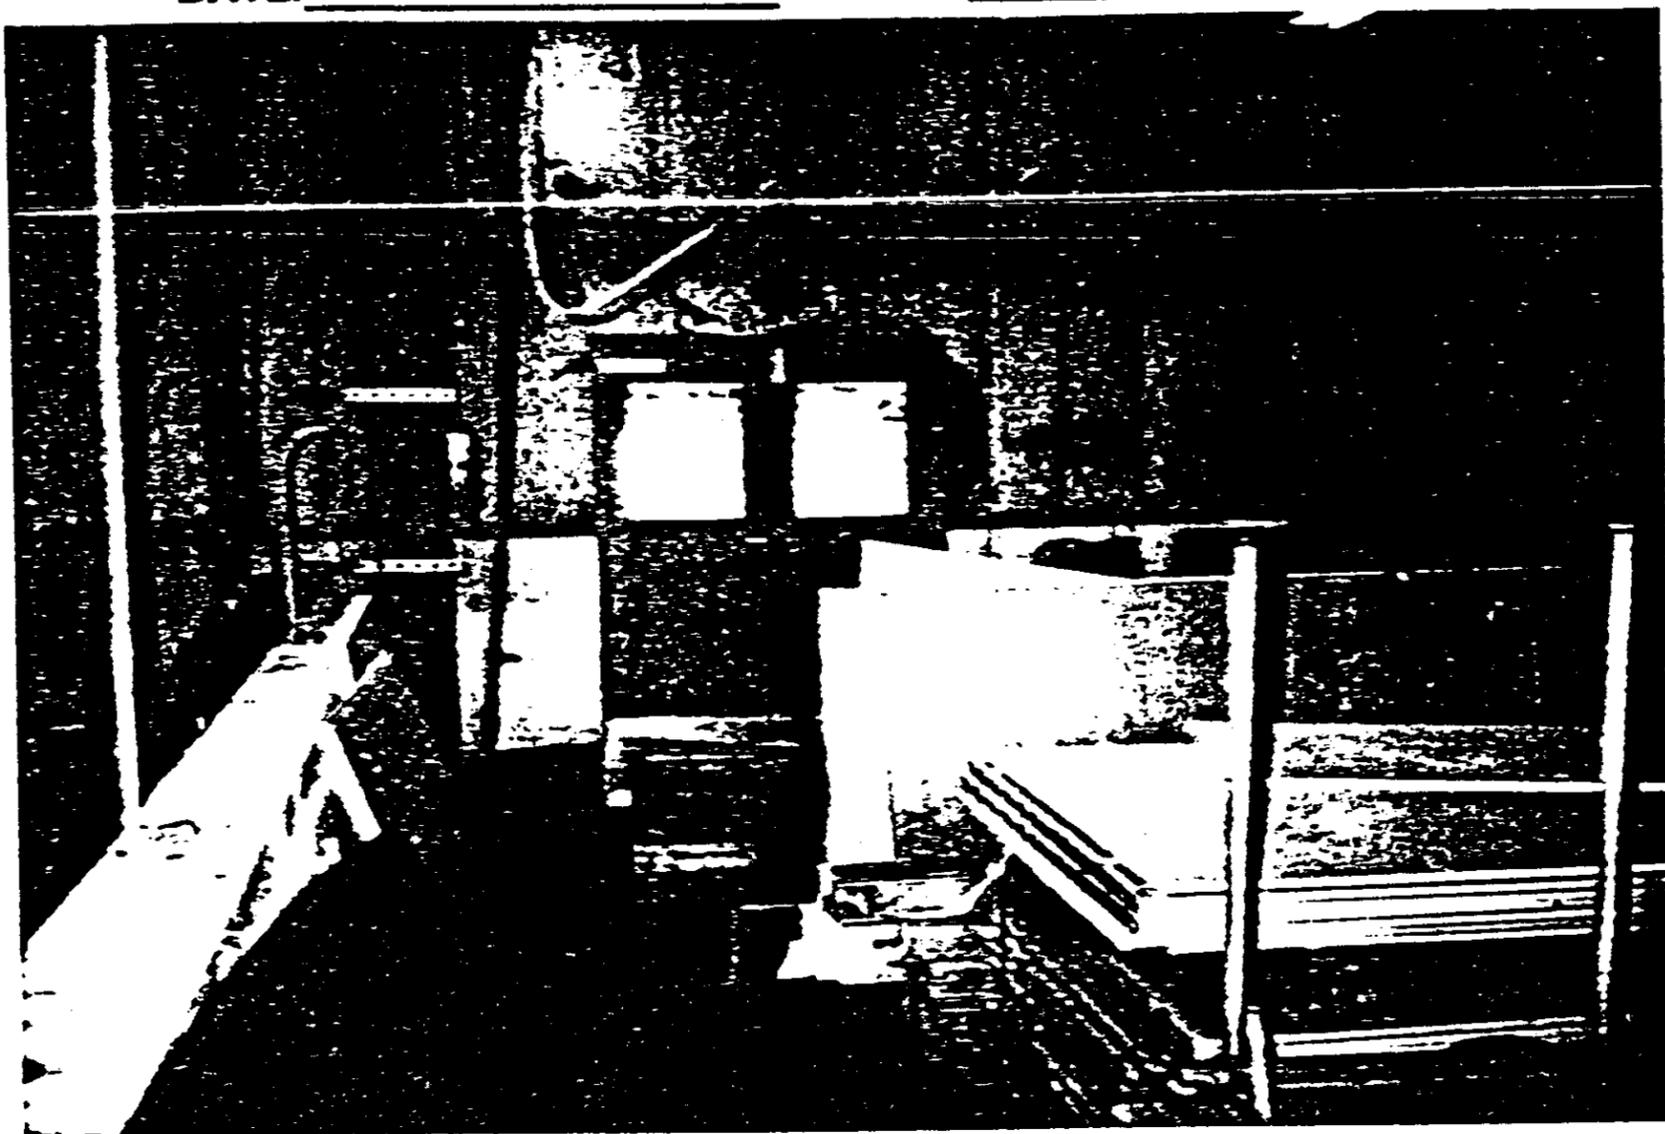
PHOTO # 4

SITE: Alcatel Network Systems LOCATION: Raleigh, NC
DESCRIPTION: SWMU #2- view of northern entrance to WWTP,
office equipment and construction materials in the foreground.
DATE: November 7, 1991 TIME: 1420

Recommendations: No Further Action (X)
RFA Phase II Sampling ()
RFI Necessary ()

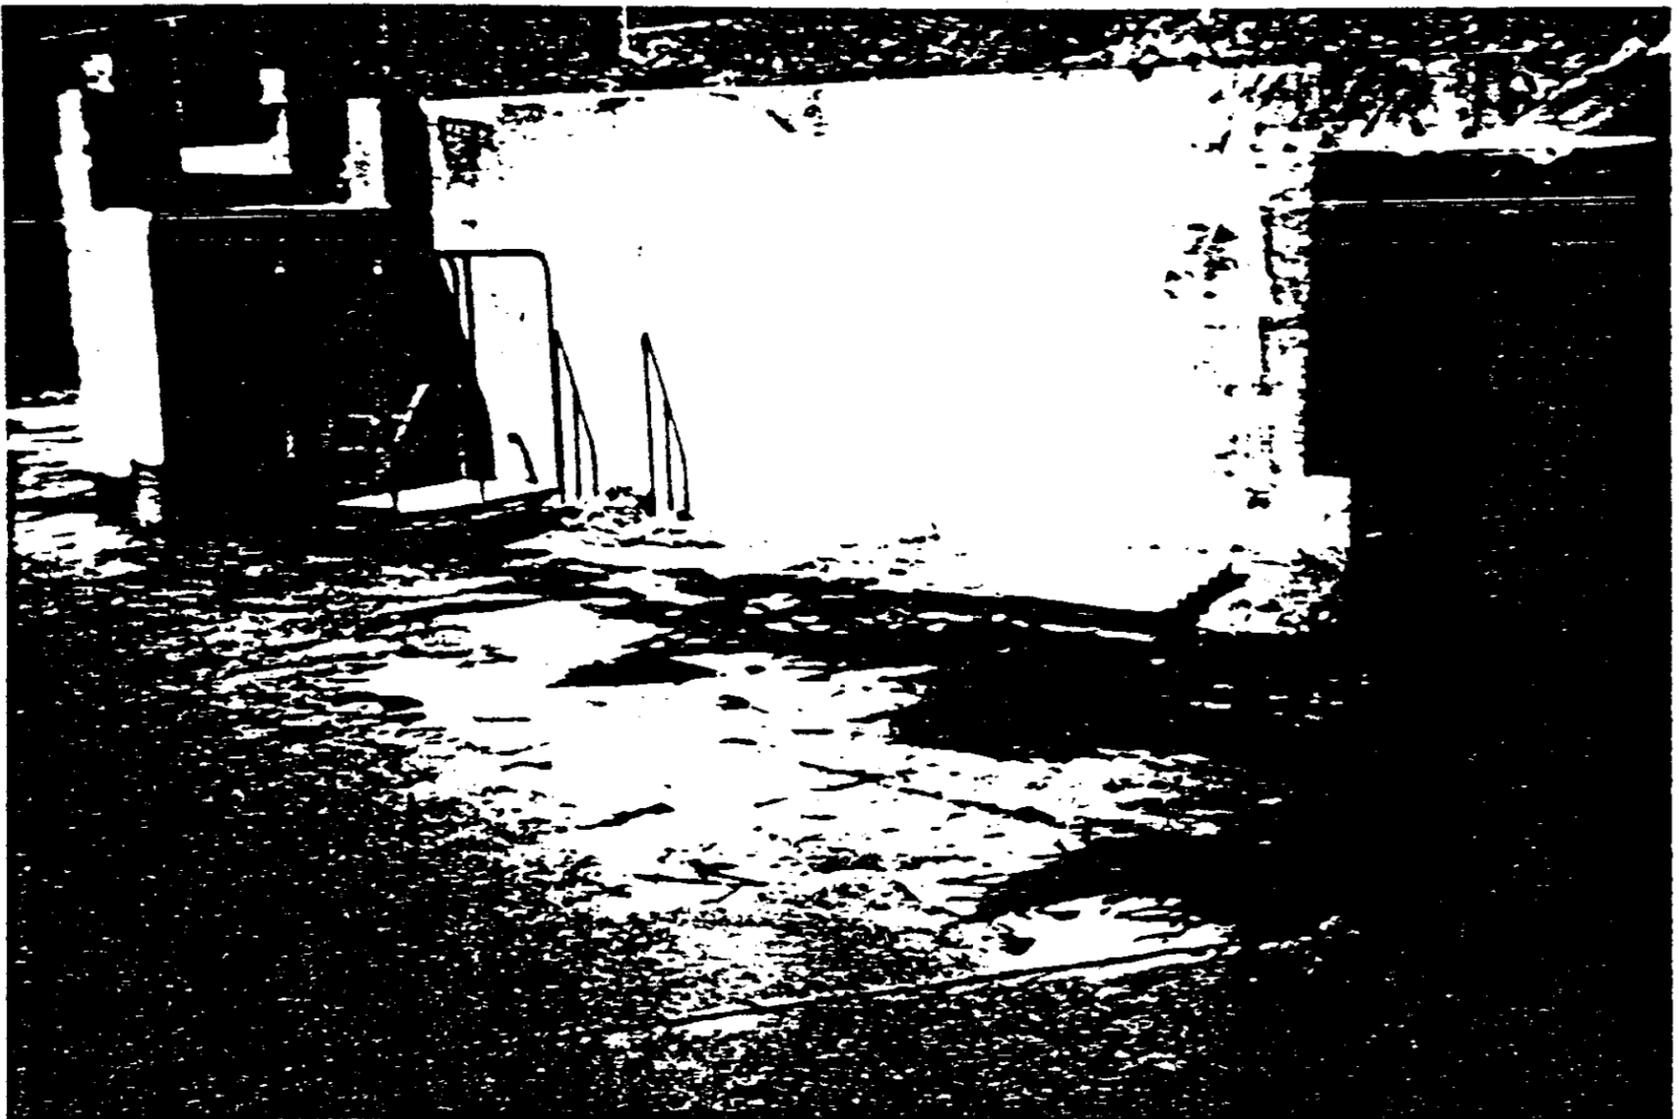
PHOTO # 8

All underground piping associated with the tank was removed during 1989. Presently, the concrete containment structure is solidly intact with a few items temporarily stored in the area. No spills or stains were observed on the concrete inside or outside the concrete structure.

SITE: Alcatel Network Systems LOCATION: Raleigh, NC
DESCRIPTION: SWMU #3- view of the concrete containment structure
for the etchant tank; the tank was removed in 1990.
