**FINAL REPORT
RCRA FACILITY ASSESSMENT
RALEIGH, WAKE COUNTY, NORTH CAROLINA**

**U.S. Environmental Protection Agency
Region IV
Atlanta, Georgia**

Work Assignment No.	: R04031C04073
EPA Region	: IV
Site No.	: NCD003185238
Contract No.	: 68-W9-004
CDM Federal Programs Corporation Document No.	: TES7-R04031-FR-DBHT
Prepared by	: CDM Federal
Work Assignment Project Manager	: Robert Rose
Telephone No.	: (404) 952-7393
EPA Work Assignment Manager	: Roberta Howes
Telephone No.	: (404) 347-3433
Date Prepared	: September 18, 1992

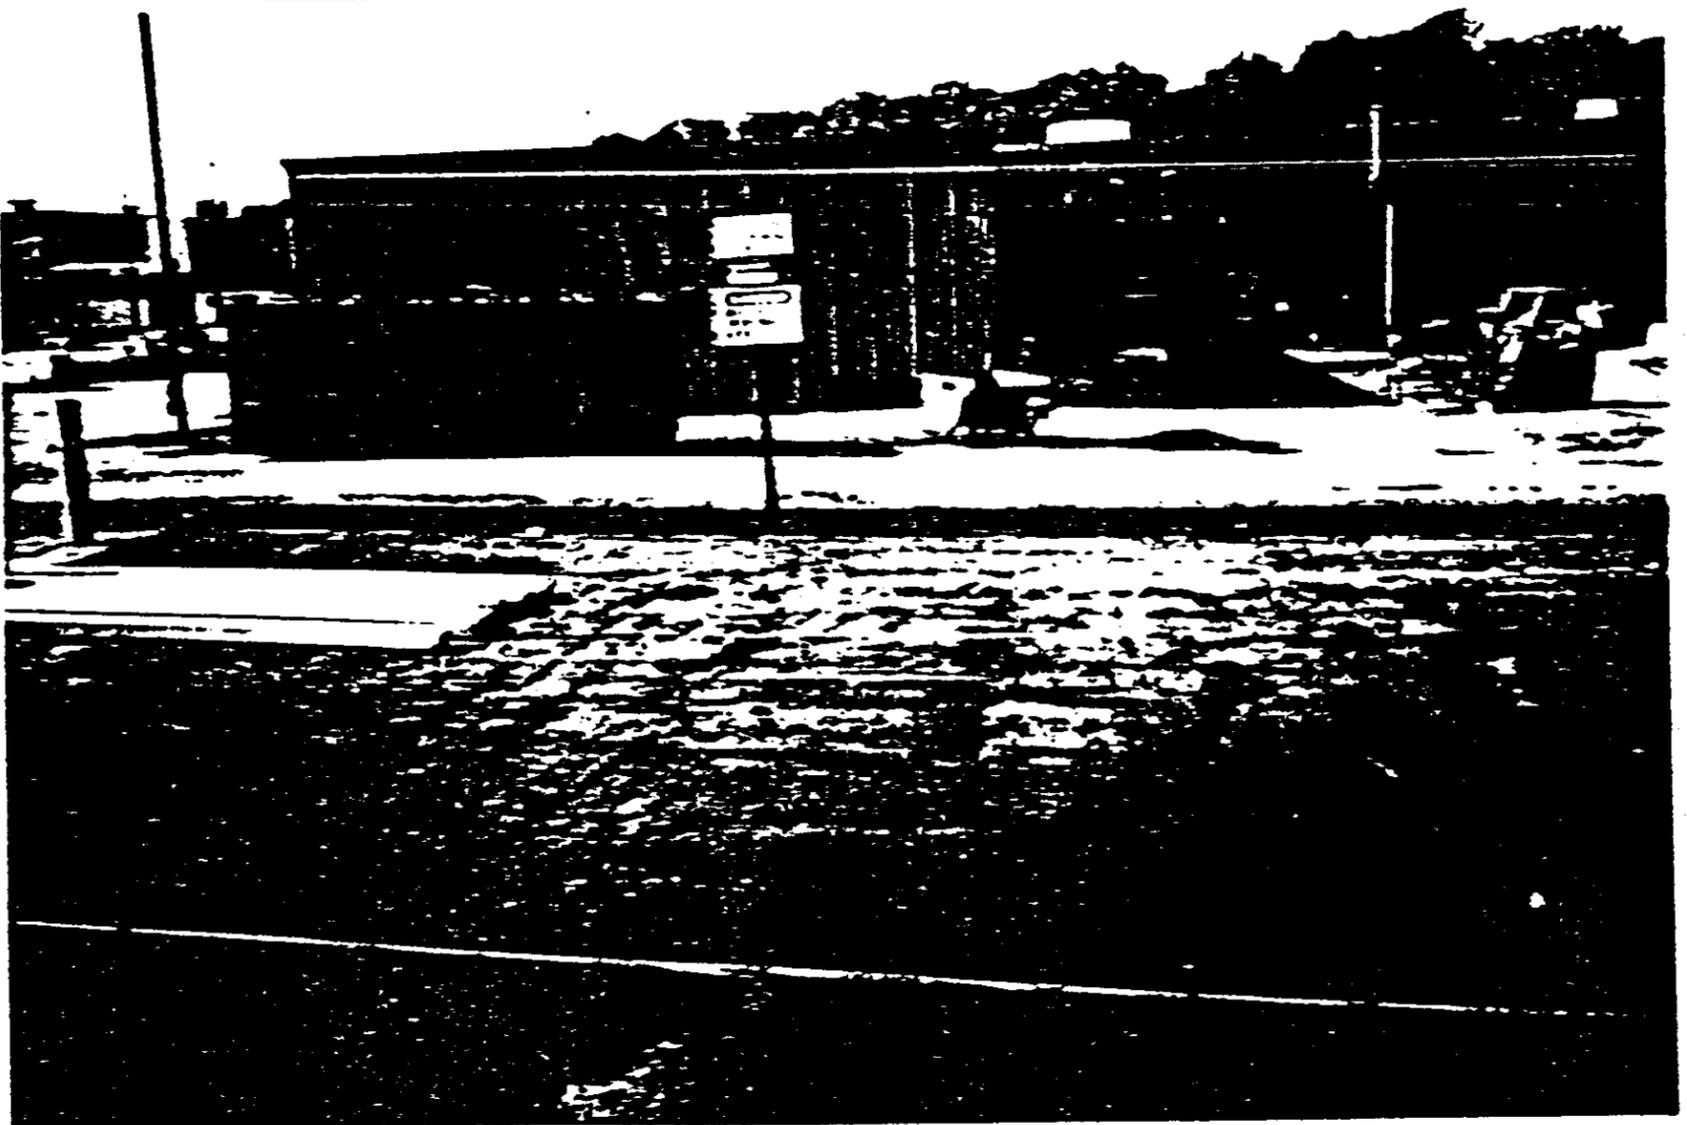
PHOTO # 10

SITE: Alcatel Network Systems LOCATION: Raleigh, NC
DESCRIPTION: SWMU #4- view of RCRA storage pad #1 looking west,
boreholes remaining from 1991 sampling investigation.

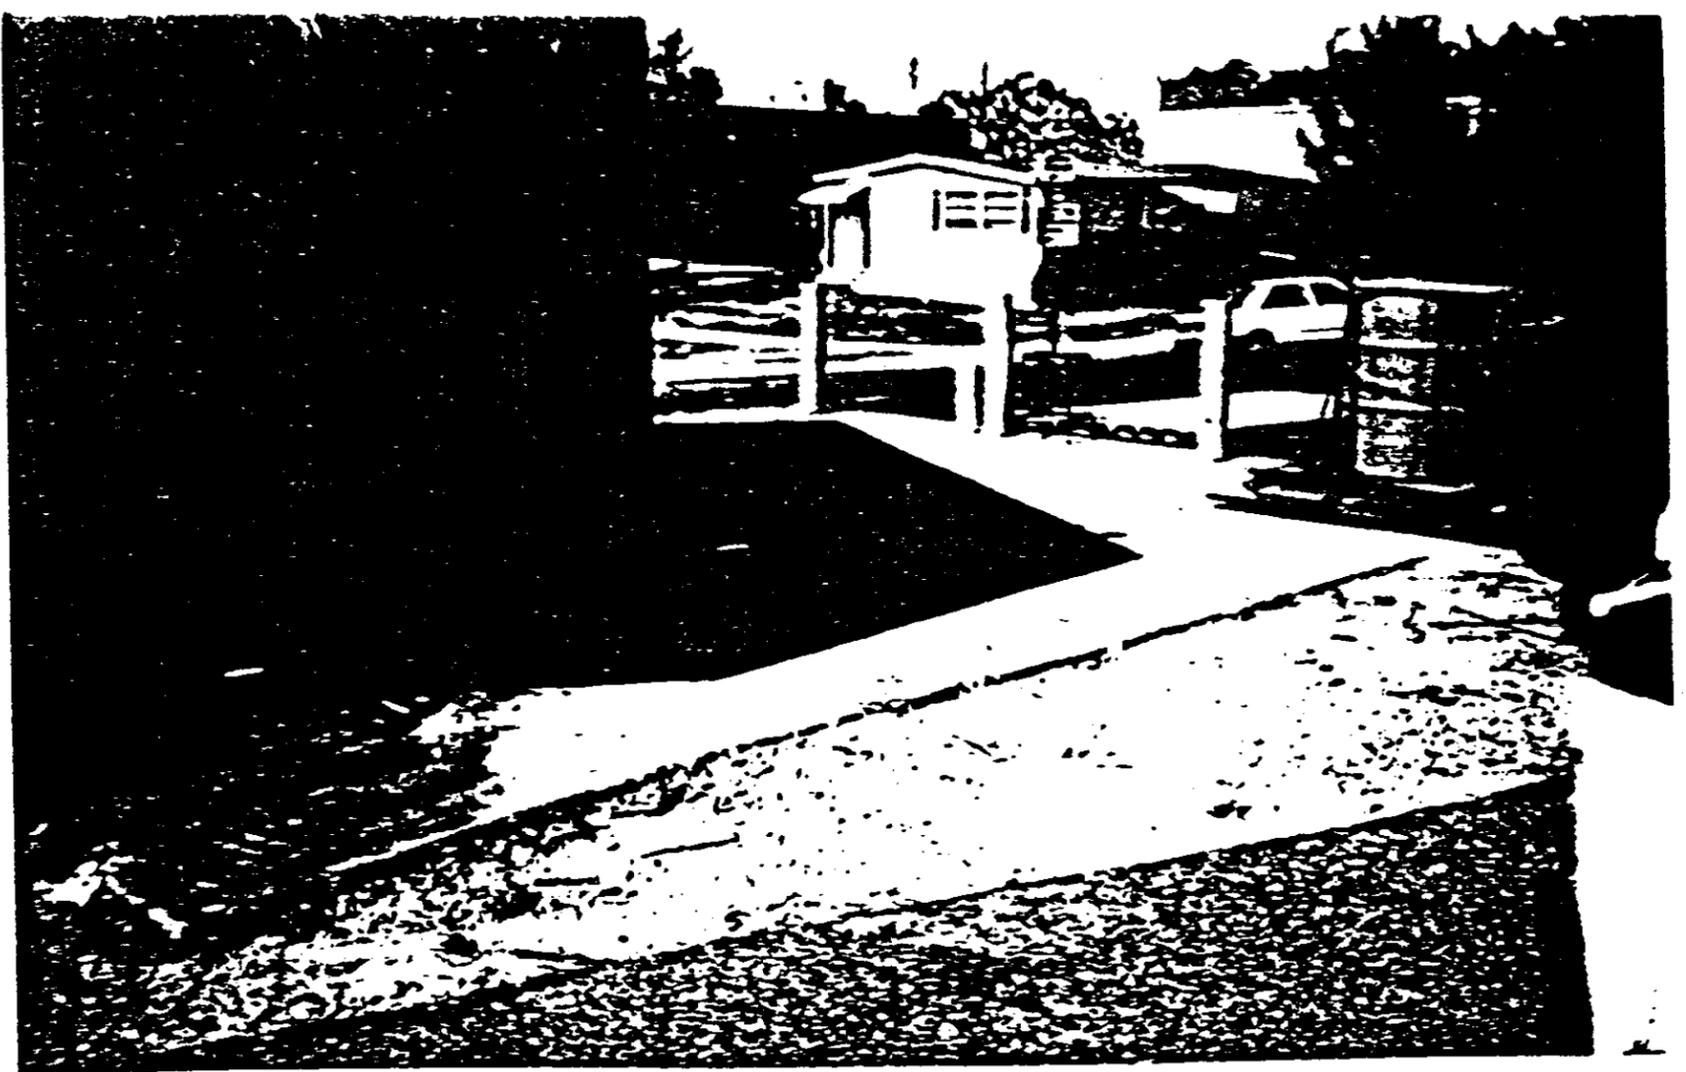
PHOTO # 11

SITE: Alcatel Network Systems LOCATION: Raleigh, NC
DESCRIPTION: SWMU #5- view of sludge containment area, metal
container stores non-hazardous wastes.

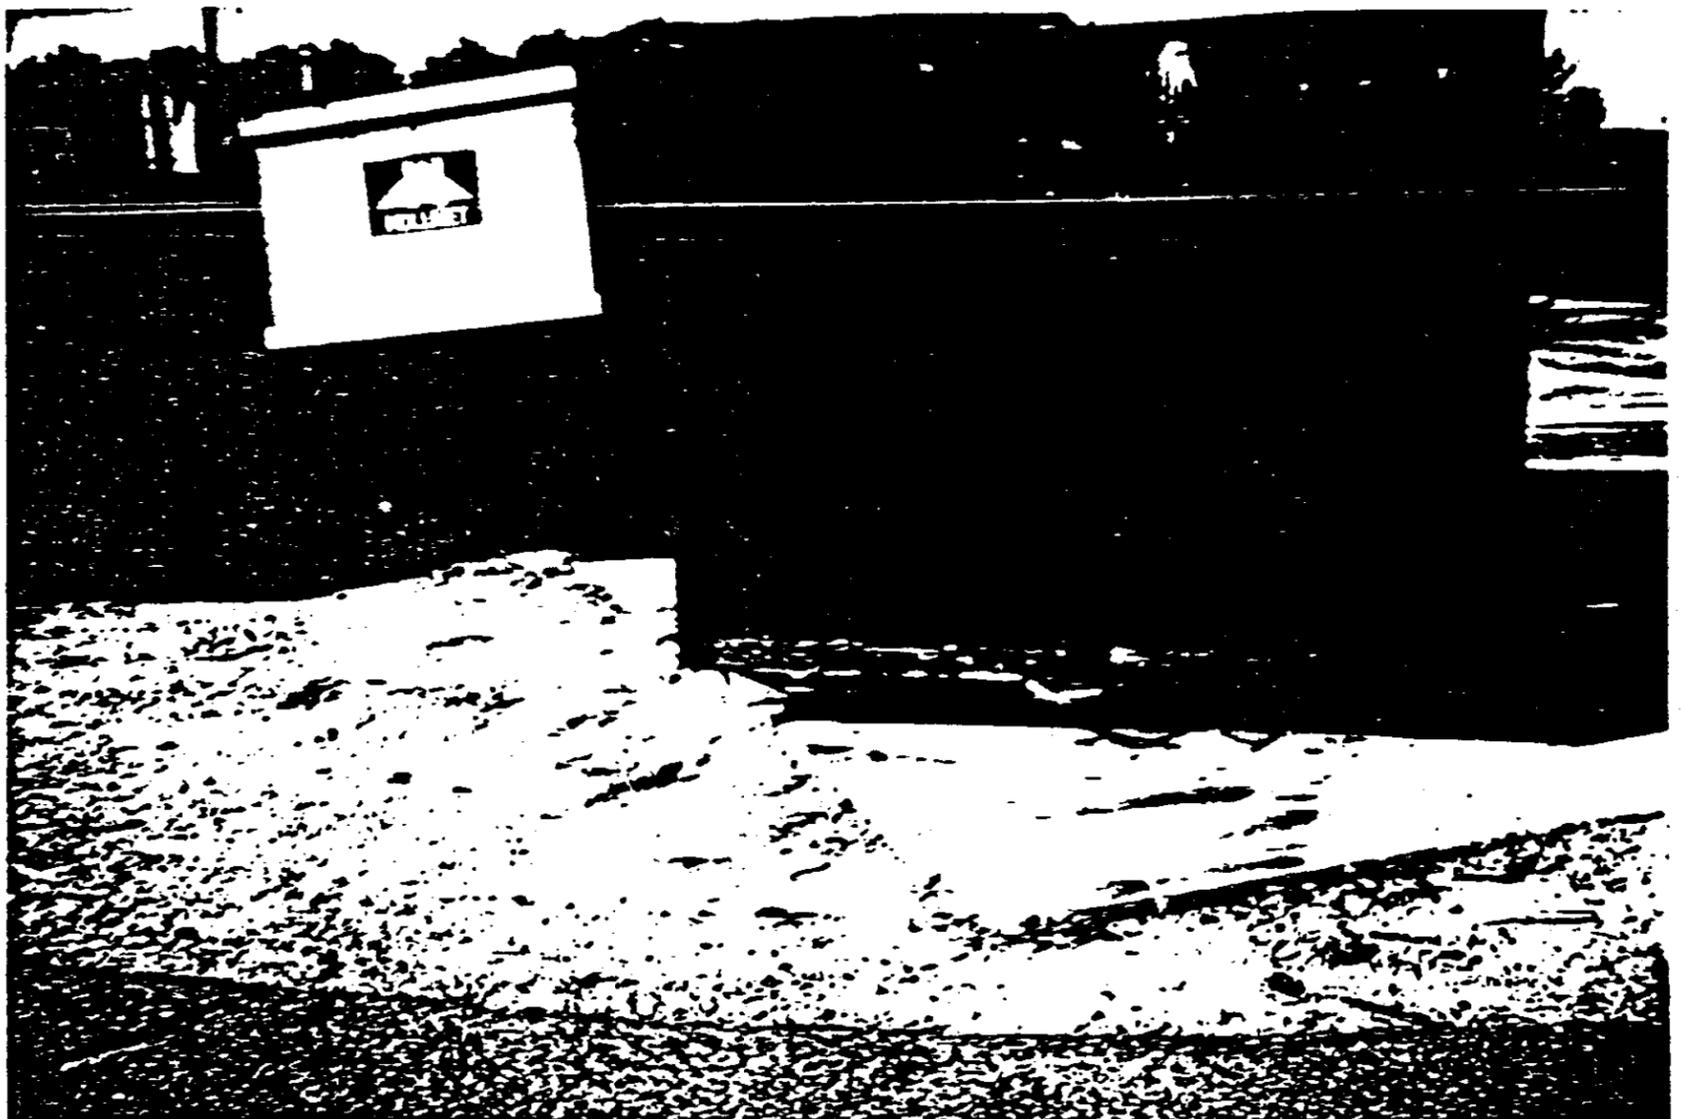
PHOTO # 12

SITE: Alcatel Network Systems LOCATION: Raleigh, NC
DESCRIPTION: SWMU #5- view of metal containers storing non-
hazardous wastes from office usage and cafeteria.

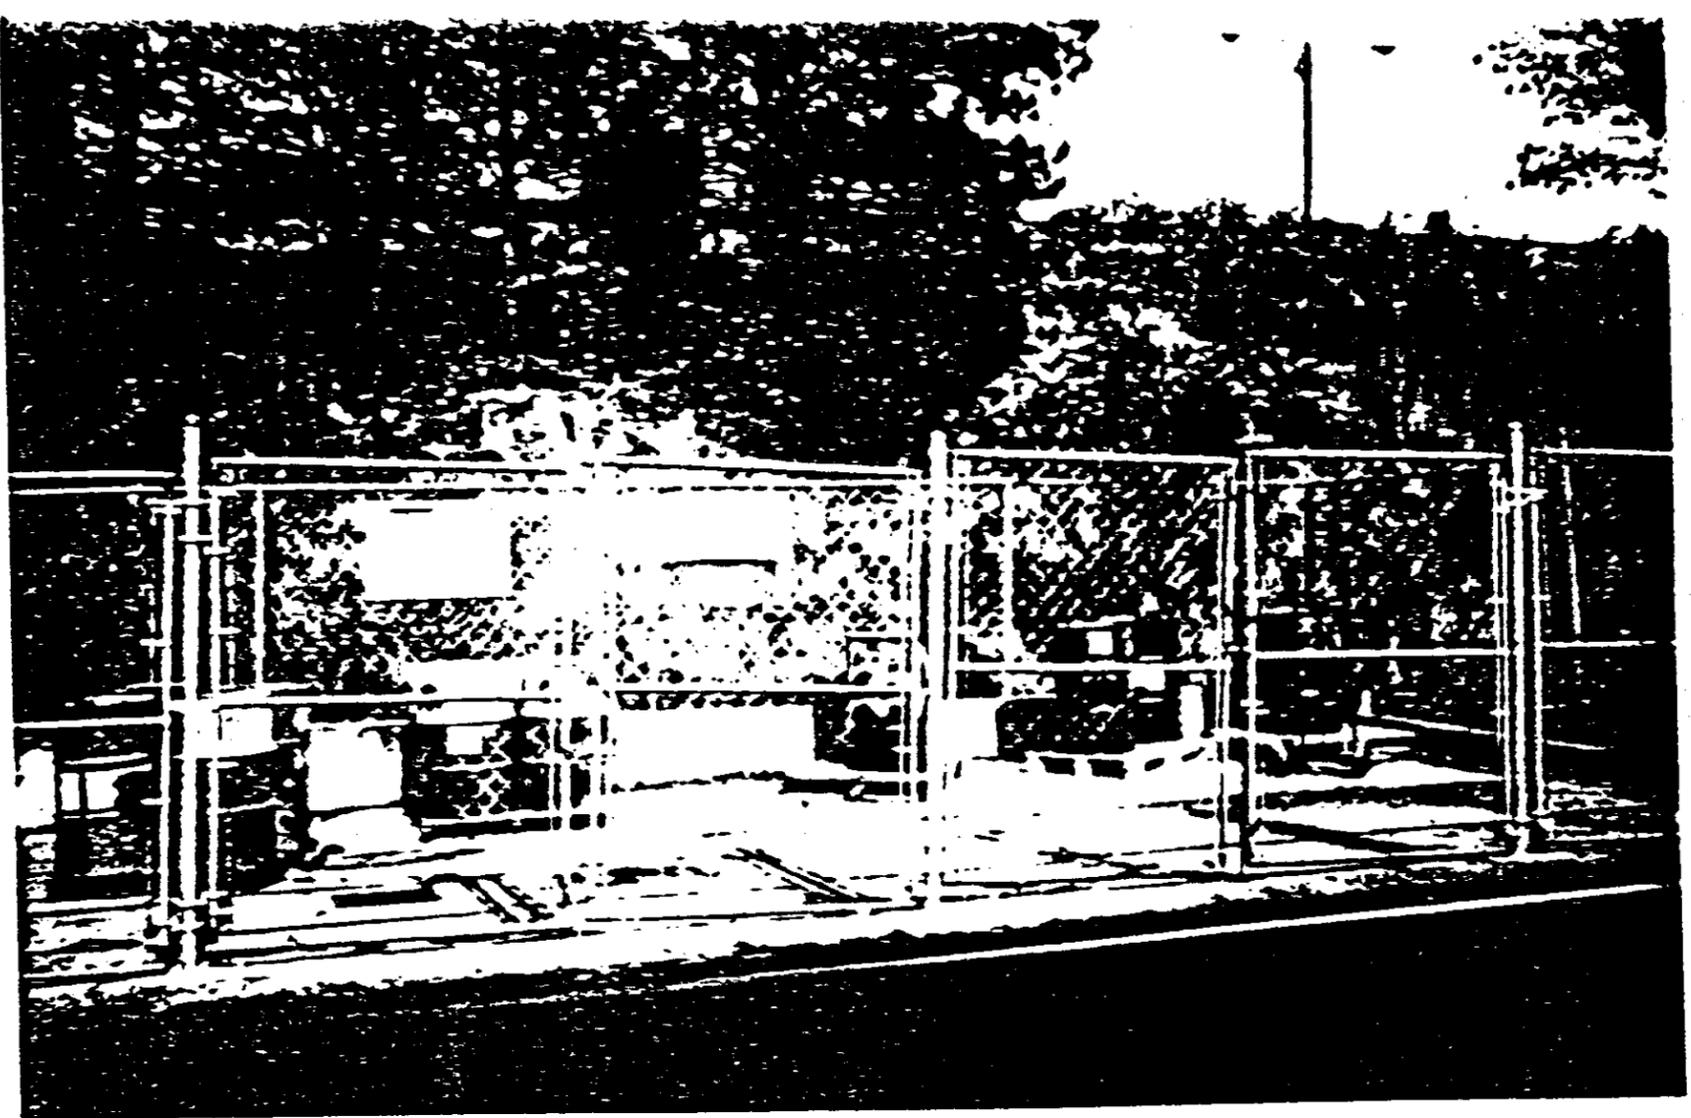
PHOTO # 13

SITE: Alcatel Network Systems LOCATION: Raleigh, NC
DESCRIPTION: SWMU #6- view of RCRA storage pad #2 looking north,
drums present onsite.

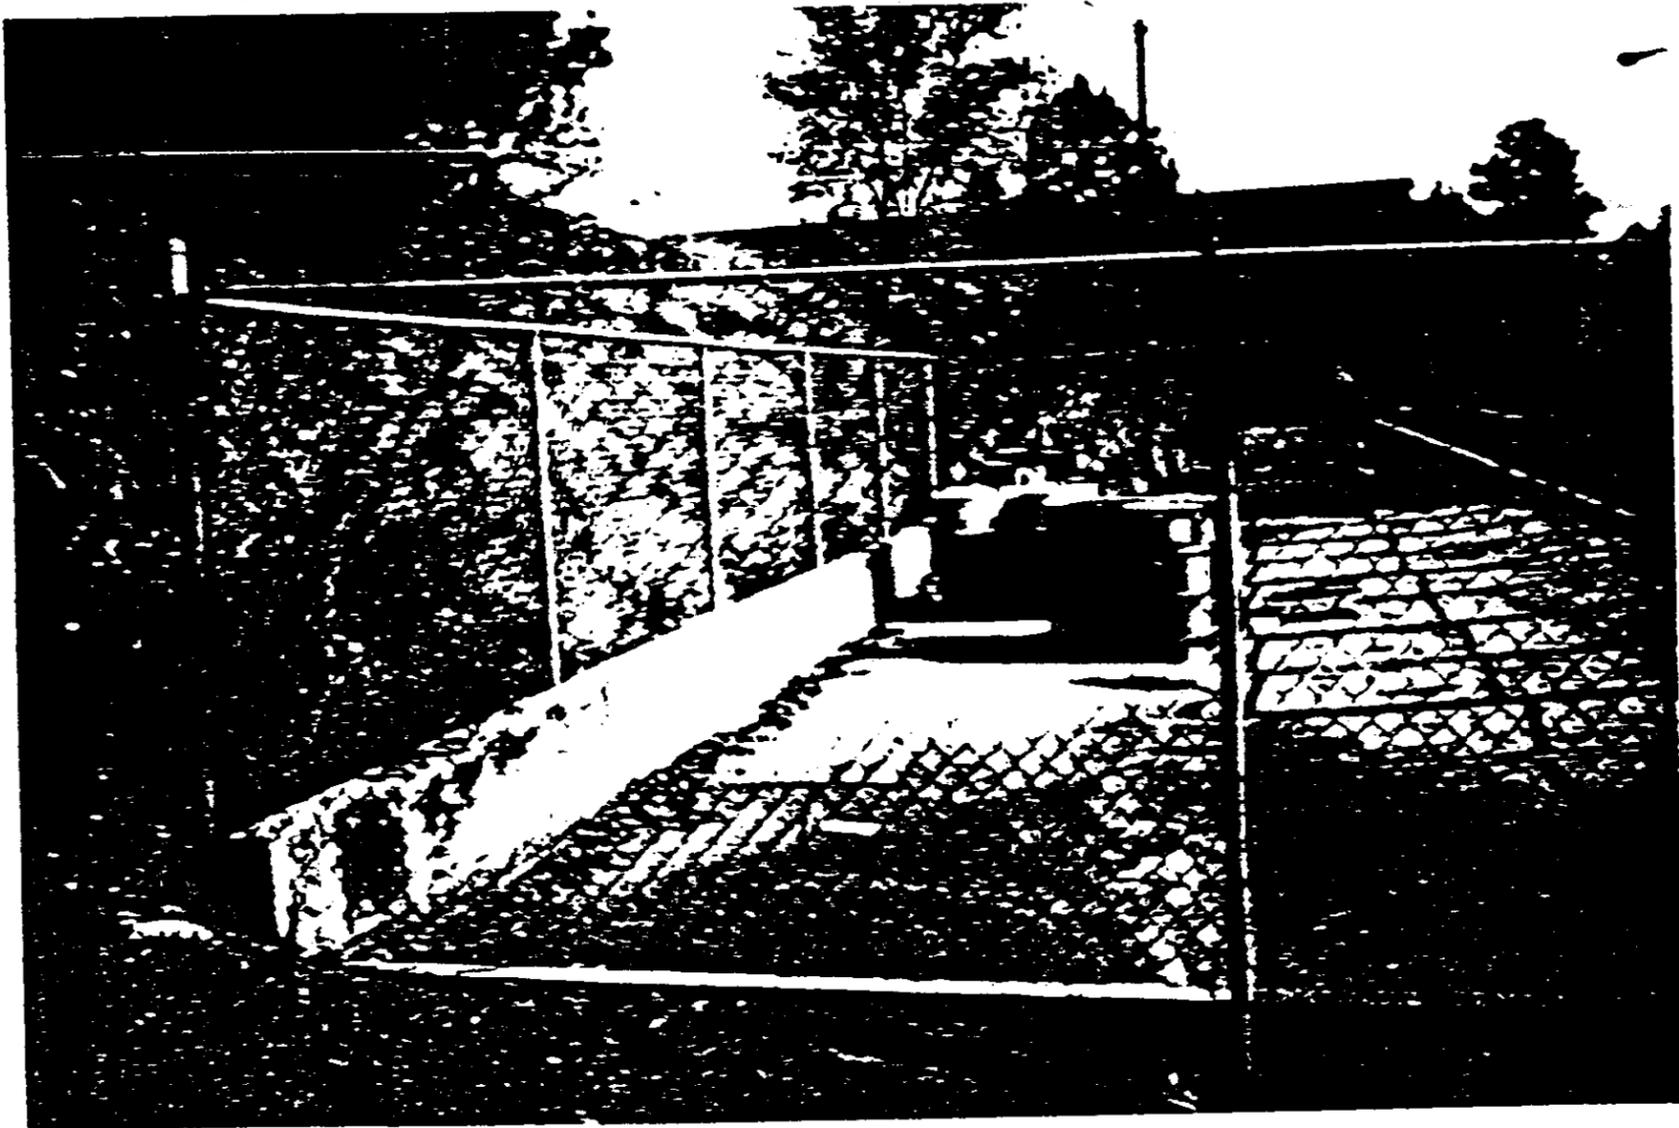
PHOTO # 14

SITE: Alcatel Network Systems LOCATION: Raleigh, NC
DESCRIPTION: SWMU #6- view of drums and the pad's slope toward
the locked drainage valve.

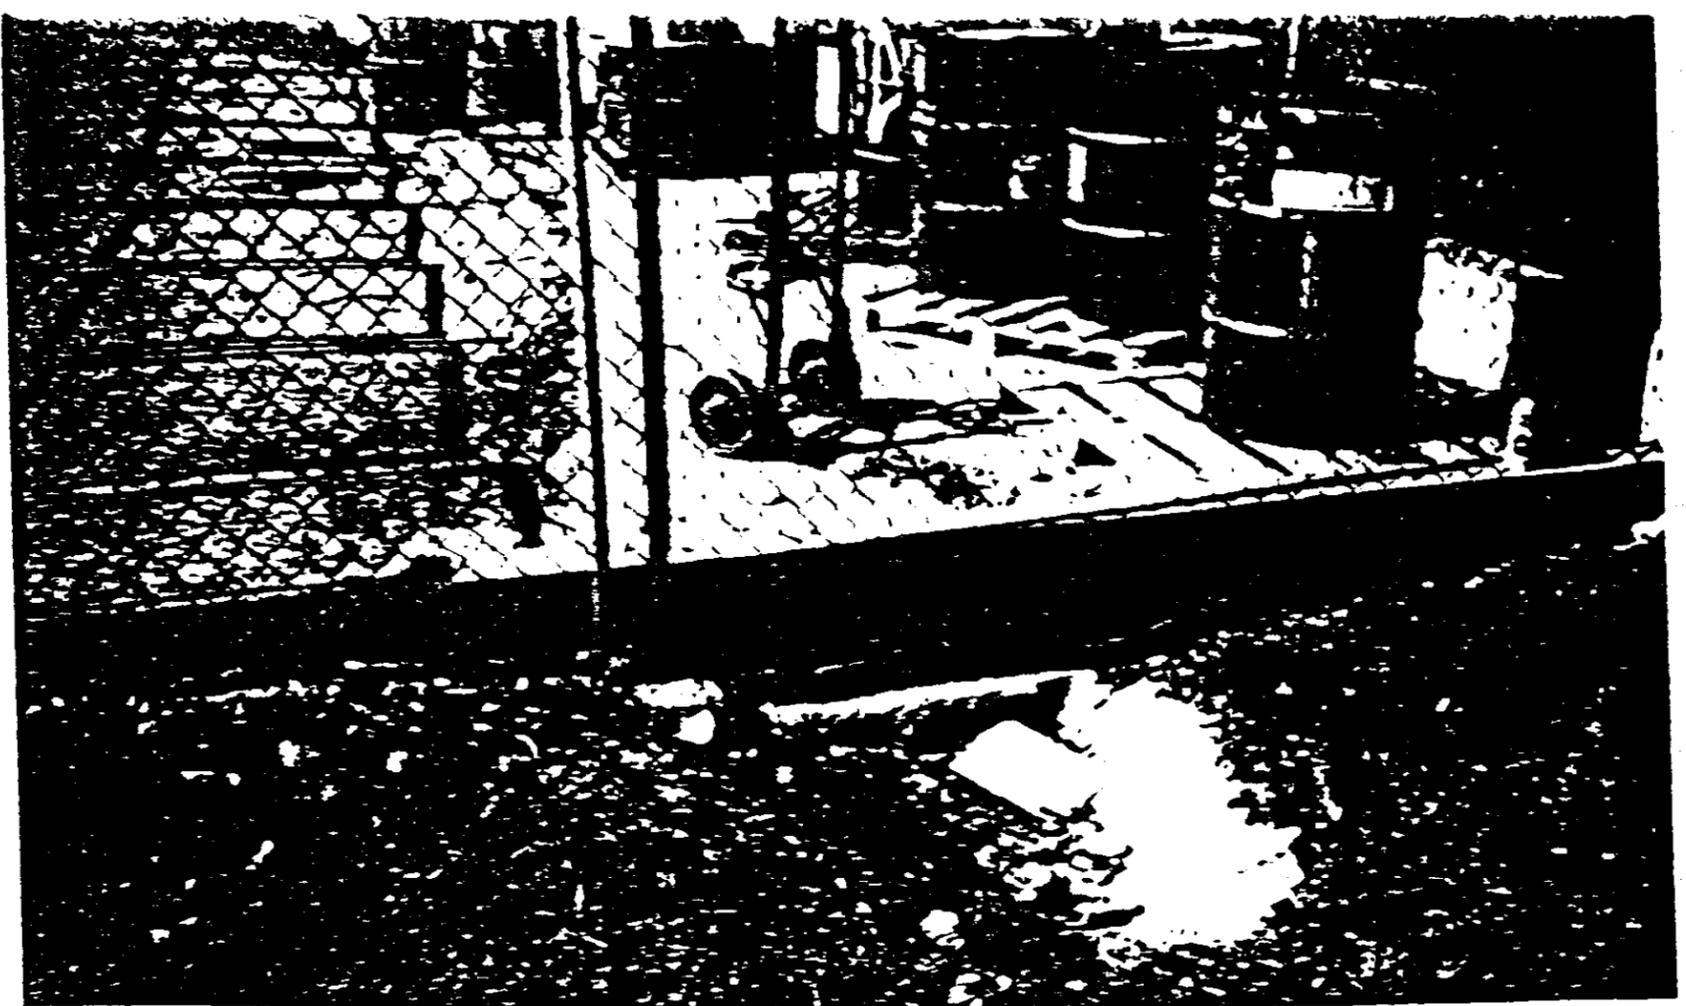
PHOTO # 15

SITE: Alcatel Network Systems LOCATION: Raleigh, NC
DESCRIPTION: SWMU #6- view of surface water drain lines underneath
the pad, which directs surface water runoff beyond unit.
DATE: November 7, 1991 TIME: 1315

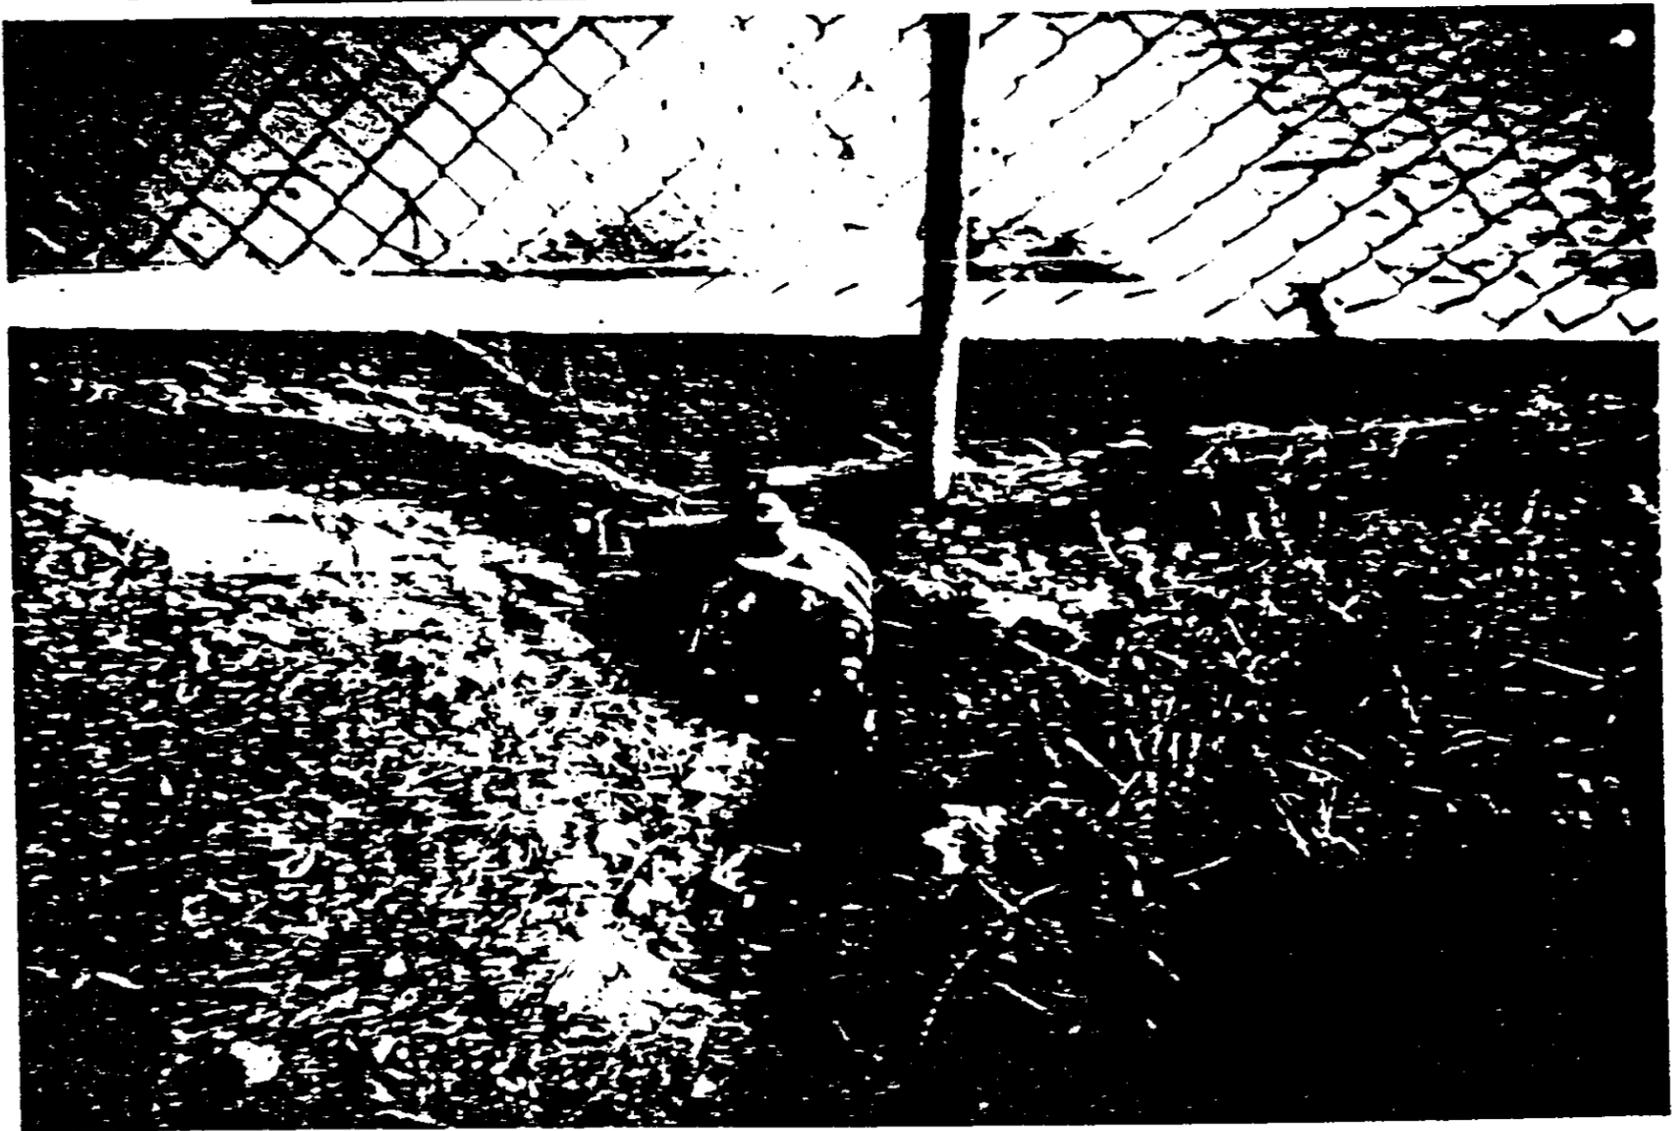
PHOTO # 16

SITE: Alcatel Network Systems LOCATION: Raleigh, NC
DESCRIPTION: SWMU #6- locked drainage valve at RCRA storage pad #2.
DATE: November 7, 1991 TIME: 1317

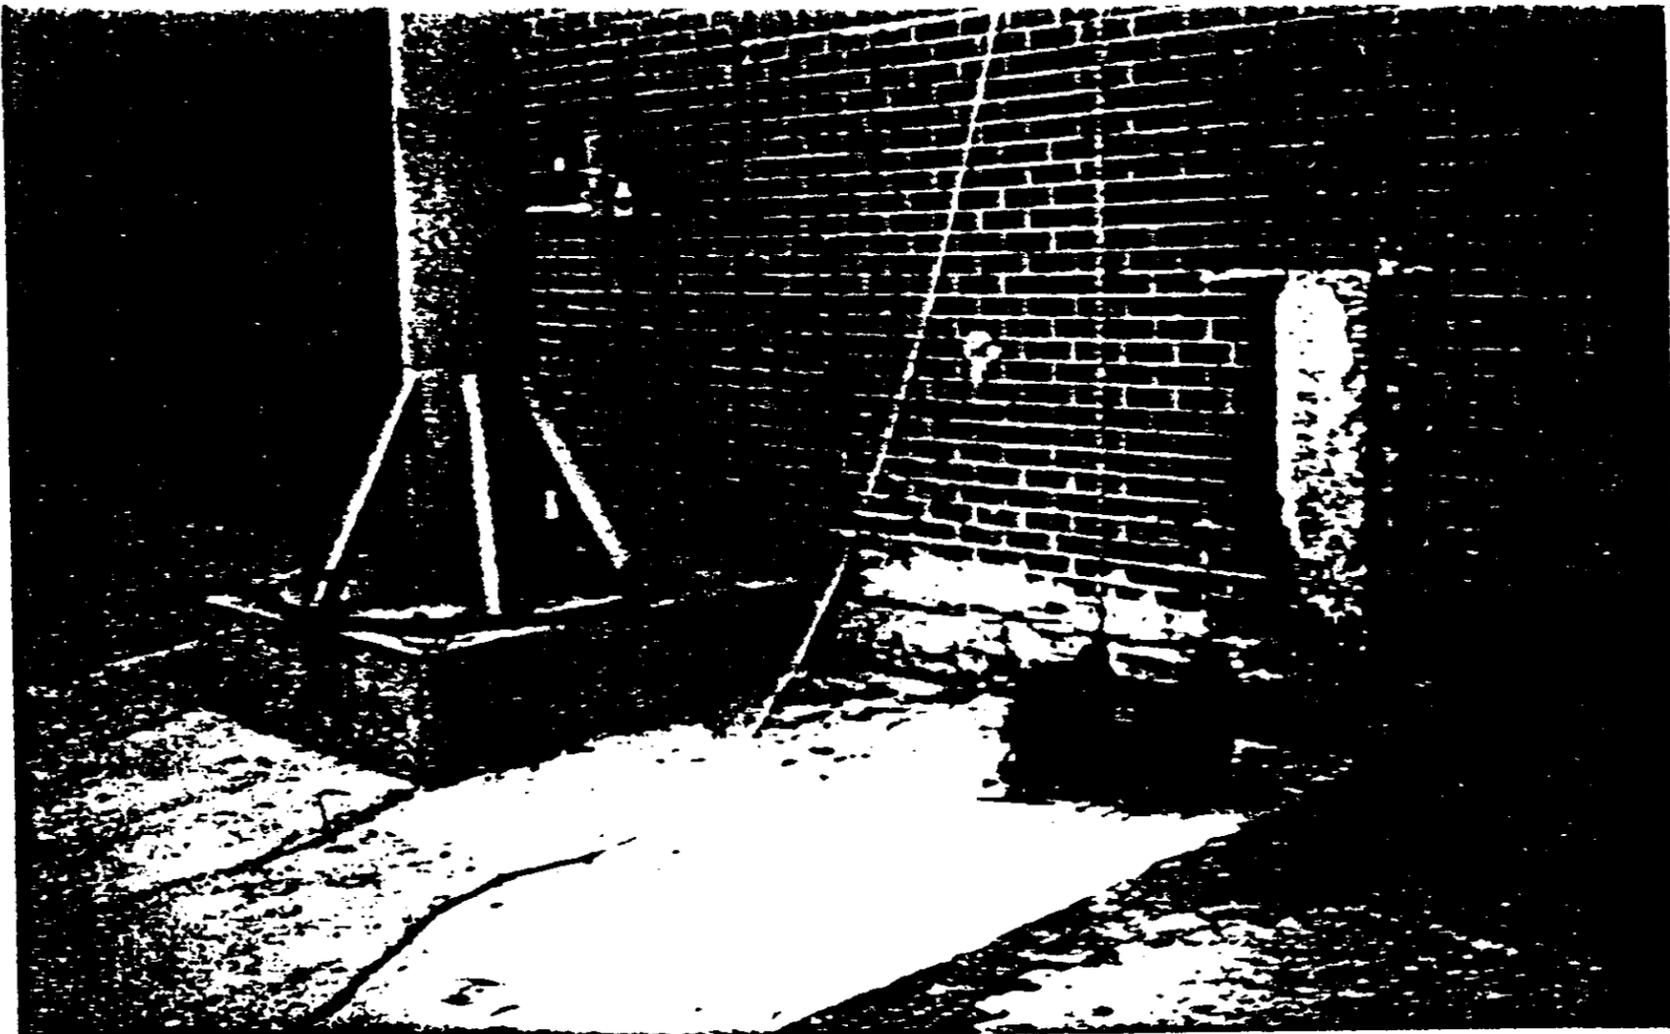
PHOTO # 23

SITE: Alcatel Network Systems LOCATION: Raleigh, NC
DESCRIPTION: AOC- drainage exit from main facility, nearest exit to WWTP;
approximate location of area #2.

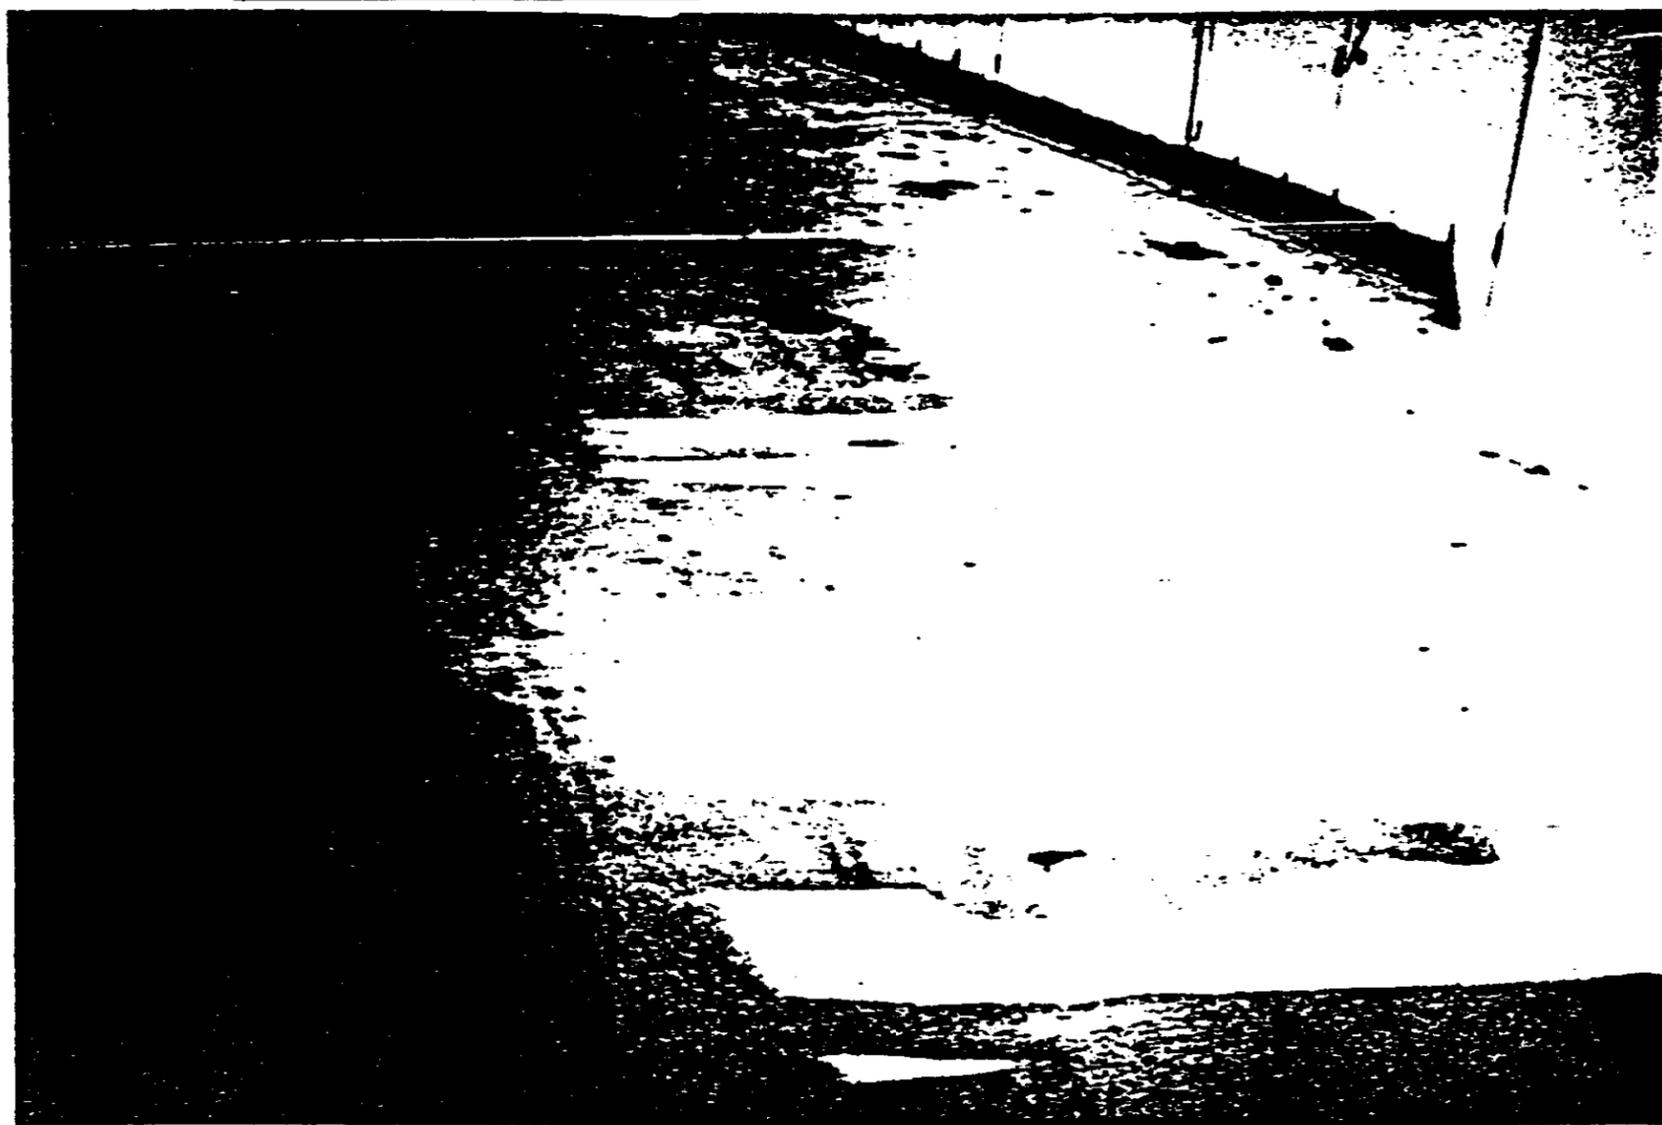
PHOTO # 24

SITE: Alcatel Network Systems LOCATION: Raleigh, NC
DESCRIPTION: AOC- concrete alleyway facing west; view of contaminated soil
area (area #3); location is 40'-50' northeast of area #1.

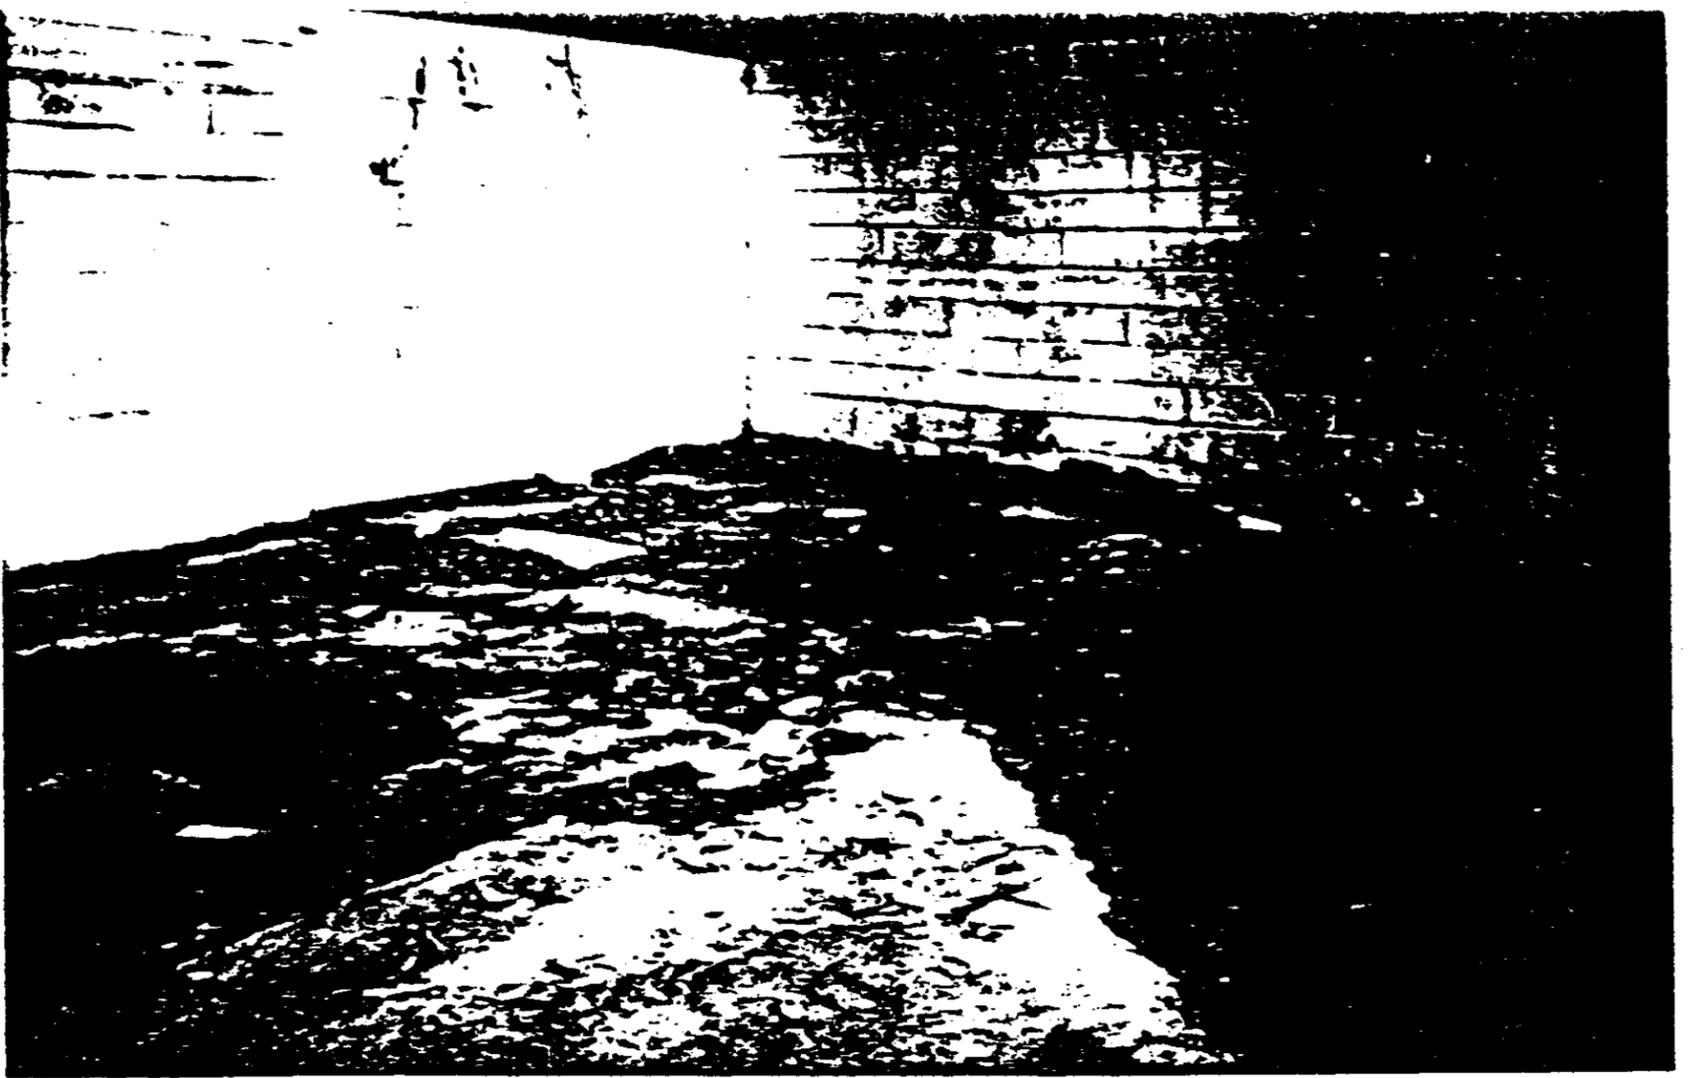
PHOTO # 25

June 1991 - WEGS prepared a report on Area 4 indicating that lead contamination was essentially limited to the top foot of soil and the overlying paving material. The area was sampled in April 1991 and the results are available in Appendix G. Removal of one foot of soil and the paving materials was recommended.

SITE: Alcatel Network Systems LOCATION: Raleigh, NC
DESCRIPTION: AOC- past location of chemical storage shed; soil investigation area (area #4).
