**RE: Leachate Release Response Plan
Davidson County Landfill (SWS Permit No. 29-06)
Lexington, North Carolina**

FACILITY COMPLIANCE INSPECTION REPORT
Division of Waste Management
Solid Waste Section

Davidson County Integrated Solid Waste Management Facility
220 Davidson County Landfill Road
Lexington, NC 27292

SUBJECT: Notice of Violation
Compliance Inspection Report
Davidson County Solid Waste Management Facility
Permit No. 2906
Davidson County

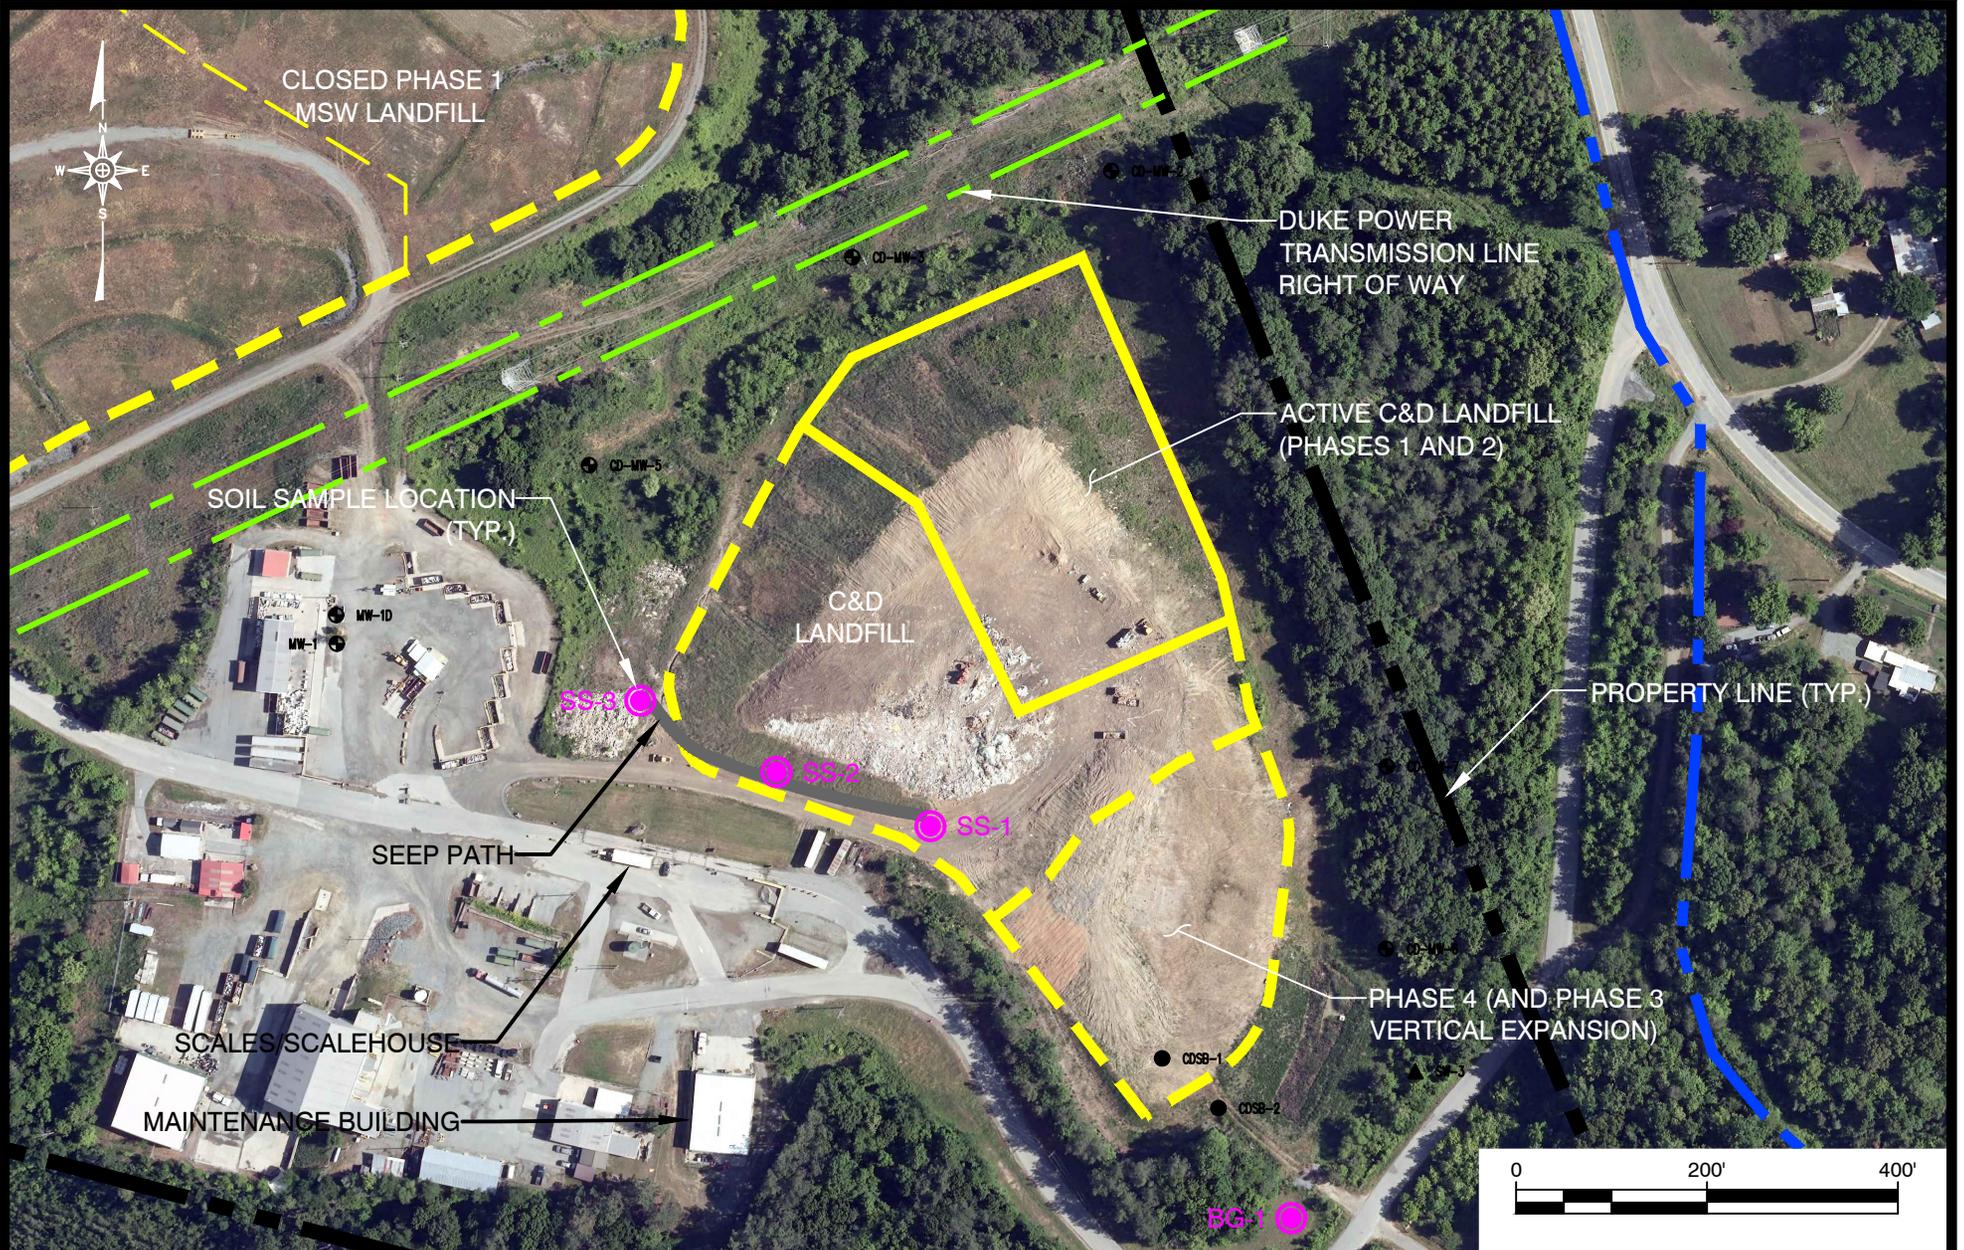
S+G personnel will mobilize to the site to collect soil samples from the flow path of the leachate release; shown on the attached **Figure 1**. To evaluate soil quality within the flow path, S+G proposes to collect a total of three discreet grab samples; one sample will be collected near the source of the release, a second sample will be collected in the flow path and the third sample will be collected where the leachate flow ended. Due to the naturally occurring inorganic metals in the soils of North Carolina, S+G will also collect a background sample upgradient and away from the leachate flow path. Background sample results will be compared with samples collected in the flow path, to evaluate the concentrations of naturally occurring constituents. The proposed sampling locations are shown on **Figure 1**.

PREPARED FOR: C&D LANDFILL DAVIDSON COUNTY, NORTH CAROLINA SEEP PATH SAMPLE LOCATIONS	DRAWN: J.A.L.	APPROVED:	SCALE: AS SHOWN	DATE: Jun 2016	PREPARED BY: _____ <small>NC LIC. NO. C-0828 [ENGINEERING]</small>
	PROJECT NO.: DAVDCO 15-9	FIGURE NO.: 1	FILENAME: DAVDCO-A0815	SMITH+GARDNER <small>14 N. Boylan Avenue, Raleigh NC 27603 919.828.0577</small>	
	© 2016 Smith Gardner, Inc.

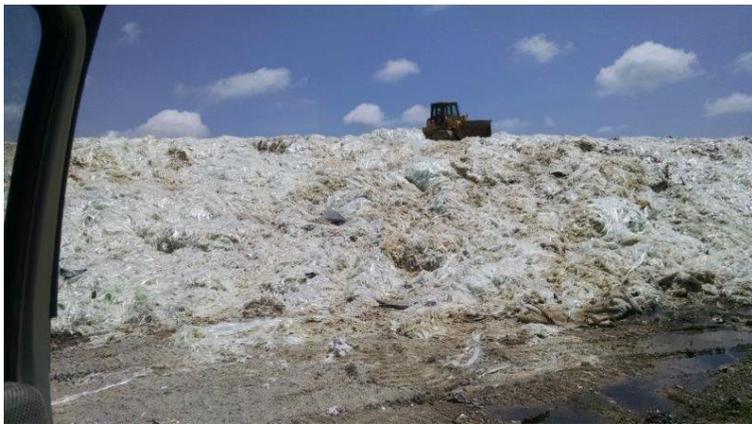
Upon initial inspection on 6/2/2016, the working face of the C&D landfill was observed to have inadequate cover, thus allowing waste to remain exposed and to become windblown. (Note that the waste stream is composed of large loads fiberglass strands.)

C&D landfill working face - observed 6/2/2016.

To achieve compliance, Davidson County must immediately apply cover to areas where waste is exposed to achieve a 6 inch layer of soil, as required by 15A NCAC 13B. 05042(f)(1).

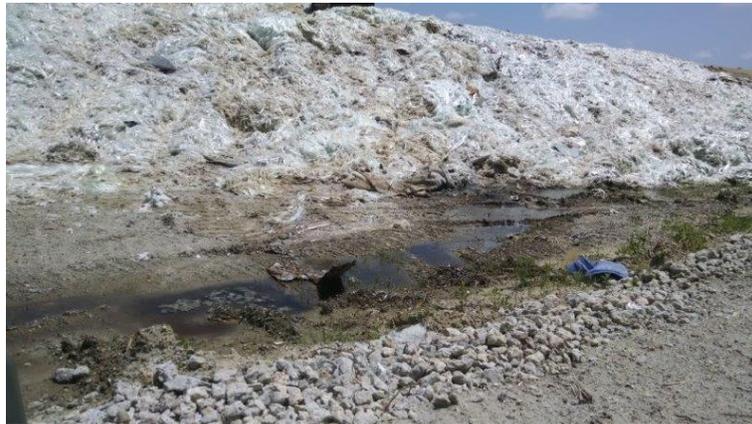
Upon initial inspection on 6/2/2016, ponding liquid was observed at the toe of the working face, along with a trail of liquid flow along the access roadway following the edge of waste downhill to an inert debris stockpile area, then out into the open area between the closed Phase 1 MSWLF and the active CDLF.

Close up view of leachate runoff at C&D landfill working face -- observed 6/2/2016.

To achieve compliance, Davidson County must contact Jaclynne Drummond, Solid Waste Section Hydrogeologist, at 828-296-4706 within ten (10) days of receipt of this report to present a sampling plan, to be implemented immediately upon her approval, which will evaluate the extent of any potential environmental impact resulting from these leachate releases. The results of this evaluation will dictate any additional corrective measures to be required. Please see the attached Notice of Violation letter for additional information about required corrective measures.

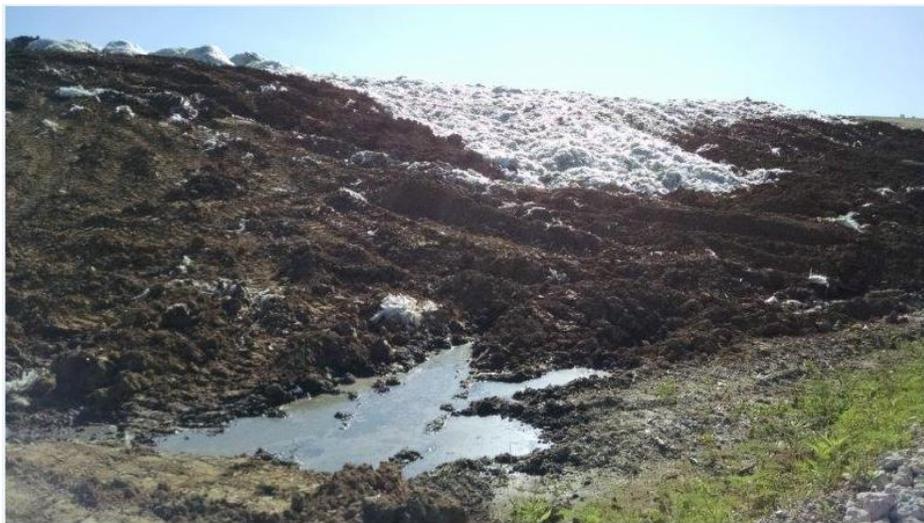
During the completion of the inspection on 6/10/2016, some progress had been made through the construction of a temporary berm which appeared to be containing much of the leachate emanating from the C&D landfill unit.

Improved cover and temporary berm to prevent leachate runoff at C&D landfill working face – observed 6-10-2016.

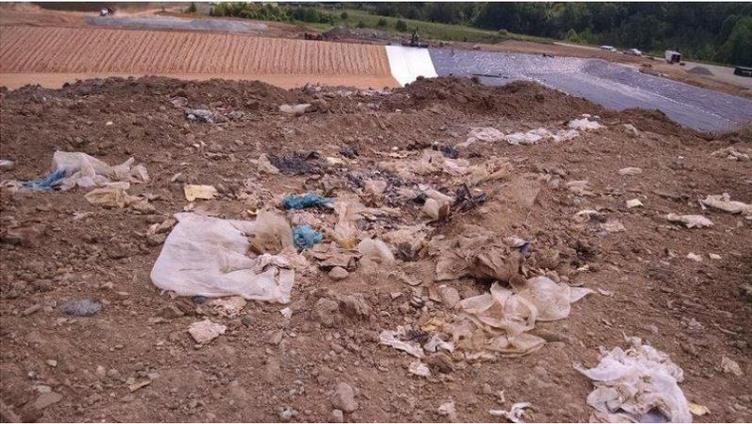
Upon initial inspection on 6/2/2016, the working face of Phase 2, Cell 2A of the MSW landfill was observed to have inadequate cover, thus allowing waste to remain exposed and to become windblown. In addition, the operating record indicating dates and times of placement of daily cover showed that the last time daily cover had been applied was the previous week.

Inadequate cover of waste, looking down the side slope toward new cell construction 6/2/2016.

To achieve compliance, Davidson County must apply cover to areas where waste is exposed to achieve a 6 inch layer of soil as required by June 30, 2016.

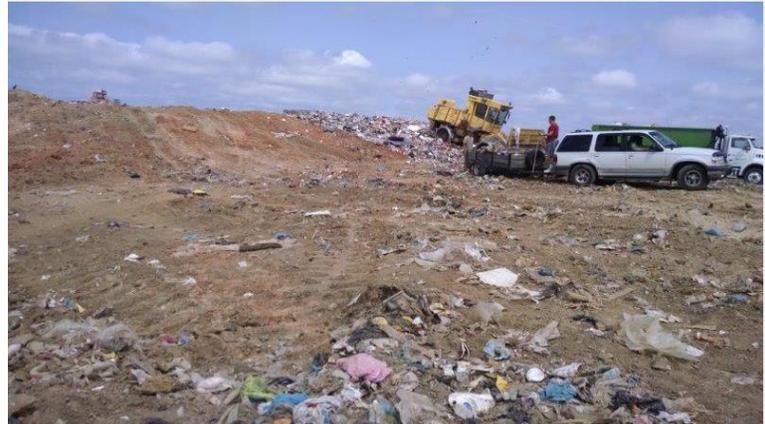
Inadequate cover of waste, looking up the side slope toward the working face 6/2/2016.

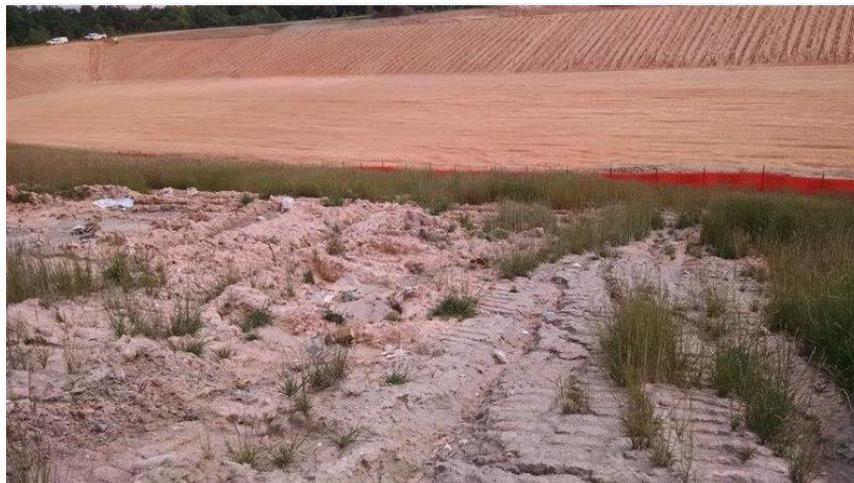
Upon initial inspection on 6/2/2016, the entire northern slope of the active landfill (Ph. 2, Area 2, Cell 1B) showed evidence of severe erosion, where silt containing exposed waste had flowed through the silt fencing and into the area of the as yet unlined portion of the new cell (Ph. 2, Area 2, Cell 2A and 2B) which is currently under construction.

Upon initial inspection on 6/2/2016, the entire northern slope of the active landfill (Ph. 2, Area 2, Cell 1B) showed evidence of severe erosion. The slope leading down to the area of new cell construction was observed to have no vegetative cover established that would prevent erosion.

View of erosion from the side slope of the active landfill looking toward the unlined cell 2A, currently under construction.

To achieve compliance, Davidson County must ensure that erosion control measures are sufficient to prevent silt from leaving the MSWLF facility and to prevent on-site erosion.

To achieve compliance, Davidson County must ensure that sufficient vegetative cover is established on the landfill slopes to prevent erosion. Vegetation must be well established to determine if compliance has been achieved.

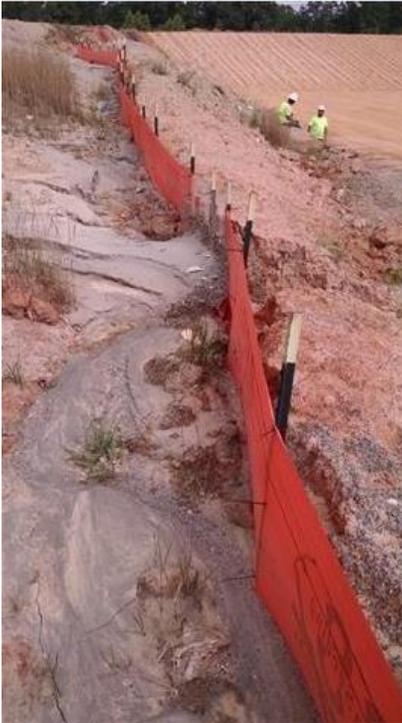
Upon initial inspection on 6/2/2016, the entire northern slope of the active landfill (Ph. 2, Area 2, Cell 1B) showed evidence of severe erosion, which had resulted in the development of deep ruts and gullies along the entire slope leading directly to the unlined portion of the new cell (Ph. 2, Area 2, Cell 2A and 2B) which is currently under construction.

View of erosion and sediment flow along the silt fence protecting the area of new cell construction.

To achieve compliance, Davidson County must ensure that erosion control measures are sufficient to prevent on-site erosion. The slope must be inspected regularly to ensure it remains intact as the vegetative cover sprouts and becomes established.

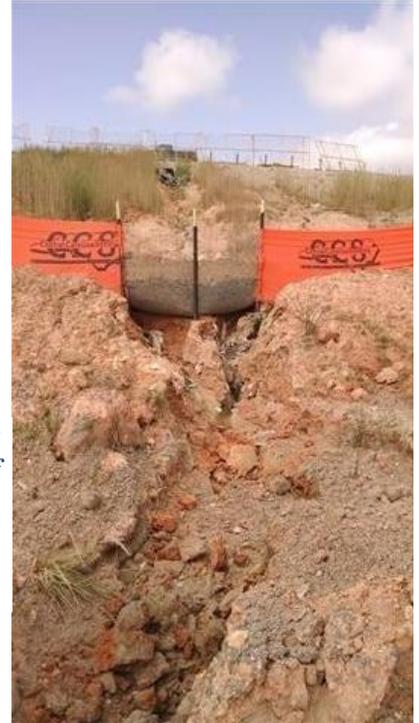
View of erosion and sediment flow as seen from the berm of the new landfill cell looking up the slope to the protective silt fence.

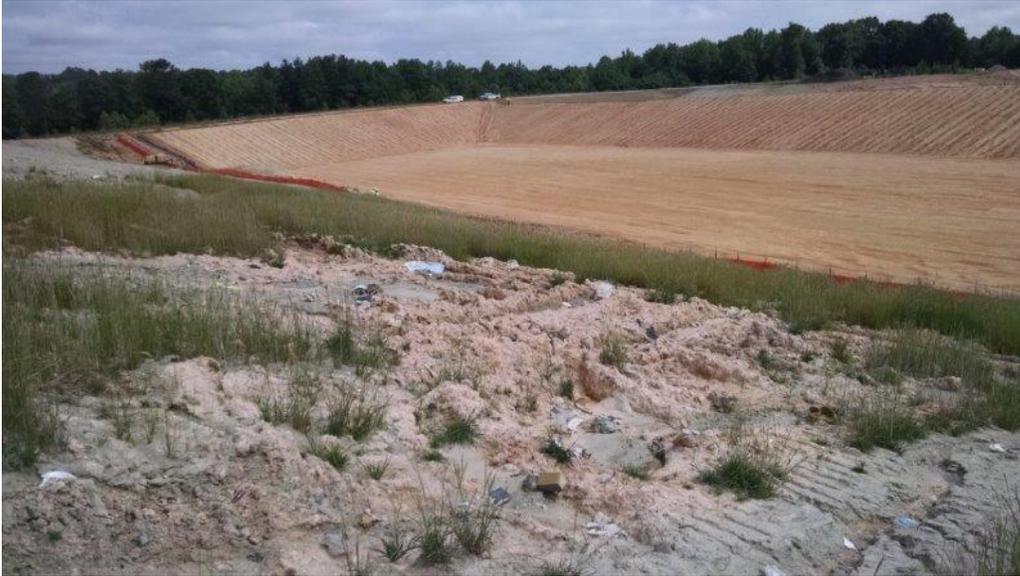
47. On the slope immediately adjacent to the new cell construction, poor waste coverage and serious erosion issues were seen to have resulted in the flow of sediment and waste into the area of the as yet unlined new Cell 2A. (See observed violations for additional information.)

North slope of active MSWLF with uncovered waste, severe erosion and sediment flow adjacent to unlined landfill cell construction.

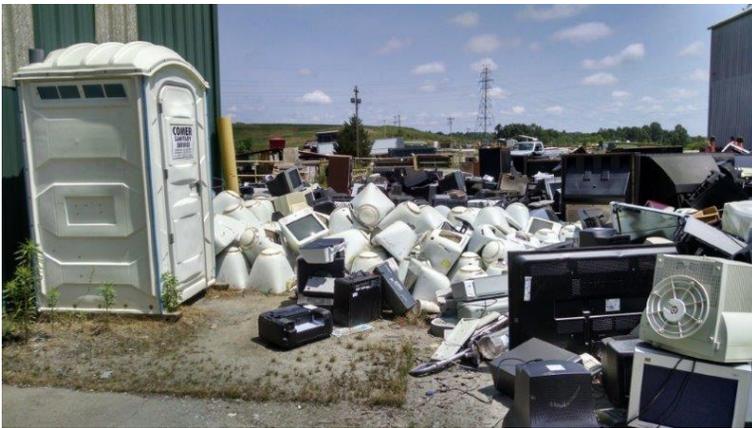
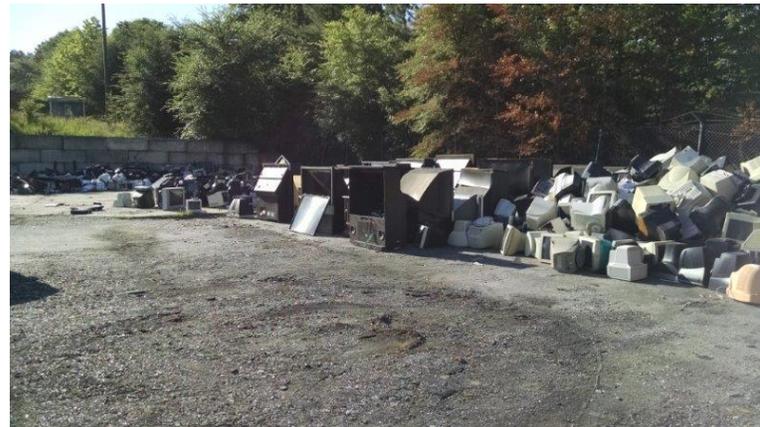
69. The date of the last electronics load transported from the facility was 01/20/2016. On 06/10/2016, paperwork was provided showing that an electronics load, comprised of some of the palletized televisions and monitors stored inside the transfer station building, had been transported on 06/03/2016. The collection area was still full at the time it was observed on 06/10/2016.

Electronics and television storage area.

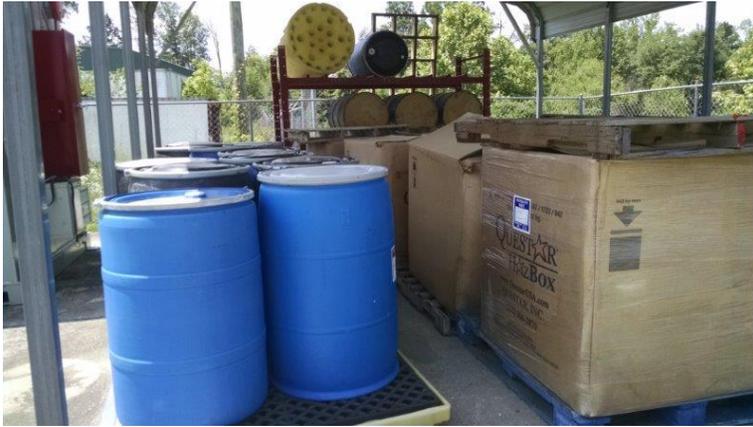
HHW collection and storage area.

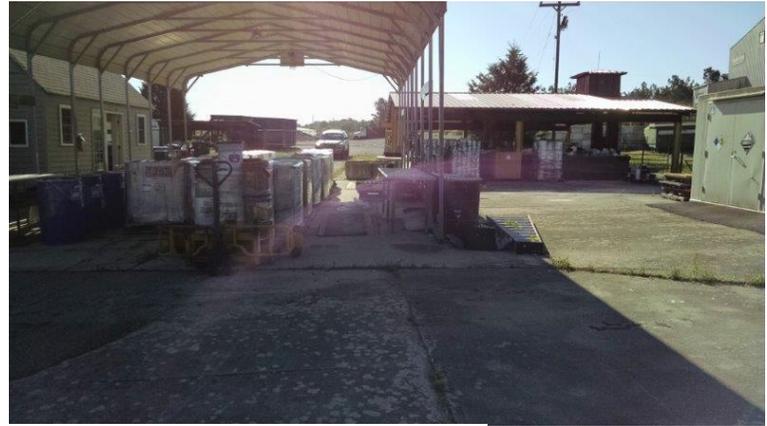
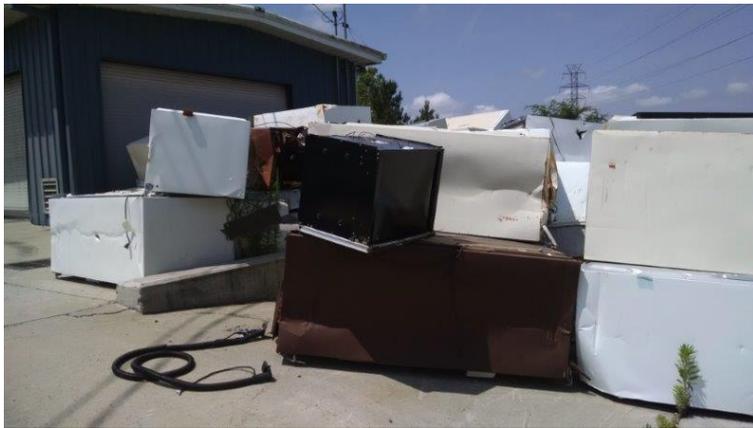
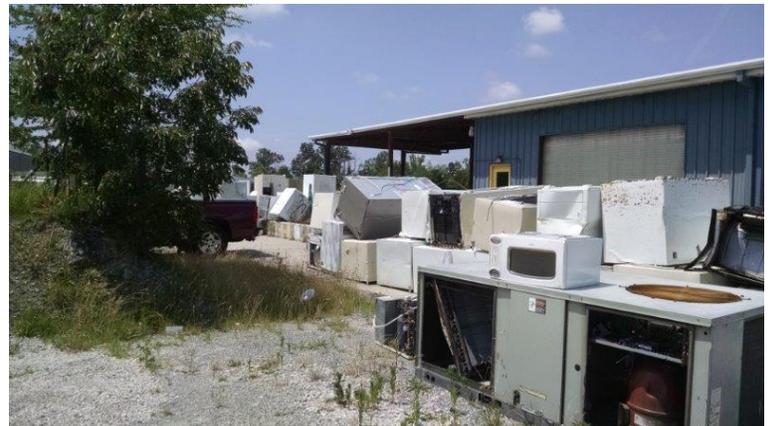
61. At the time of the inspection, the white goods area was observed to be full. Units containing CFCs were not properly staged to ensure that gas lines remained intact and the CFCs safely contained. Mr. Sink stated that a contact was currently being negotiated to provide for CFC evacuation and removal of the accumulated white goods and scrap metals.
62. **Please ensure that white goods are handled and stored properly to eliminate the unintentional release of CFC gases at the site. In addition, please ensure that white goods are removed from the site in a timely manner so that adequate space is available for safe storage of the materials received.**

White goods collection and storage area.
