FACILITY COMPLIANCE INSPECTION REPORT
Division of Waste Management
Solid Waste Section

Date of Site Inspection: June 23, 2016

Phillippie LCID Landfill – Kimesville Road
4301 Kimesville Road
Burlington, NC 27215

Comprehensive Inspection (to ensure that the notified land clearing and inert debris (LCID) landfill is in compliance with 15A North Carolina Administrative Code (NCAC) 13B .0563, .0564, and .0566)

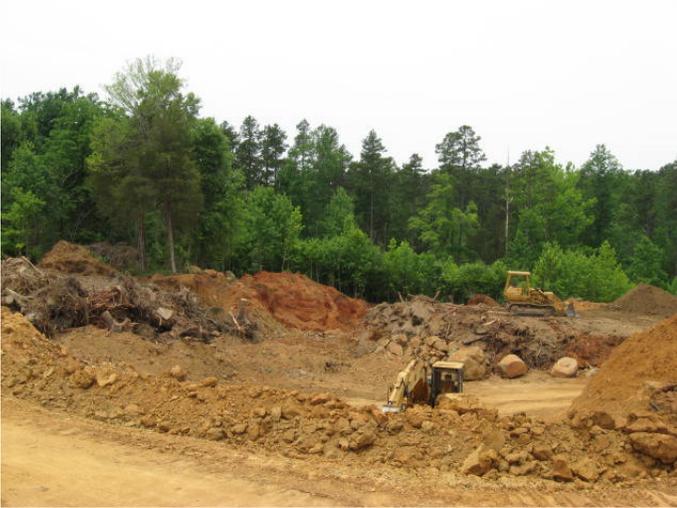
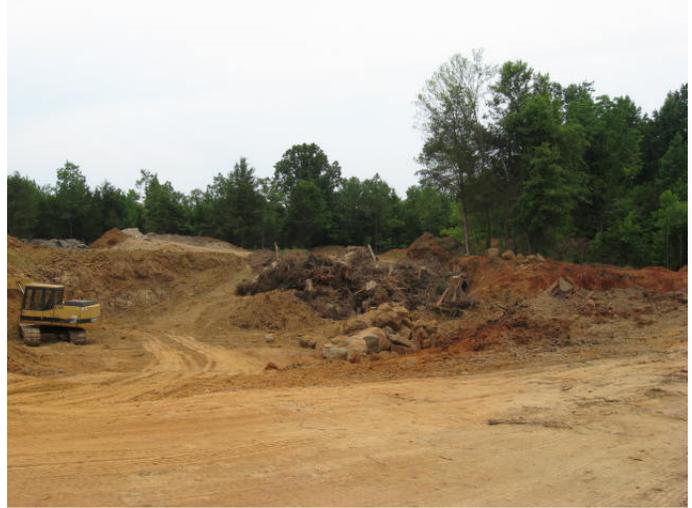
LCID landfill – active area

8. Per 15A NCAC 13B .0566(3), “Solid waste shall be restricted to the smallest area feasible and compacted as densely as practical into cells.”
9. Per 15A NCAC 13B .0566(4), “Adequate soil cover shall be applied monthly, or when the active area reaches one acre in size, whichever occurs first.”

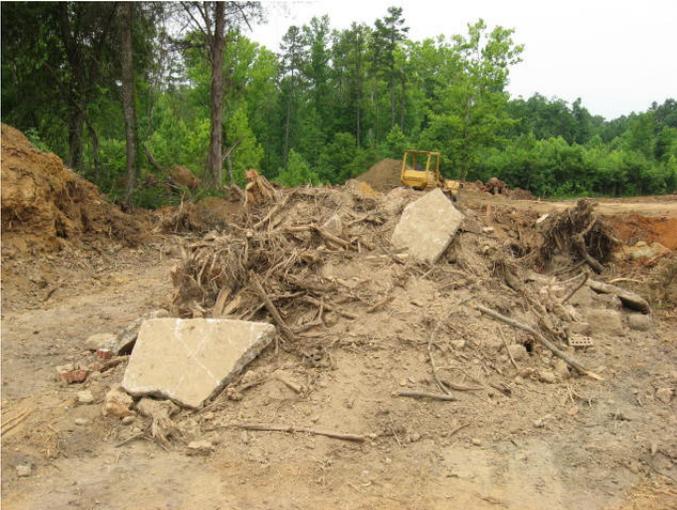
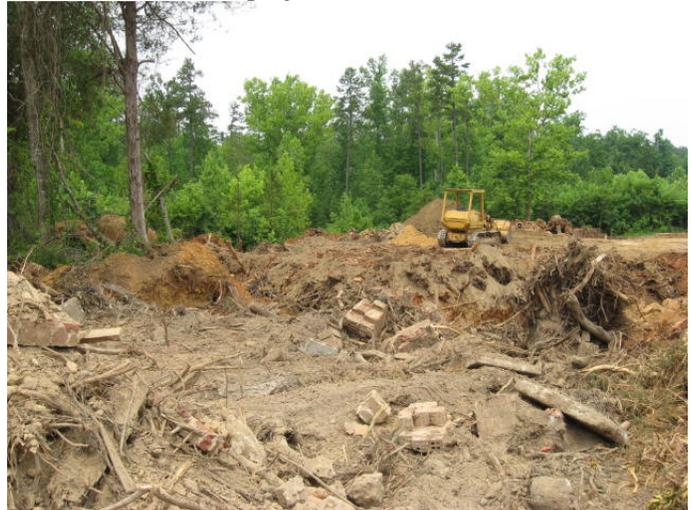
10. Side slopes should be graded such that a 3:1 slope ratio is obtained or a ratio of which no indication of erosion or runoff is observed.
11. The SWS received a complaint on June 21, 2016 stating that the complainant was told that a load of demolition debris was observed being hauled into the Phillipie LCID Landfill – Kimesville Road. Mr. Patrone contacted Mr. Phillipie on June 21, 2016 to discuss the complaint. Mr. Phillipie stated that the facility has received a load of material consisting of LCD and inert materials from a DOT project. Mr. Patrone conducted an inspection of the landfill on June 23, 2016 and met with Mr. Phillipie. The load of material in question was left uncovered. No unacceptable material was observed.

Load of material brought on site from DOT project
