Hazardous Waste Compliance Data Entry Form – Side A

RCRA INSPECTION REPORT

Facility Name: Consolidated Metco, Inc – Canton
Location: 171 Great Oak Lane, Canton, NC 28716
Mailing Address: 171 Great Oak Lane, Canton, NC 28716
EPA ID#: NCR 000 137 588 **Phone Number:** 828-400-3789
Contact/ Title: Everett Lynch EH&S **Inspection Date:** April 12, 2011
Last Inspection: June 29, 2010 **Status:** Large Quantity Generator
Type of Inspection: CEI **Inspector(s):** Spring Allen

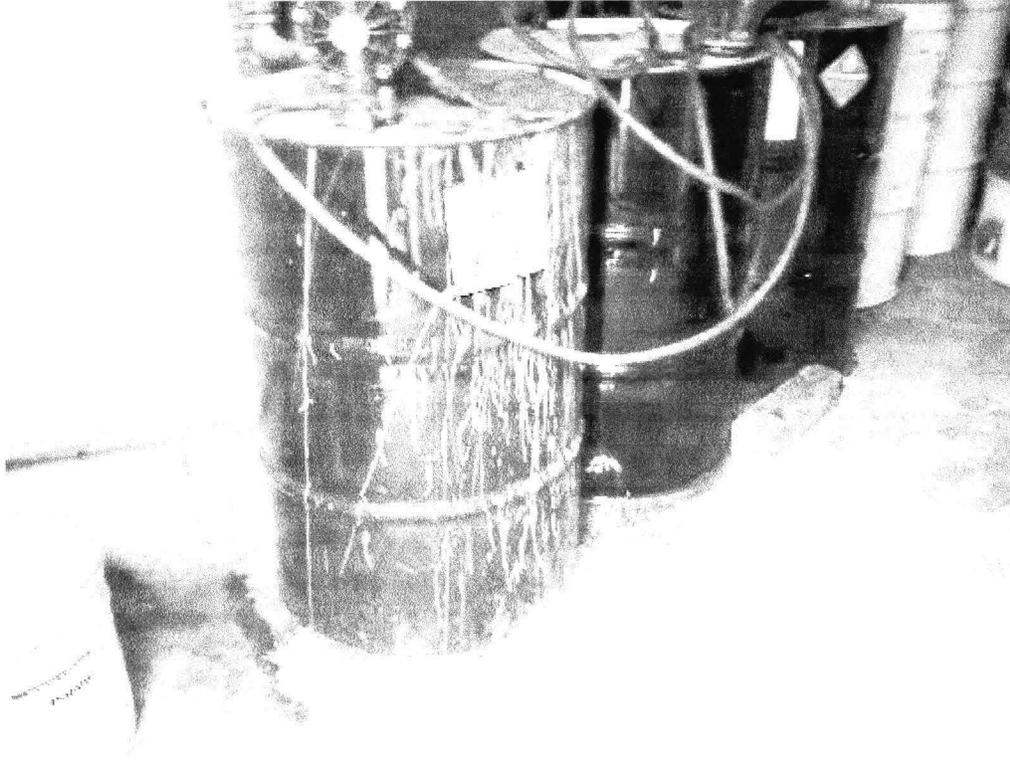
ConMet Canton release around accumulation containers in the storage building

40 CFR 262.34(a)(1)(i) Two (2) 55-gallon accumulation containers holding D001/ F003 paint waste had waste outside the container, including on the floor surrounding one of the 55-gallon containers. These were satellite accumulation containers located in the HW storage building. (3 photos taken with door open)

1. Continue to update arrangements with emergency responders with personal contact each three years at minimum as discussed.
2. Develop a general maintenance schedule for areas where hazardous wastes and other chemicals are stored to assure areas are kept clean, containers closed, and waste is inside containers.

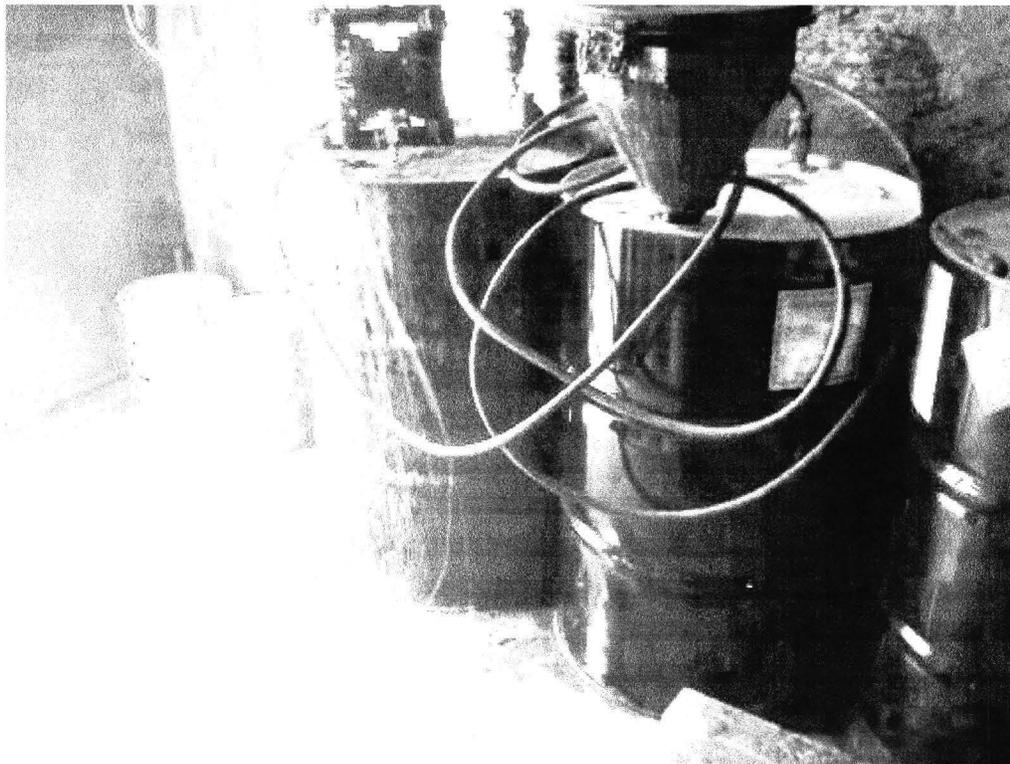
ConMet Canton 2 accumulation containers side-by-side – both are almost full

40 CFR 262.34(c)(1) Two 55-gallon containers identified as satellite accumulation containers were located side by side in the HW storage building. Both were almost full. (photos)

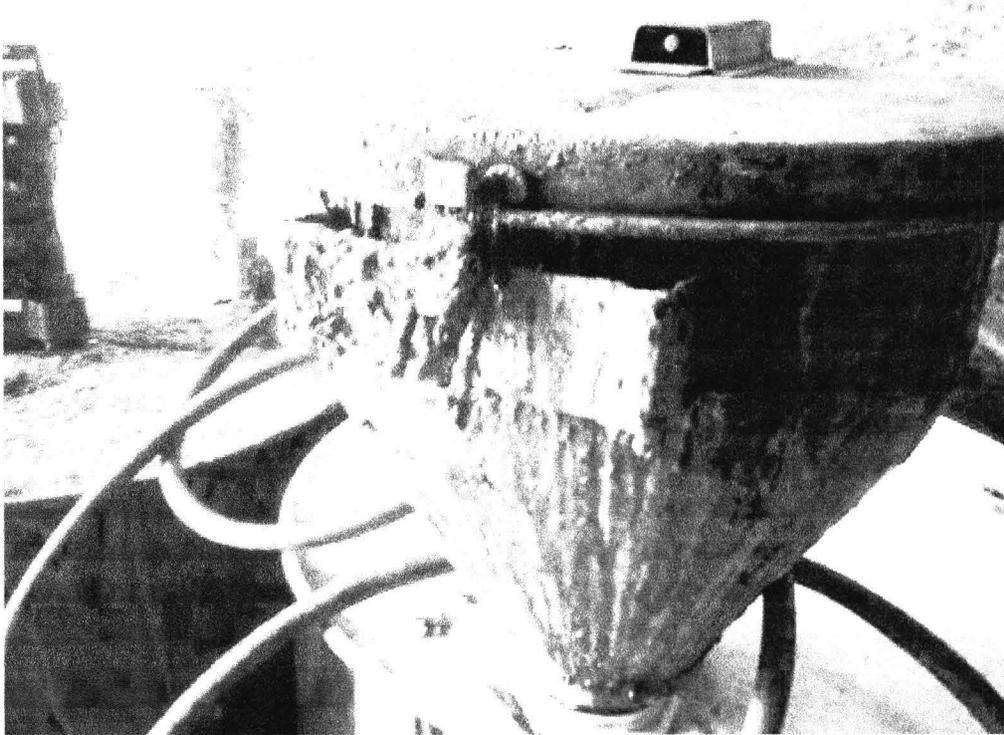
ConMet Canton funnel on accumulation container build-up will not allow the funnel to be latched / the funnel is not fitted with a device to assure the container is closed.

40 CFR 262.34(d) / 265.173(a) Three accumulation containers holding F003/ D001 paint waste were open at the time of inspection. These containers were located in the HW storage building, in the manual spray booth, and outside the manual spray booth. (photos in storage area, none taken at spray booths due to vapors)

The facility changed their process in the robotic arm paint booth to assure the accumulation container remains closed unless adding or removing waste.
