FACILITY COMPLIANCE INSPECTION REPORT
Division of Waste Management
Solid Waste Section

Date of Site Inspection: 06/28/2016

Davidson County Integrated Solid Waste Management Facility
220 Davidson County Landfill Road
Lexington, NC 27292

Partial Inspection

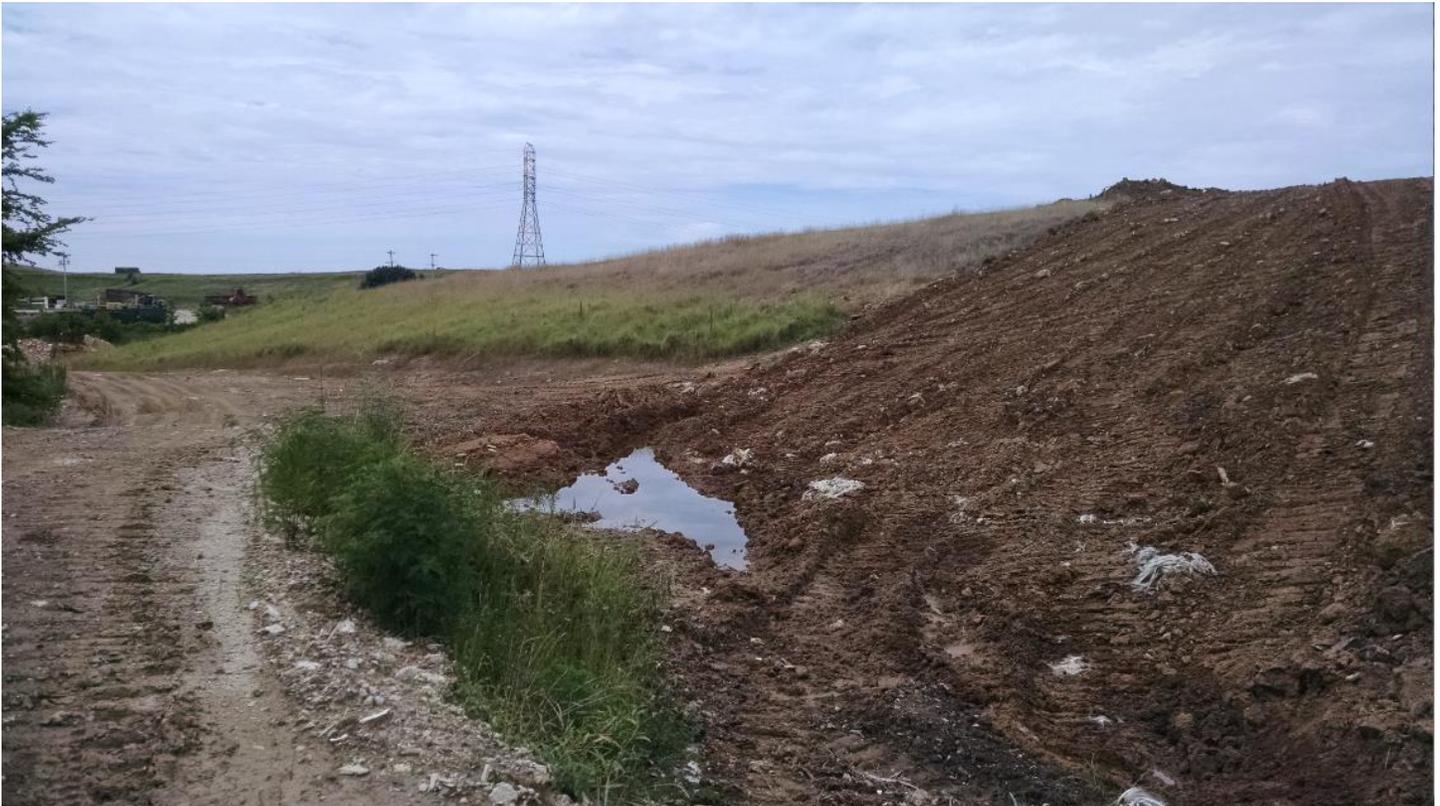
- 1. 15A NCAC 13B .0203(d) cited for failing to perform and/or document the required waste screening provisions stated in the Revised Operations Manual (July 2013). No review of records was made during this inspection.
2. CORRECTIVE MEASURES IN PROGRESS: 15A NCAC 13B .0542(1)(4) cited for failure to capture leachate or to treat it prior to discharge. Since the last site visit on June 10, 2016, an earthen berm had been put into place to retain the leachate accumulating at the toe of the C&D landfill slope. A sampling plan had been developed by Smith Gardner, Inc. and submitted to and approved by the Solid Waste Section on June 24, 2016. Sampling is to take place on June 30, 2016 and a report will be forwarded to the Solid Waste Section within 15 days of receipt of the analytical data. Additional soil cover had been applied to the

3. **CORRECTIVE MEASURES IN PROGRESS:** 15A NCAC 13B .0542(f)(1) cited for failure to apply adequate cover to waste at the C&D landfill. Additional cover has been applied and will continue to be applied as the site is prepared for the closure process.

Leachate being captured and retained by earthen berm at the toe of C&D landfill face and additional soil cover observed 6/28/2016.

working face and, as stated by Mr. Sink, the final loads of material have been accepted at the site prior to initiating the closure process.
