FACILITY COMPLIANCE INSPECTION REPORT
Division of Waste Management
Solid Waste Section

Date of Site Inspection: February 22, 2016

Veach LCID Landfill
4261 Old Thomasville Road, Winston-Salem, Davidson County

Comprehensive Inspection

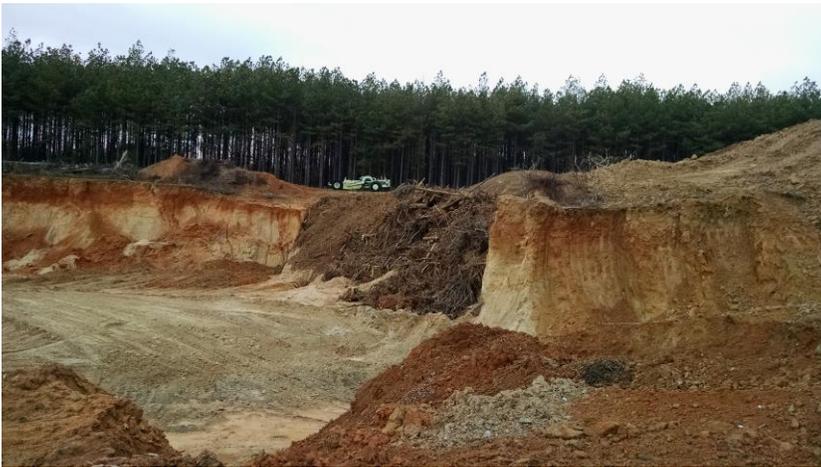
Mining area and working face.

10. The facility mines soil, and the mined area is being used as the current landfill area.
11. An inspection of the facility was conducted by Division of Energy, Mineral and Land Resources (DEMLR) in November 2015.

24. Ensure permanent markers that accurately designate the waste disposal boundary are installed and maintained.
25. Ensure that the mined area and base of the working face are properly graded so as not to collect water.
