FACILITY COMPLIANCE INSPECTION REPORT
Division of Waste Management
Solid Waste Section

Date of Site Inspection: 06/14/2016 Date of Last Inspection: 10/27/2011

Cherokee County Municipal Solid Waste Landfill
State Road 1515, Fairview Road
Marble, N. C. 28905

Comprehensive Audit of Closed Landfill

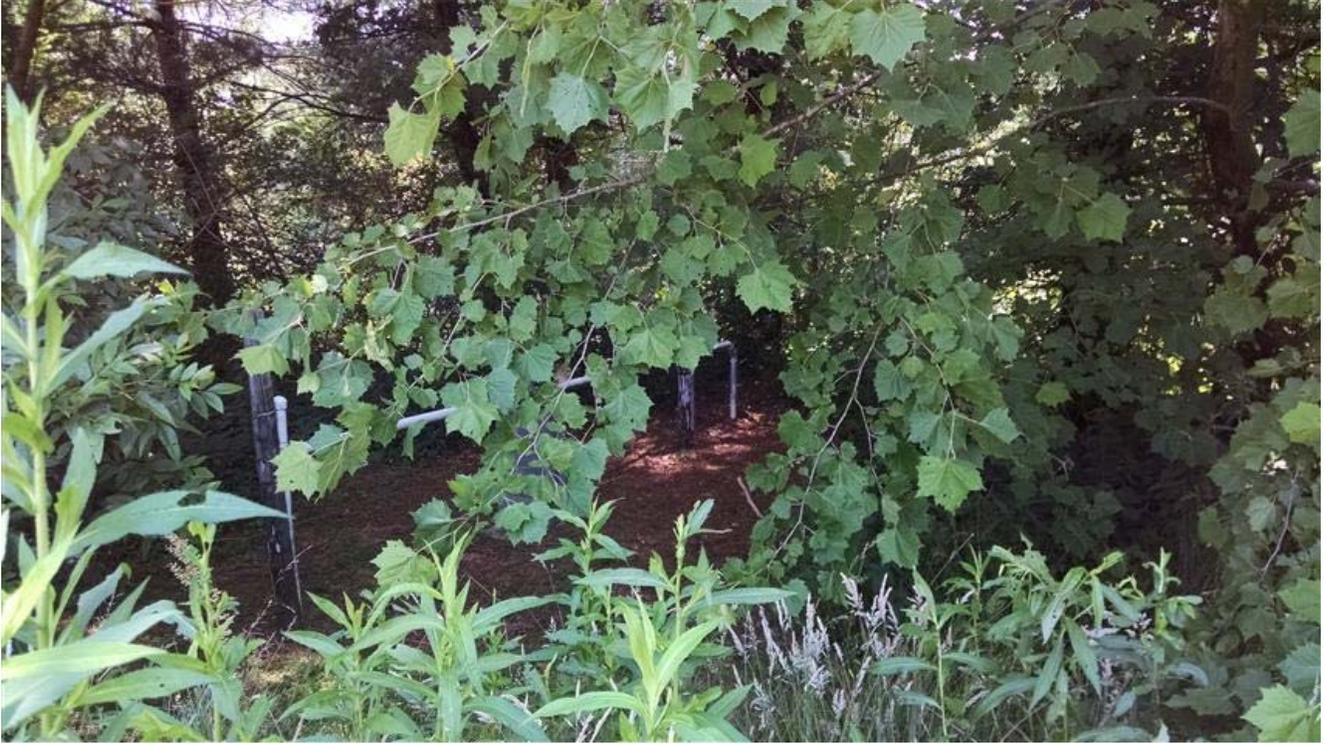
- Trees were planted on the east side of the landfill at the time of construction of the landfill. Mr. Clark stated that these trees are located on waste.

Gas Extraction Well and Trees on Waste

- Trees, bushes and vines are growing and encroaching in on the cap on all sides of the landfill. **Cherokee County must submit a plan for review and approval to remove woody vegetation from the permitted disposal area and repair the final cover system. See observed violation section of this report.**

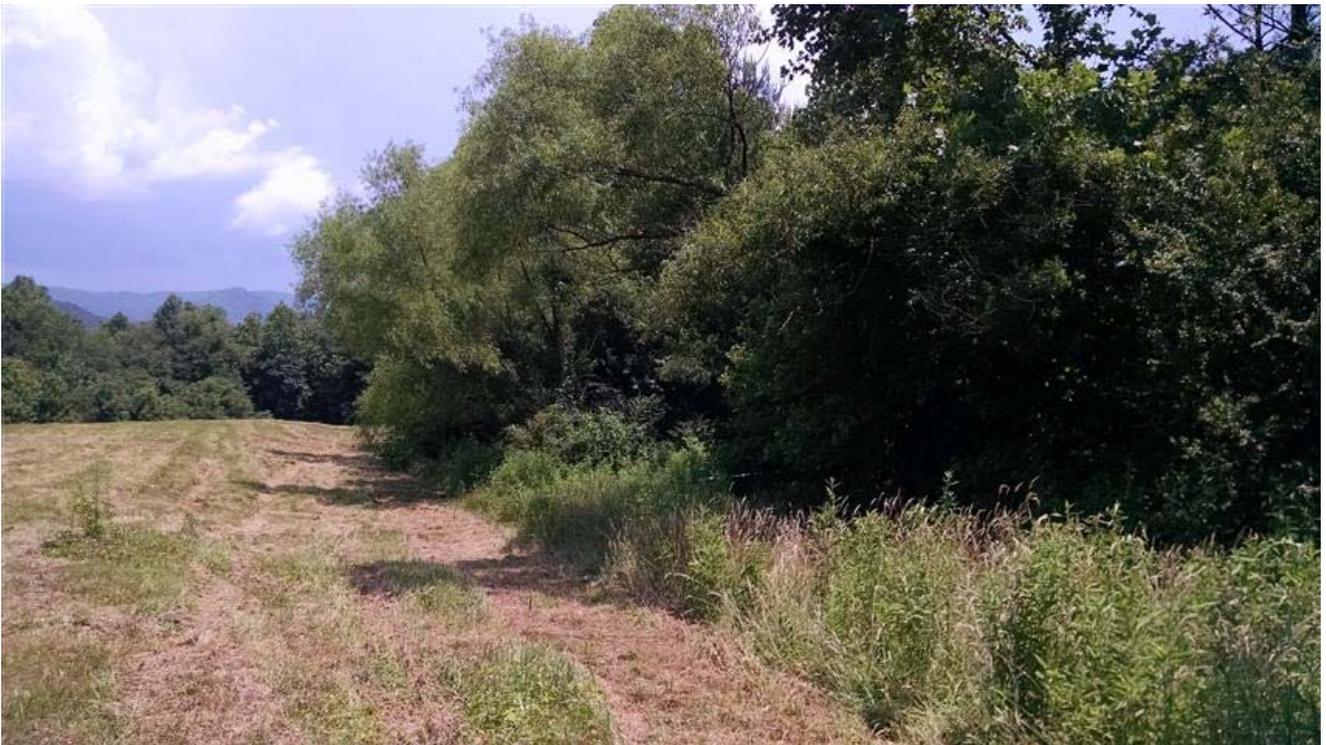
On June 14, 2016, woody vegetation (trees, shrubs and briars) were observed growing on the north and east side

of the landfill on the final cover system. Thus, the final cover system was not maintained. This constitutes a violation of 15 NCAC 13B .0510(c). In order to achieve compliance, Cherokee County must submit a plan for review and approval to remove woody vegetation from the permitted disposal area and repair the final cover system with timeframes for implementation. Submit this plan no later than July 31, 2016 via U.S. Mail or electronic correspondence to Lee Hill at:

- Vegetation was well established on the top of the cap of landfill.
- The top of the cap had been recently mowed at the time of inspection.
- Edge of Waste (EOW) markers are installed; however heavy vegetation has grown up around the outside of the landfill including small trees and bushes and needs to be removed. **Cherokee County must submit a plan for review and approval to remove woody vegetation from the permitted disposal area and repair the final cover system. See observed violation section of this report.**

Overgrown Perimeter of Landfill.
