**FACILITY COMPLIANCE INSPECTION REPORT**  
**Division of Waste Management**  
**Solid Waste Section**

**Date of Site Inspection:** June 28, 2016

ARBD LLC dba Stone Company LLP LCID Landfill  
52 Rock Hill Drive  
Chapel Hill, NC 27517

Comprehensive Inspection

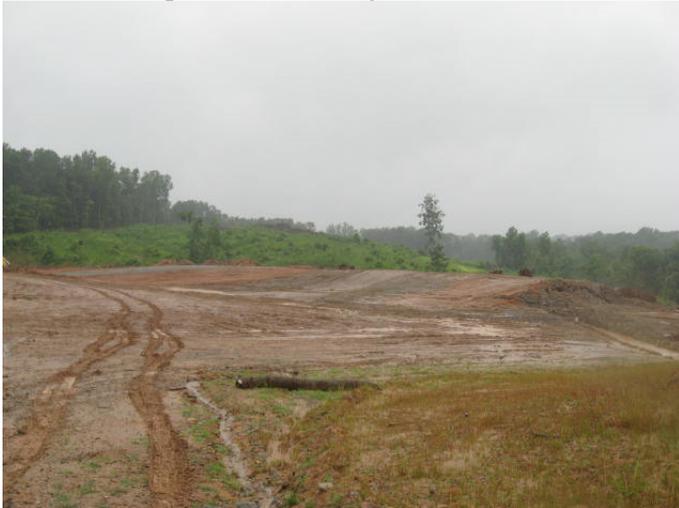
Soil cover atop Phase 1 abutting Phase 3

18. Ensure stormwater does not pool atop the intermediate cover. Grade low areas accordingly.
19. Sediment basins observed appeared maintained.
20. Mr. Stone stated that bare areas will be sown with grass seed and that erosion rills are repaired accordingly.

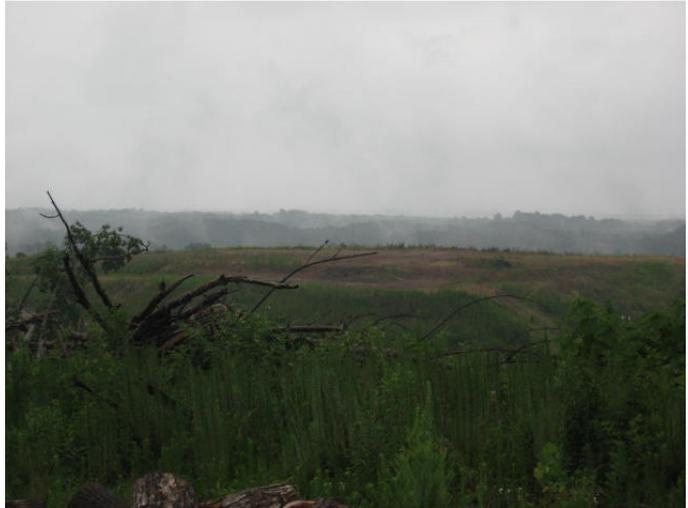
LCID landfill – view from future Phase 4 toward Phase 3

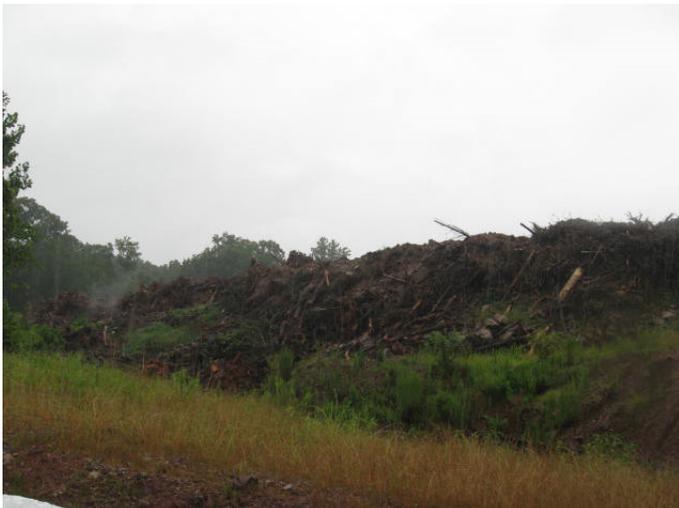
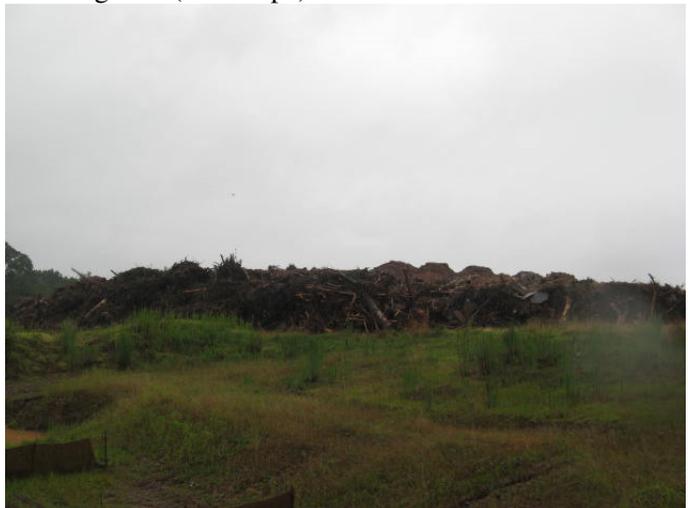
15. The working face was extended along the width of Phase 3. Mr. Stone stated that the facility covers the material with soil monthly.
16. Mr. Stone stated that exterior side slopes are constructed with benched lifts. When the exterior side slope is near completion additional soil is added to the benched area to create a uniformly graded exterior side slope.

LCID landfill Phase 3 working face (side slope)
