Groundwater Assessment Report

Former Sealtest Dairy, 2115 Highway 70 SE, Hickory, Catawba
County, NC
ECS Project No. 49.1624A

Reference: Groundwater Assessment Report
Former Sealtest Dairy
2115 Highway 70 Southeast
Hickory, Catawba County, North Carolina
ECS Project No. 49.1624A

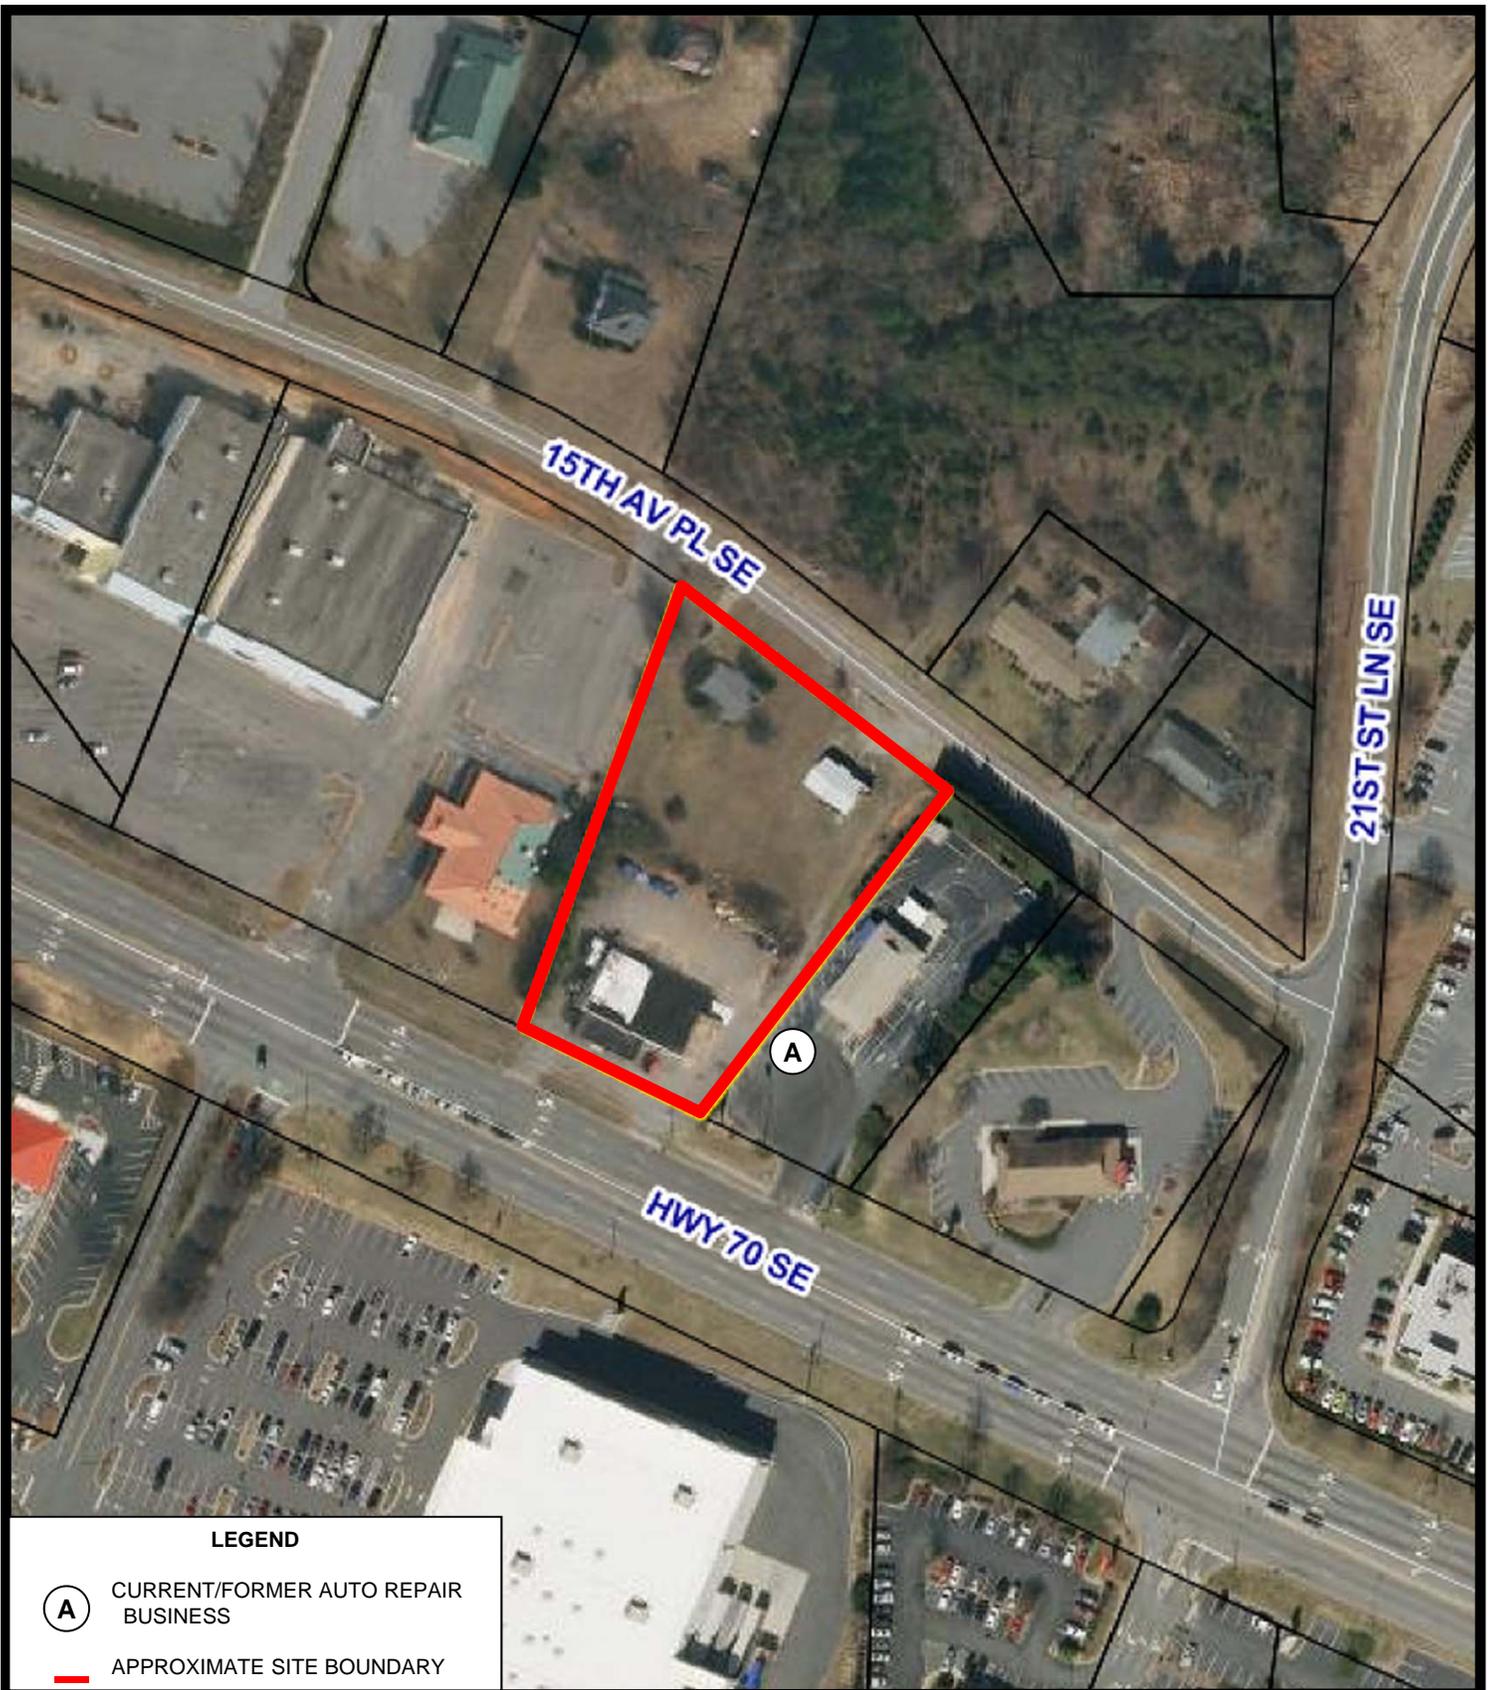
FIGURE 2

The soil boring for the monitoring well was advanced using hollow-stem augers. The location of the soil boring is shown on Figure 2. Prior to advancing the boring, the down hole equipment and Geoprobe® drill rig were decontaminated utilizing a high pressure steam cleaner that utilized municipal water. The down hole equipment and drill rig were decontaminated to prevent cross-contamination between drilling locations.

CURRENT/FORMER AUTO REPAIR BUSINESS

APPROXIMATE SITE BOUNDARY

SITE MAP

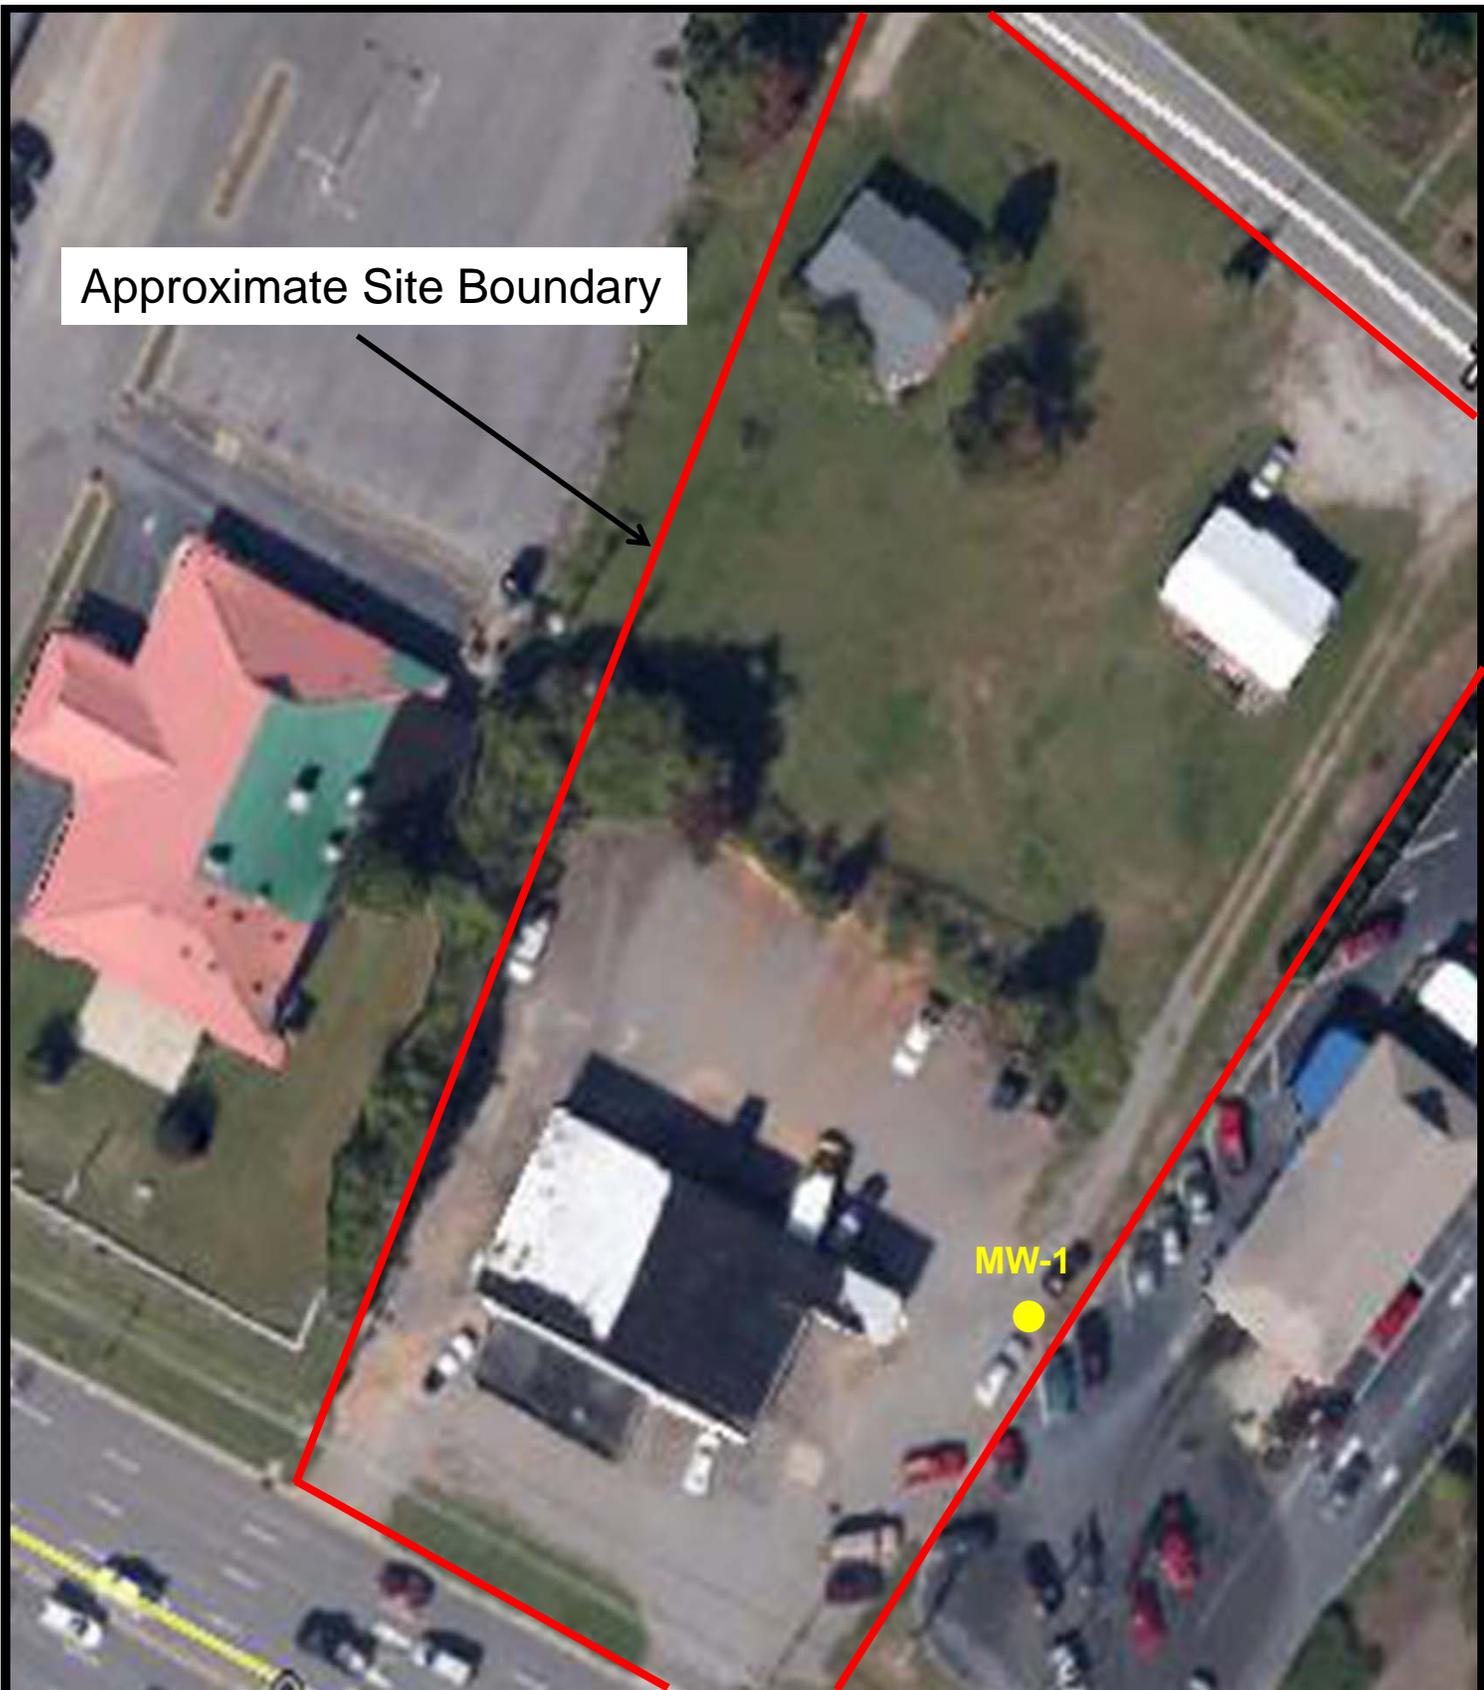
FIGURE 3

In November 2015, ECS collected two groundwater samples using a direct push rig in the area of the former USTs (previous sample of MW-1) and in what is believed to be the downgradient direction (based on surface topography). The samples were submitted to Research and Analytical Laboratory (R&A) in Kernersville, North Carolina for chemical analysis for volatile organic compounds (VOCs) using EPA Method 8260 and semi-volatile organic compounds (SVOCs) using EPA Method 8270BNA (base neutrals and acid extractable). Laboratory analysis of groundwater samples GWB1 and GWB2 did not detect VOCs or SVOCs above laboratory quantitation limits.

MW-1

SAMPLE LOCATION MAP
