FACILITY COMPLIANCE INSPECTION REPORT
Division of Waste Management
Solid Waste Section

Date of Site Inspection: 07/13/2016

Macon County Landfill
1448 Lakeside Dr.
Franklin, NC 28724

Comprehensive Inspection

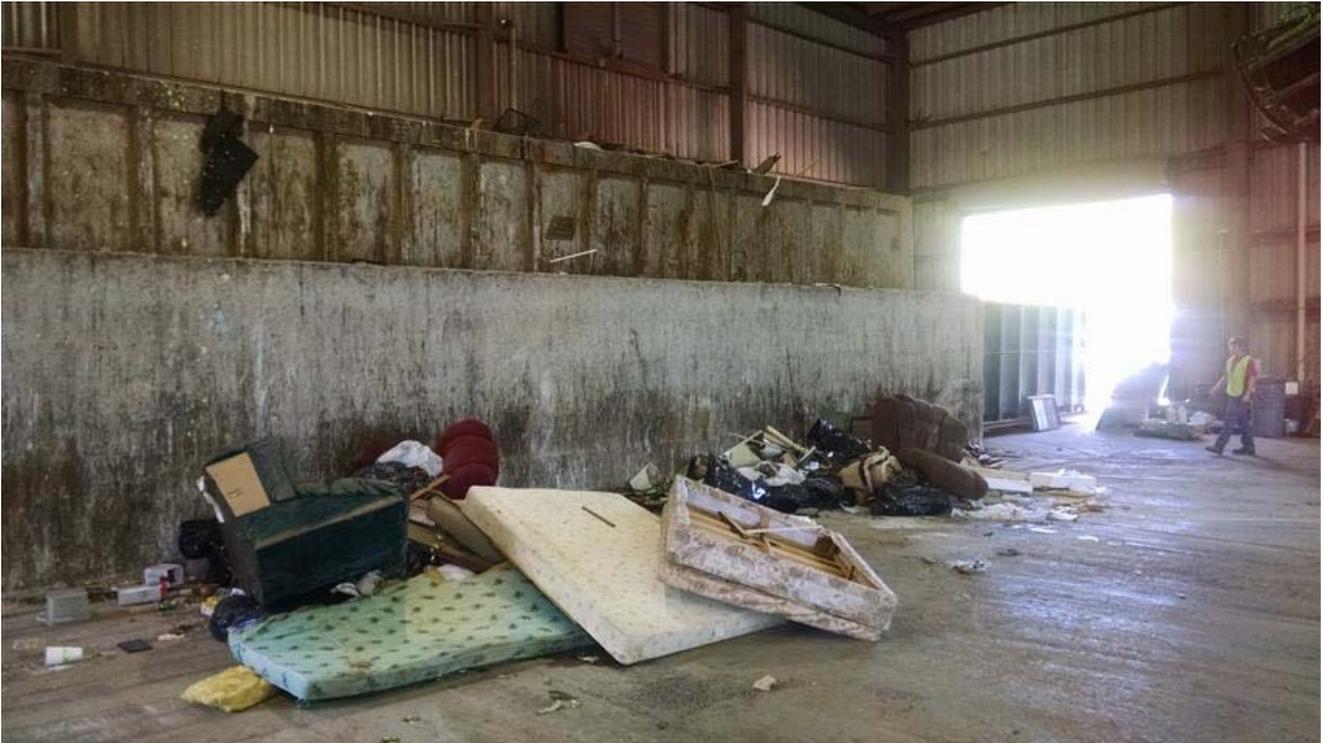
25. The Recovery Center is located to the east of the landfill.
26. All non-commercial loads of waste are directed to the Recovery Center. The facility loads MSW waste into a trailer and transports the material to the working face.
27. No unacceptable waste was observed on the tipping floor at the time of inspection.
28. The tipping floor was clean and the floor drains were free of debris and appeared to be working properly. The floor drains in the Recovery Center are connected directly to the Town of Franklin sanitary sewer.
29. The Recovery Center also accepts scrap metal, cardboard, electronics, fluorescent tubes, thermostats, carpet padding and shingles for recycling. **Please update the Operations Plan to include shingle recycling.**
30. Scrap tires are collected in van trailers outside of the Recovery Center.

Tipping Floor of Recovery Center.

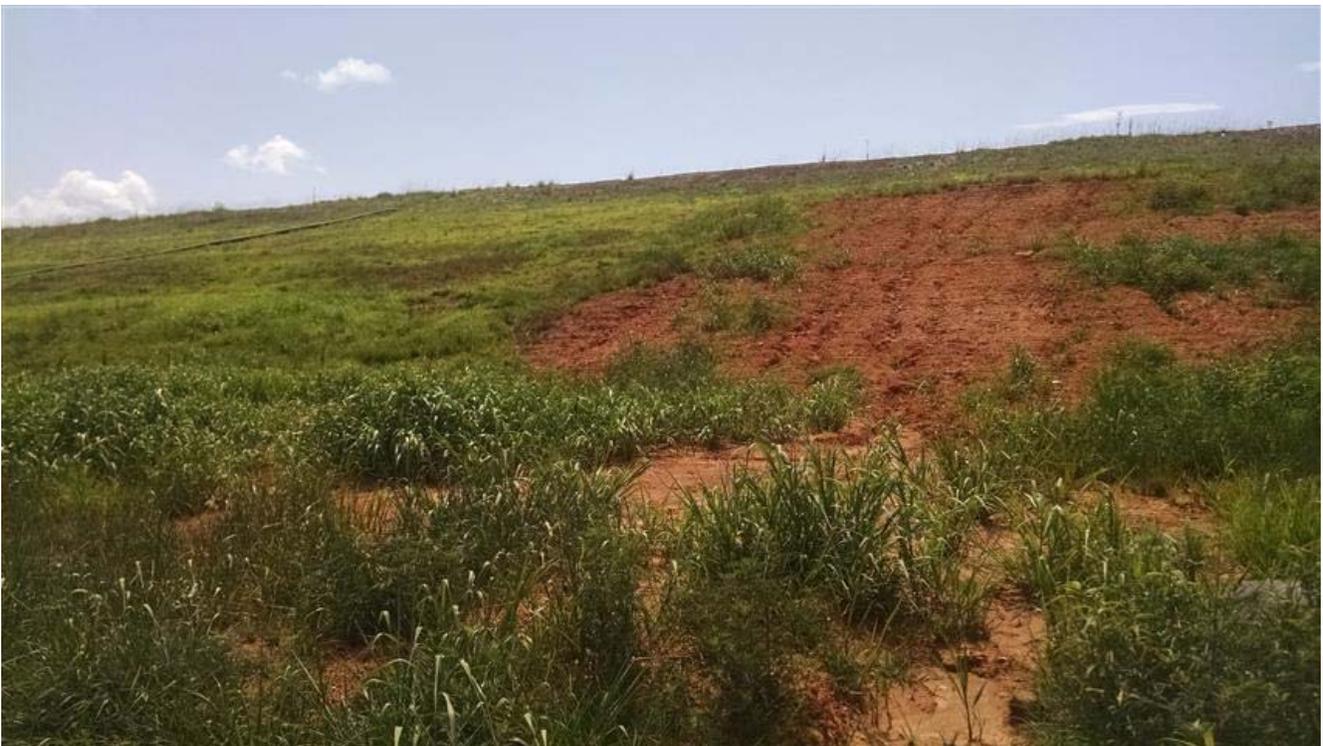
20. Facility staff repaired two leachate seeps on the north side of the landfill in May. A small amount of erosion had occurred on these areas. **Please continue to monitor these areas, repair any erosion that occurs, and establish a groundcover when conditions become favorable.**

Repaired Seep Area

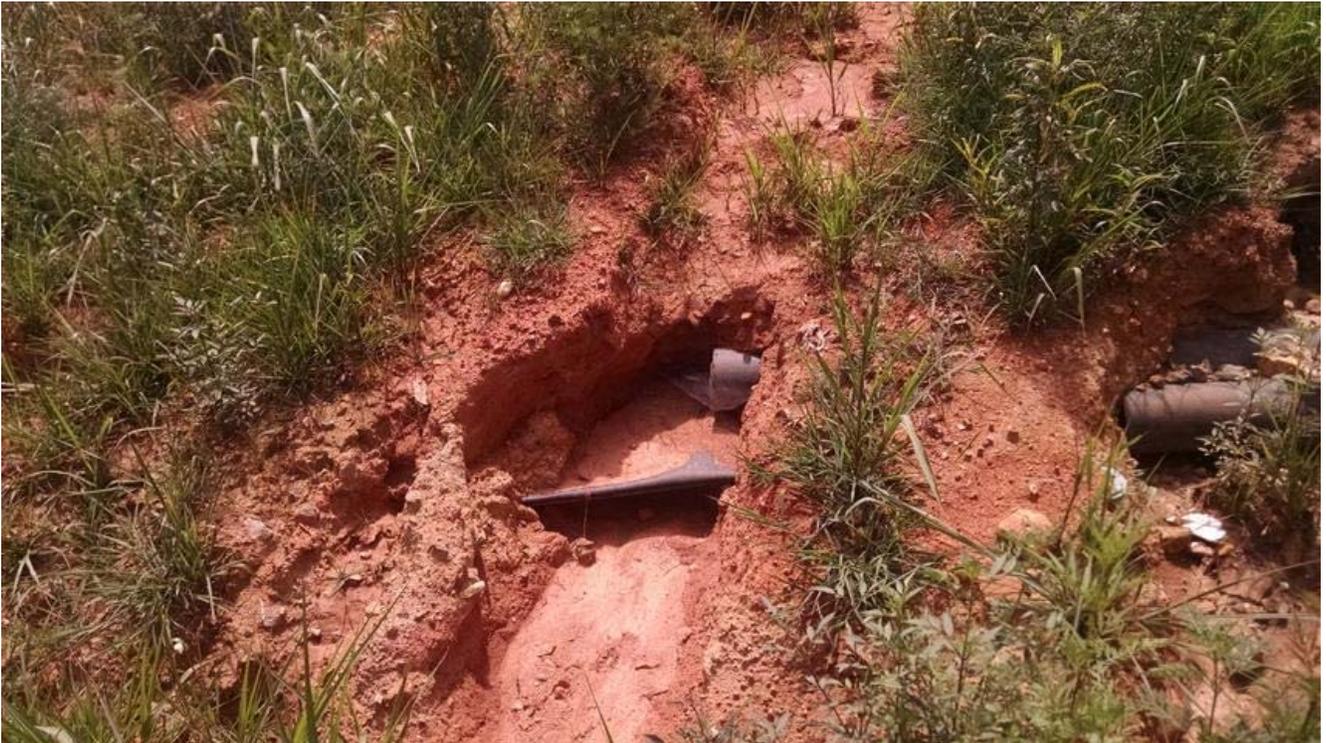
21. A small amount of erosion was observed outside of the anchor trench leaving a small portion of the liner exposed. **Please cover the exposed anchor trench and establish a vegetative cover.**

Exposed Liner outside of Anchor Trench

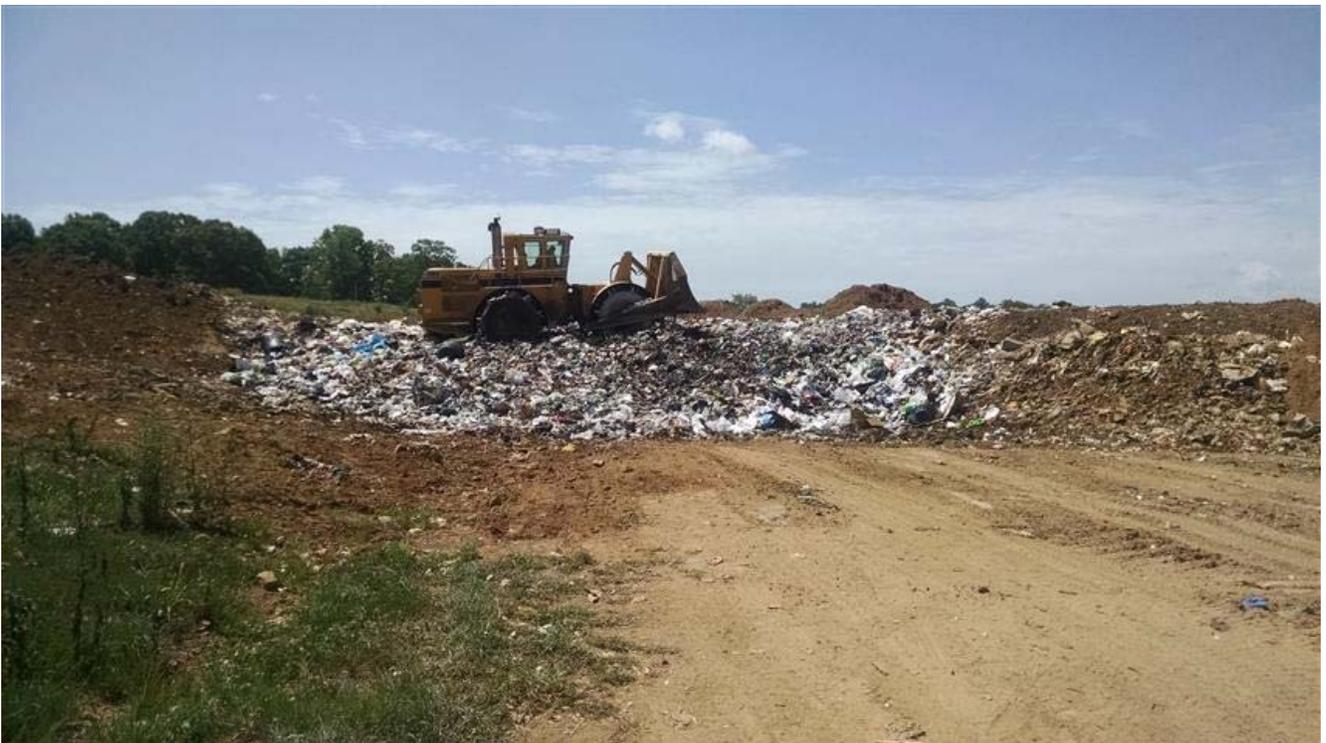
18. The working face was small, compact and no unacceptable waste was observed at the time of inspection.
19. Minimal windblown litter was observed around the facility and it appears to be well managed.

Working Face
