FACILITY COMPLIANCE INSPECTION REPORT
Division of Waste Management
Solid Waste Section

Date of Site Inspection: 07/12/2016 Date of Last Inspection: 06/28/2016

Davidson County Integrated Solid Waste Management Facility
220 Davidson County Landfill Road
Lexington, NC 27292

Partial Inspection

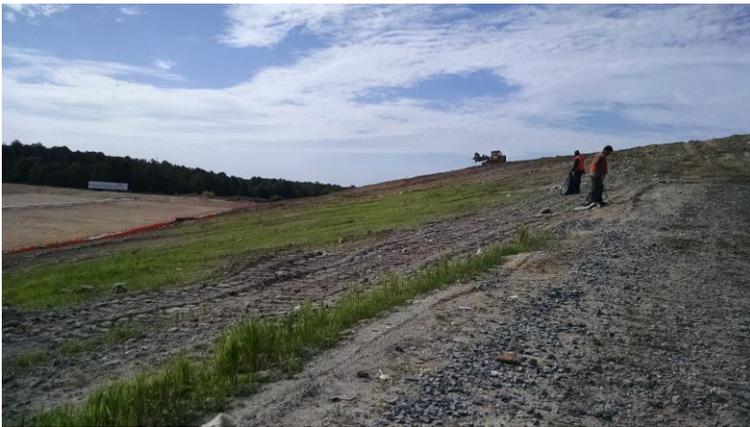
*Regraded north slope of MSW landfill and inmates picking up windblown trash.*

6. **CORRECTIVE MEASURES IN PROGRESS:** 15A NCAC 13B. 1626(7)(b) cited for failure to prevent on-site erosion. In addition to regrading and seeding of the slope facing new cell construction, top soil had been spread on some of the eroded areas of the remaining slopes of Phase 2 of the MSW landfill. Mr. Sink stated that slope repairs and regrading will be completed prior to the reseeding scheduled for July 15, 2016.

7. **CORRECTIVE MEASURES IN PROGRESS:** 15A NCAC 13B. 1626(7)(c) cited for failure to provide for a vegetative cover sufficient to restrain erosion within 30 working days or 120 calendar days of completion of any phase of MSWLF development. Initial efforts at establishing a stable vegetative cover were not effective. Evidence of additional cover and regrading were observed, and Mr. Sink advised that reseeding would take place on July 15, 2016.

1. Trees had been removed from the area of the edge of waste at the MSW landfill. Mr. Sink stated that work is continuing on clearing the vegetative growth in the drainage channels located on the Phase 2 (active) and Phase 1 (closed) MSW landfill slopes.
2. The amount of windblown litter previously observed at the facility had been reduced, and inmate crews were observed collecting windblown trash during this inspection.
3. Access roads were of all-weather construction and in good repair.
4. The working face of the MSW landfill appeared to be more compact, with a tipping area that was more defined and

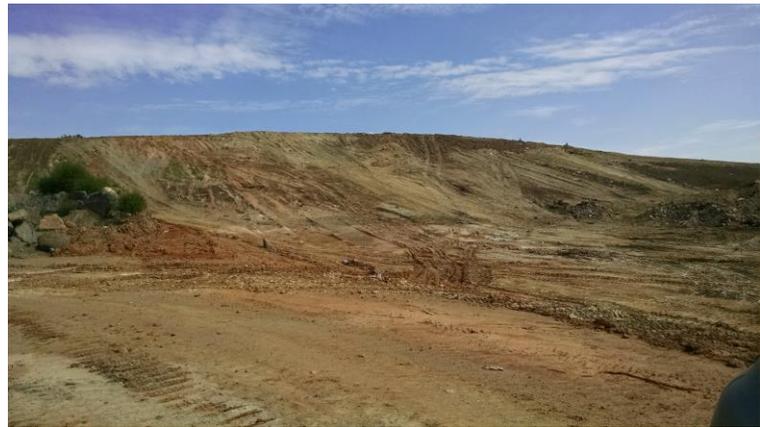
*Regraded south slope of MSW landfill.*

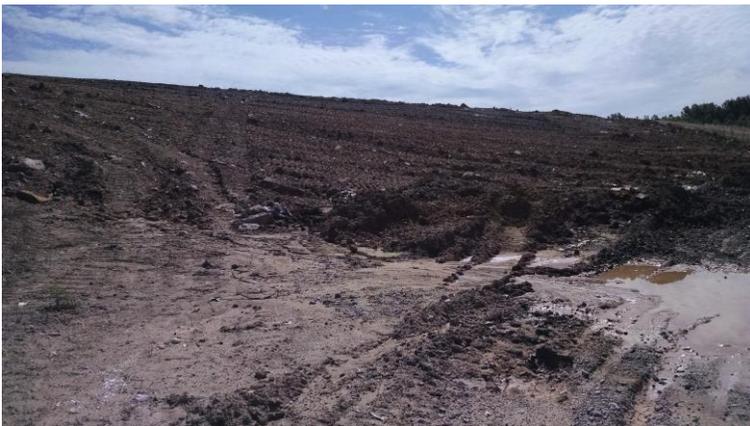
*South slope of C&D landfill regraded with additional cover, Note the new runoff area seen in foreground.*

he would rework the slope again to ensure capture of all the liquid runoff. He further noted that the sampling plan had been approved by the Solid Waste Section and implemented on June 30<sup>th</sup>. Although the laboratory results have not yet been received, Mr. Sink notified me by telephone on July 14<sup>th</sup> that the results showed no contamination. Written documentation will be provided as soon as it becomes available.

3. **CORRECTIVE MEASURES IN PROGRESS:** 15A NCAC 13B .0542(f)(1) cited for failure to apply adequate cover to waste at the C&D landfill. A great deal of progress was observed during this inspection. Mr. Sink stated that he will apply additional cover to the slopes and cap to provide the final cover needed prior to closure of the landfill operation.

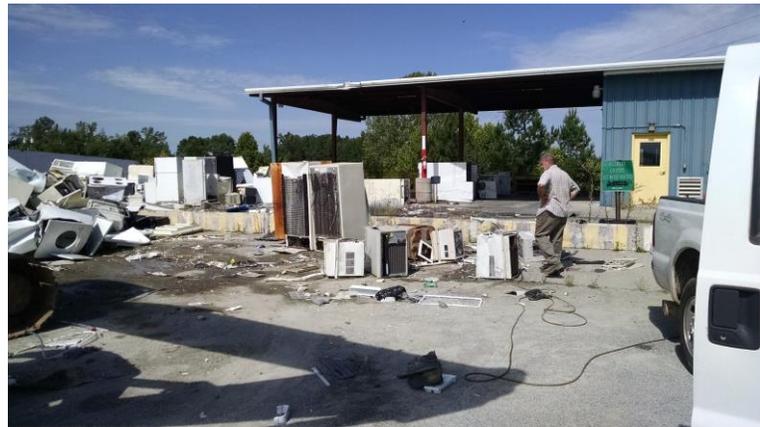
*Contractor working on the evacuation of CFCs from white goods.*

5. At the time of this inspection, a contractor was observed evacuating CFCs from white goods, and a portion of the white goods stockpile had been removed. Mr. Sink advised me by telephone that evacuation and removal of all white goods units and scrap metals from the site had been completed on July 15, 2016.

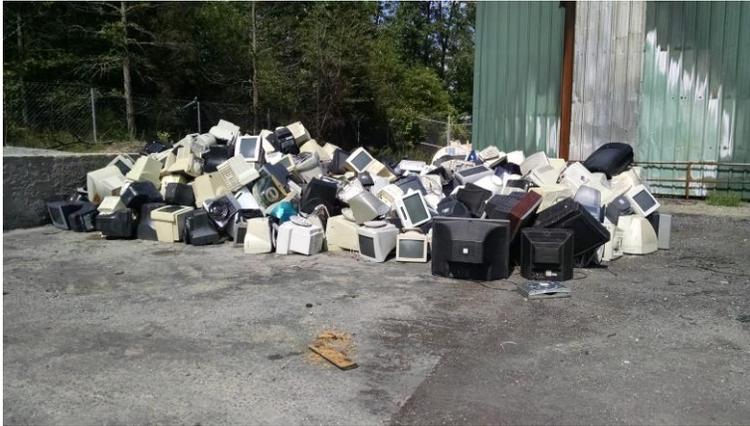
*Pile of unprocessed monitors in electronics area.*

6. The electronics collection and processing area was observed. A number of shrink-wrapped pallets and gaylords of electronics were stored in the cardboard collection building and in the unused transfer station awaiting pick-up by the electronics recycling contractor. A small pile of unsorted materials remained between these two buildings. Mr. Sink stated that inmate crews were being used to help process and sort the electronics, and that he anticipated the remaining materials would be sorted and palletized before the end of July. Mr. Sink also stated that several trailer loads of electronics had already been removed, and that the contractor would continue to transport loads until the large stockpile of electronics was eliminated.

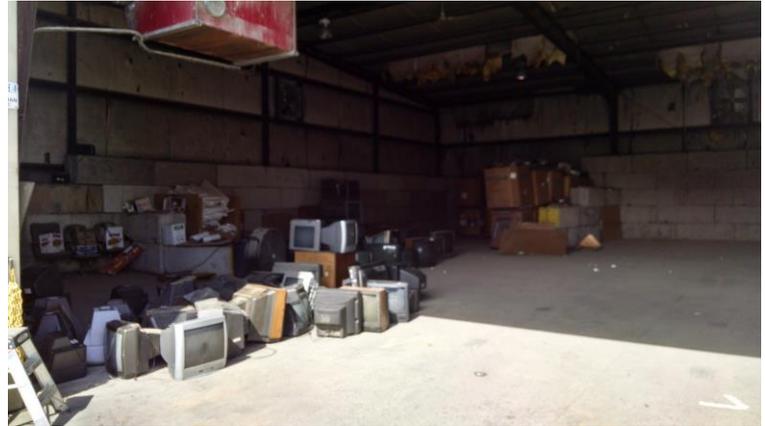
*Unprocessed electronics stored in cardboard collection building.*
