Phase I Environmental Site Assessment

**John Stone Property
500 E. Davie Street
Raleigh, North Carolina**

City of Raleigh

April 26, 2000

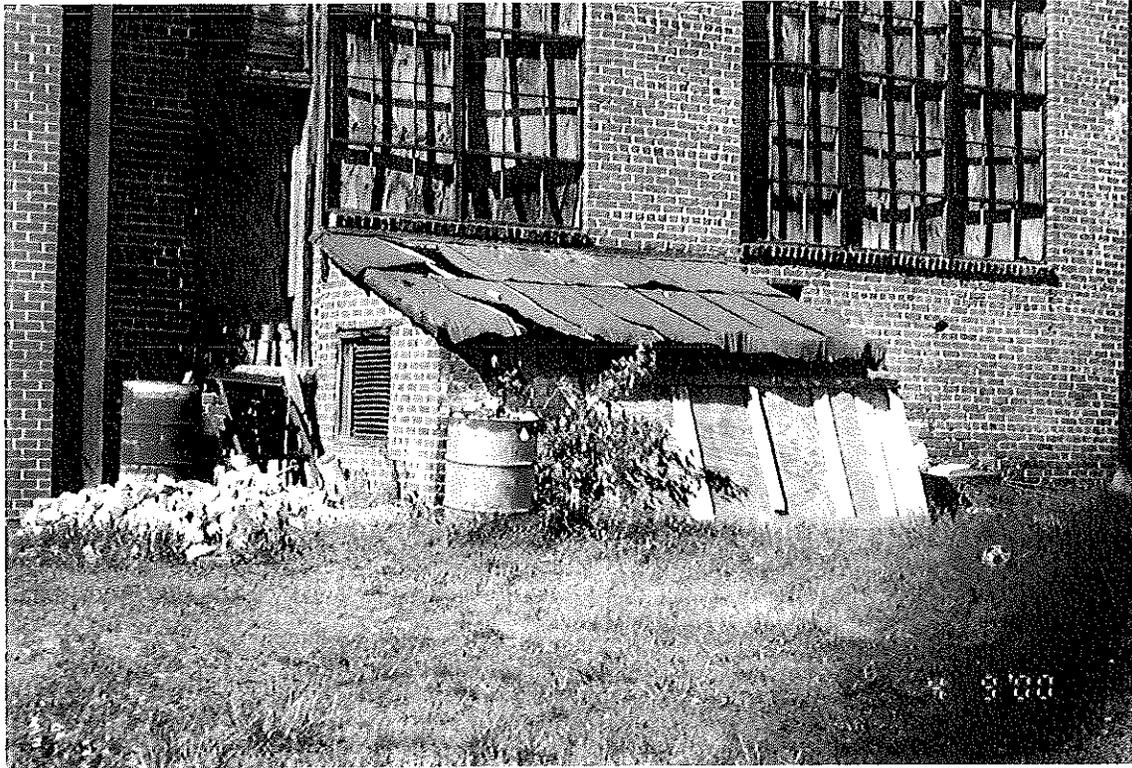
Storage containers and 55-gallon drums were observed inside the building and also outside the building near the former coal storage bin during the site reconnaissance. Some of the drums are used for waste disposal. The contents of other drums and containers is unknown.

Former Coal Storage Bin and Drums Behind Building on Subject Property

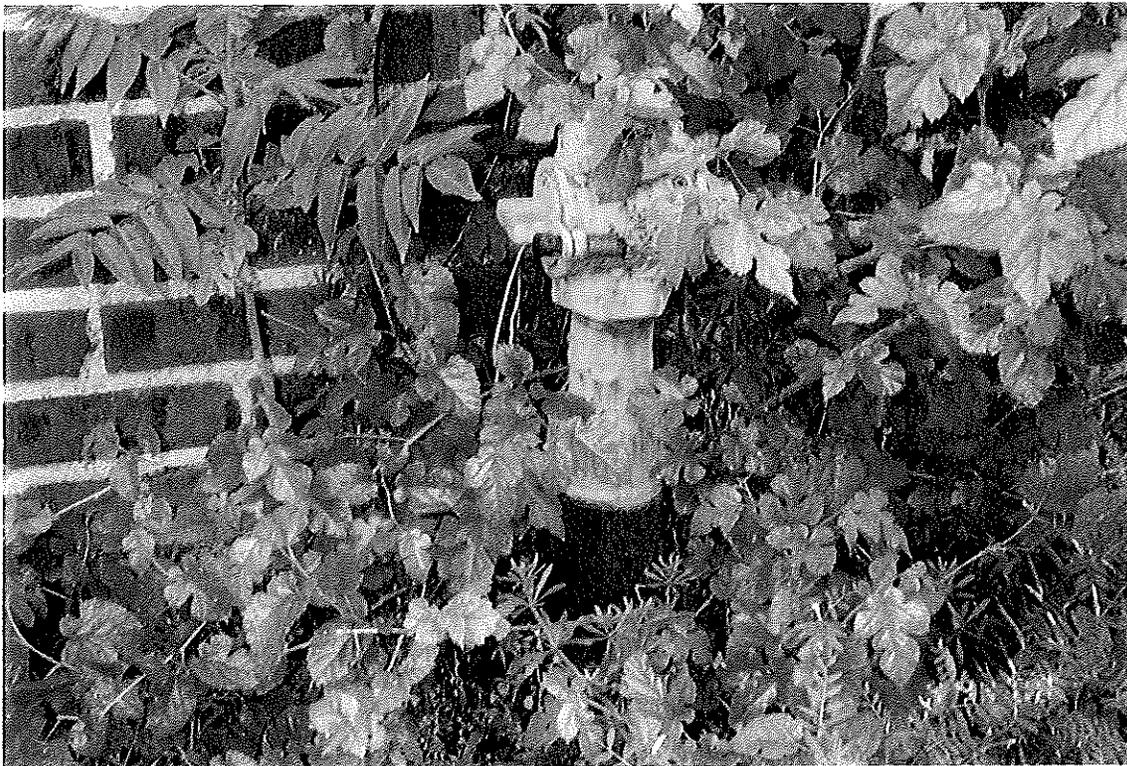
Pipe From Former Coal Storage Bin Area to Underground - Function of Pipe Unknown

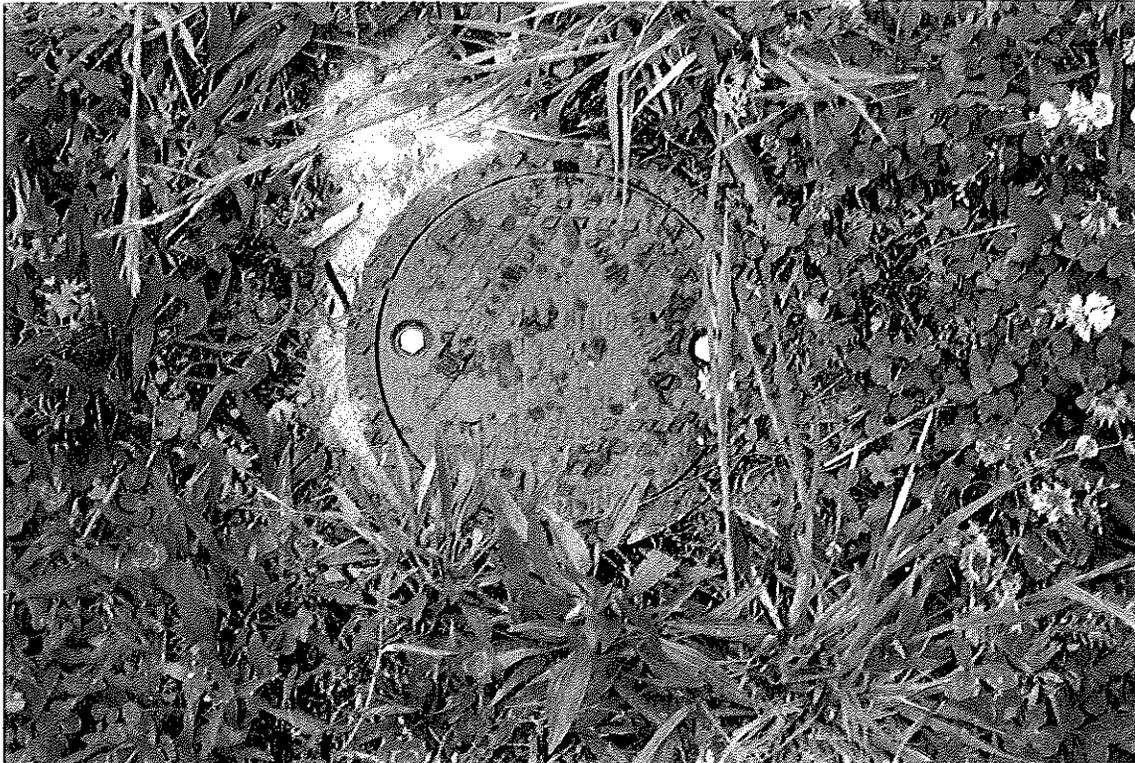
A monitoring well was observed behind the on-site building in the grassy area. Another monitoring well was observed near the southern property boundary in a vacant lot. It is unsure if this well is actually on the subject property. An interview indicated that the wells were constructed to analyze groundwater samples due to a reported release from an underground storage tank located across S. East St. No other wells, piezometers or other subsurface monitoring devices were observed on the subject property during the site reconnaissance.

Monitoring Well Location in Back Yard of Building on Subject Property

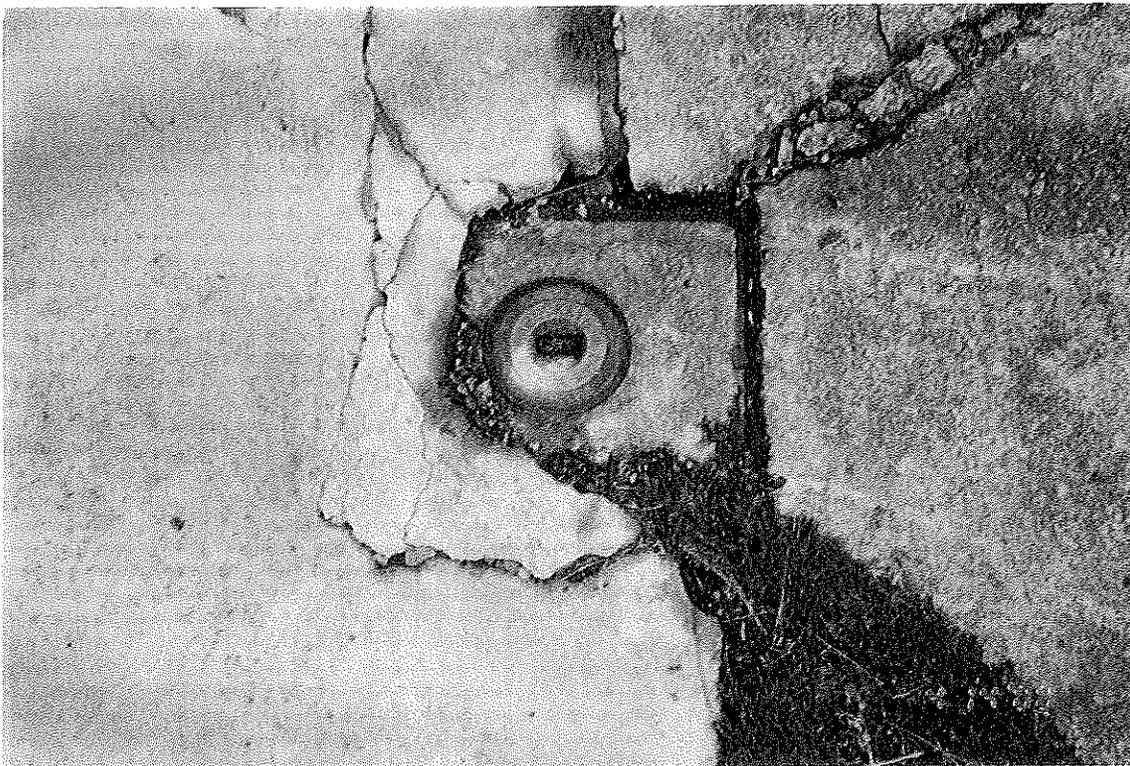
No underground storage tanks (USTs) are registered on the subject property. A fill pipe was observed in the sidewalk on the E. Davie St. side (see picture). There was other physical evidence observed during the site reconnaissance which may indicate the existence of a UST(s) on the tract. A number of pipes were observed inside the building which protrude from the building floor. According to Mr. John Stone, the series of small, capped pipes (see picture) located around the inside perimeter of the building were old gas lines which were capped by the City of Raleigh. A pipe (see picture) was observed in the rear of the building protruding from a former coal storage bin. The pipes may lead to a basement level piping system, underground tank(s) or other collection device. No mounds or depressions suggesting the existence of a UST were observed on the subject property during the site reconnaissance. Several above ground storage tanks were observed on the ground level of the building during the site reconnaissance.

There was evidence of a potential underground storage tank (UST) or tanks observed on the subject property during the site reconnaissance. A fill cap observed in the sidewalk along E. Davie St. near the northeast corner of the tract may be associated with a UST. Its function is unknown. According to an interview with Mr. Stone, the small pipes located around the inside perimeter of the building were old gas lines capped by the City. Other pipes were observed protruding from the building's ground-level floor during the site reconnaissance. Their function is unknown. A pipe was observed protruding from the former coal storage bin in back of the building. It is unknown if the pipes observed lead to underground storage tanks, a basement level piping system, or basement collection device. Several above-ground storage tanks were observed during the site reconnaissance inside the building on the subject property.

2" Fill Cap Located in Sidewalk on E. Davie St. Near Northeast Corner of Subject Property

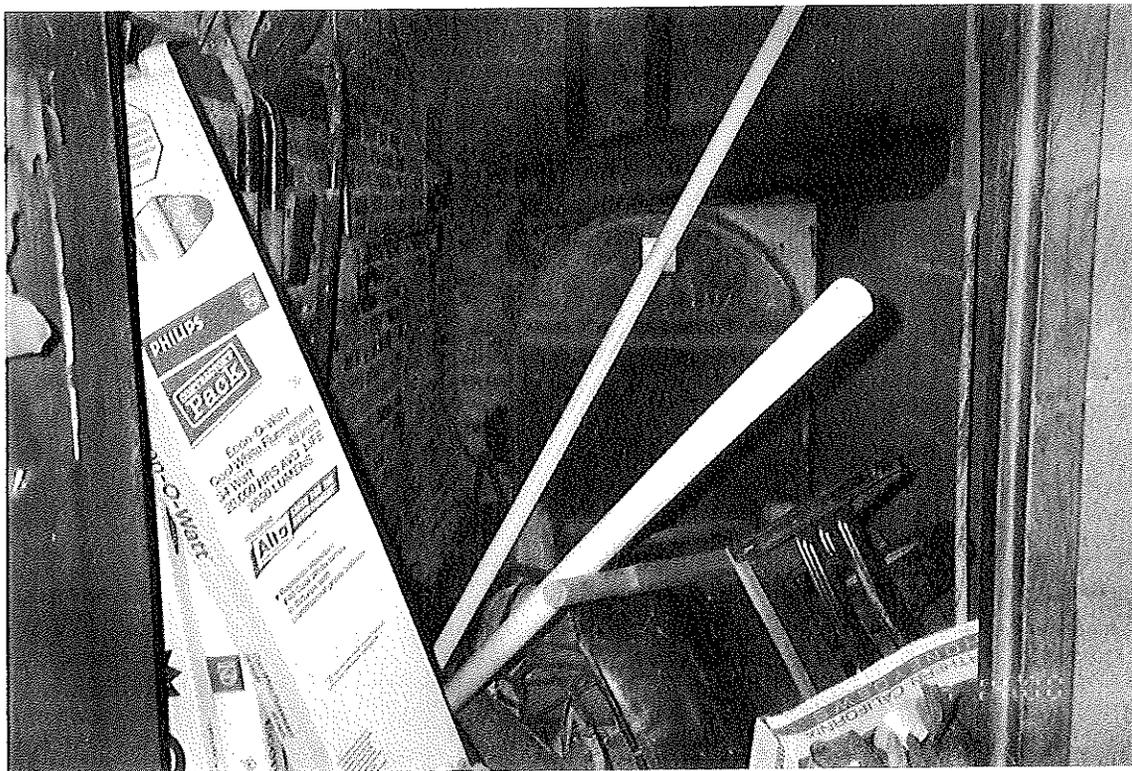
Old Coal Furnace Inside Building

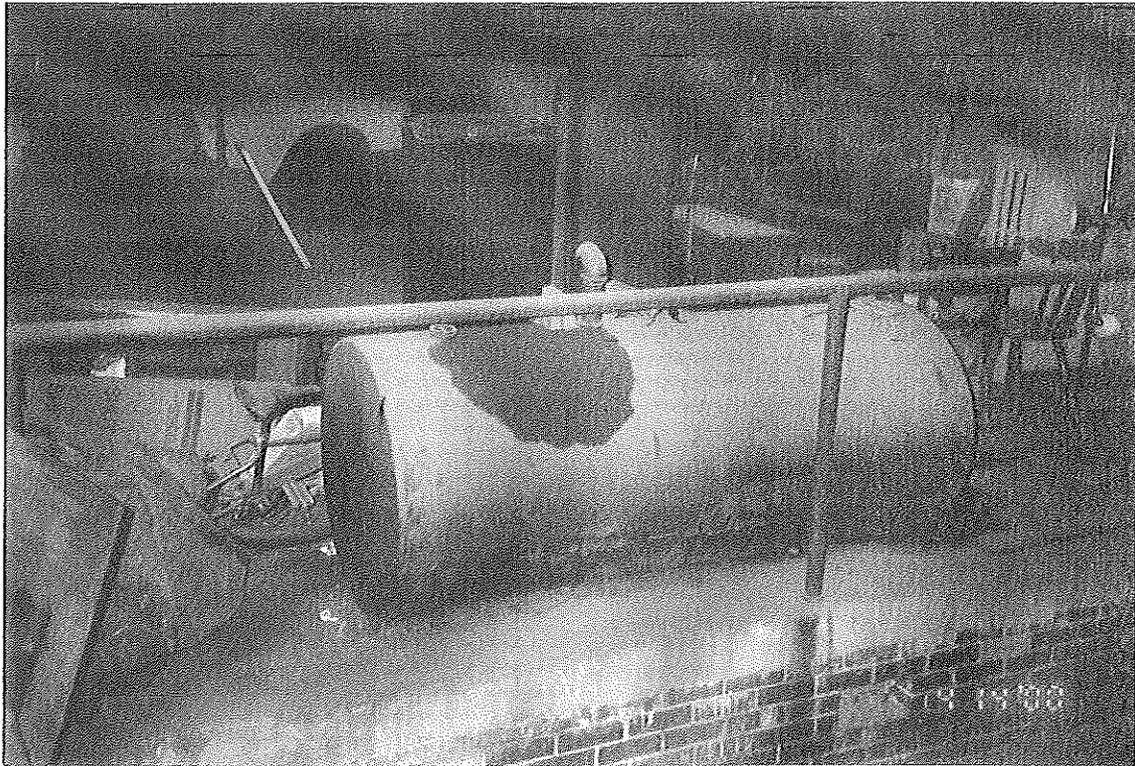
Containers of petroleum products were observed inside the building on site during the site walkover. Diesel fuel is reportedly contained in a 55-gallon drum in a shed inside the building. Another, larger fuel storage tank was observed inside the building. Its contents are unknown.

Fuel Storage Tank Inside Building

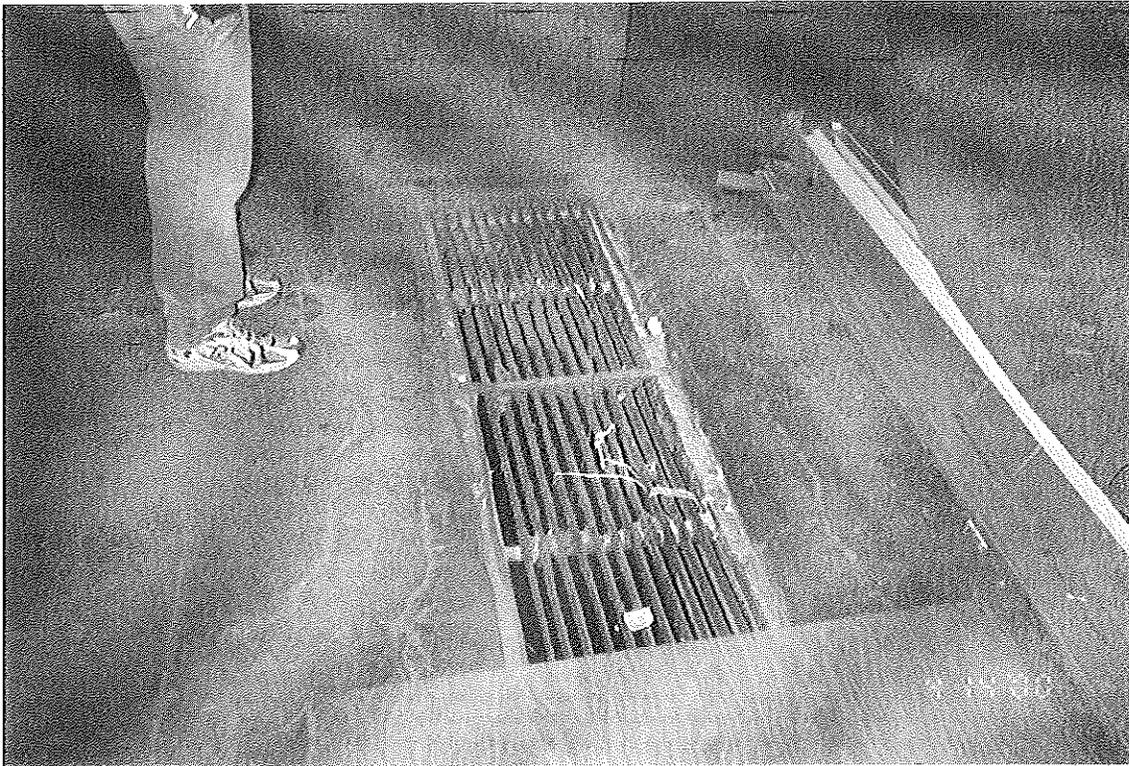
Floor drains were observed at various locations within the on-site building during the site reconnaissance. Some drains were open, and other were covered with plywood. It is unknown where the drains lead. It is possible that they drain directly into the City of Raleigh storm sewer system. No other drains, floor drains or sumps were observed during the on-site reconnaissance.

One of Several Floor Drains Located Inside Building on Subject Property

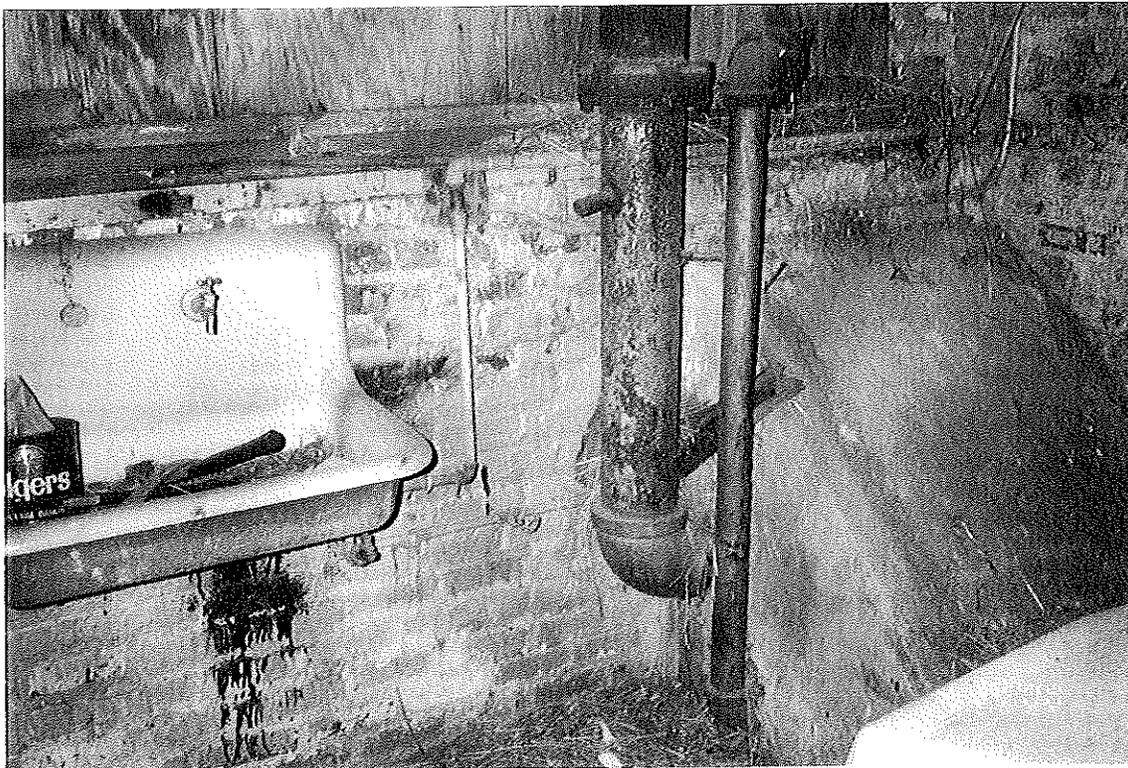
One of a Number of Pipes Which Go Below Grade From Inside Building
