Re: Notice of No Further Action  
15A NCAC 2L .0407(d)  
Risk-based Assessment and Corrective Action for  
Petroleum Underground Storage Tanks

Raleigh's 500 E. Davie Street Property  
Facility # N/A  
500 E. Davie Street  
Raleigh, NC 27601  
Wake County  
Incident Number: 33560  
Risk Classification: N/A  
Ranking: N/A

**UST Closure Report**  
**Incident #: 33560**  
**City of Raleigh - 500 E. Davie Street Property**  
**500 E. Davie Street**  
**Raleigh, North Carolina**

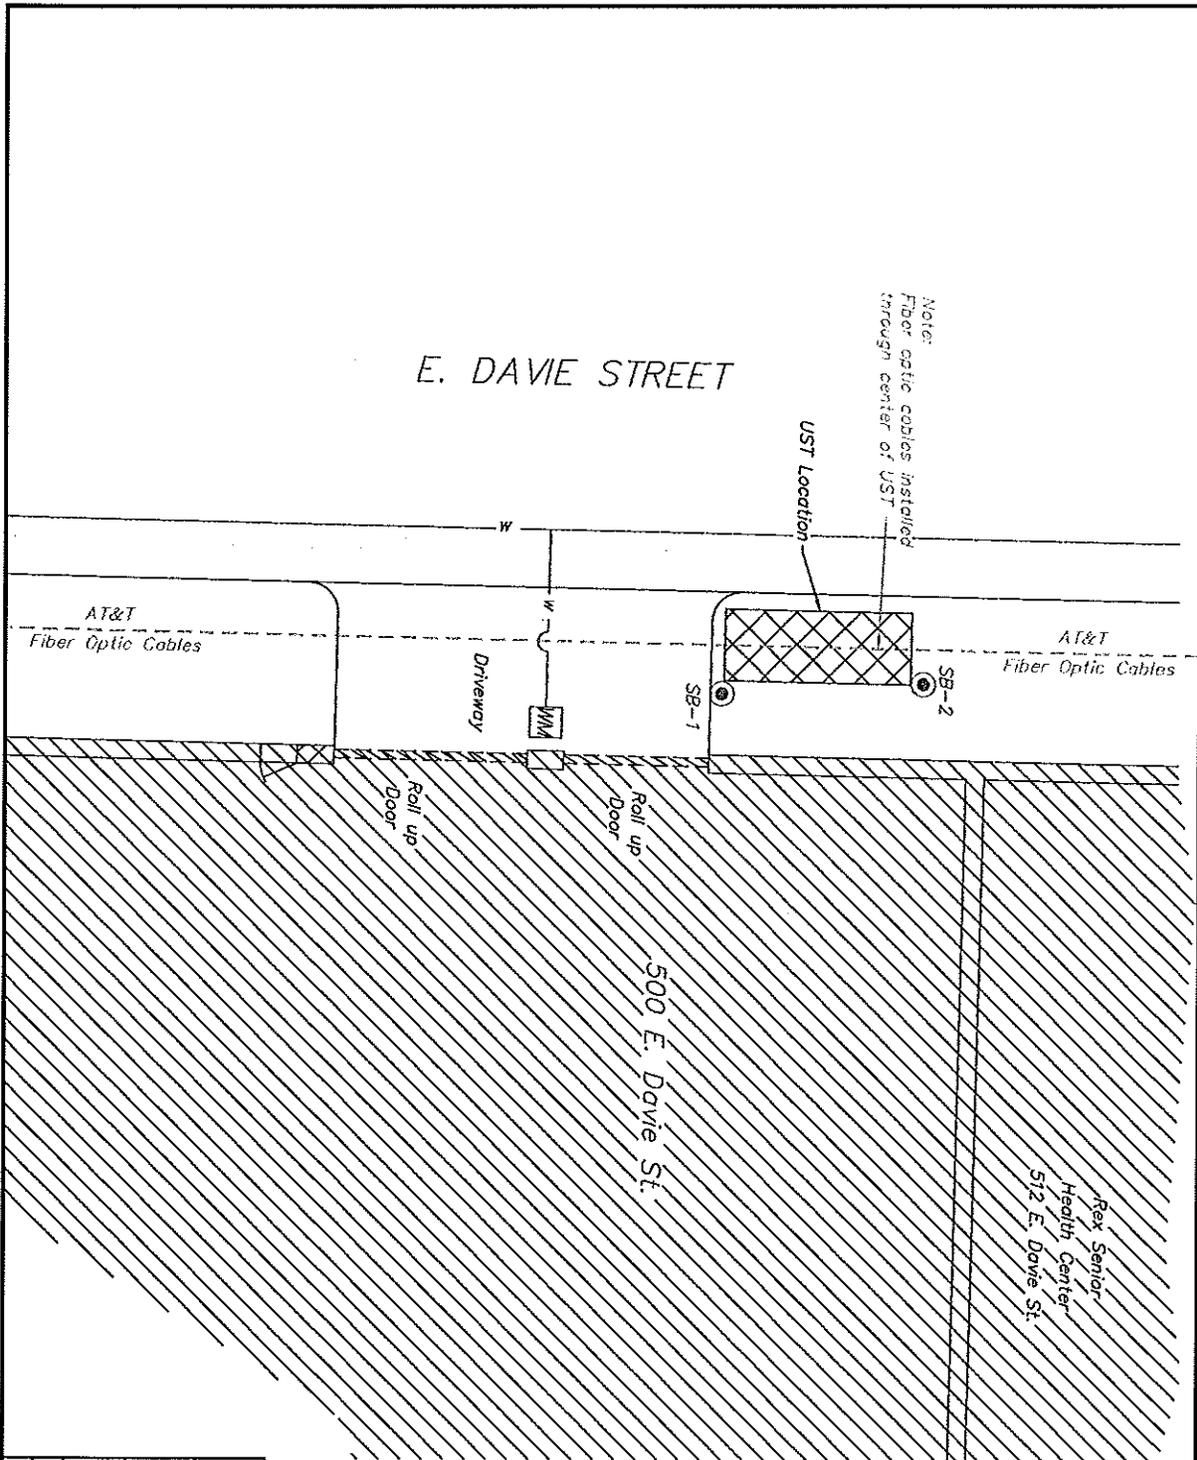
<b>UST &amp; SOIL BORING LOCATIONS</b>	
500 EAST DAVIE STREET RALEIGH, WAKE COUNTY, NORTH CAROLINA	
3334 Hillsborough Street Raleigh, North Carolina 27607 A PROFESSIONAL CORPORATION 919.847.4100 919.847.4200	
DATE: 07/29/09	REVISION NO. 0
JOB NO: RAL-002	FIGURE NO. 2

This site is located within a mixed commercial and residential neighborhood near, but not within, the Southeast Raleigh Historic District. The subject site is bounded by E. Davie Street to the north, the Rex Senior Health Center (512 E. Davie Street) to the east, a vacant lot and residential area along E. Cabarrus Street to the south, and the new Carlton Place residential condominium development that encompasses the entire city block to the west along S. East Street. A site location map and site plan are included as Figures 1 and 2.

Note:  
Fiber optic cables installed  
through center of UST

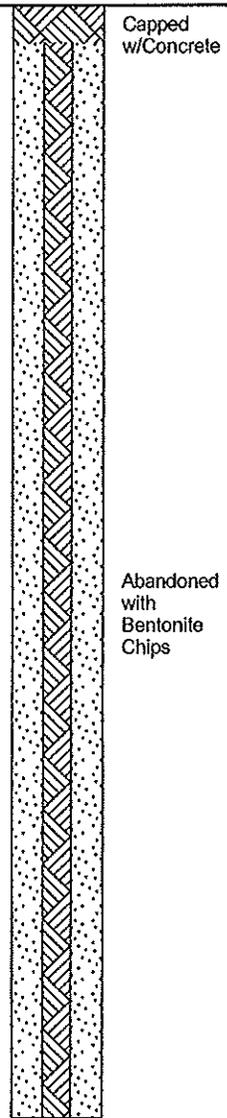
# BORING NUMBER SB-1

DEPTH (ft)	RECOVERY (%)	SAMPLE TYPE NUMBER	OVA (ppm)		LITHOLOGY	MATERIAL DESCRIPTION	WELL DIAGRAM	DEPTH (ft)
			BKG.	SAMP.				
0.0					Concrete		0.0	
					Moist Brownish Orange CLAY			
				8.7	Moist Orange Medium to Coarse SAND		2.5	
				14.6	Moist White/Tan Medium to Coarse SAND		5.0	
		GB		17.3	Moist to Wet Tannish White & Dark Gray Weathered Rock (Like a Coarse SAND)		7.5	
				16			7.5	
				15.4	Moist to Wet Tannish White, Dark Gray, and Orange Weathered Rock (Like a Coarse SAND)		10.0	
				17.2	Wet White & Tan Weathered Rock (Like a Coarse SAND)		12.5	
				11.1			15.0	
15.0					Refusal at 15.0 feet. Bottom of borehole at 15.0 feet.		15.0

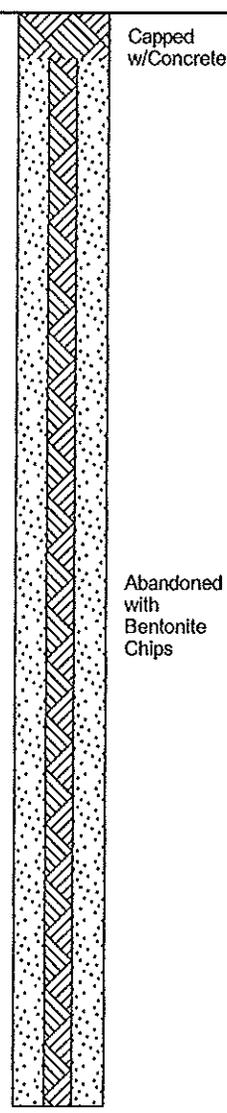
# BORING NUMBER SB-2

DEPTH (ft)	RECOVERY (%)	SAMPLE TYPE NUMBER	OVA (ppm)		LITHOLOGY	MATERIAL DESCRIPTION	WELL DIAGRAM	DEPTH (ft)
			BKG.	SAMP.				
0.0					Concrete		0.0	
					Moist Orange & Brown CLAY			
					Moist CLAY. Stained Dark Gray/Brown w/Odor of Creosote/Coal/Oil			
					Moist Red Micaceous SILT			
2.5				7.8			2.5	
					Moist Light Brown & Red SILTY Coarse SAND			
5.0				9.3			5.0	
		GB						
7.5				9.9			7.5	
					Moist Tan Micaceous SILTY SAND			
10.0				11.7			10.0	
					Moist Red Micaceous SILT			
12.5				33.3			12.5	
					Bottom of borehole at 12.0 feet.			
				12.2
