Subject: **Wetlands Determination**
Hickory Grocery Site
Hickory, North Carolina
SUMMIT Project No. 2910-14

WETLANDS DETERMINATION

**2315 N DAVIDSON STREET 421 E 26th Street
CHARLOTTE
MECKLENBURG COUNTY
NORTH CAROLINA
SUMMIT PROJECT NO. 3621.01**

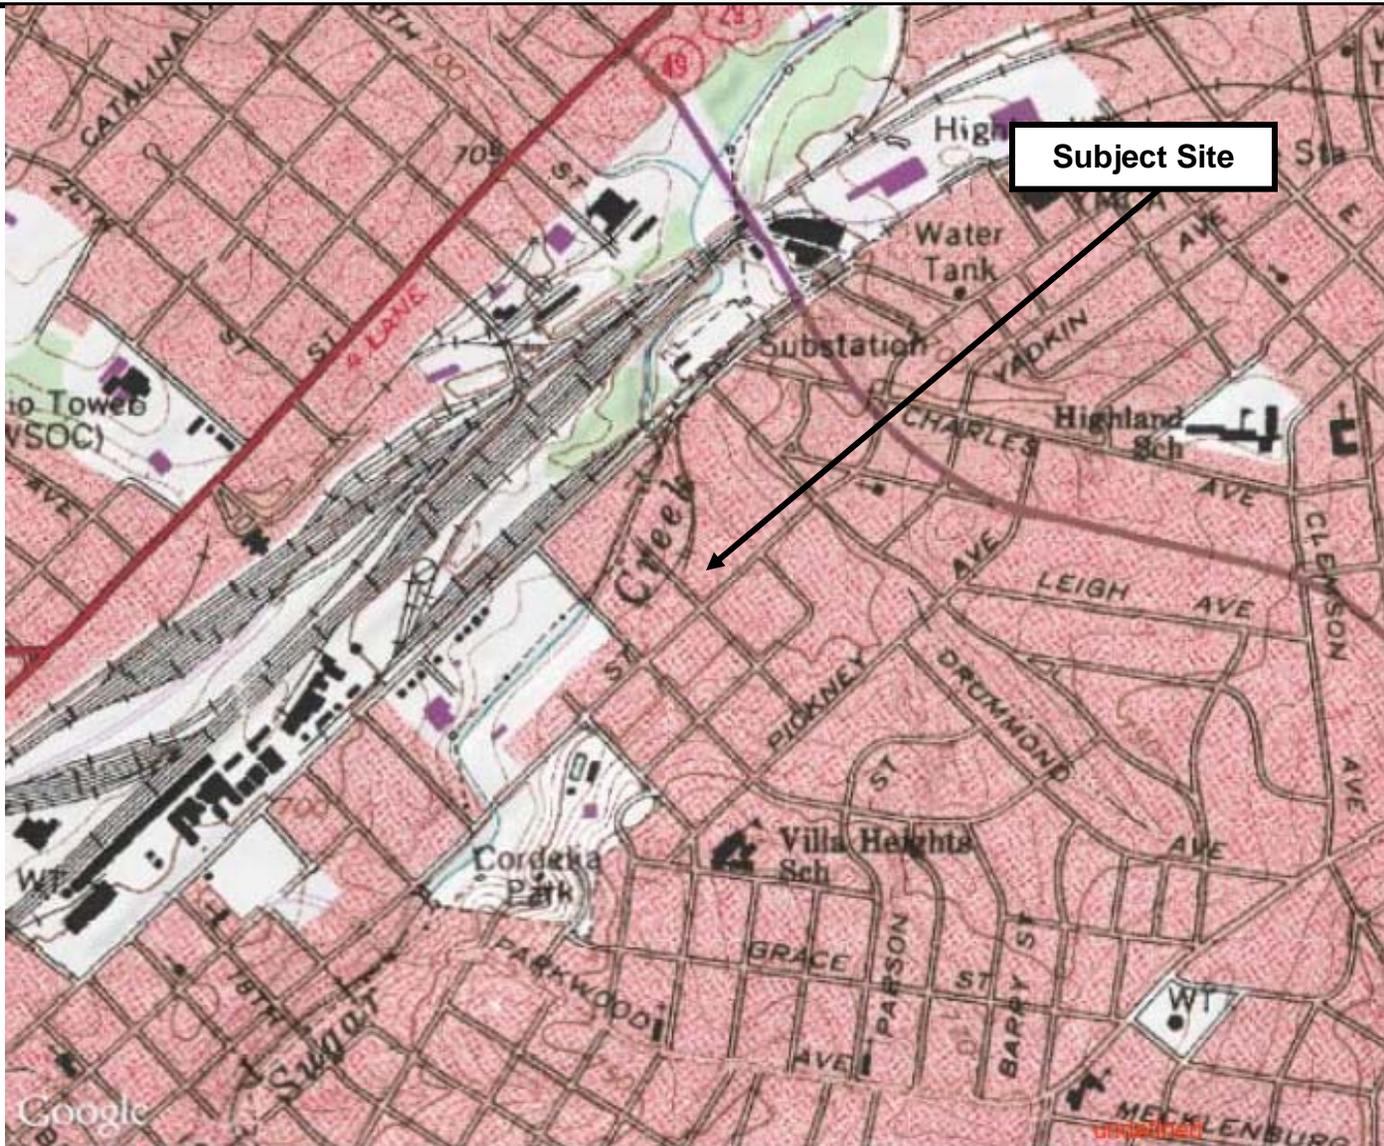
Based on a review of the United States Geological Survey (USGS) “Charlotte, North Carolina, United States” quadrangle topographic map, the inferred groundwater flow direction based on topography appears to be to the west along an un-named creek. Refer to Figure 1 in Appendix I for a topographic map for the subject properties.

USGS Topographic Map

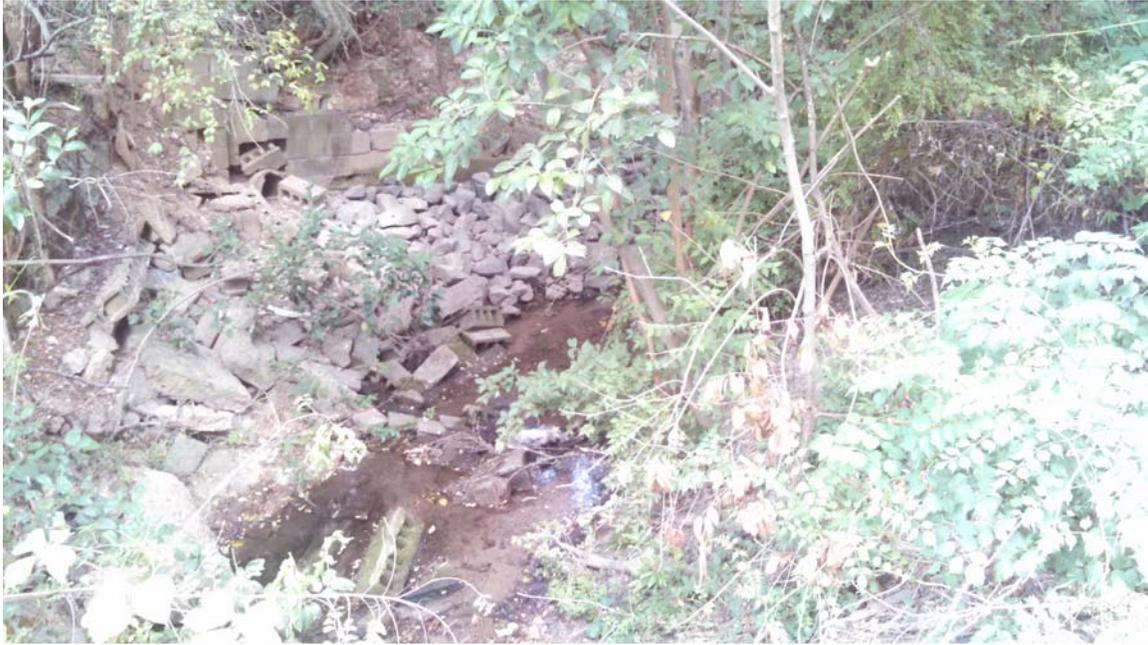
There is an un-named creek along the northern property boundary of parcel 08305204, and Little Sugar Creek borders parcel 08305204 to the west.

Un-named creek on northern portion of site, looking west.

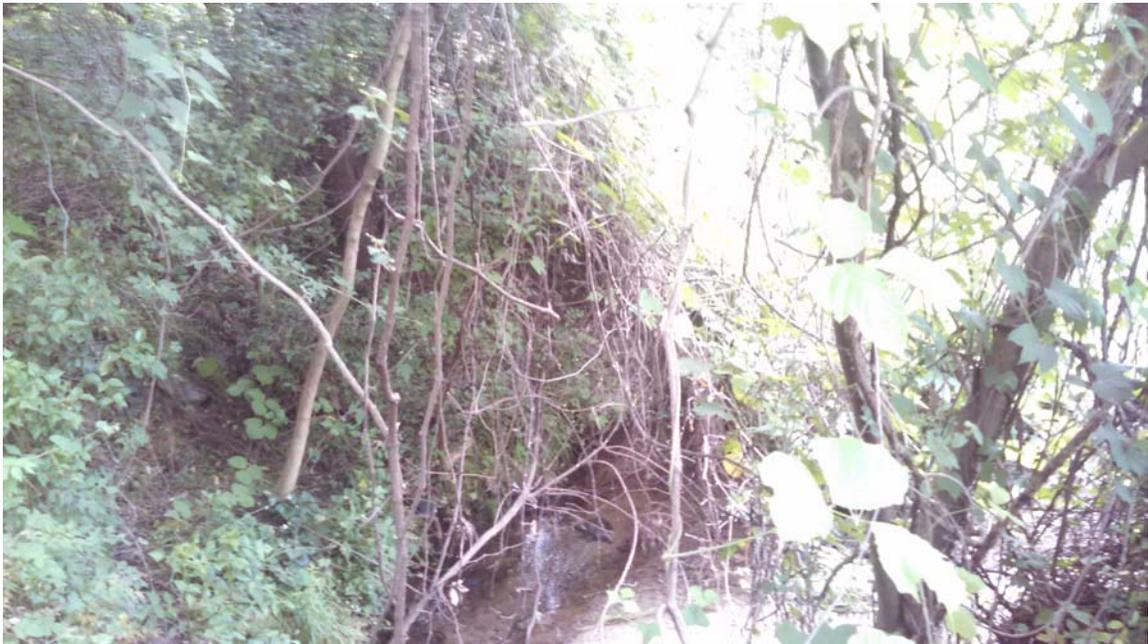
Un-named creek on northern portion of site, looking east.
