**FACILITY COMPLIANCE INSPECTION REPORT**  
**Division of Waste Management**  
**Solid Waste Section**

**Date of Inspection:** 27 July 2016

Greene County C&D Landfill  
 105 Landfill Rd  
 Walstonburg, NC 27888

4002\_INSP\_20160727

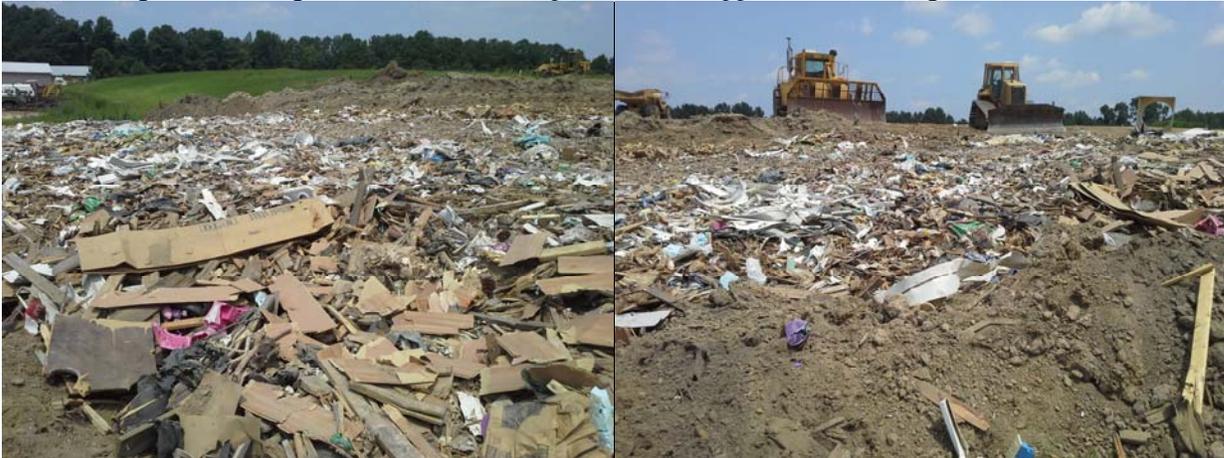
- 13) The working face is being maintained in a compact size and appears well managed at this time.

- 14) The waste type was reviewed; only Construction & Demolition waste was observed and no unpermitted waste streams were noted in the active disposal area during this Facility Compliance Inspection.

- 15) \*Please continue to ensure that all waste is being covered with a minimum of six inches of soil at least once per week or when the active disposal area reaches ½ acre in size, whichever occurs first.

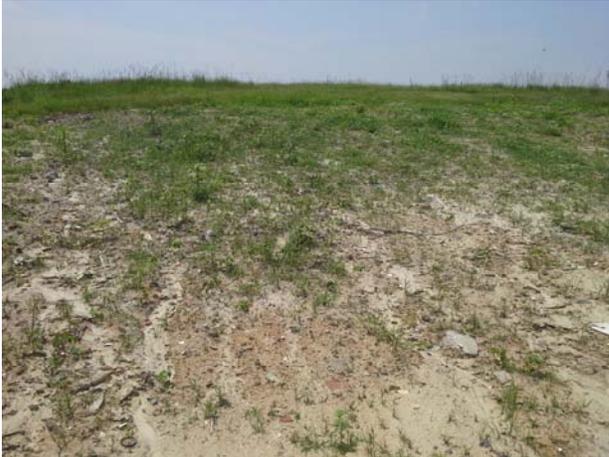
- 19) The cover crop is mowed throughout the year as needed. \*Portions of the cover crop are in need of mowing.  
20) The groundwater monitoring wells were observed during this Facility Compliance Inspection. All the wells were readily accessible, properly labeled, and secured with functioning locks.

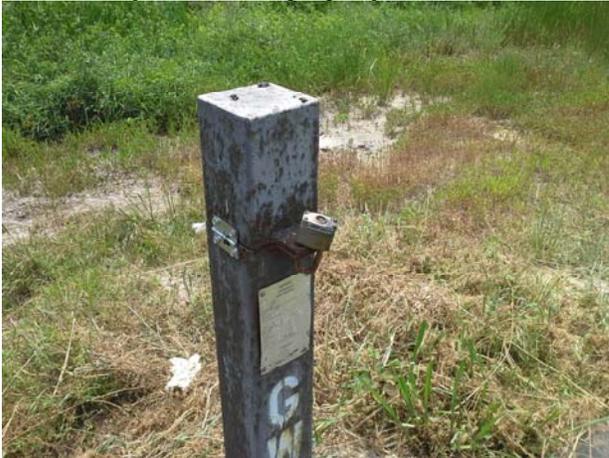
- 21) The landfill gas monitoring wells were observed during this Facility Compliance Inspection. All the wells were readily accessible, properly labeled, and secured with functioning locks.
