FACILITY COMPLIANCE INSPECTION REPORT
Division of Waste Management
Solid Waste Section

Date of Site Inspection: 08/10/2016

Henderson County Solid Waste Landfill
802 Stoney Mountain Rd
Hendersonville, NC 28791

Comprehensive Inspection

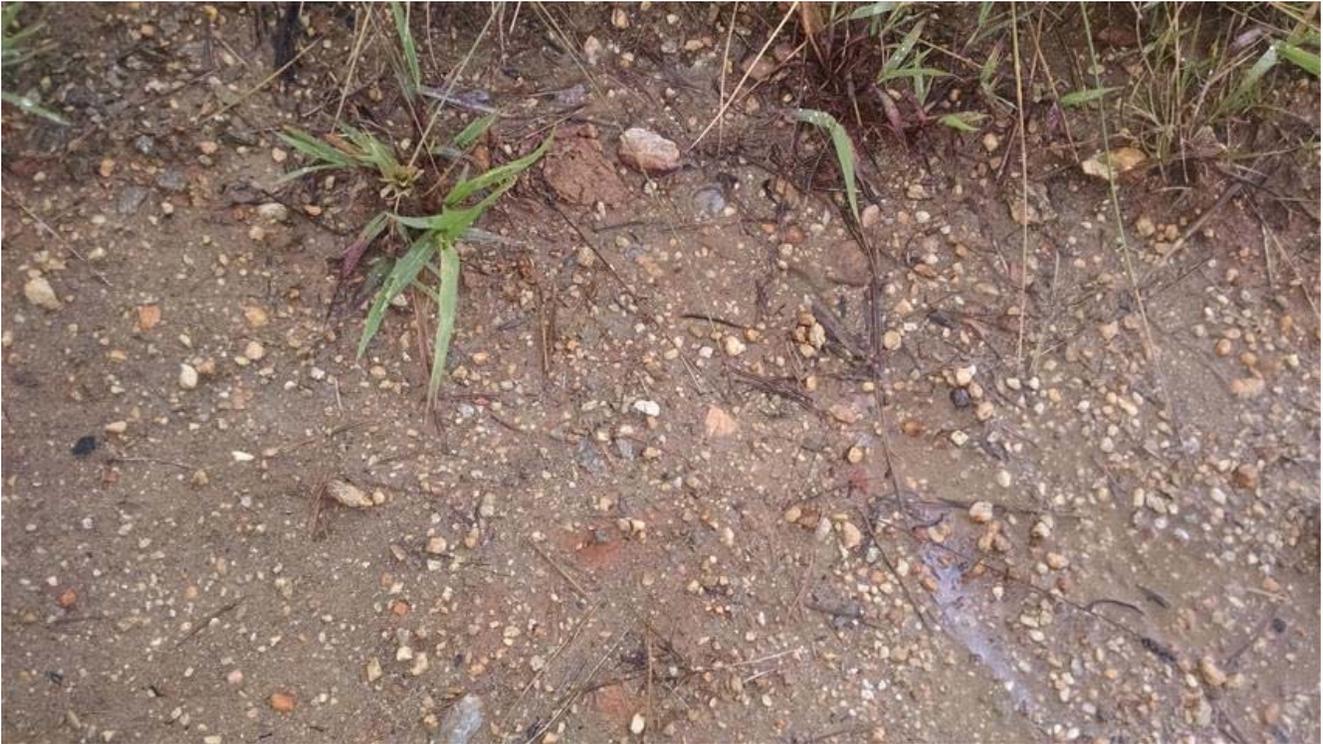
6. The landfill has converted from active landfill gas collection system to a passive system.
7. Bubbling which appears to be landfill gas was observed on a bare spot located on the northwest side slope of the landfill in the general vicinity of MP-4. This kind of activity is indicative of a landfill gas collection system that is not operating optimally.

Landfill Gas Bubbles on Northwest Side slope

To achieve compliance, Henderson County must immediately take all necessary steps to ensure protection of human health and submit a Landfill Gas Remediation Plan within 60 days of the detection date per 15A NCAC 13B .1626(4)(c)(iii) to the Solid Waste Section for review. This documentation should be submitted to:

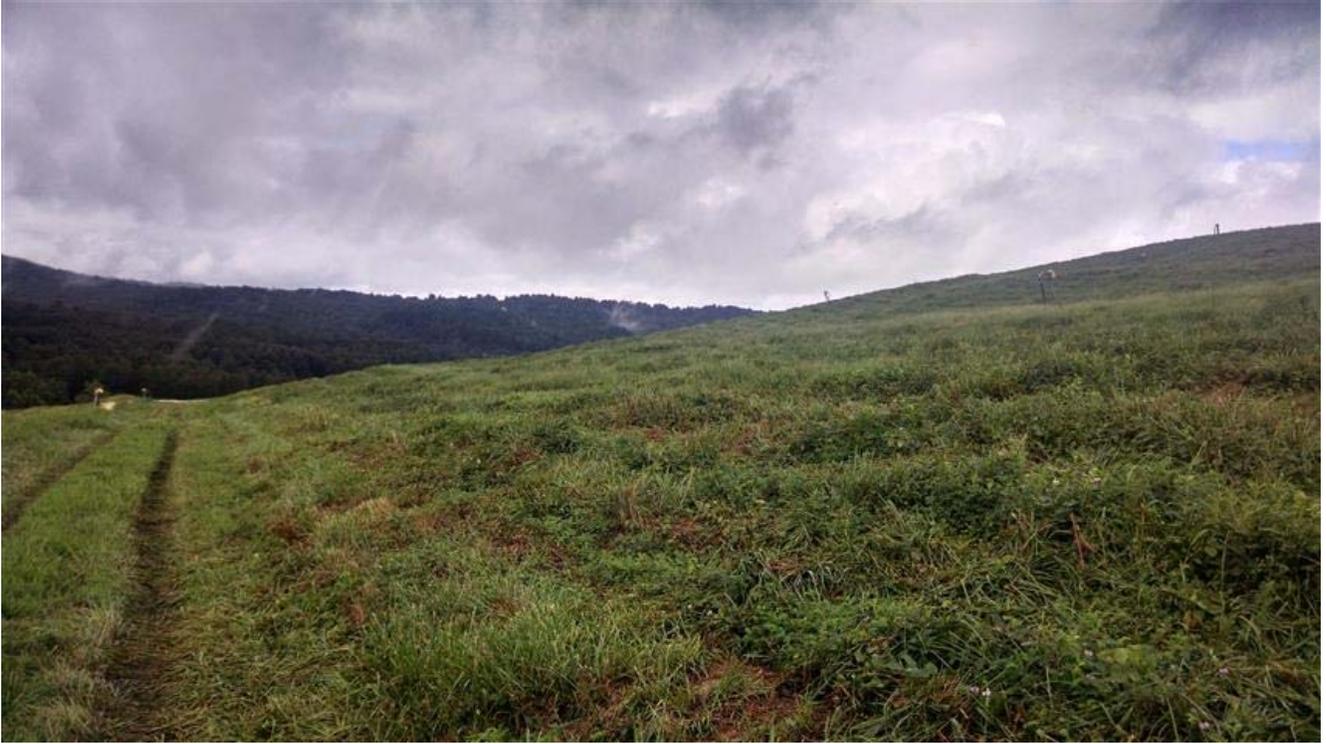
10. Good vegetative cover was observed on the landfill slopes and top. The landfill had been recently mowed at the time of inspection and no woody vegetation was observed.

Vegetation on East side of Landfill

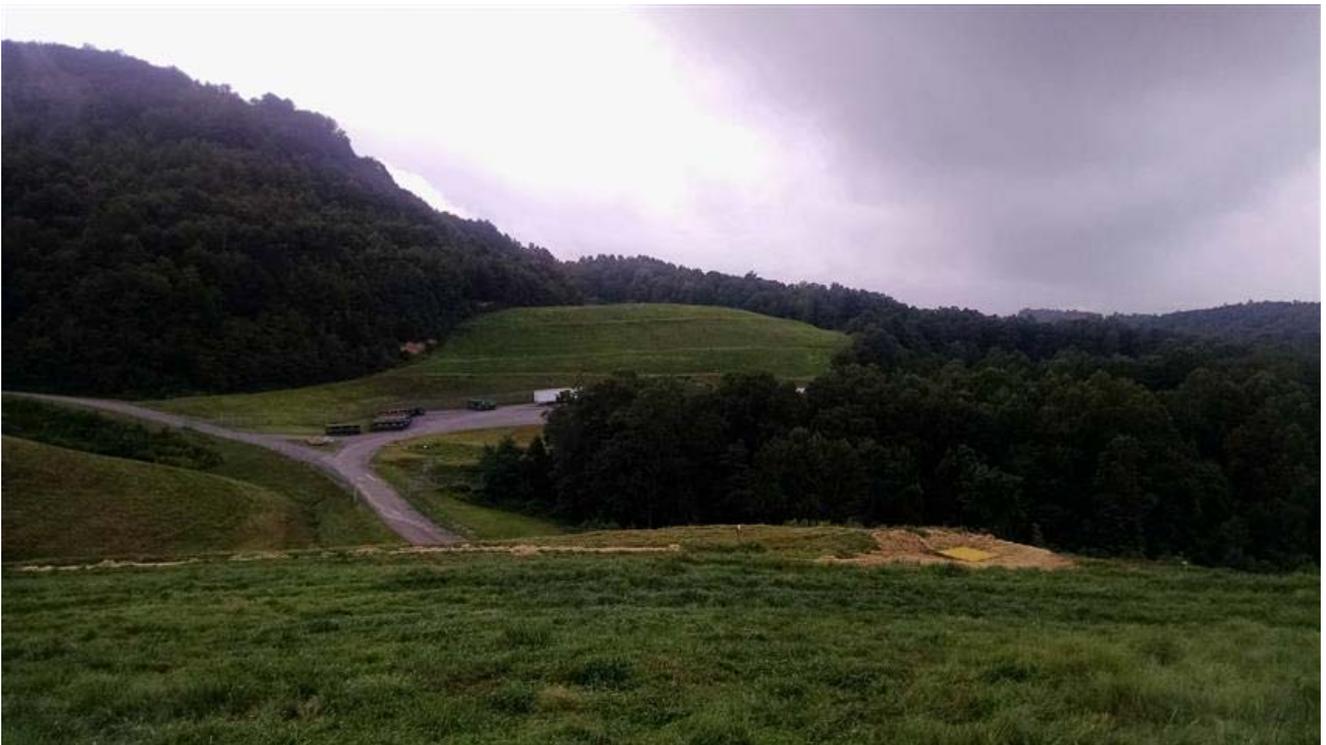
11. Edge of waste markers are installed.
12. Groundwater monitoring wells were locked and clear of vegetative growth.
13. A new stormwater grate has been installed on the southeast side of the landfill to help with stormwater management.

New Stormwater Structure on Southeast Side of Landfill
