RE: UST Closure Report
Convenient Food Mart #5433
205 West Morganton Road
Southern Pines, Moore County, NC 28387
Telephone # (919) 692-1616
Facility ID# 0-023516

Handex of the Carolinas, Inc. (Handex), has prepared this report documenting permanent closure of an underground storage tank (UST) at the above referenced facility on behalf of the UST owner, Dairy Mart Convenience Stores, Inc. (Dairy Mart).

**UNDERGROUND STORAGE TANK
SITE CLOSURE REPORT
Convenient Food Mart #5433
205 West Morganton Road
Southern Pines, Moore County, NC**

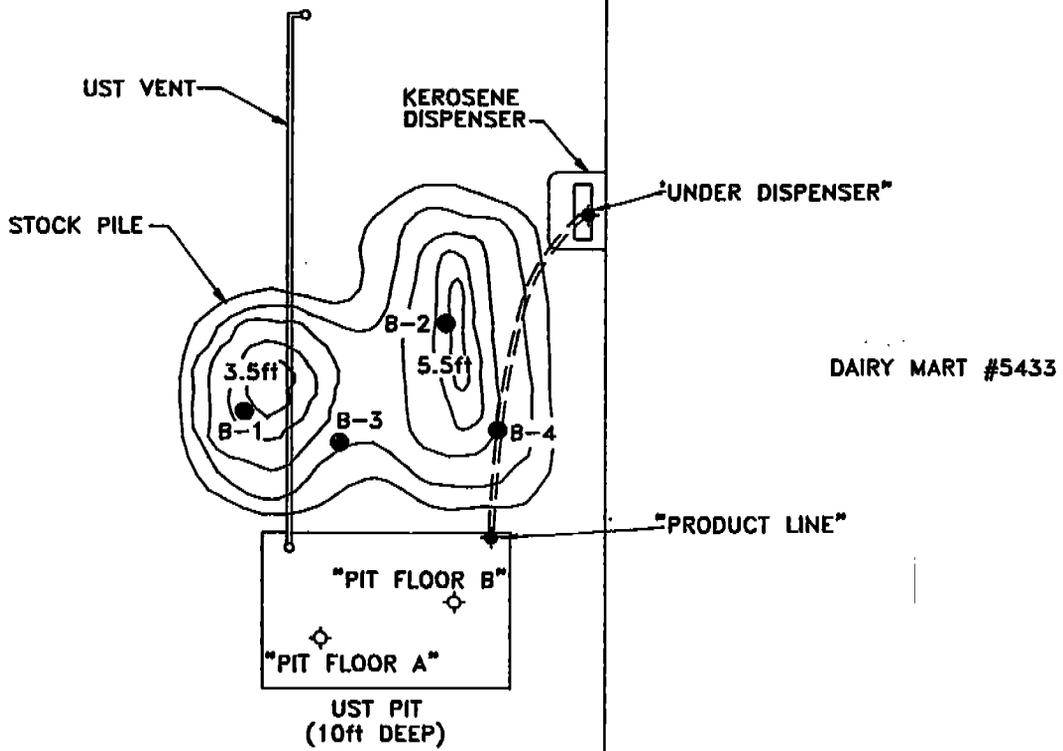
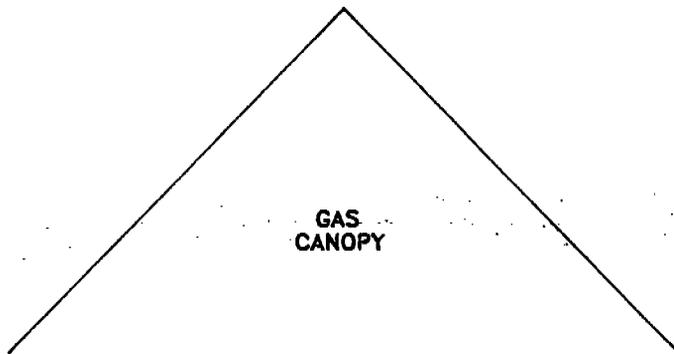
FIGURE 2
SITE PLAN

The kerosene dispenser was located approximately 19.5 feet from the tank pit edge, as depicted in **Figure 2**. The vent and product lines were grouted and abandoned in place.

Both field screening and laboratory analyses of each of the two stockpiled soil samples were below detectable levels. Laboratory analytical results indicate levels of DRO-TPH for samples *Pit Floor B* and *Under Dispenser* of 11 milligrams per kilogram (mg/kg) or ppm and 752 mg/kg, respectively. Analyses of other samples were below detectable limits. The results of the field screening and laboratory analyses are summarized in **Table 1**. The sampling locations are depicted in **Figure 2**.

Handex recommends installing one soil boring at the former location of the kerosene dispenser terminated at the water table. Split-spoon soil samples should be collected every two feet and field screened. The most impacted sample and a sample collected immediately above the water table should be analyzed at a certified laboratory by EPA methods 5030 and 3550. If field observations indicate obvious potential impact to groundwater, a monitoring well should be installed within the soil boring. In addition, a receptor survey should be conducted to determine the existence and location of any potable wells within 1,500 feet of the site. The resulting information will help determine if further action is warranted.
