FACILITY COMPLIANCE INSPECTION REPORT
Division of Waste Management
Solid Waste Section

Date of Inspection: 22 August 2016

Craven County Landfill
7400 Old Highway 70
New Bern, NC

Closed MSWLF under Subtitle D

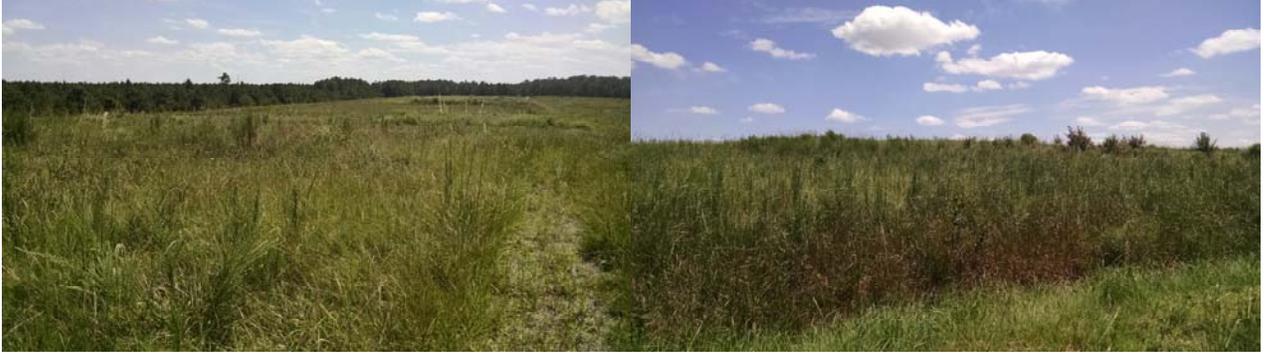
- 7) Overall this facility has a well-established and maintained cover crop of native warm season grasses. The cover crop is mowed twice per year. *The cover crop is in need of mowing. Plans need to be underway for mowing the cover crop.
